CONSTRUCTION MONITORING REPORT

Eversource	Transmission	Lines:
	F10	7

Eversource Seacoast Reliability Project

Construction Monitoring Report #118

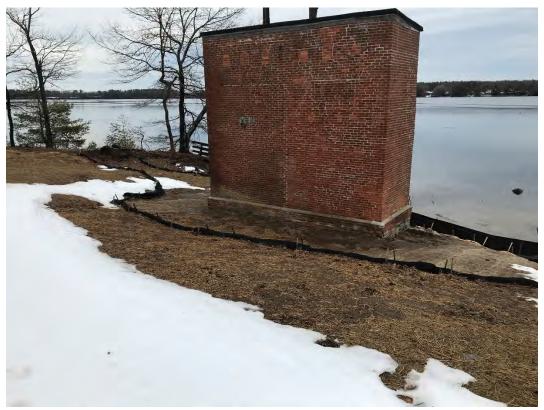
Fig 1: Slope leading down to cable house and salt marsh restoration at the Eversource property/west side of the bay. Viewing northeast. (03-01-21)

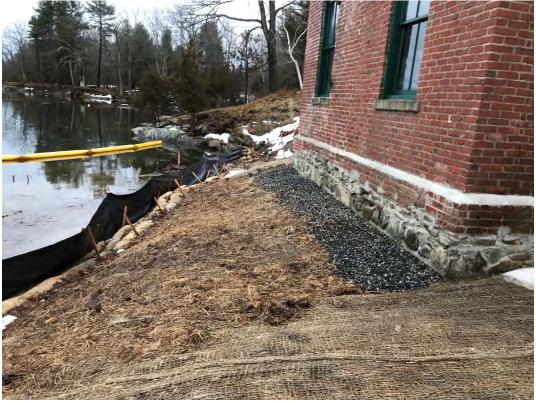
Fig 2: Slope between the cable house and salt marsh restoration at the Eversource property/west side of the bay. Viewing south. (03-01-21)

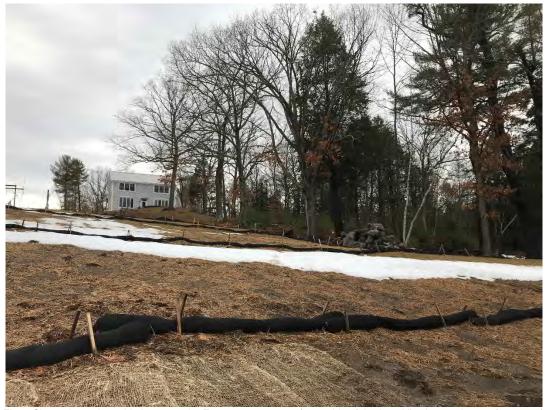
Fig 3: Slope above the cable house at the Eversource property/west side of the bay. Viewing northwest. (03-01-21)

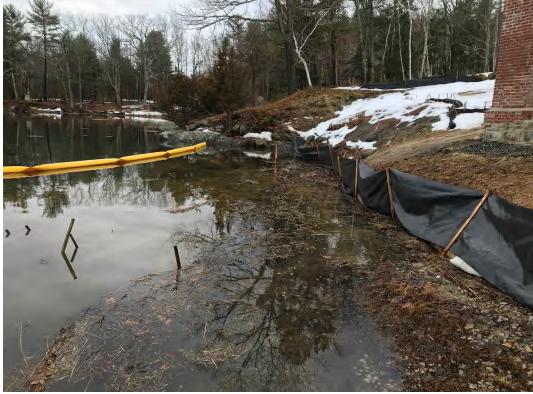
Fig 4: Toe of the slope and salt marsh restoration at the Eversource property/west side of the bay. Viewing south. (03-01-21)

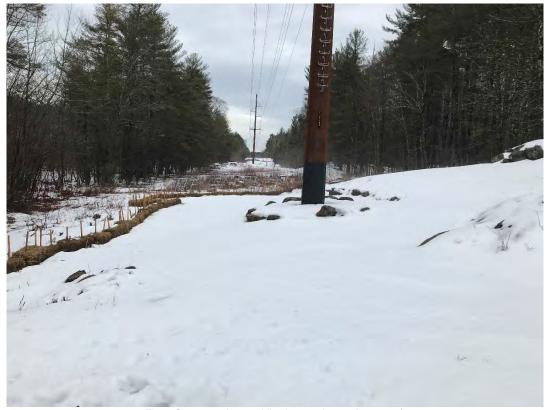
Fig 5: Str. 89 work area. Viewing southeast. (03-01-21)

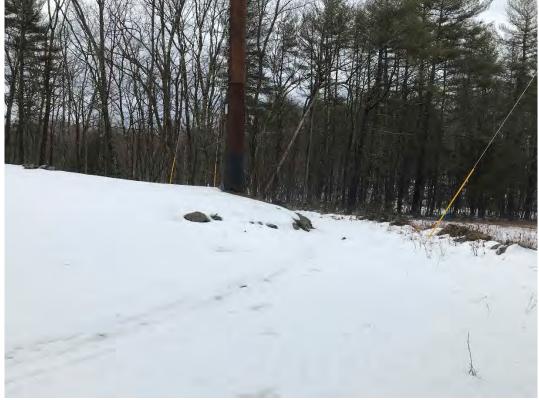
Fig 6: Str. 90 work area. Viewing northeast. (03-01-21)

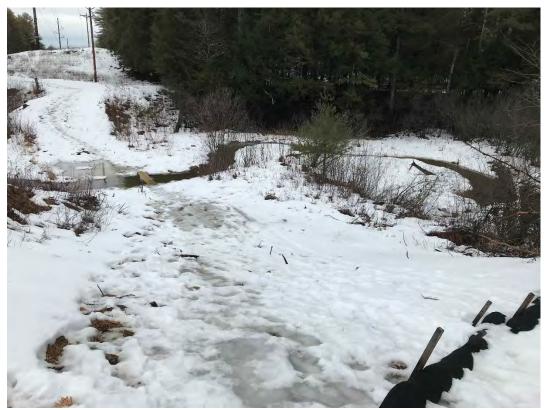
Fig 7: Stream DS46 between Strs. 51 and 52. Viewing northeast. (03-01-21)

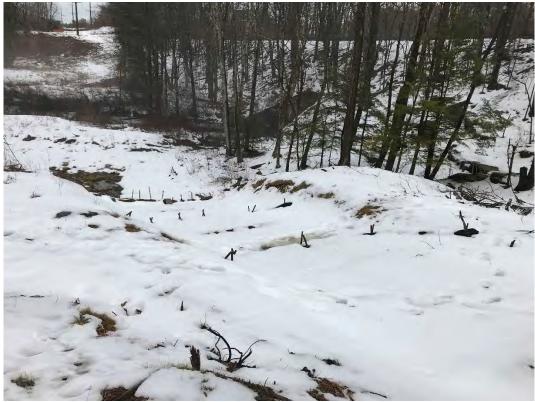
Fig 8: Lower portion of slope between Strs. 28 and 29. Viewing northeast. (03-01-21)

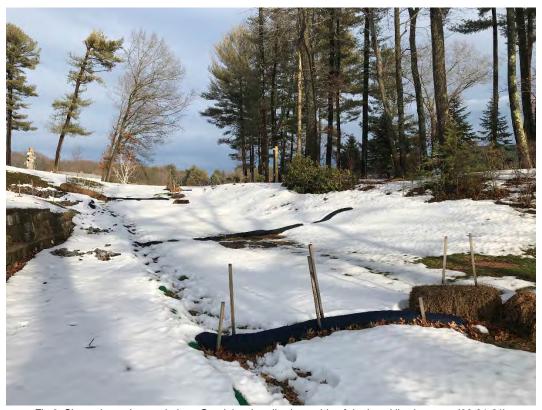
Fig 9: Slope above the manhole at Gundalow Landing/east side of the bay. Viewing east. (03-01-21)

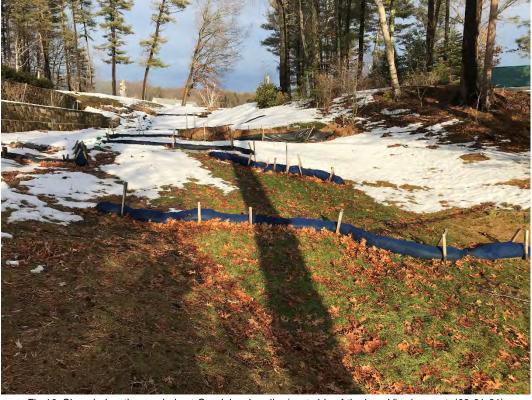
Fig 10: Slope below the manhole at Gundalow Landing/east side of the bay. Viewing east. (03-01-21)

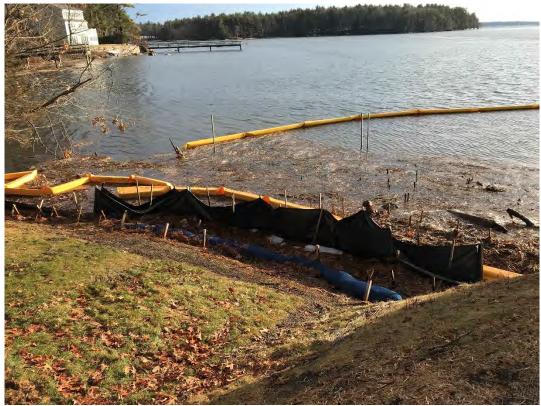
Fig 11: Toe of the slope at Gundalow Landing/east side of the bay. Viewing south. (03-01-21)

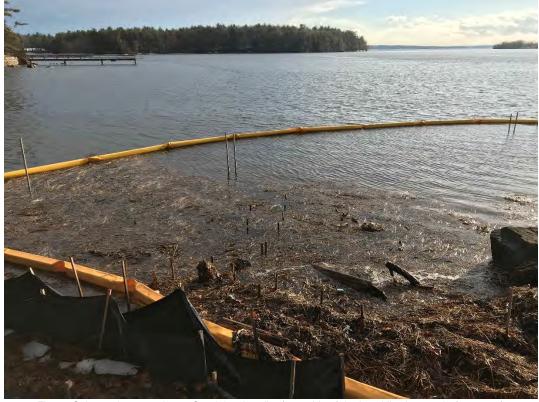
Fig 12: Salt marsh restoration at Gundalow Landing/east side of the bay. Viewing south. (03-01-21)
