CONSTRUCTION MONITORING REPORT

Eversource Transmission Lines:
F107

**Madbury, Durham,
Newington, Portsmouth, NH**

TYPE OF INSPECTION: Weekly Storm Event Incident Corrective Action

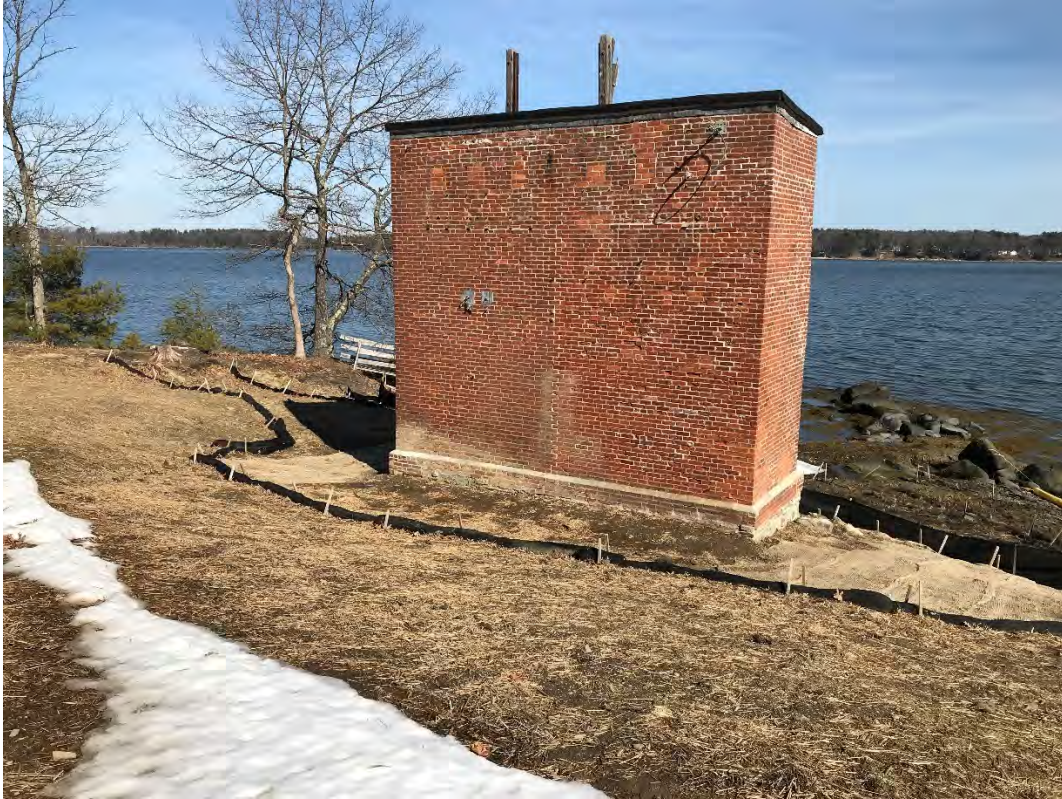
Areas that have been restored and mulched, but have little germination: Hannah Ln, Eversource property/west side of bay, Strs. 89-90

Fig 1: Slope leading down to cable house and salt marsh restoration at the Eversource property/west side of the bay. Viewing northeast. (03-10-21)

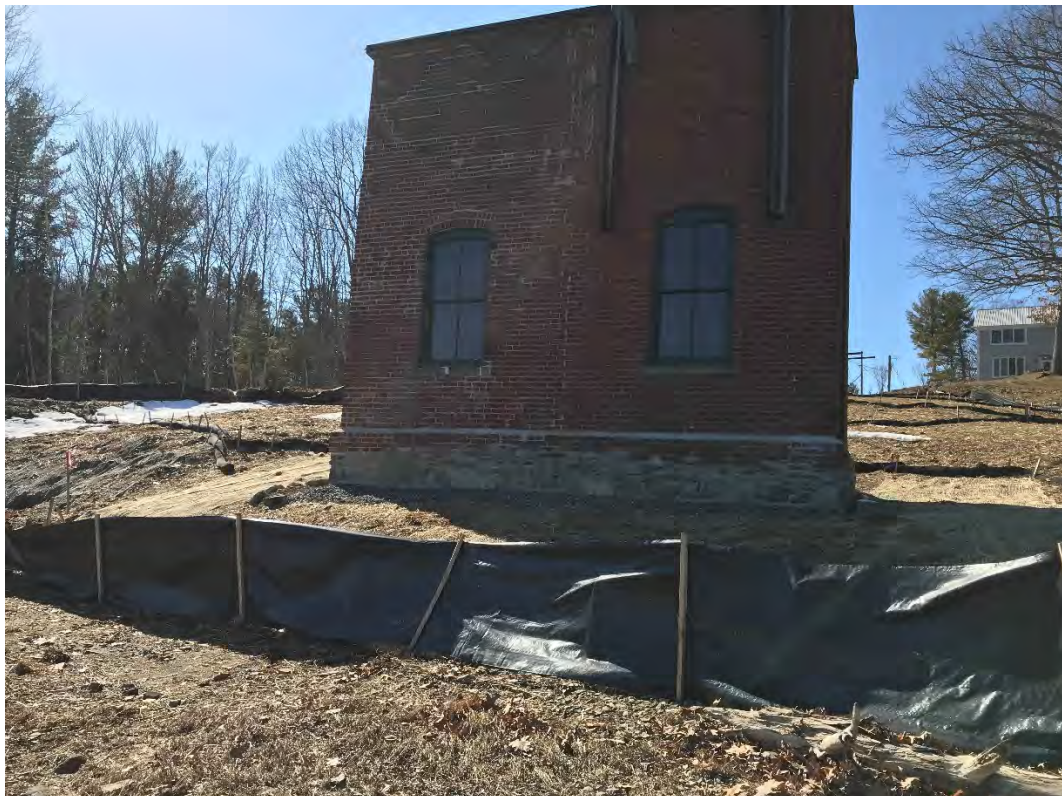
Fig 2: Slope between the cable house and salt marsh restoration at the Eversource property/west side of the bay. Viewing southwest. (03-10-21)

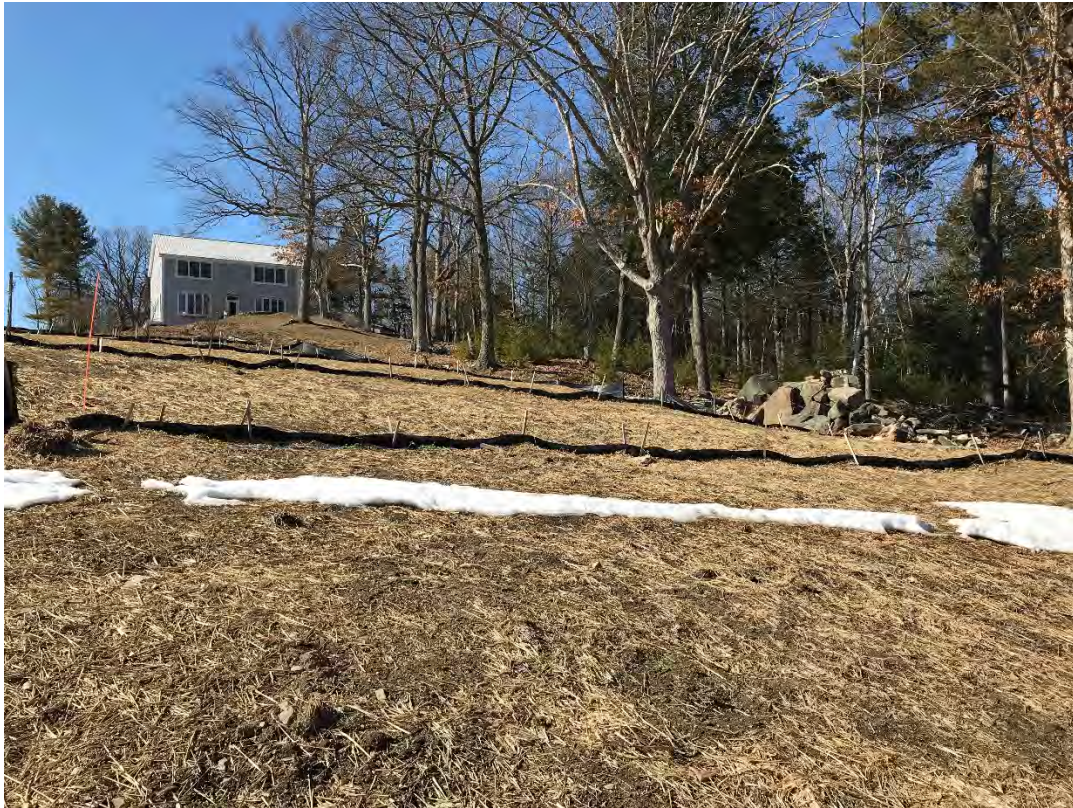
Fig 3: Slope above the cable house at the Eversource property/west side of the bay. Viewing northwest. (03-10-21)

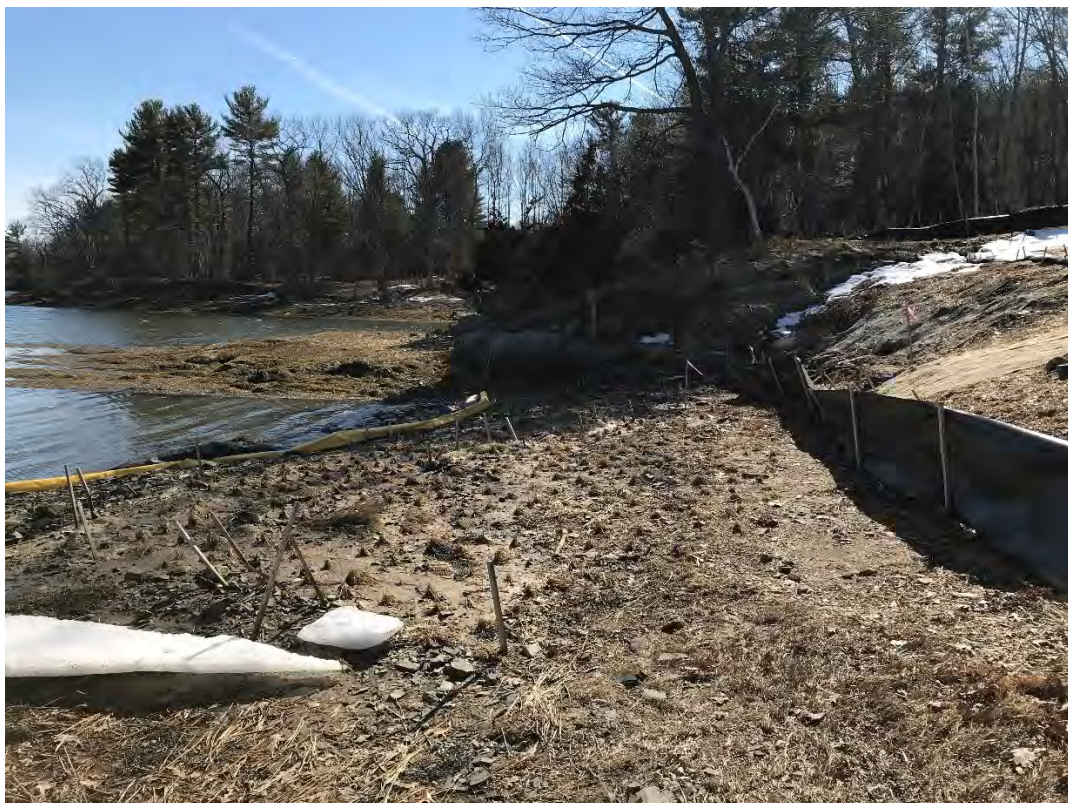
Fig 4: Toe of the slope and salt marsh restoration at the Eversource property/west side of the bay. Viewing south. (03-10-21)

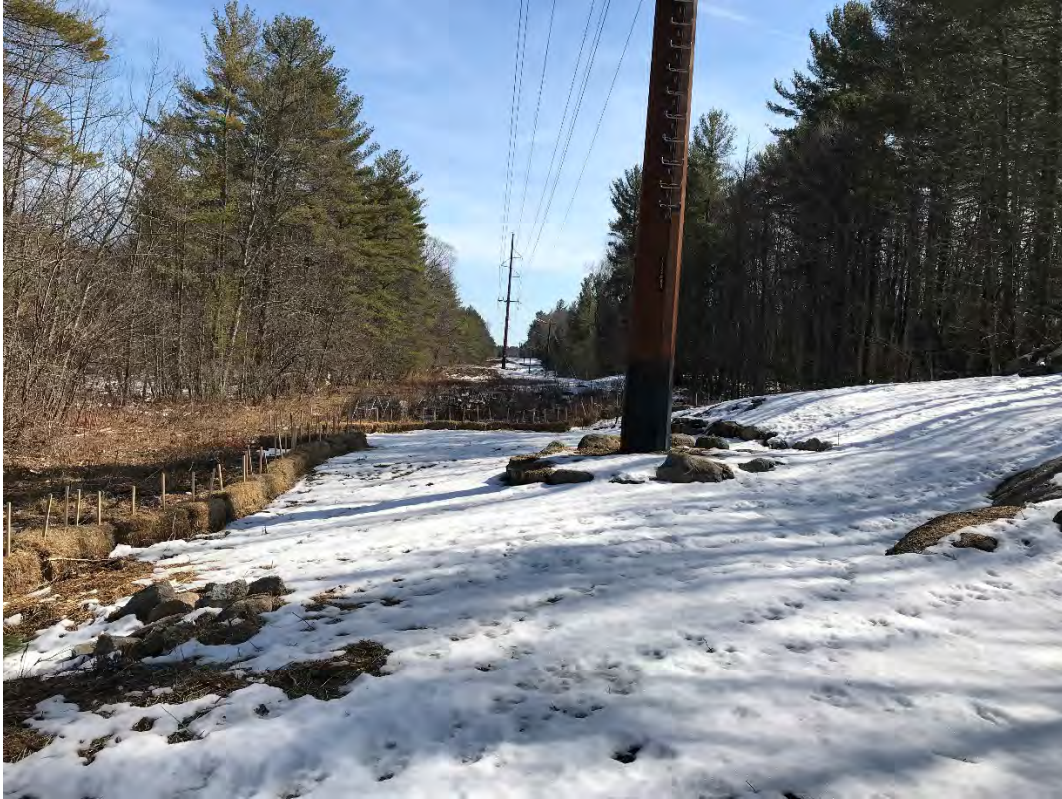
Fig 5: Str. 89 work area. Viewing southeast. (03-10-21)

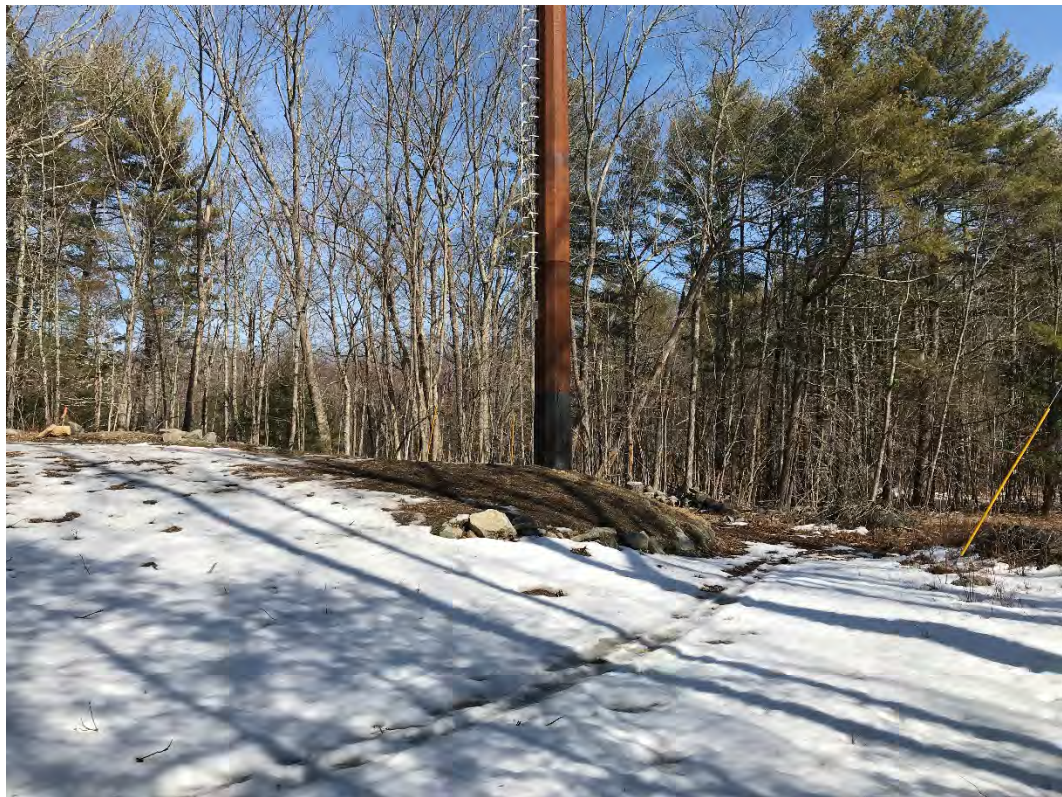
Fig 6: Str. 90 work area. Viewing northeast. (03-10-21)

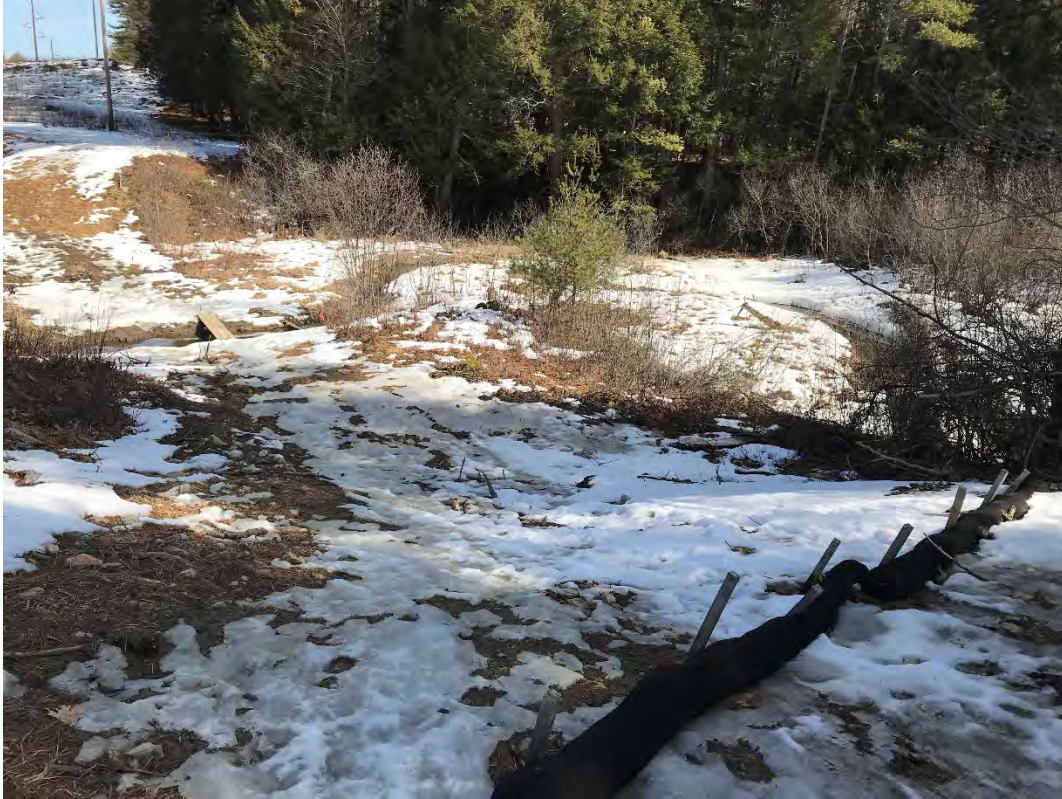
Fig 7: Stream DS46 between Strs. 51 and 52. Viewing northeast. (03-10-21)

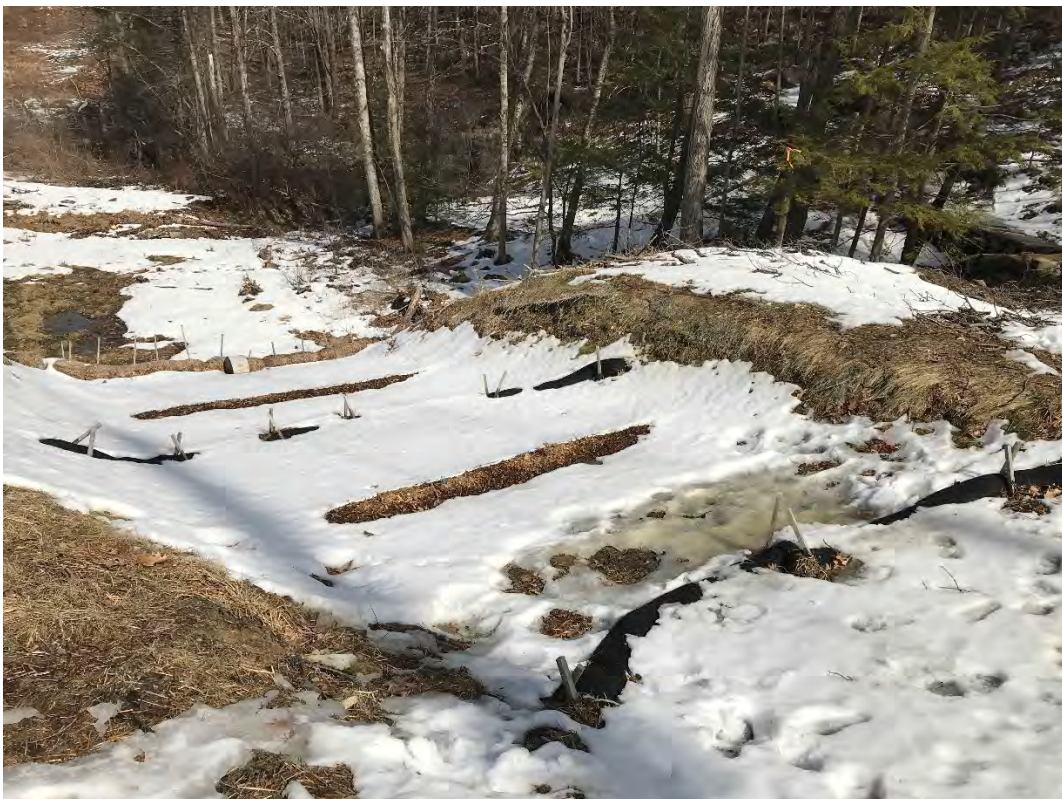
Fig 8: Lower portion of slope between Strs. 28 and 29. Viewing northeast. (03-10-21)

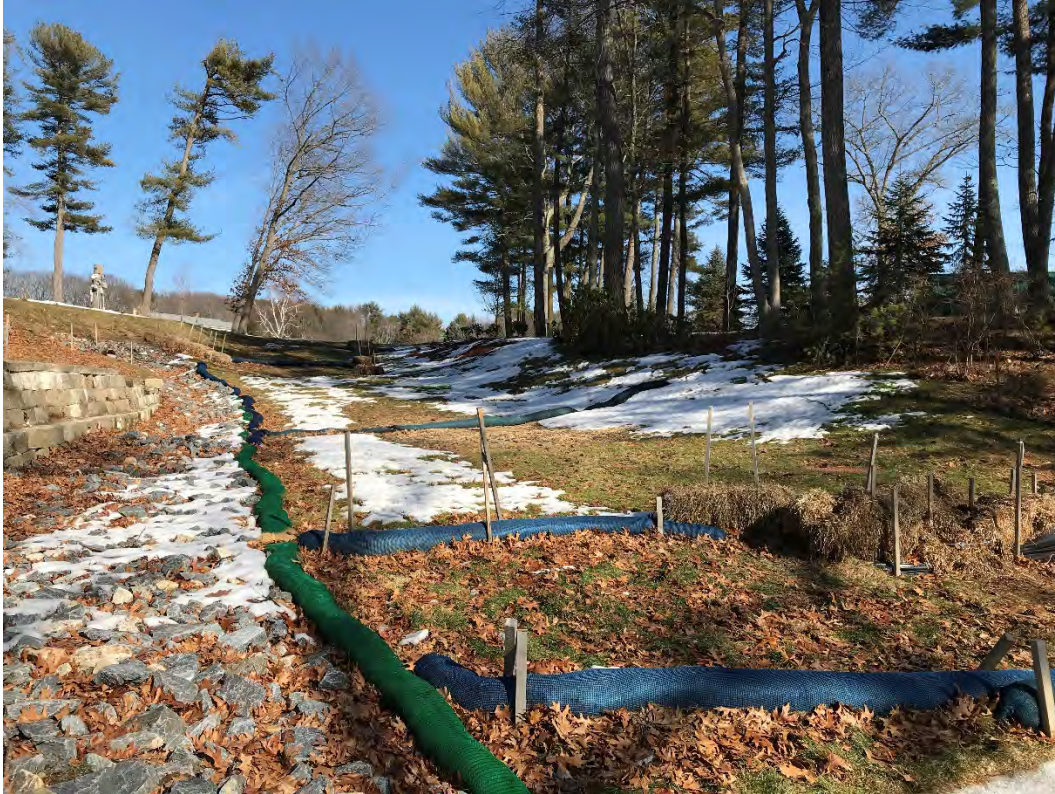
Moderate germination: Strs. 4-6, Strs. 7-21, 25-34, 36-88, 91-101, 107, 109-112, 122-127, 129-130, and Gundalow Landing/east side of bay.

Fig 9: Slope above the manhole at Gundalow Landing/east side of the bay. Viewing east. (03-10-21)

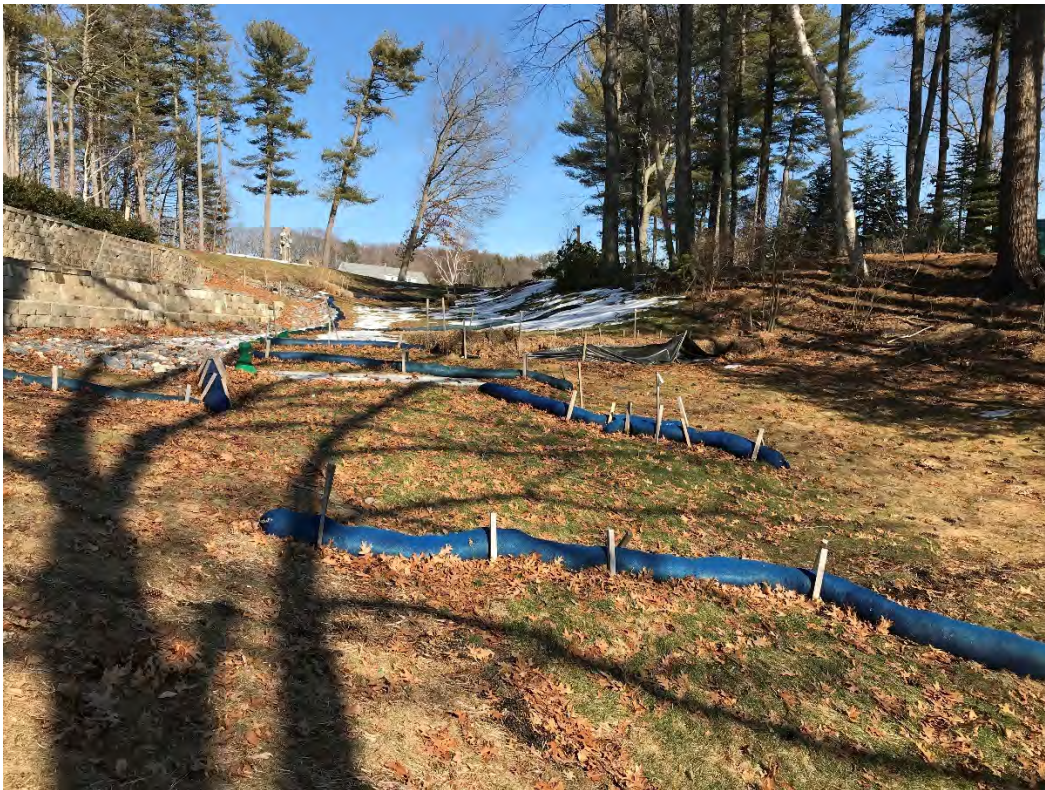
Fig 10: Slope below the manhole at Gundalow Landing/east side of the bay. Viewing east. (03-10-21)

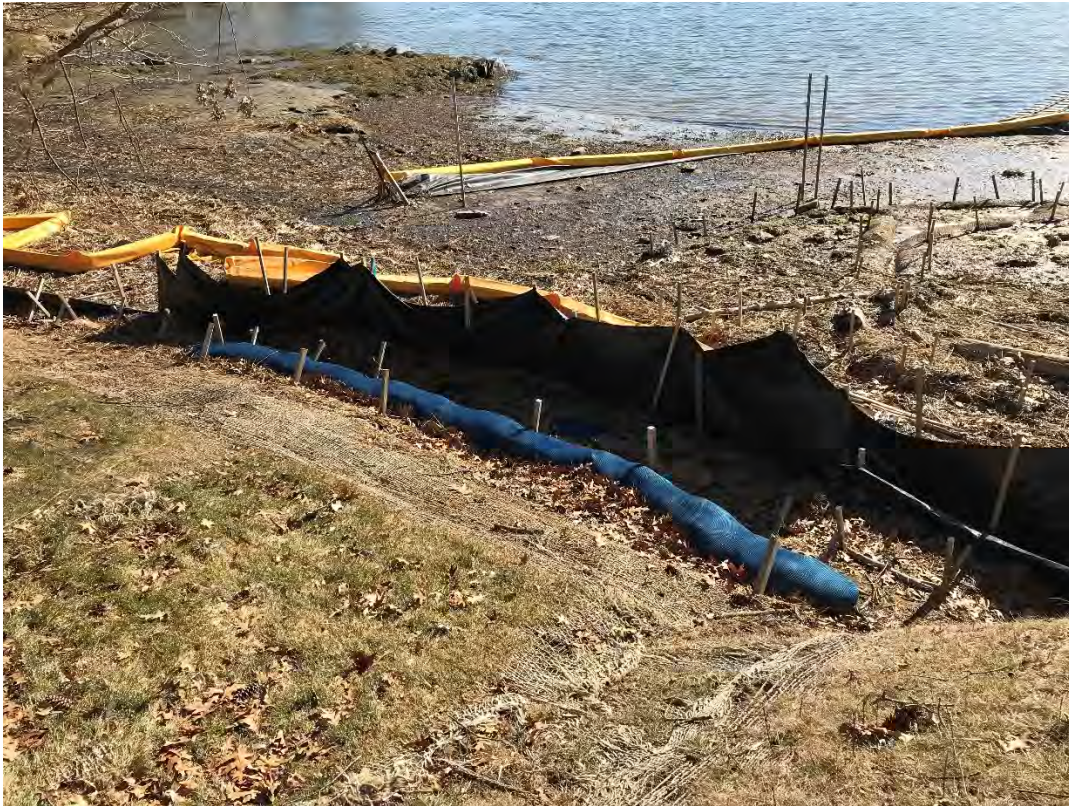
Fig 11: Toe of the slope at Gundalow Landing/east side of the bay. Viewing south. (03-10-21)

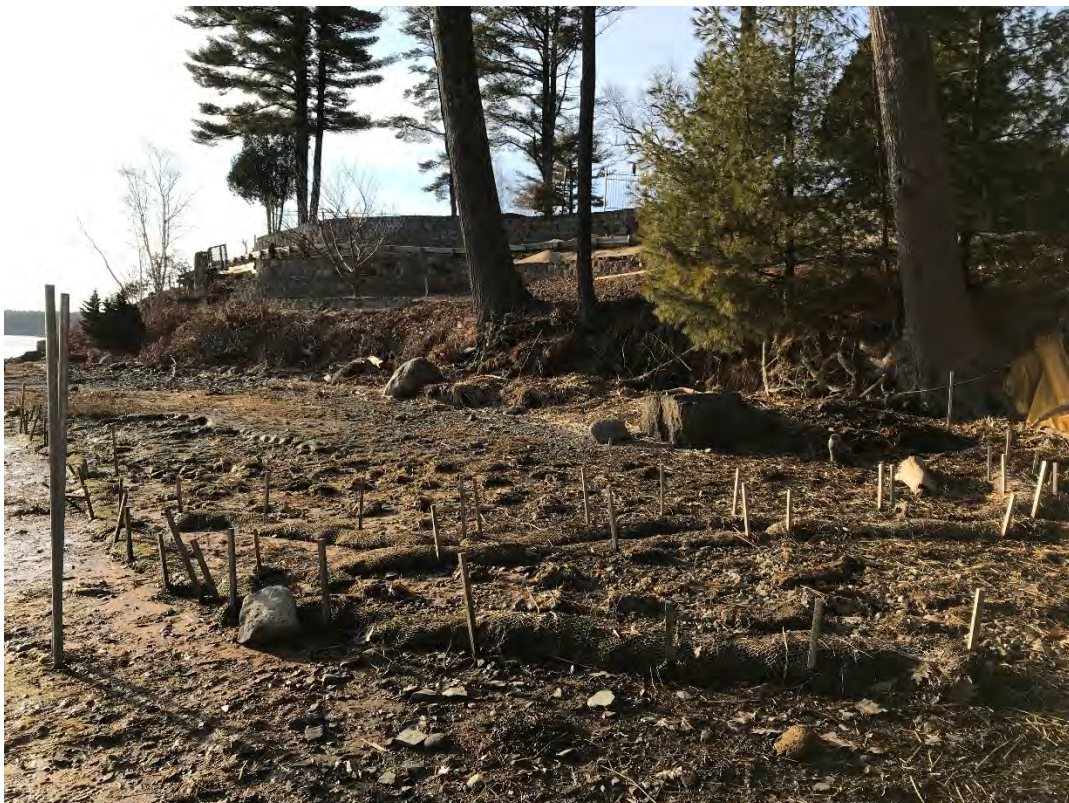
Fig 12: Salt marsh restoration at Gundalow Landing/east side of the bay. Viewing south. (03-10-21)
