DRAINAGE MONITORING REPORT

F107 - Seacoast Reliability Project

Newington, New Hampshire

04.0190967.00

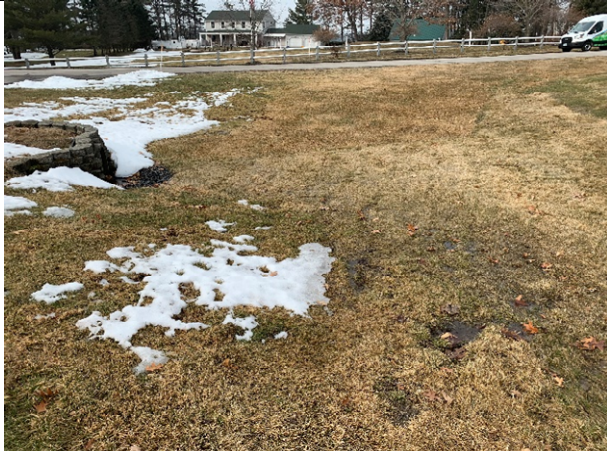
29 Gundalow - 1 (Drainage Area)

Observations/Notes: Intermittent standing water, max depth approx. 1".

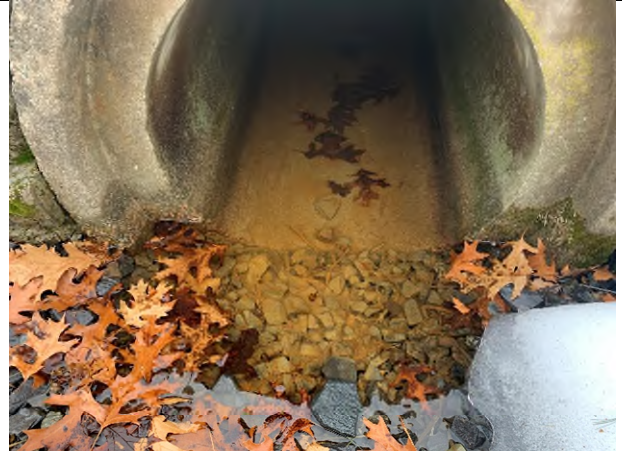
29 Gundalow - 2 (Culvert)

pH: **12.1**

Observations/Notes: Approx. 6" of flowing water within culvert inlet. Crystalline precipitate observed on stone and leaf litter under water surface.

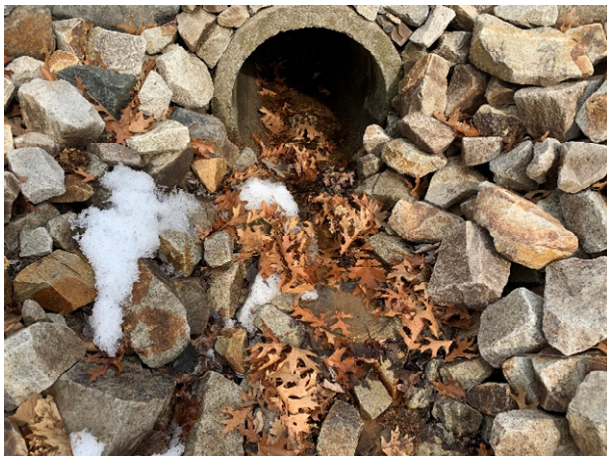
64 Gundalow - 1 (Drainage Course)

pH: **11.8**

Observations/Notes: Accessible flowing water extending approx. 3' beyond culvert outlet.

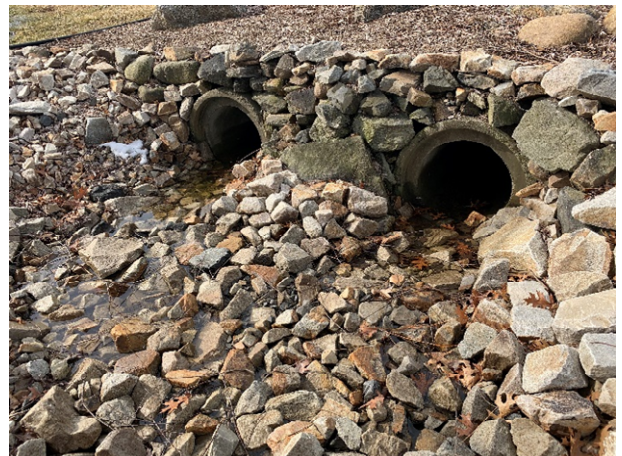
64 Gundalow - 2 (Drainage Course)

pH: **10.4**

Observations/Notes: Large area of intermittent water extending approx. 5' from culvert inlets.

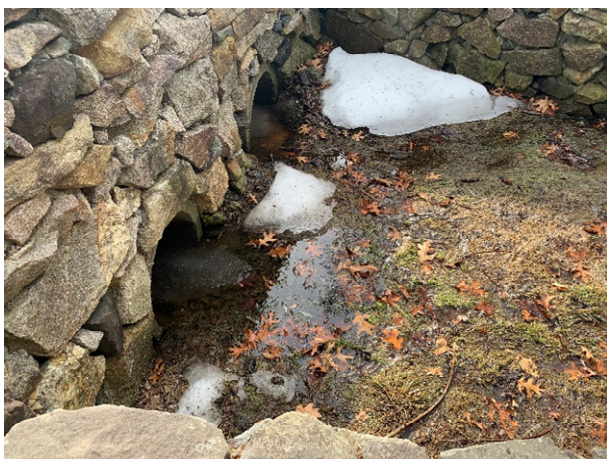
4 Brickyard Circle - 1 (Drainage Course)

pH: **9.4**

Observations/Notes: Large area of water in drainage course at culvert outlets, max depth approx. 8".

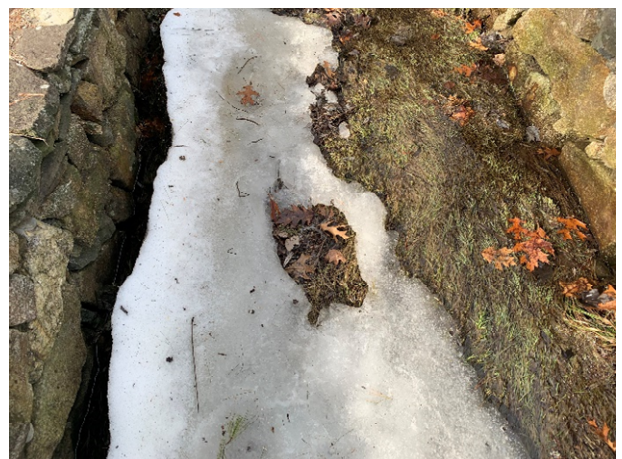
4 Brickyard Circle - 2 (Drainage Course)

pH: **7.9**

Observations/Notes: Water flowing approx. 2" deep, some snow and ice still in raceway.

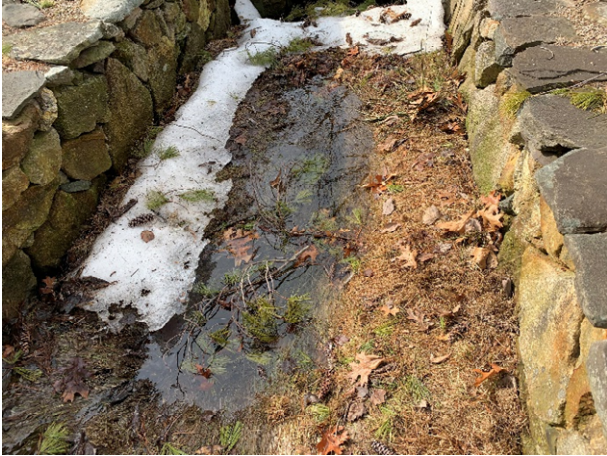
4 Brickyard Circle – 3 (Drainage Course)

pH: **7.6**

Observations/Notes: Water flowing approx. 3" deep, some snow and ice still in raceway.
