CONSTRUCTION MONITORING REPORT

Eversource Transmission Lines:
F107

**Madbury, Durham,
Newington, Portsmouth, NH**

NAI Project No:
23840.39

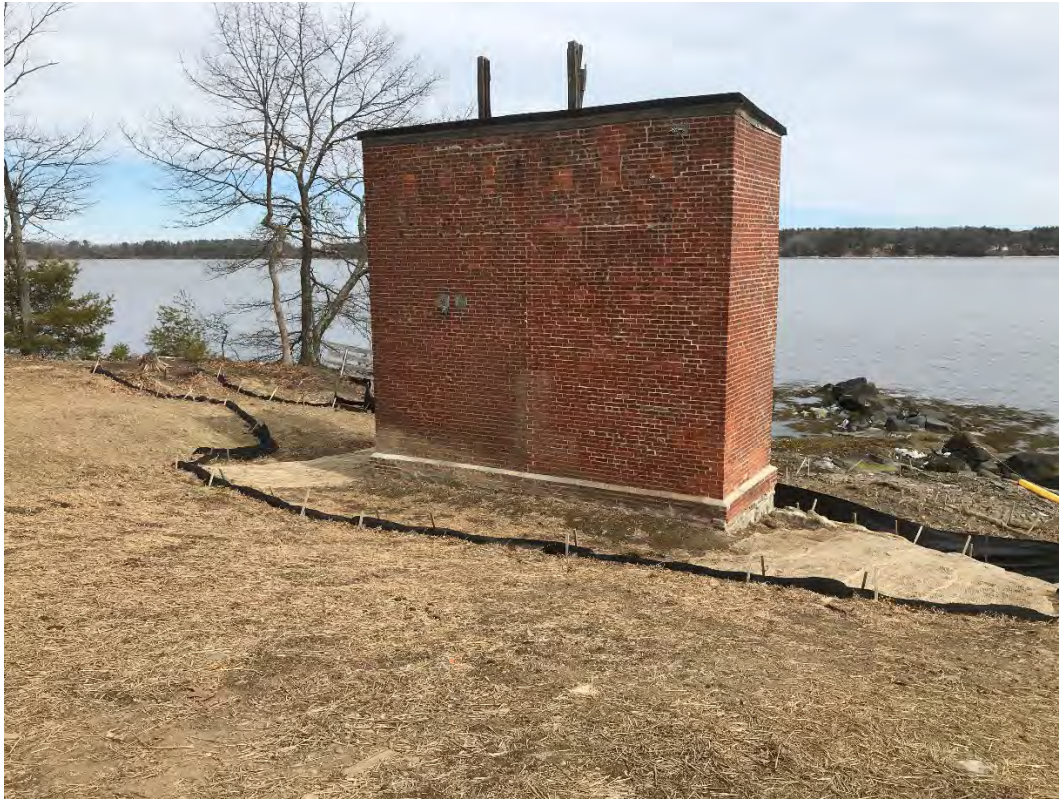
Areas that have been restored and mulched, but have little germination: Hannah Ln, Eversource property/west side of bay, Strs. 89-90

Fig 1: Slope leading down to cable house and salt marsh restoration at the Eversource property/west side of the bay. Viewing northeast. (03-16-21)

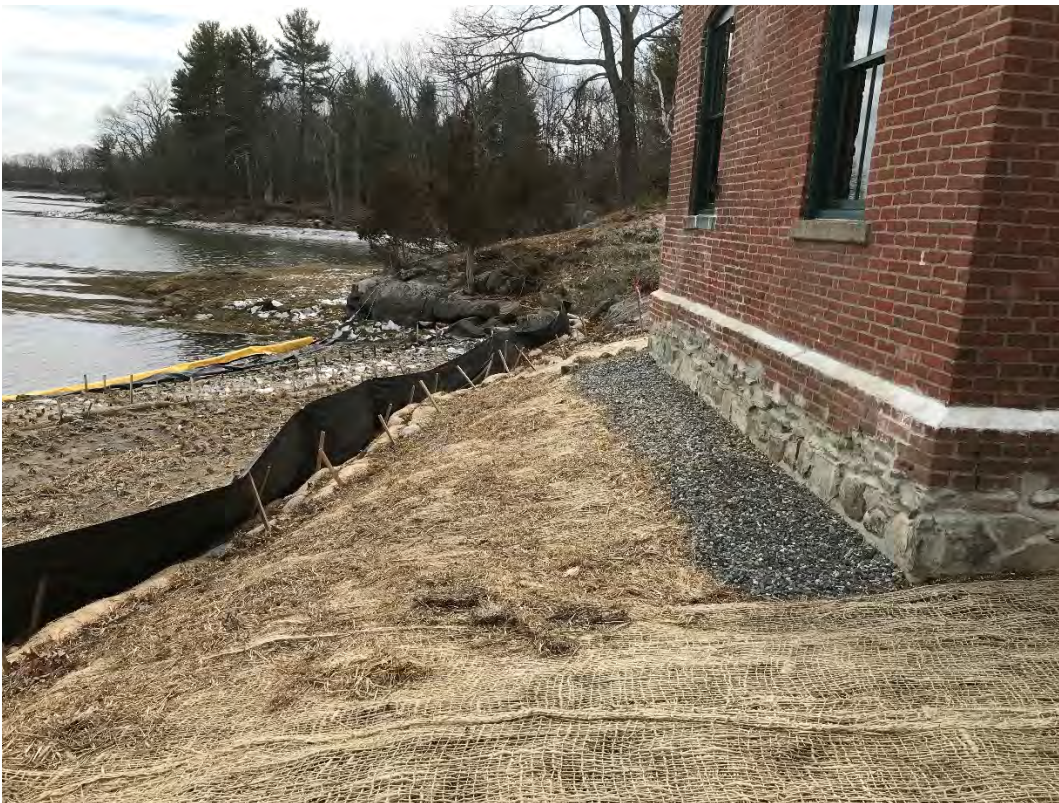
Fig 2: Slope between the cable house and salt marsh restoration at the Eversource property/west side of the bay. Viewing south. (03-16-21)

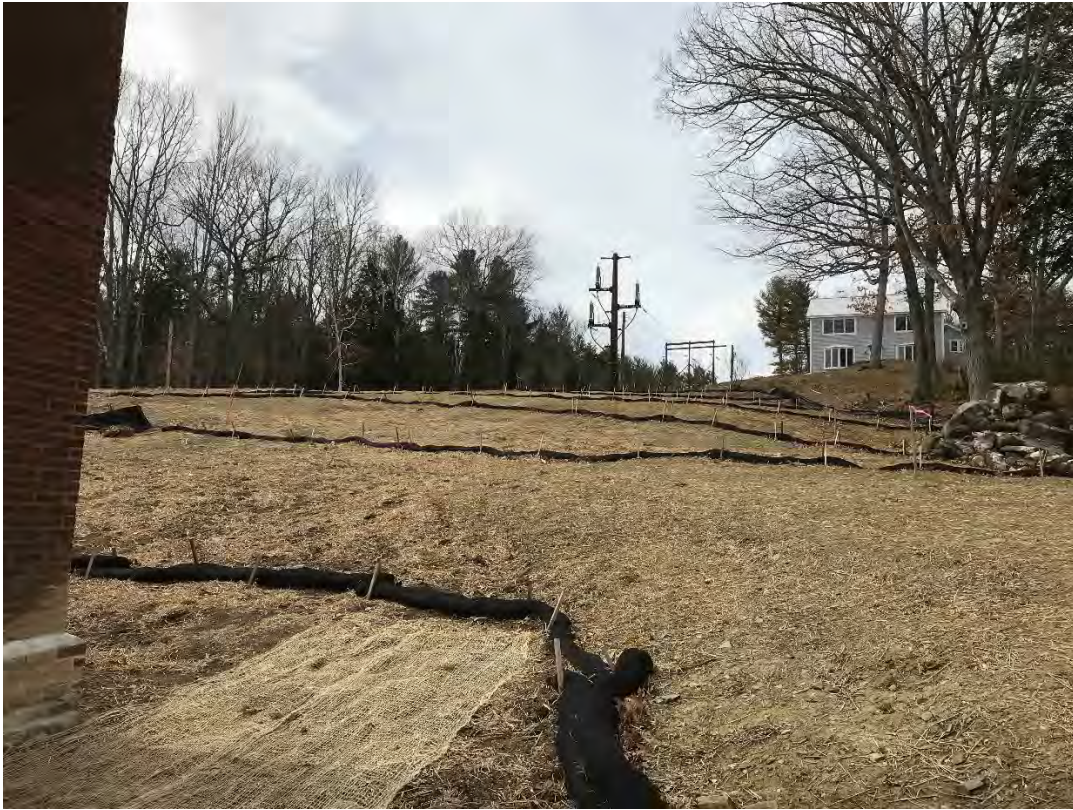
Fig 3: Slope above the cable house at the Eversource property/west side of the bay. Viewing southwest. (03-16-21)

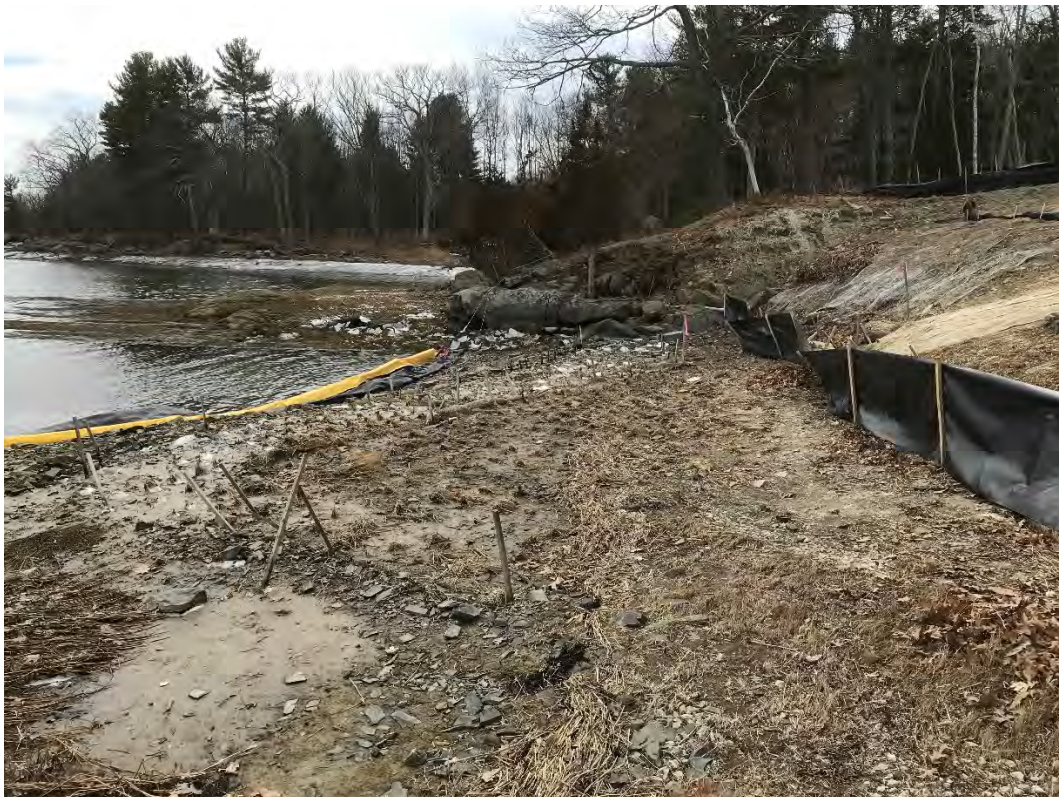
Fig 4: Toe of the slope and salt marsh restoration at the Eversource property/west side of the bay. Viewing south. (03-16-21)

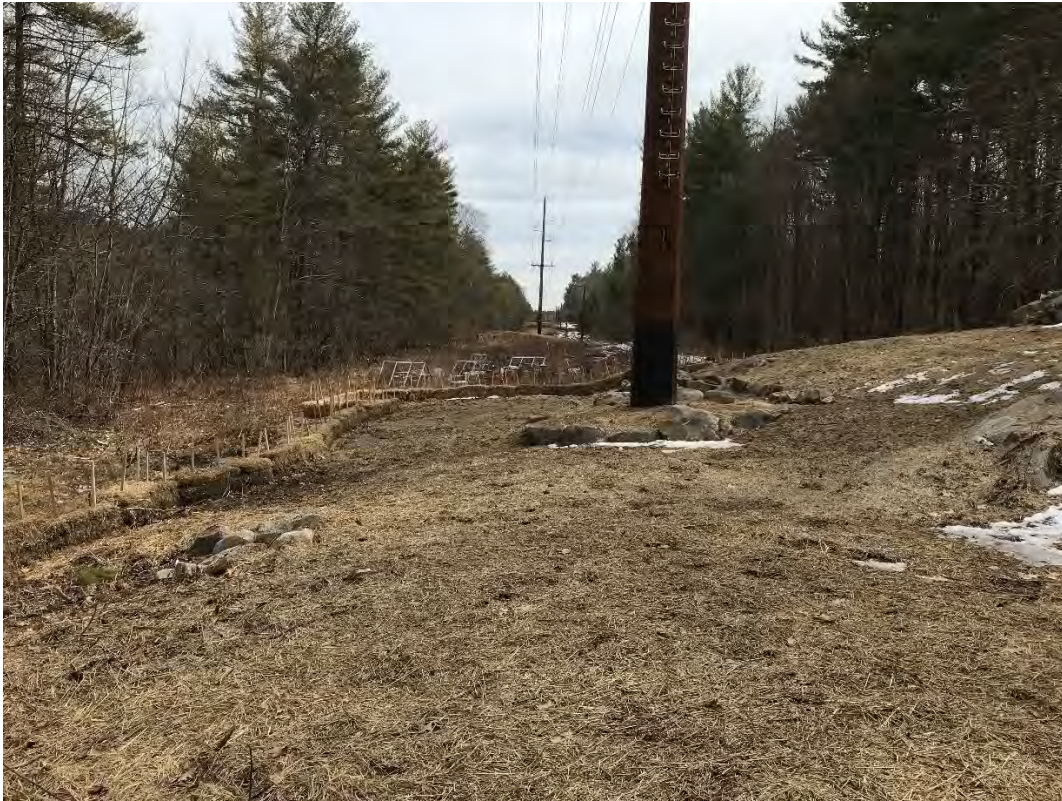
Fig 5: Str. 89 work area. Viewing southeast. (03-16-21)

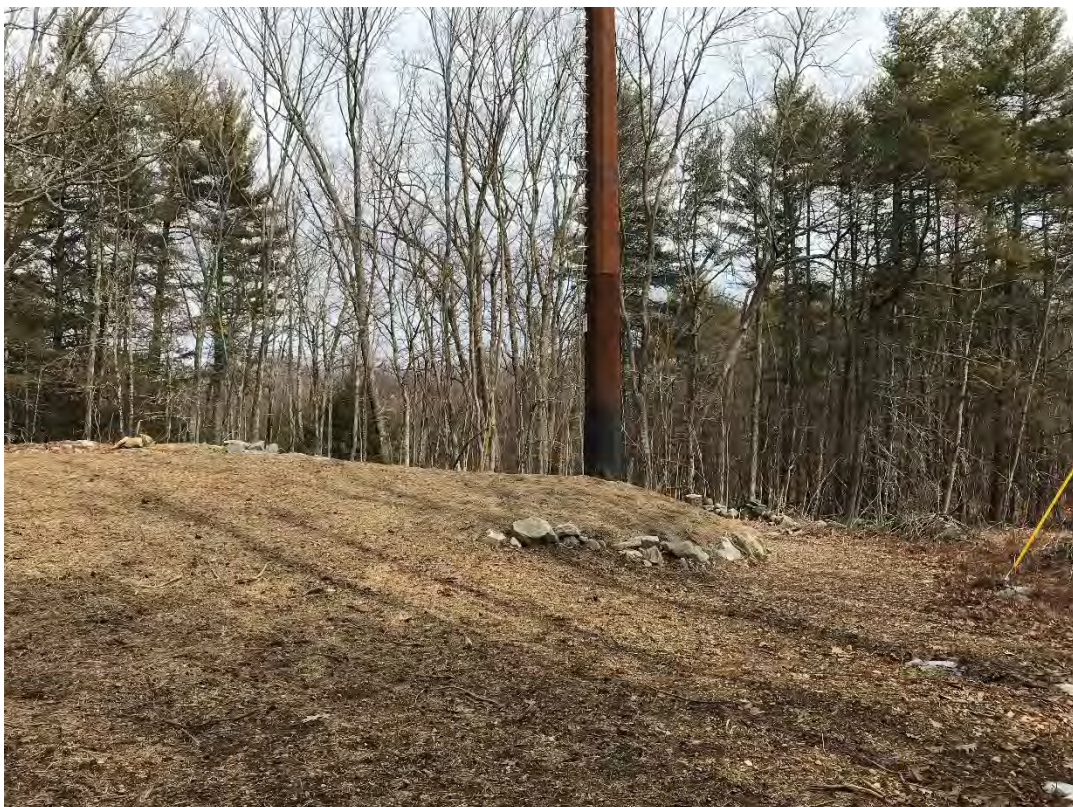
Fig 6: Str. 90 work area. Viewing northeast. (03-16-21)

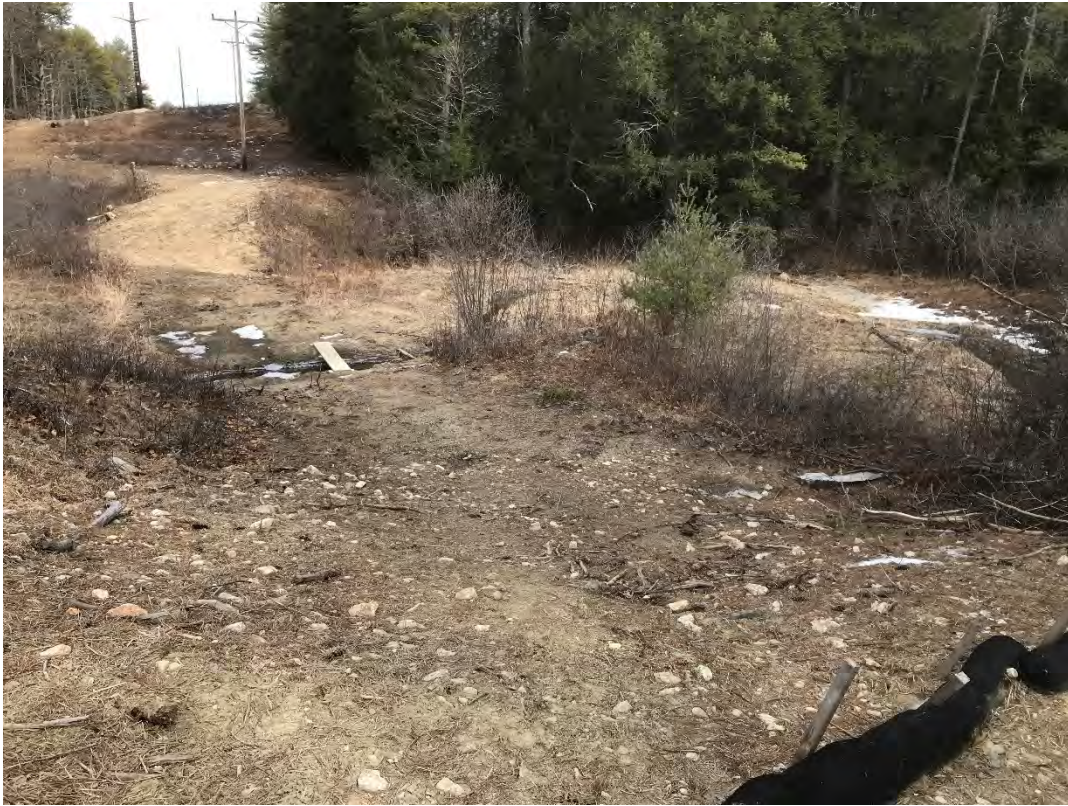
Fig 7: Stream DS46 between Strs. 51 and 52. Viewing northeast. (03-16-21)

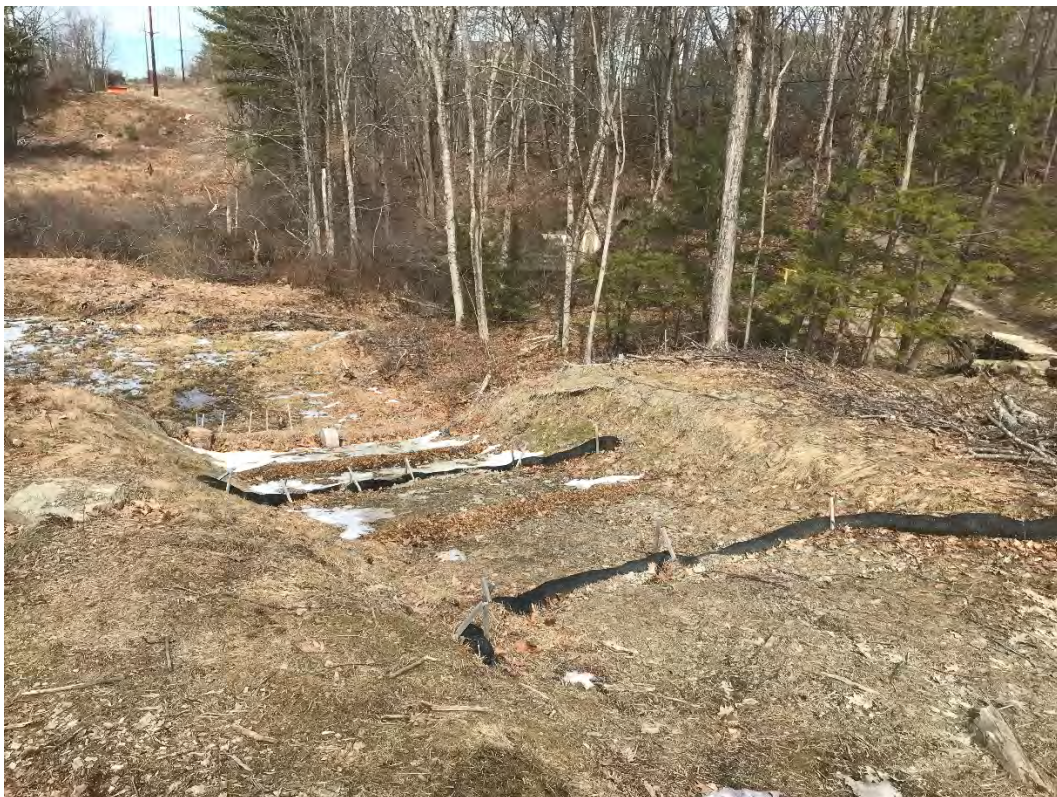
Fig 8: Lower portion of slope between Strs. 28 and 29. Viewing northeast. (03-16-21)

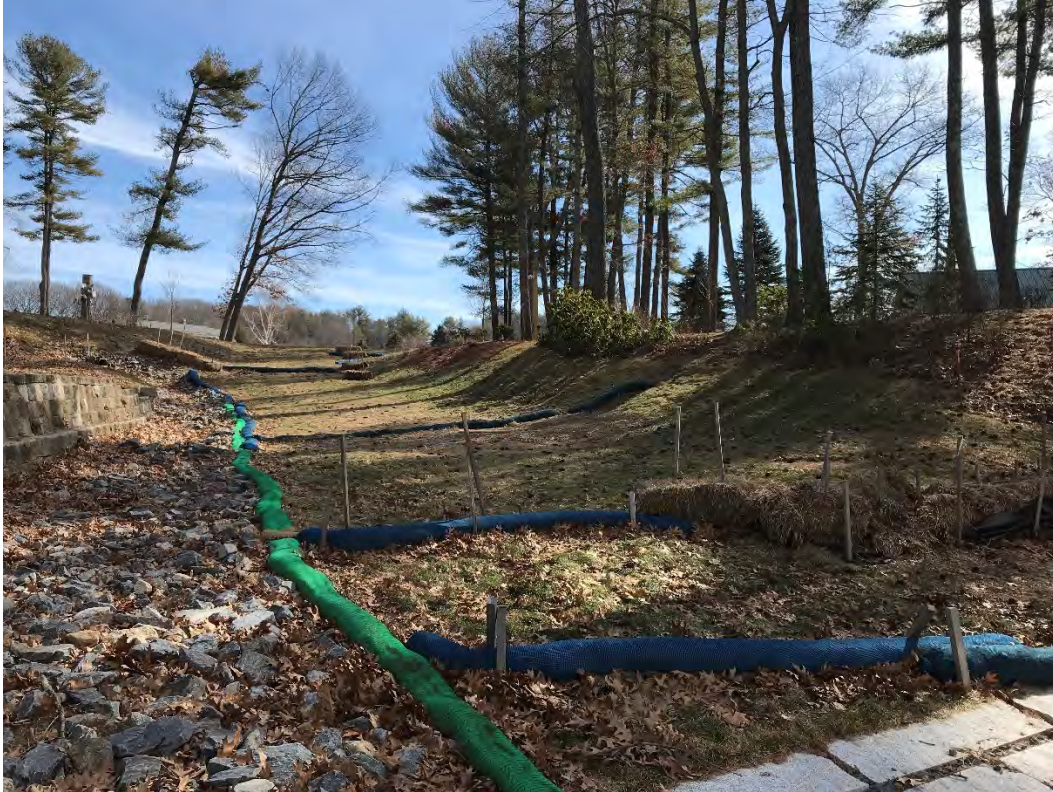
Fig 9: Slope above the manhole at Gundalow Landing/east side of the bay. Viewing east. (03-16-21)

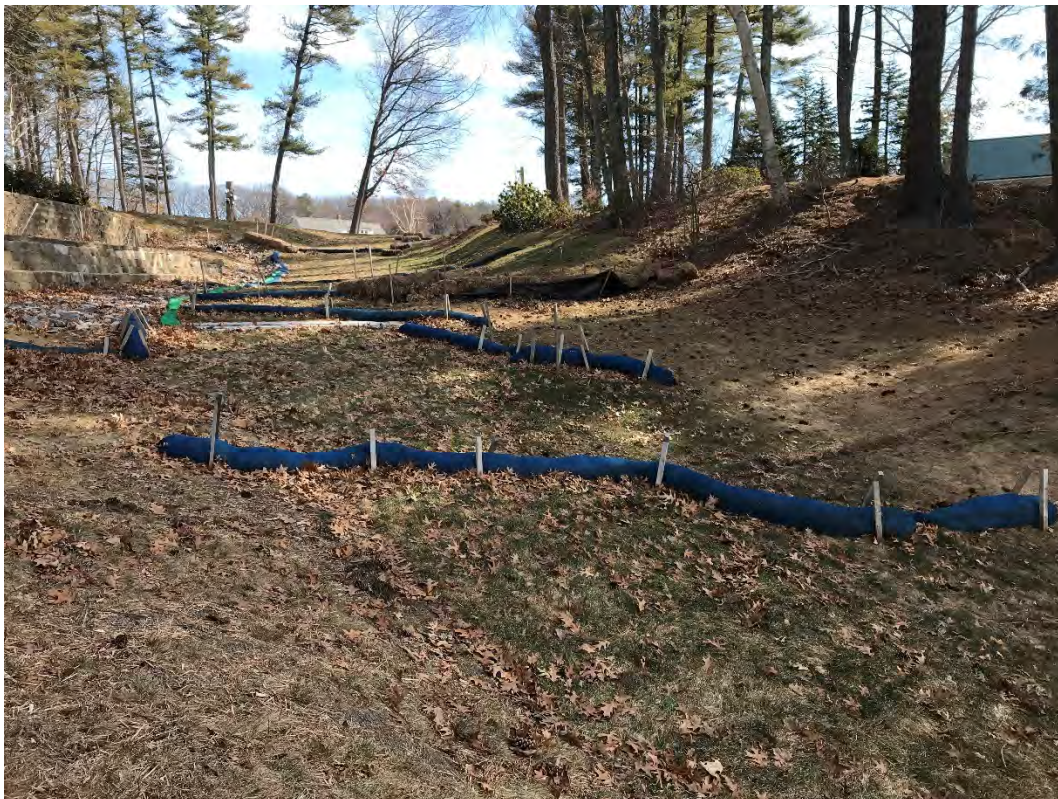
Fig 10: Slope below the manhole at Gundalow Landing/east side of the bay. Viewing east. (03-16-21)

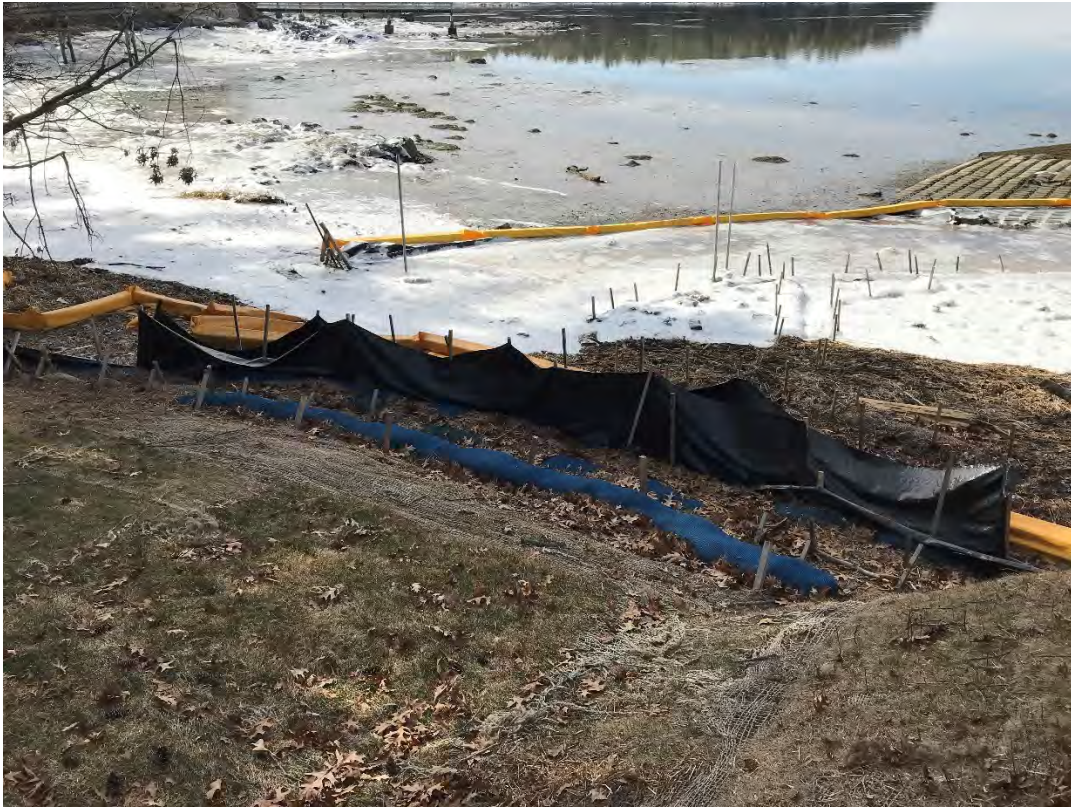
Fig 11: Toe of the slope at Gundalow Landing/east side of the bay. Viewing south. (03-16-21)

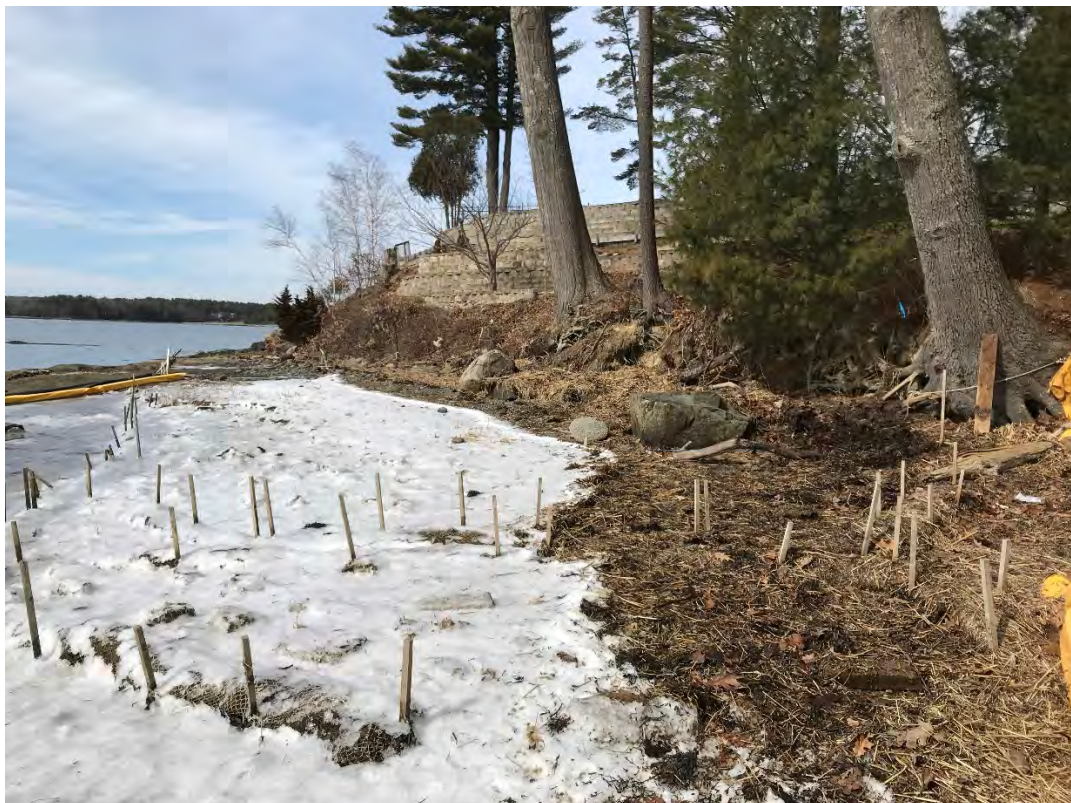
Fig 12: Salt marsh restoration at Gundalow Landing/east side of the bay. Viewing south. (03-16-21)
