DRAINAGE MONITORING REPORT

F107 - Seacoast Reliability Project

Newington, New Hampshire

04.0190967.00

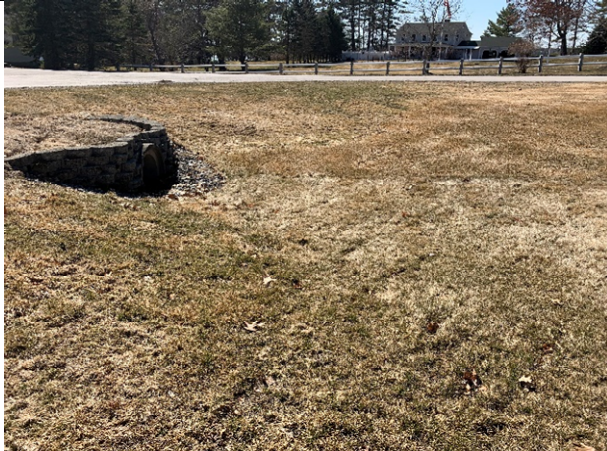
29 Gundalow - 1 (Drainage Area)

Observations/Notes: Soil saturated and partially frozen

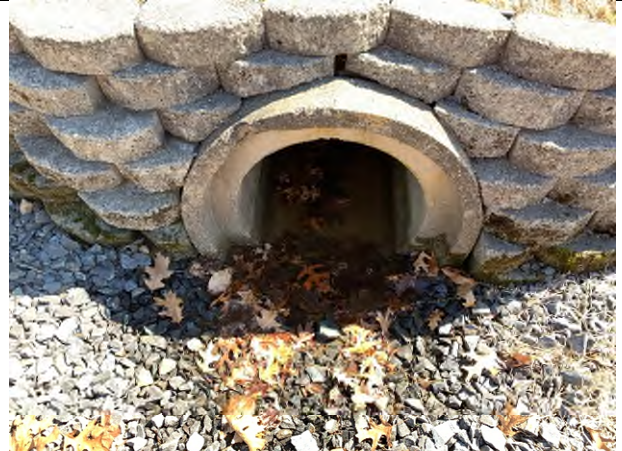
29 Gundalow - 2 (Culvert)

pH: 12.4

Observations/Notes: Approx. 5" of water at culvert inlet. Leaf litter in and around culvert outlet. No visible flow.

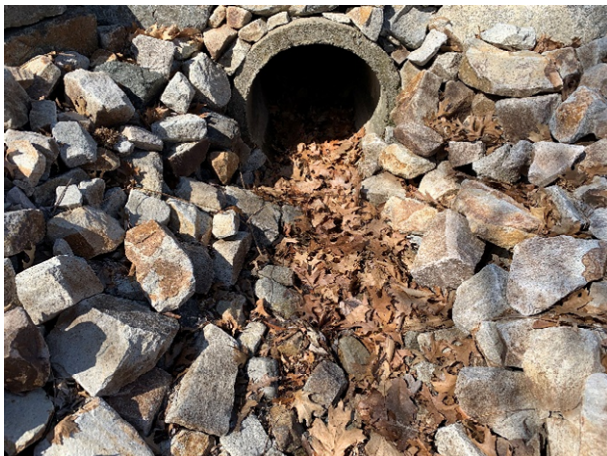
64 Gundalow - 1 (Drainage Course)

pH: 12.1

Observations/Notes: Accessible water extending approx. 2' beyond culvert outlet, leaf litter in drainage course.

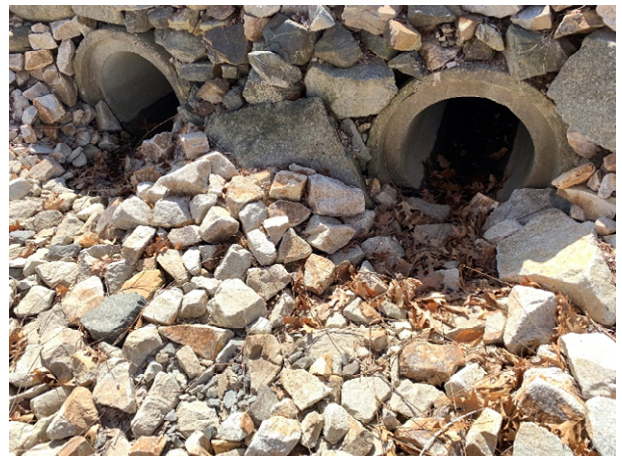
64 Gundalow - 2 (Drainage Course)

pH: 10.3

Observations/Notes: Area of intermittent water extending approx. 12" from culvert inlets.

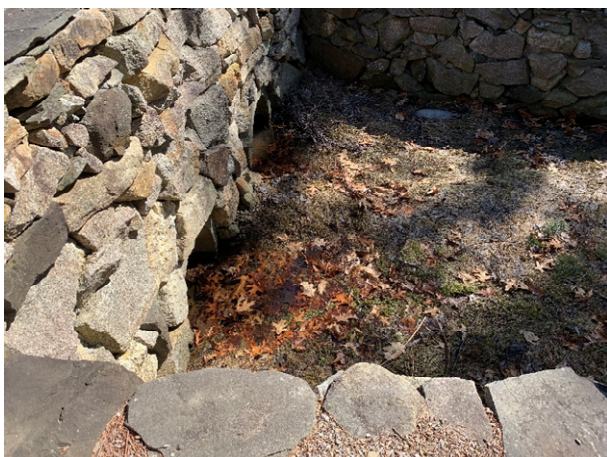
4 Brickyard Circle - 1 (Drainage Course)

pH: 8.0

Observations/Notes: Water in drainage course extending approx. 2' from culvert outlets, max depth approx. 8".

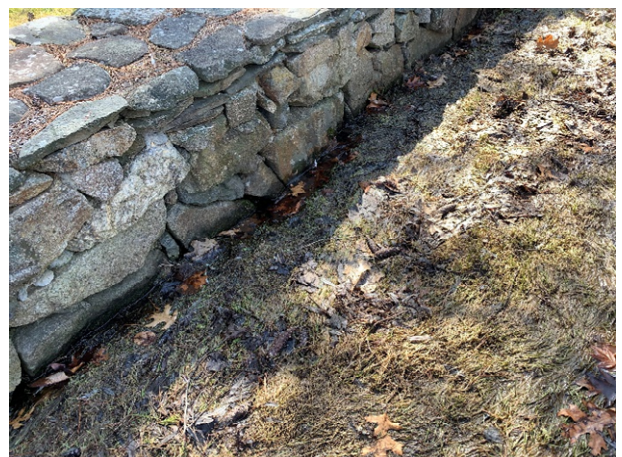
4 Brickyard Circle - 2 (Drainage Course)

pH: 7.6

Observations/Notes: Water against east wall of raceway approx. 2" deep.

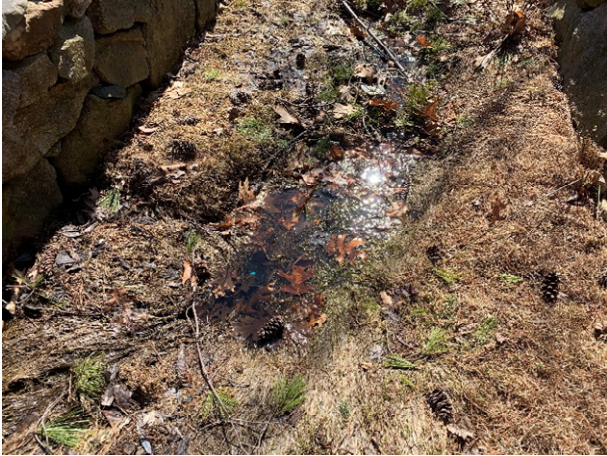
4 Brickyard Circle – 3 (Drainage Course)

pH: 7.5

Observations/Notes: Water approx. 3" deep in center of raceway.
