DRAINAGE MONITORING REPORT

F107 - Seacoast Reliability Project

Newington, New Hampshire

04.0190967.00

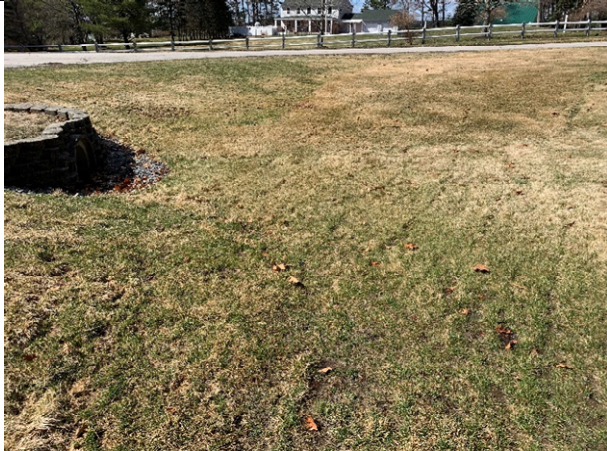
29 Gundalow - 1 (Drainage Area)

pH: **6.0**

Observations/Notes: Soil saturated with some small areas of standing water approx. 0.5" deep.

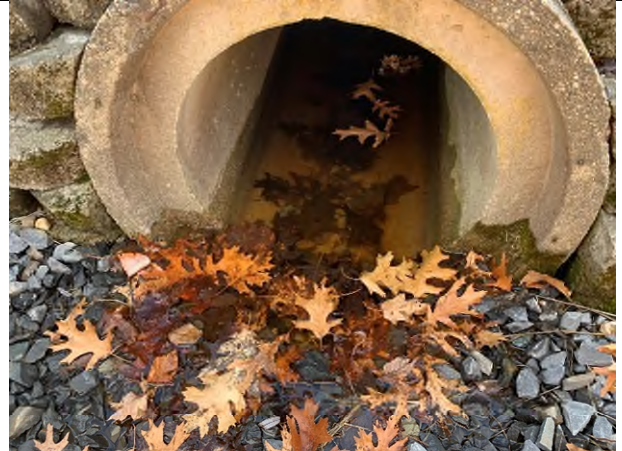
29 Gundalow - 2 (Culvert)

pH: **12.0**

Observations/Notes: Approx. 6" of flowing water at culvert inlet.

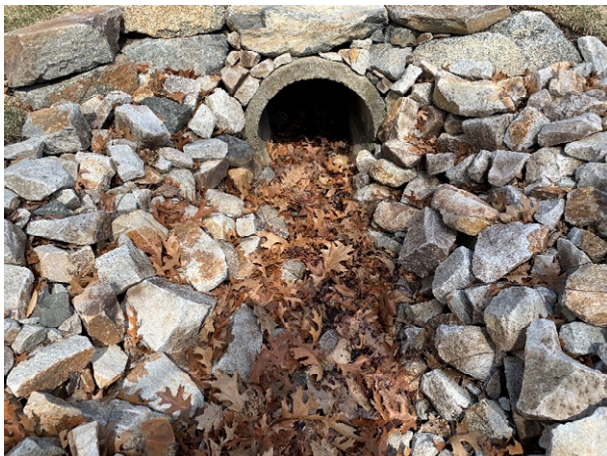
64 Gundalow - 1 (Drainage Course)

pH: **11.4**

Observations/Notes: Accessible flowing water extending approx. 2' beyond culvert outlet, leaf litter in drainage course.

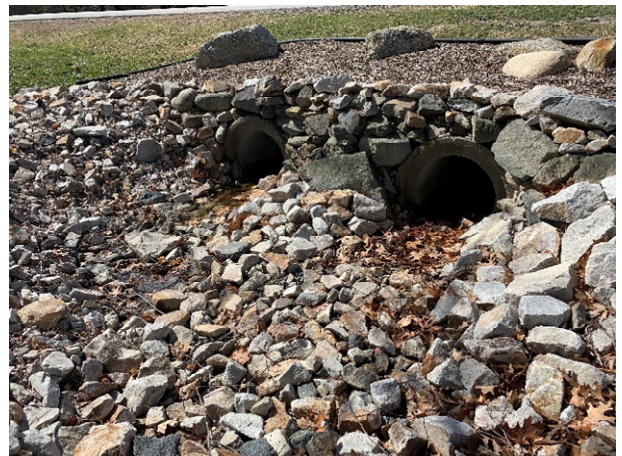
64 Gundalow - 2 (Drainage Course)

pH: **9.9**

Observations/Notes: Area of intermittent water extending approx. 18" from culvert inlets.

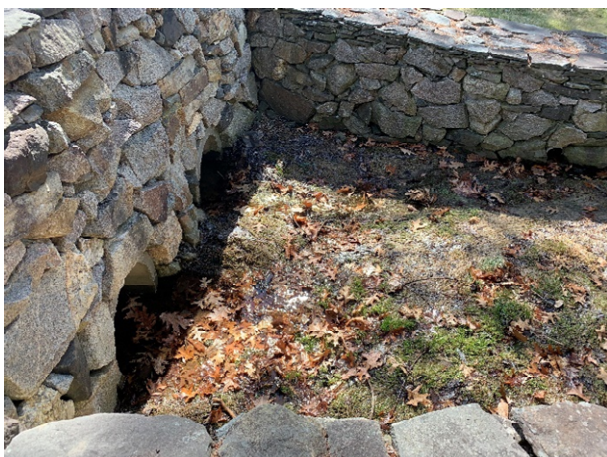
4 Brickyard Circle - 1 (Drainage Course)

pH: **9.4**

Observations/Notes: Flowing water in drainage course extending approx. 2' from culvert outlets, max depth approx. 8".

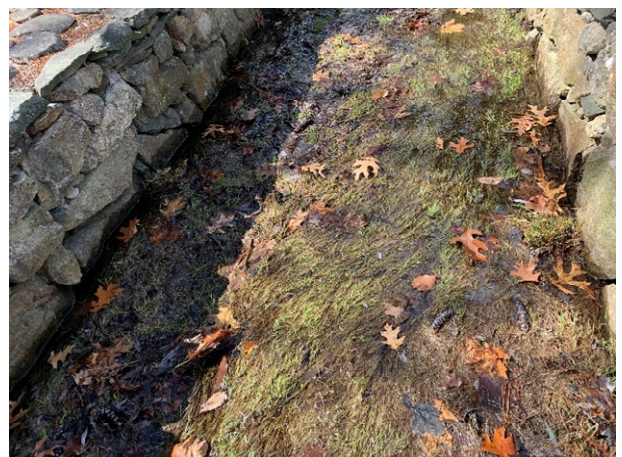
4 Brickyard Circle - 2 (Drainage Course)

pH: **7.8**

Observations/Notes: Water flowing approx. 2" deep.

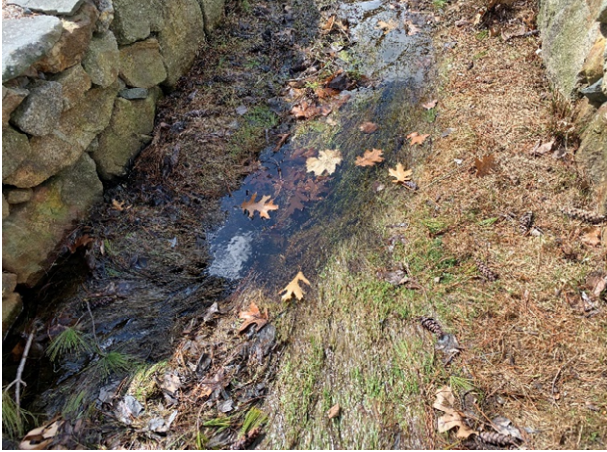
4 Brickyard Circle – 3 (Drainage Course)

pH: **7.4**

Observations/Notes: Water flowing approx. 4" deep.

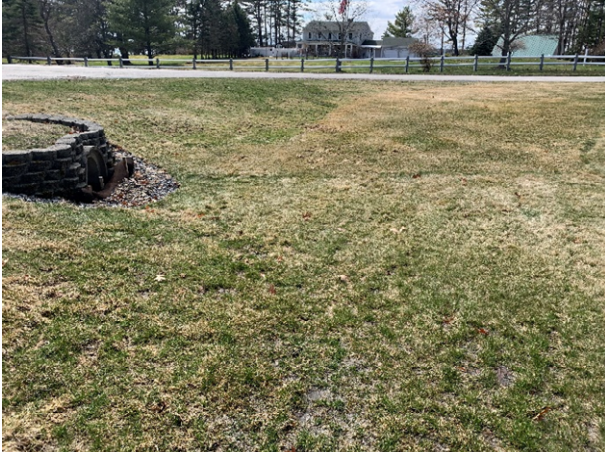
29 Gundalow - 1 (Drainage Area)

Observations/Notes: Soil saturated, not enough standing water to obtain measurement.

- Peat moss socks installed in drainage areas on 29 Gundalow Landing (1), 64 Gundalow Landing (3), and 4 Brickyard Circle (1) on the morning of 04/02/2021.

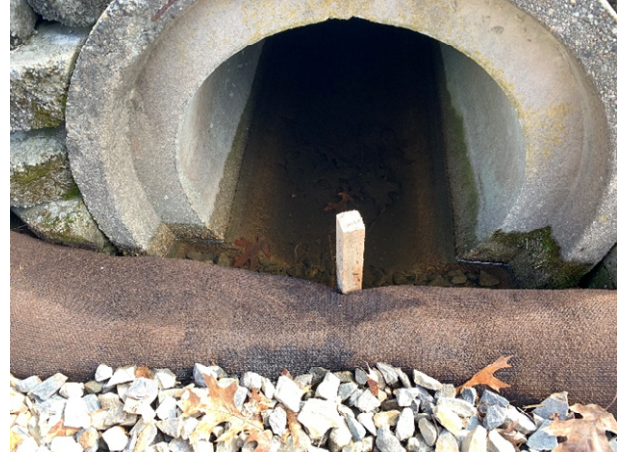
29 Gundalow - 2 (Culvert)

pH: 12.1

Observations/Notes: Approx. 6" of flowing water at culvert inlet.

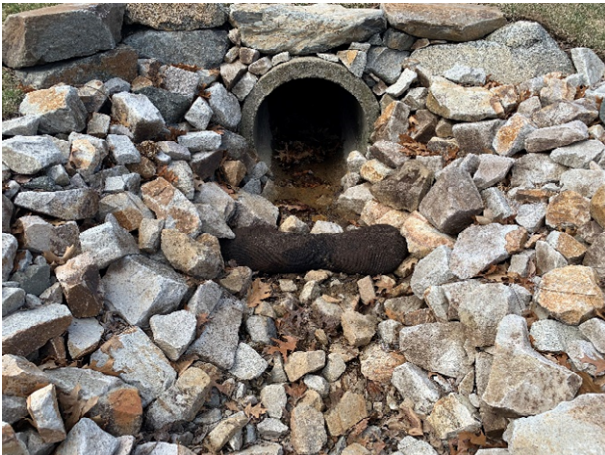
64 Gundalow - 1 (Drainage Course)

pH: 11.3

Observations/Notes: Accessible flowing water extending approx. 10" beyond culvert outlet.

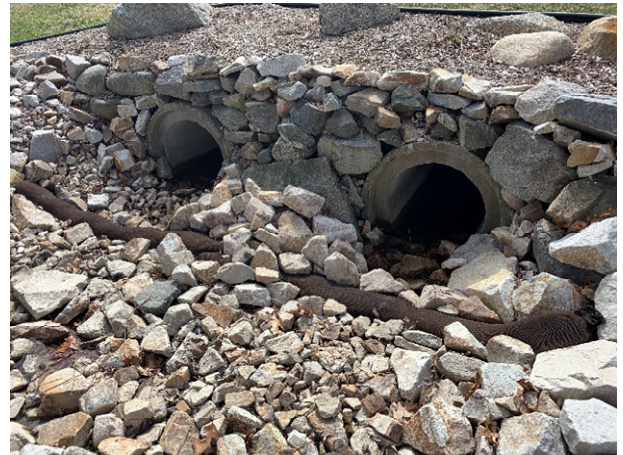
64 Gundalow - 2 (Drainage Course)

pH: 9.2

Observations/Notes: Area of intermittent water extending approx. 18" from culvert inlets.

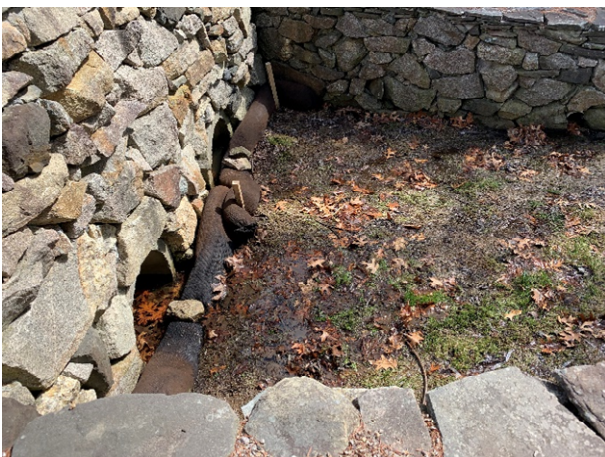
4 Brickyard Circle - 1 (Drainage Course)

pH: 8.4

Observations/Notes: Flowing water in drainage course extending approx. 2' from culvert outlets, max depth approx. 8".

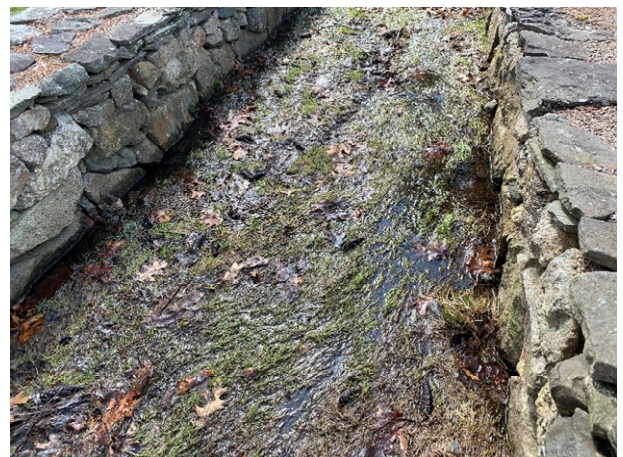
4 Brickyard Circle - 2 (Drainage Course)

pH: 7.6

Observations/Notes: Water flowing approx. 2" deep.

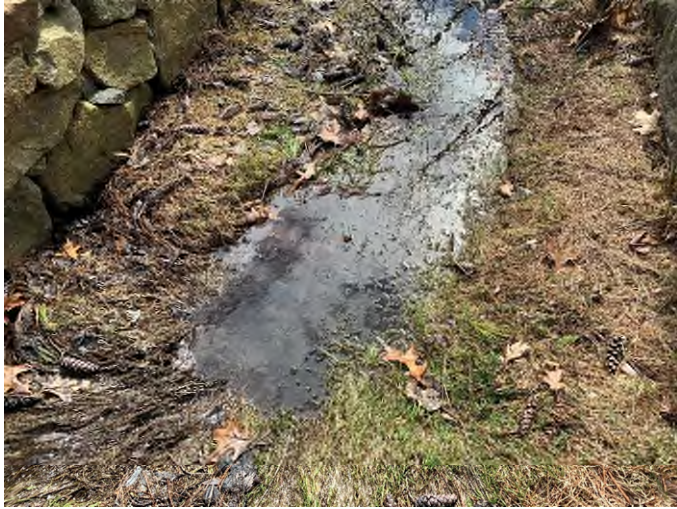
4 Brickyard Circle – 3 (Drainage Course)

pH: 7.4

Observations/Notes: Water flowing approx. 4" deep.
