## CONSTRUCTION MONITORING REPORT

Eversource Transmission Lines:  
**F107**

**TYPE OF INSPECTION:**  Weekly  Storm Event  Incident  Corrective Action

Date of inspection: **04/01/21** Start Time: **9:30am** Previous inspection: **03/29/21**

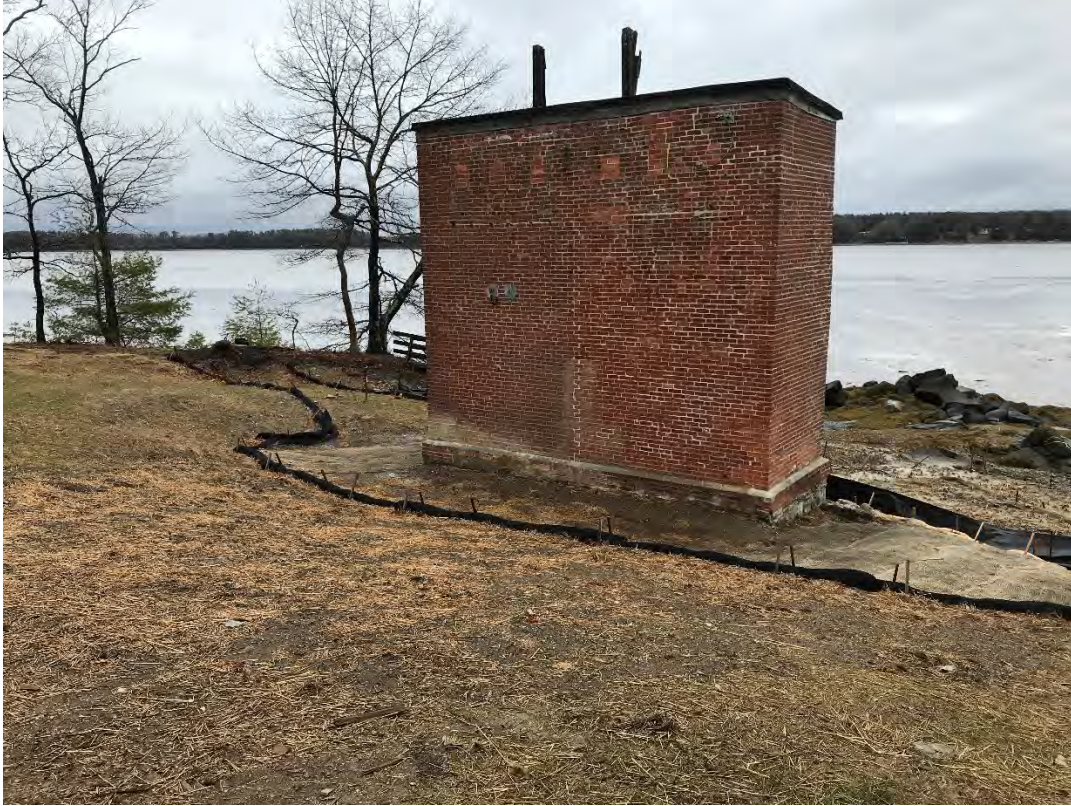
**Areas that have been restored and mulched, but have little germination:** Hannah Ln, Eversource property/west side of bay, Strs. 89-90

Fig 1: Slope leading down to cable house and salt marsh restoration at the Eversource property/west side of the bay. Viewing northeast. (04-01-21)

- **BMPs**
  - All remaining BMPs should be left in place until the sites are determined to be stabilized by the environmental monitor.

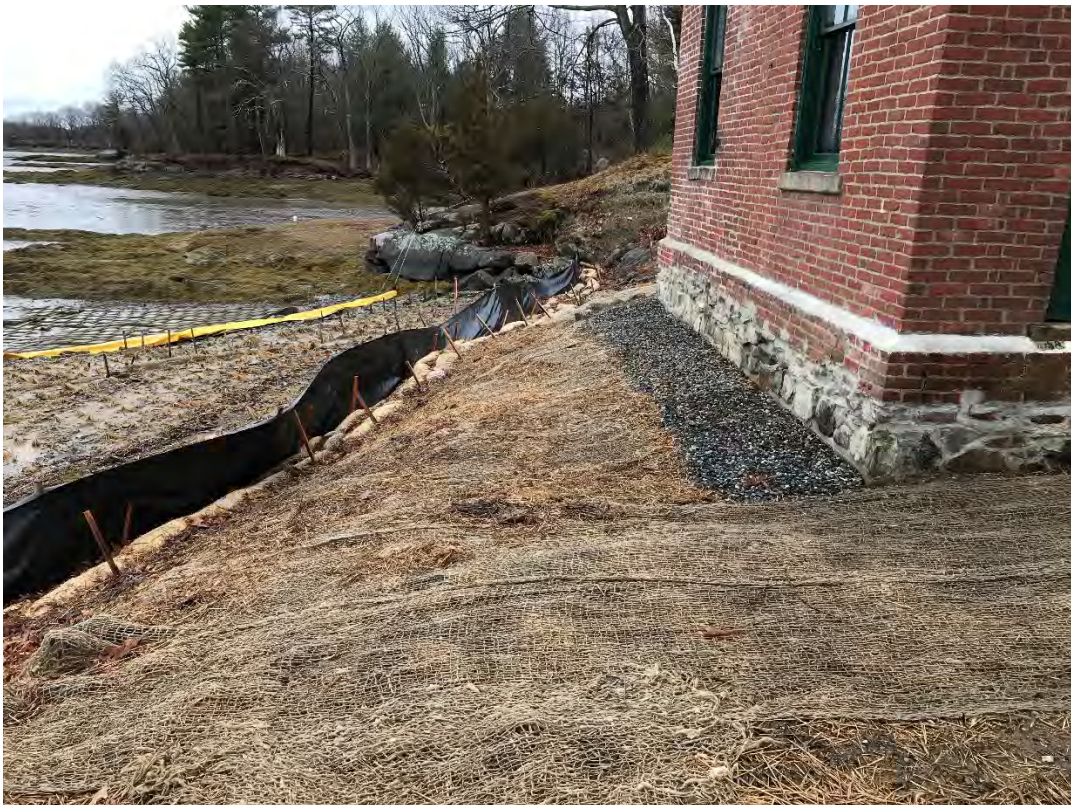
Fig 2: Slope between the cable house and salt marsh restoration at the Eversource property/west side of the bay. Viewing south. (04-01-21)

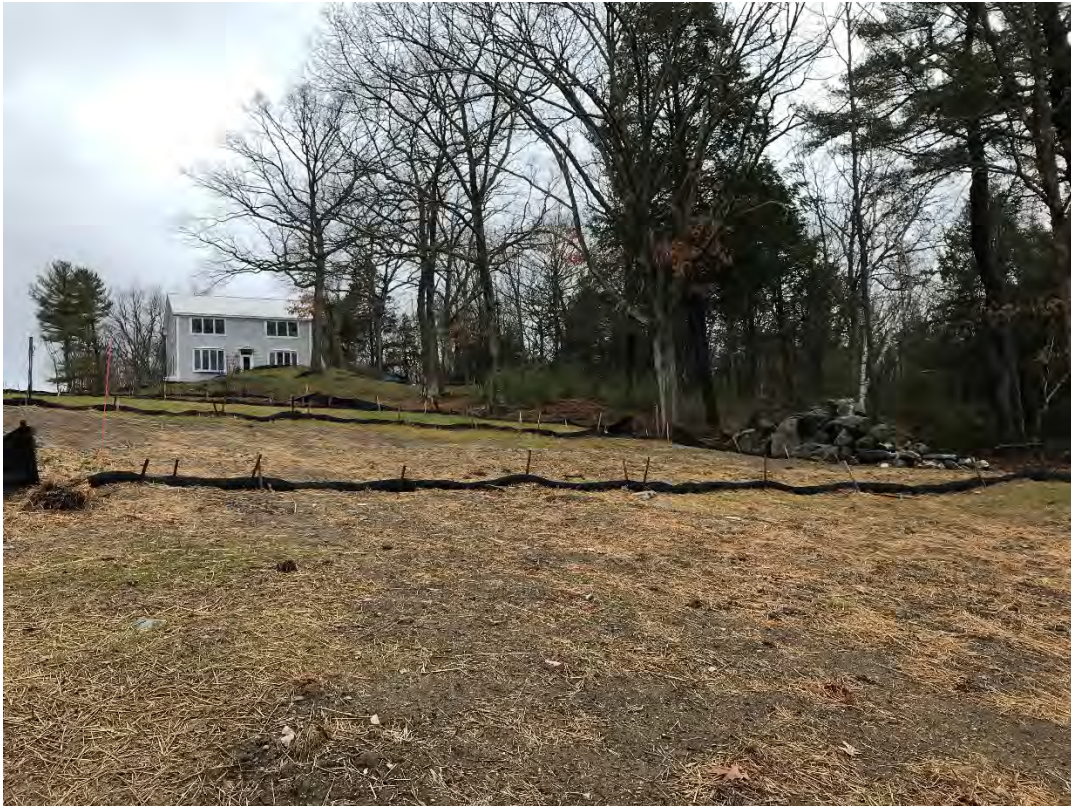
Fig 3: Slope above the cable house at the Eversource property/west side of the bay. Viewing northwest. (04-01-21)

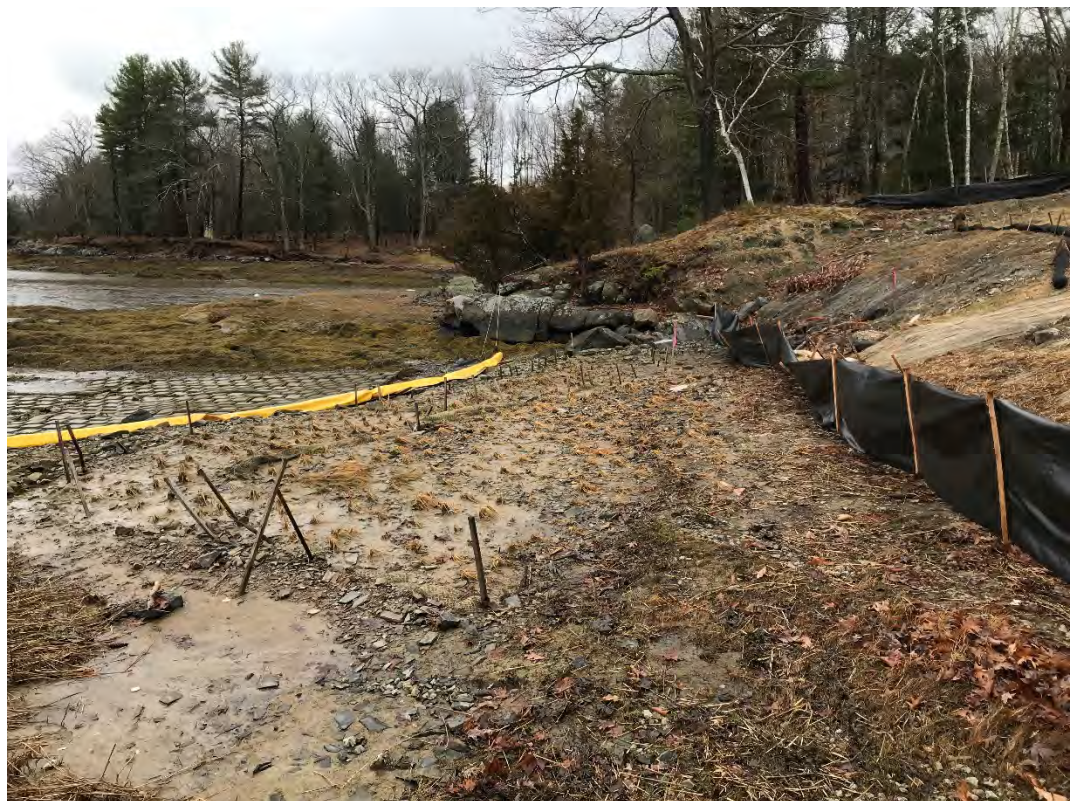
Fig 4: Toe of the slope and salt marsh restoration at the Eversource property/west side of the bay. Viewing south. (04-01-21)

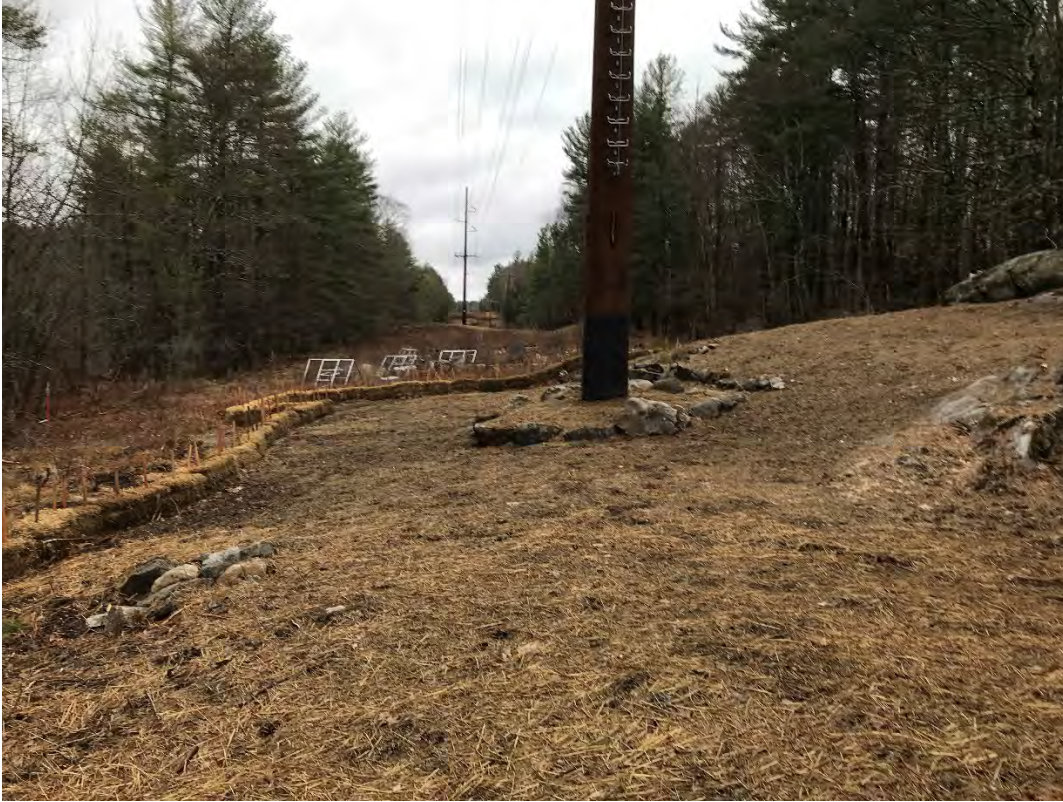
Fig 5: Str. 89 work area. Viewing southeast. (04-01-21)

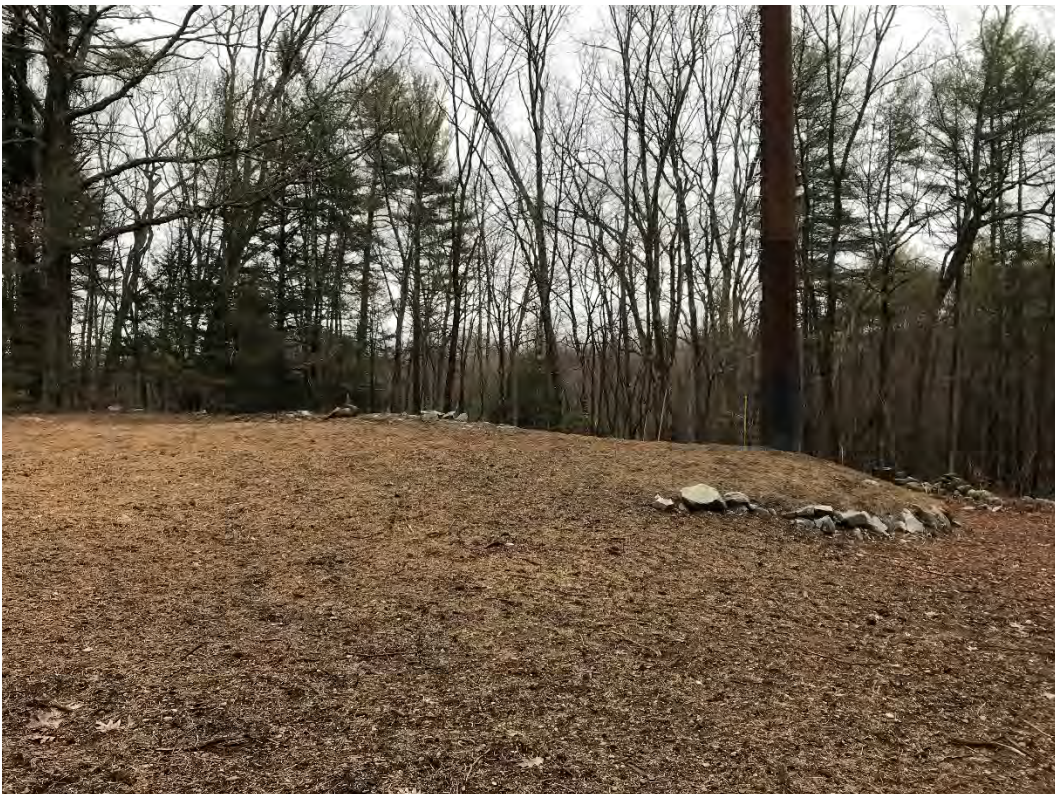
Fig 6: Str. 90 work area. Viewing northeast. (04-01-21)

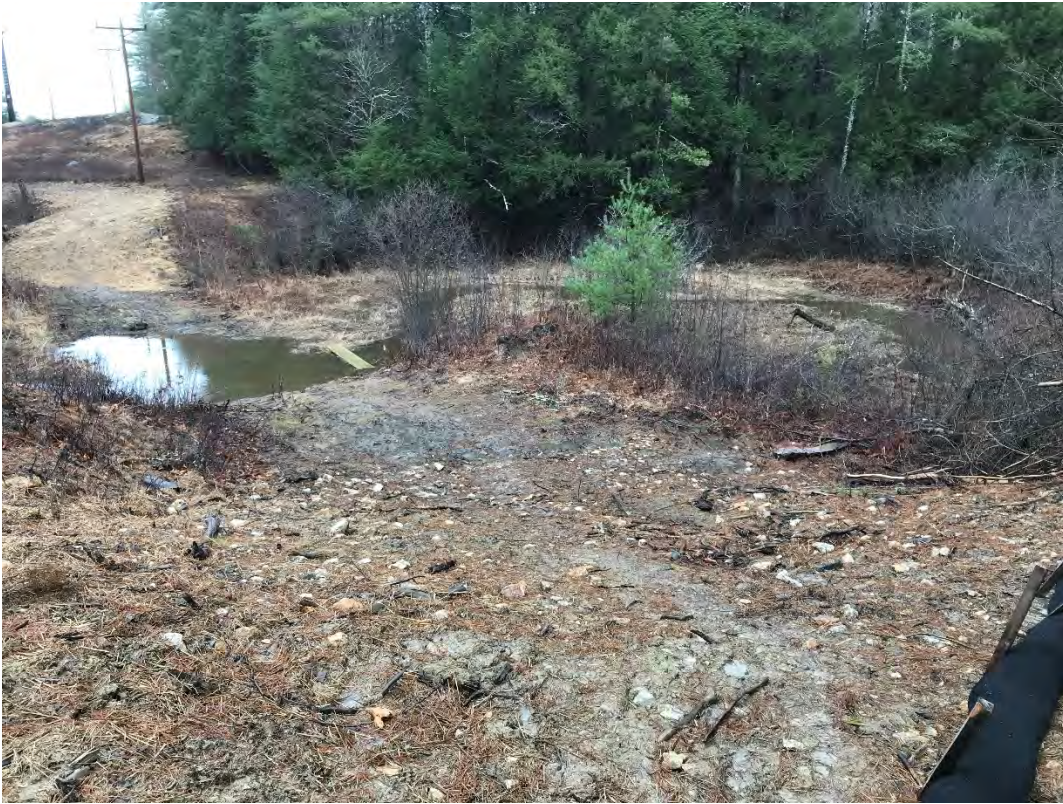
Fig 7: Stream DS46 between Strs. 51 and 52. Viewing northeast. (04-01-21)

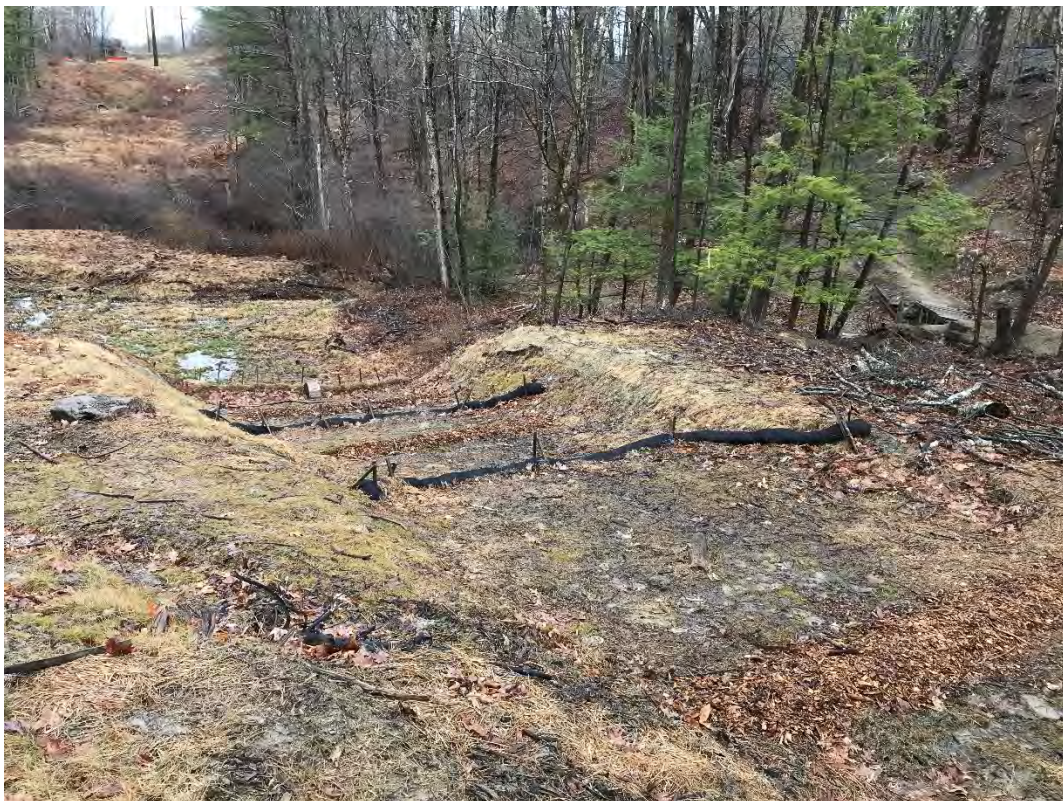
**Moderate germination:** Strs. 4-6, Strs. 7-21, 25-34, 36-88, 91-101, 107, 109-112, 122-127, 129-130, and Gundalow Landing/east side of bay.

Fig 8: Lower portion of slope between Strs. 28 and 29. Viewing northeast. (04-01-21)

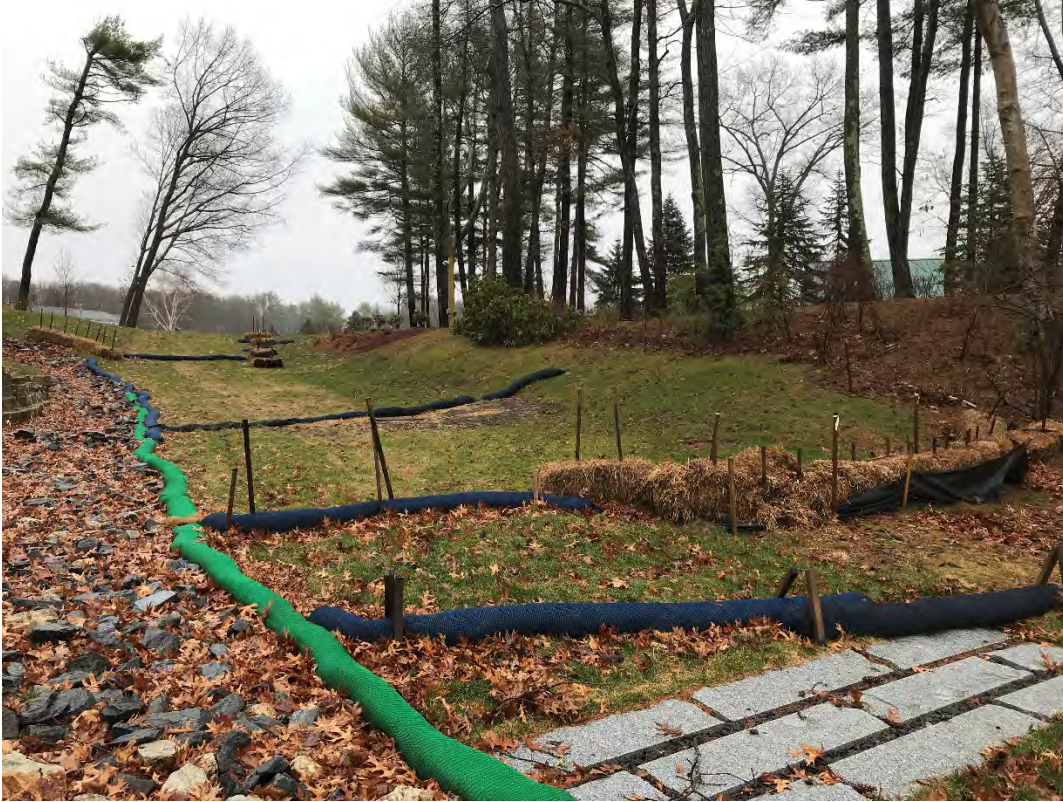
Fig 9: Slope above the manhole at Gundalow Landing/east side of the bay. Viewing east. (04-01-21)

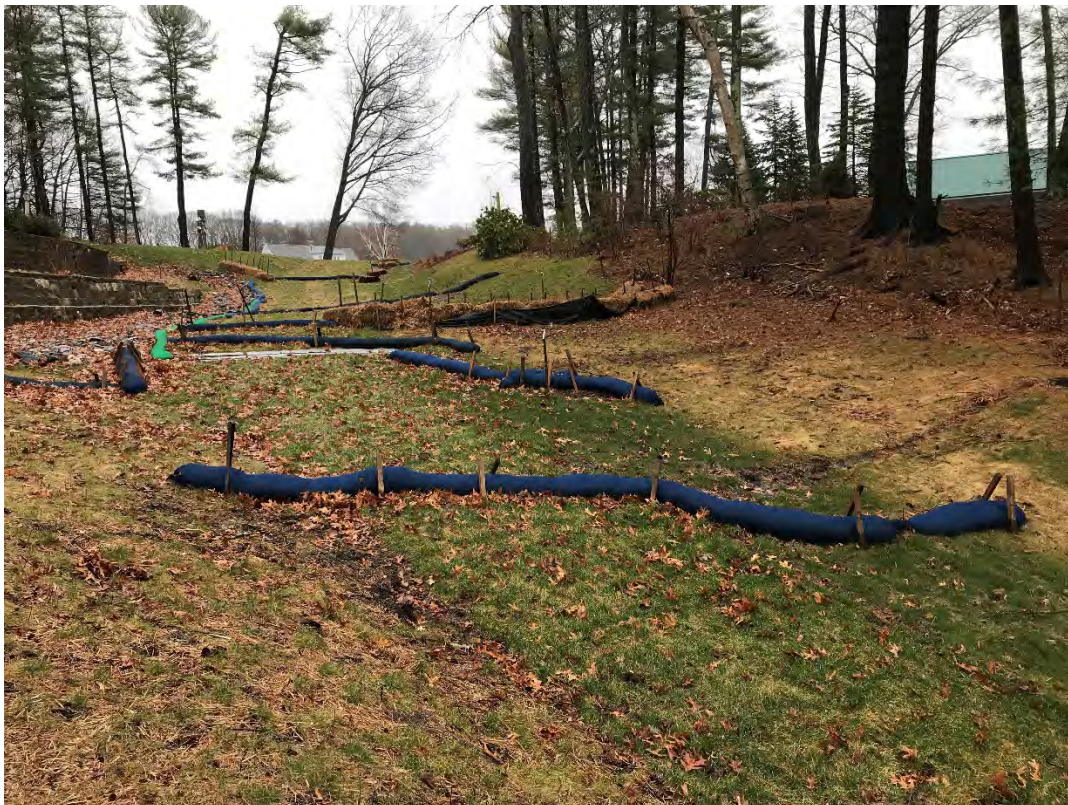
Fig 10: Slope below the manhole at Gundalow Landing/east side of the bay. Viewing east. (04-01-21)

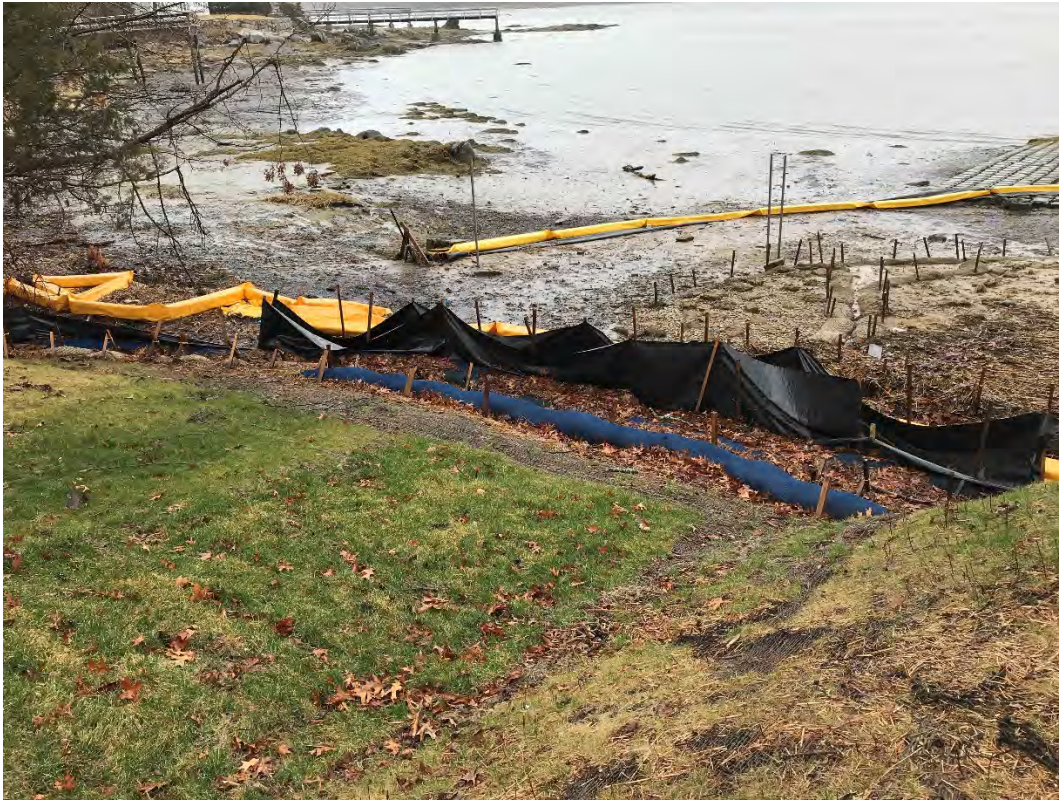
Fig 11: Toe of the slope at Gundalow Landing/east side of the bay. Viewing south. (04-01-21)

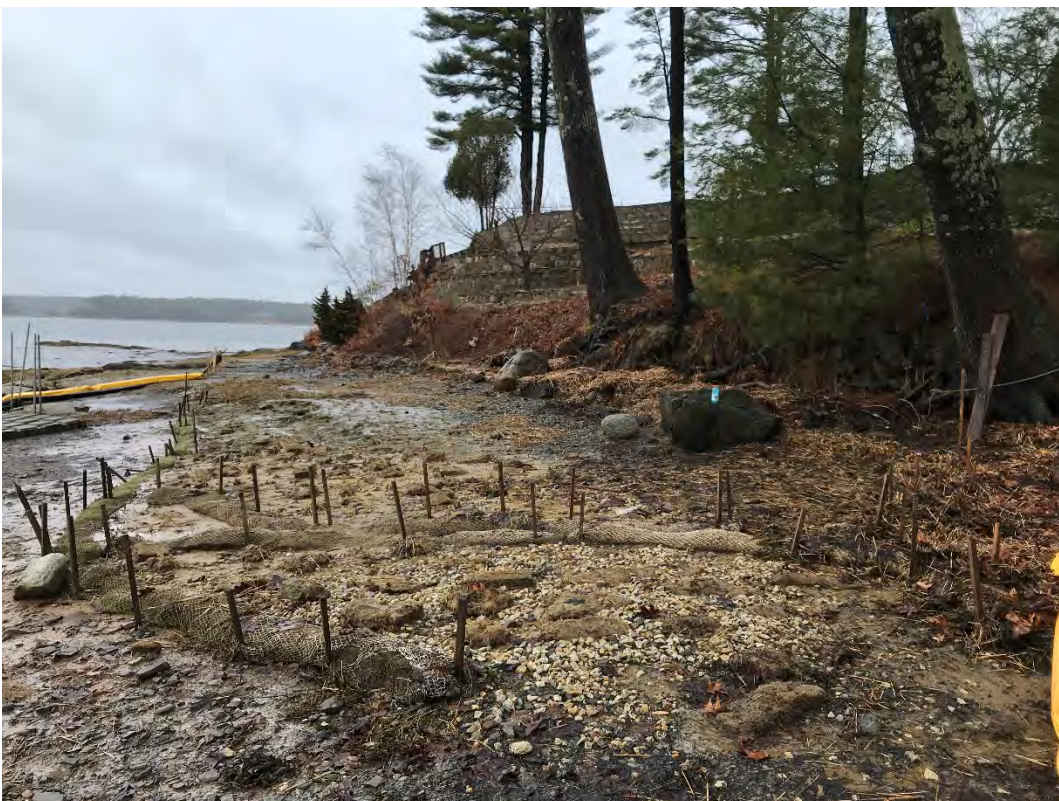
Fig 12: Salt marsh restoration at Gundalow Landing/east side of the bay. Viewing south. (04-01-21)
