CONSTRUCTION MONITORING REPORT

Eversource Transmission Lines: F107

Eversource Seacoast Reliability Project

Construction Monitoring Report #124

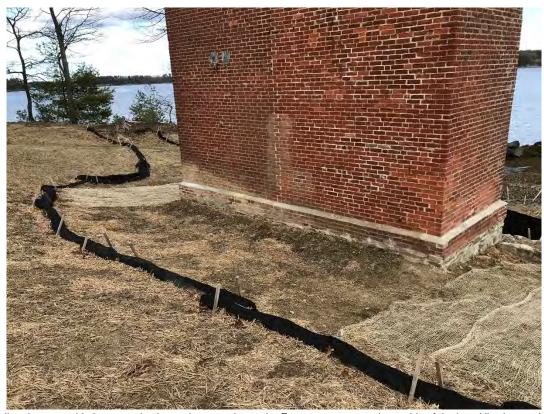
Fig 1: Slope leading down to cable house and salt marsh restoration at the Eversource property/west side of the bay. Viewing northeast. (04-06-21)

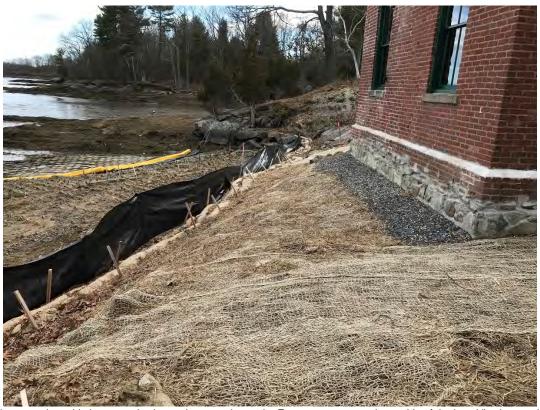
Fig 2: Slope between the cable house and salt marsh restoration at the Eversource property/west side of the bay. Viewing south. (04-06-21)

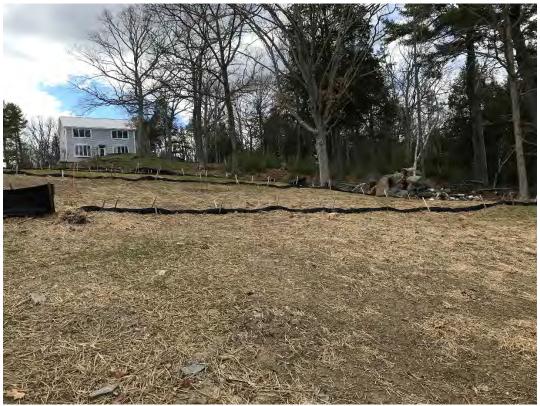
Fig 3: Slope above the cable house at the Eversource property/west side of the bay. Viewing northwest. (04-06-21)

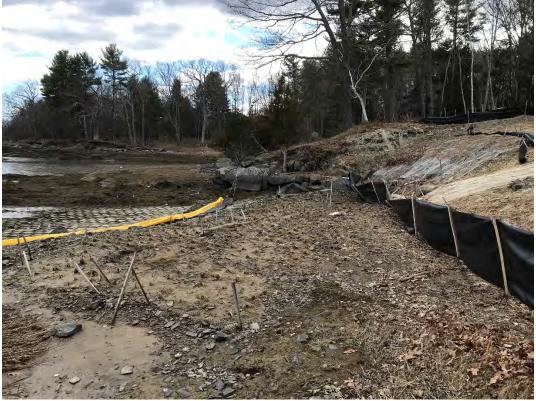
Fig 4: Toe of the slope and salt marsh restoration at the Eversource property/west side of the bay. Viewing south. (04-06-21)

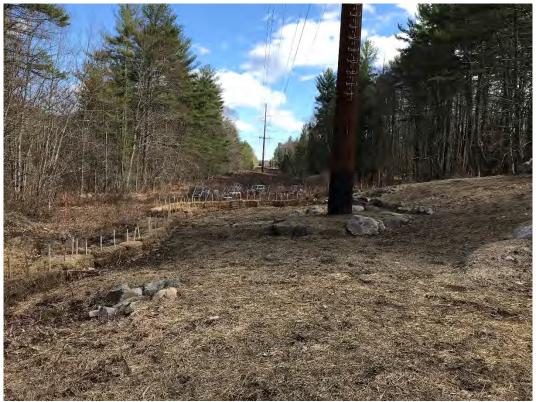
Fig 5: Str. 89 work area. Viewing southeast. (04-06-21)

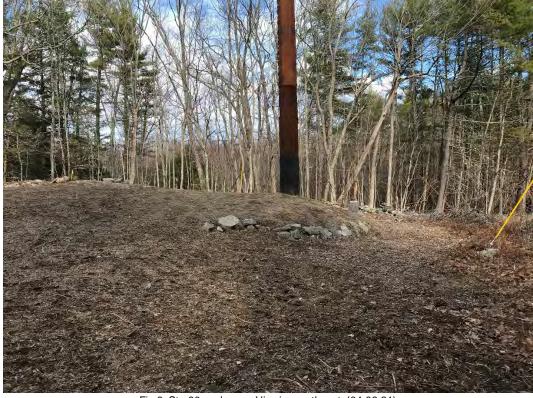
Fig 6: Str. 90 work area. Viewing northeast. (04-06-21)

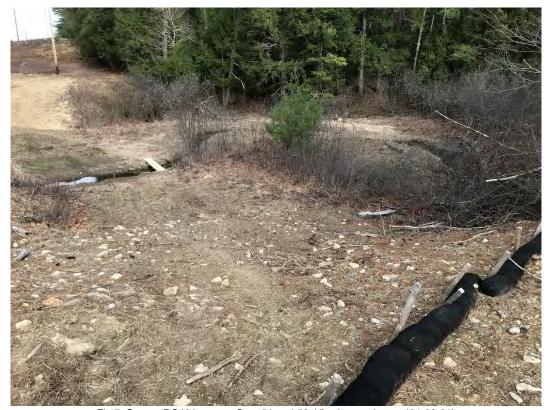
Fig 7: Stream DS46 between Strs. 51 and 52. Viewing northeast. (04-06-21)

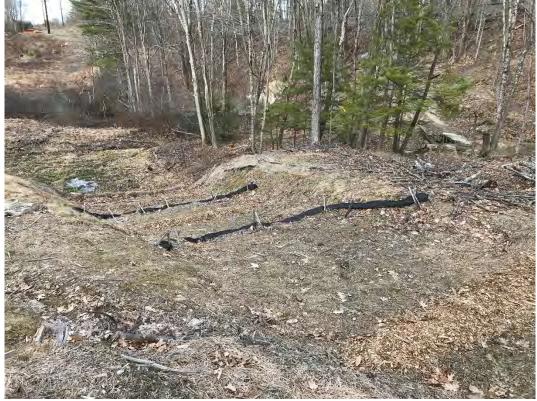
Fig 8: Lower portion of slope between Strs. 28 and 29. Viewing northeast. (04-06-21)

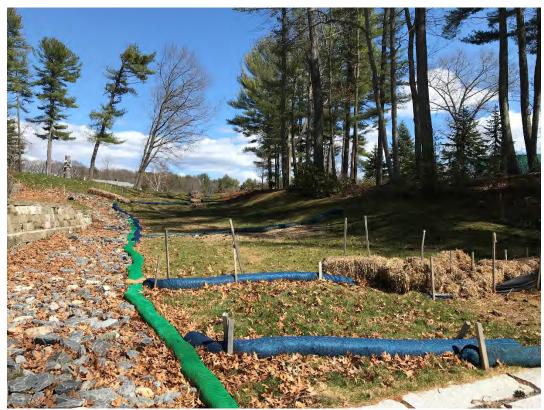
Fig 9: Slope above the manhole at Gundalow Landing/east side of the bay. Viewing east. (04-06-21)

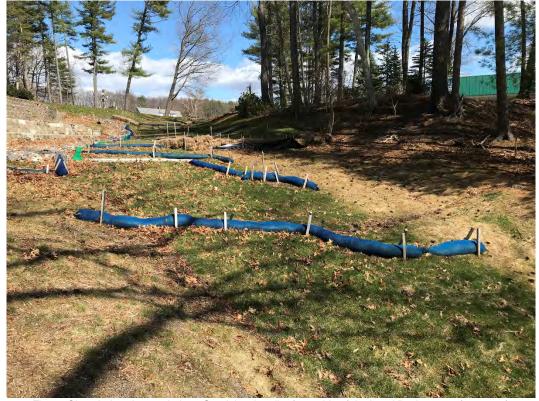
Fig 10: Slope below the manhole at Gundalow Landing/east side of the bay. Viewing east. (04-06-21)

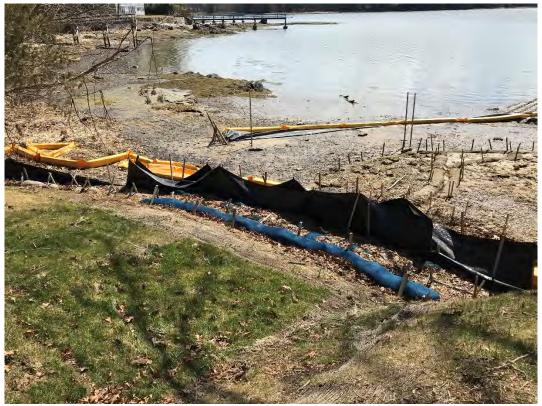
Fig 11: Toe of the slope at Gundalow Landing/east side of the bay. Viewing south. (04-06-21)

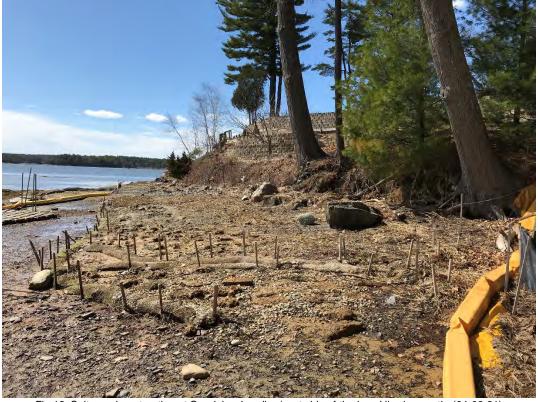
Fig 12: Salt marsh restoration at Gundalow Landing/east side of the bay. Viewing south. (04-06-21)
