DRAINAGE MONITORING REPORT

F107 - Seacoast Reliability Project

Newington, New Hampshire

04.0190967.00

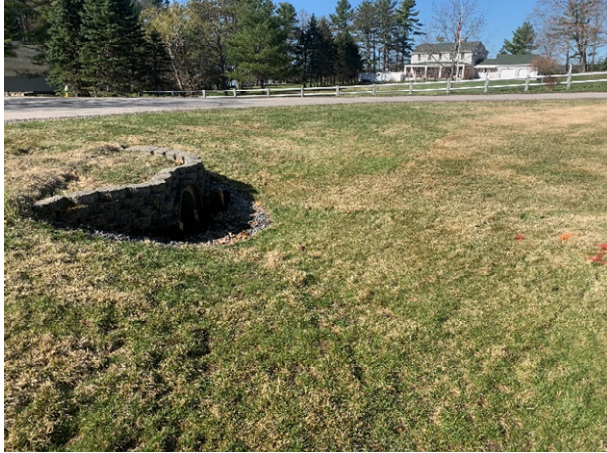
29 Gundalow - 1 (Drainage Area)

Observations/Notes: Soil saturated, not enough standing water to obtain measurement.

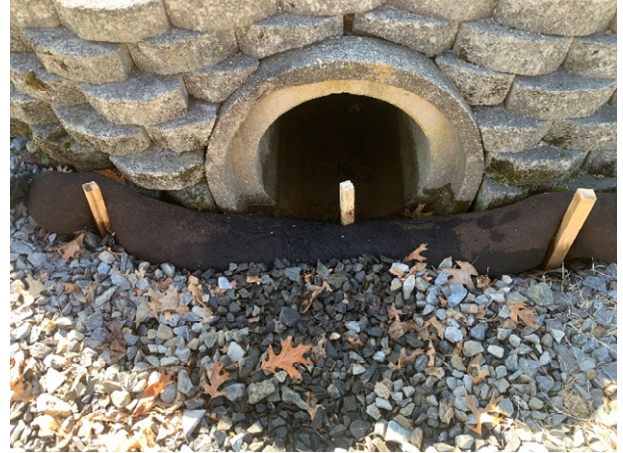
29 Gundalow - 2 (Culvert)

pH: 12.6

Observations/Notes: Approx. 6" of flowing water at culvert inlet.

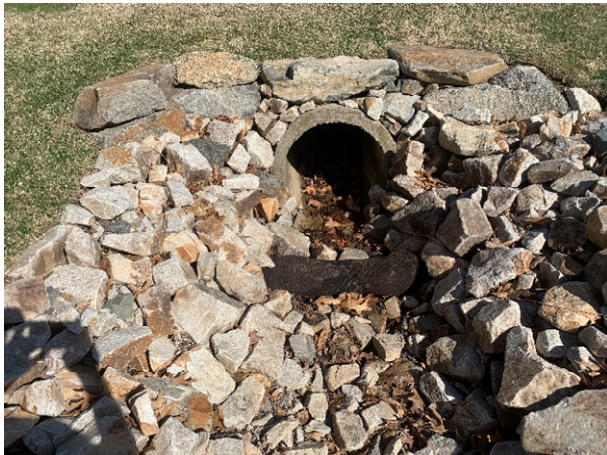
64 Gundalow - 1 (Drainage Course)

pH: 12.1

Observations/Notes: Accessible flowing water extending approx. 6" beyond culvert outlet.

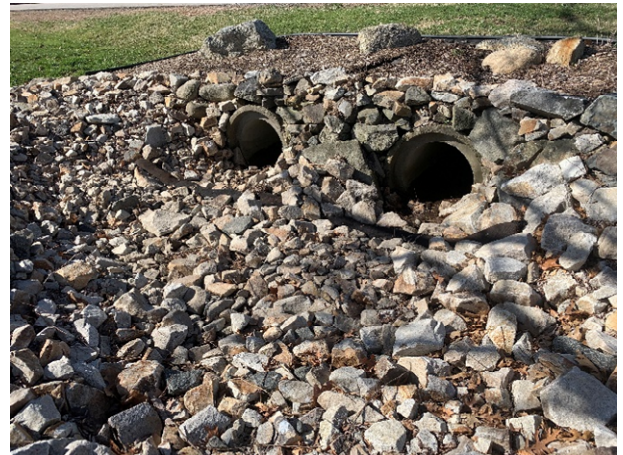
64 Gundalow - 2 (Drainage Course)

pH: 8.1

Observations/Notes: Area of intermittent water extending approx. 10" from culvert inlets.

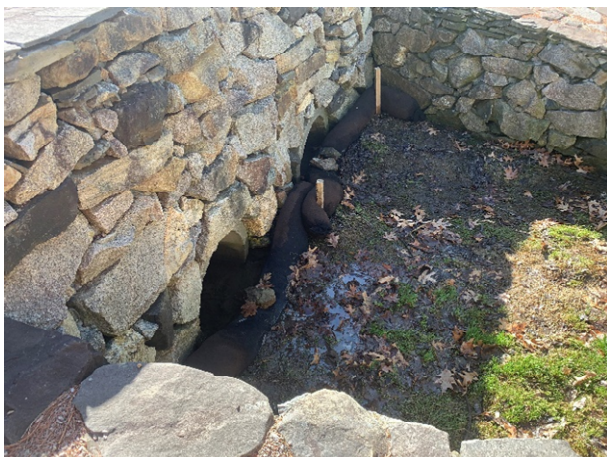
4 Brickyard Circle - 1 (Drainage Course)

pH: 7.3

Observations/Notes: Flowing water in drainage course extending approx. 18" from culvert outlets, max depth approx. 8".

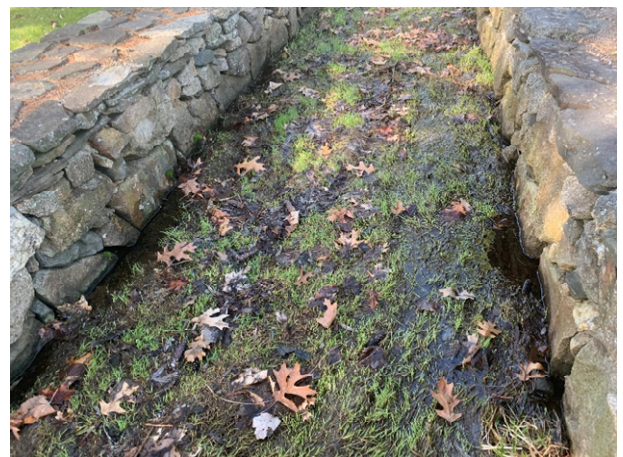
4 Brickyard Circle - 2 (Drainage Course)

pH: 7.2

Observations/Notes: Water flowing approx. 2" deep.

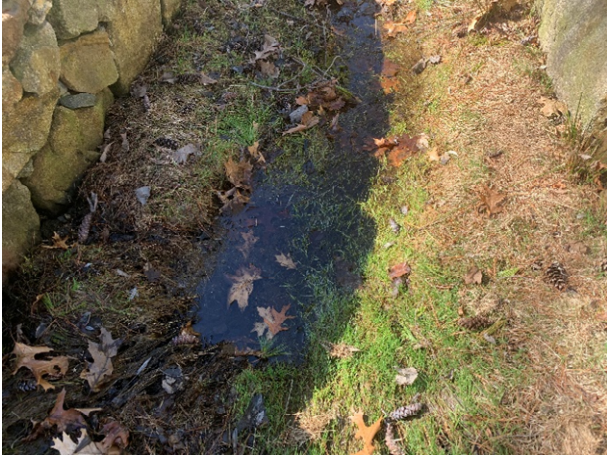
4 Brickyard Circle – 3 (Drainage Course)

pH: 7.2

Observations/Notes: Water flowing approx. 3" deep.
