DRAINAGE MONITORING REPORT

F107 - Seacoast Reliability Project

Newington, New Hampshire

04.0190967.00

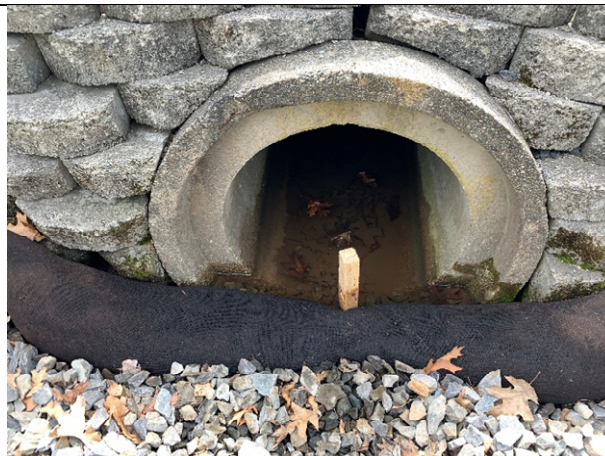
29 Gundalow - 2 (Culvert)

pH: 12.5

Observations/Notes: Approx. 6" of flowing water at culvert inlet.

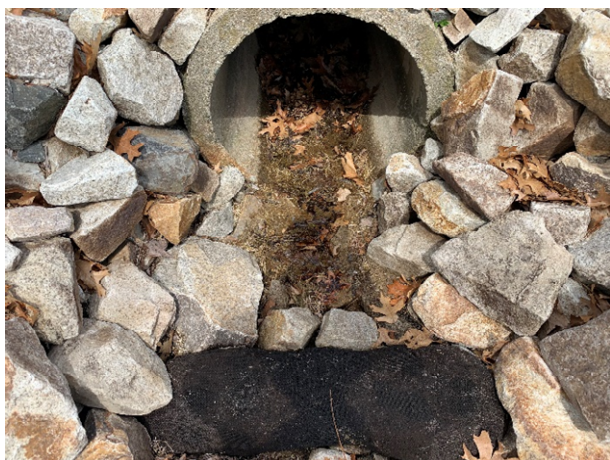
64 Gundalow - 1 (Drainage Course)

pH: 11.6

Observations/Notes: Intermittently accessible flowing water extending approx. 6" beyond culvert outlet.

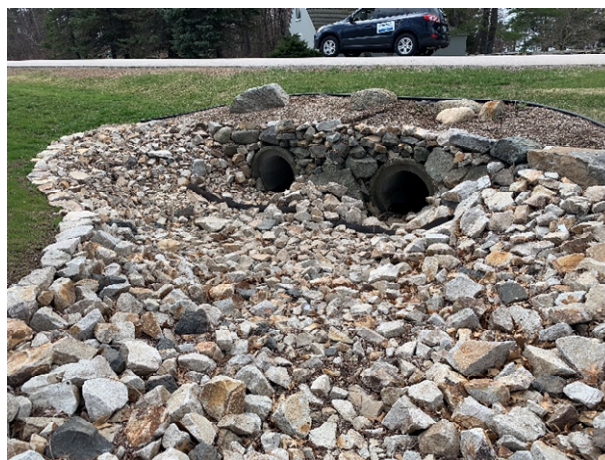
64 Gundalow - 2 (Drainage Course)

pH: 7.9

Observations/Notes: Area of intermittent water extending approx. 8" from culvert inlets.

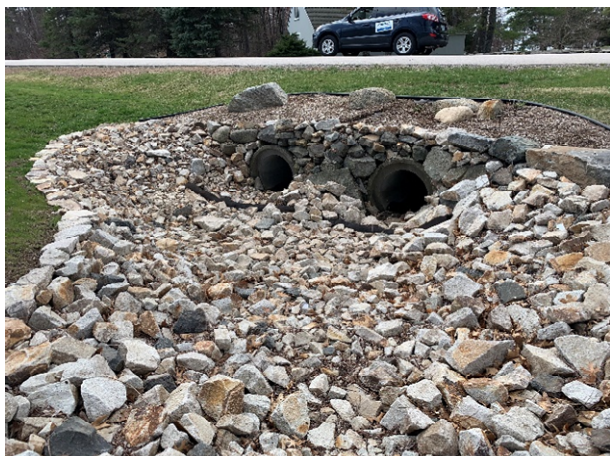
4 Brickyard Circle - 1 (Drainage Course)

pH: 7.5

Observations/Notes: Flowing water in drainage course extending approx. 18" from culvert outlets, max depth approx. 8".

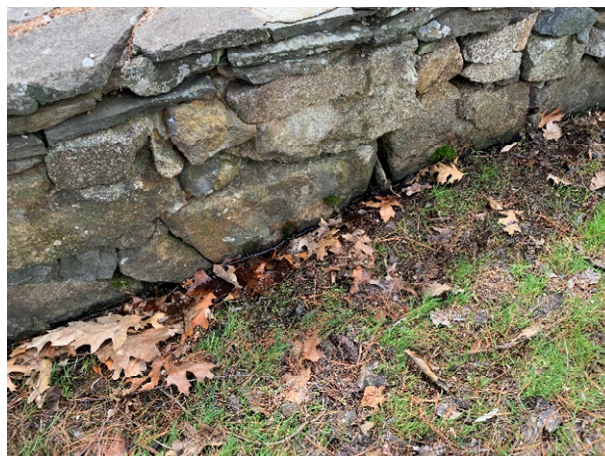
4 Brickyard Circle - 2 (Drainage Course)

pH: 7.3

Observations/Notes: Water flowing approx. 2" deep.

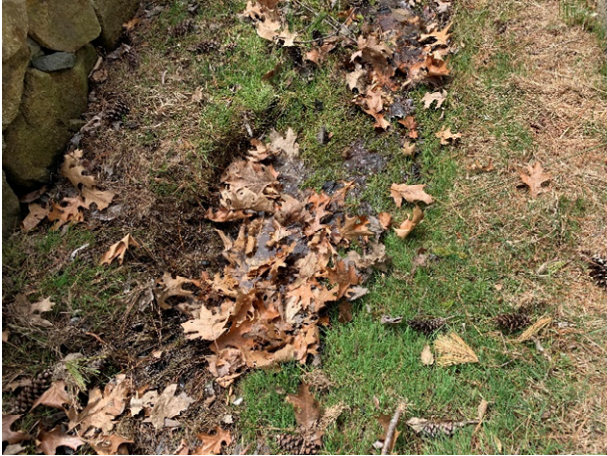
4 Brickyard Circle – 3 (Drainage Course)

pH: 7.3

Observations/Notes: Water flowing approx. 2" deep.
