CONSTRUCTION MONITORING REPORT

Eversource Transmission Lines:
F107

**Madbury, Durham,
Newington, Portsmouth, NH**

TYPE OF INSPECTION: Weekly Storm Event Incident Corrective Action

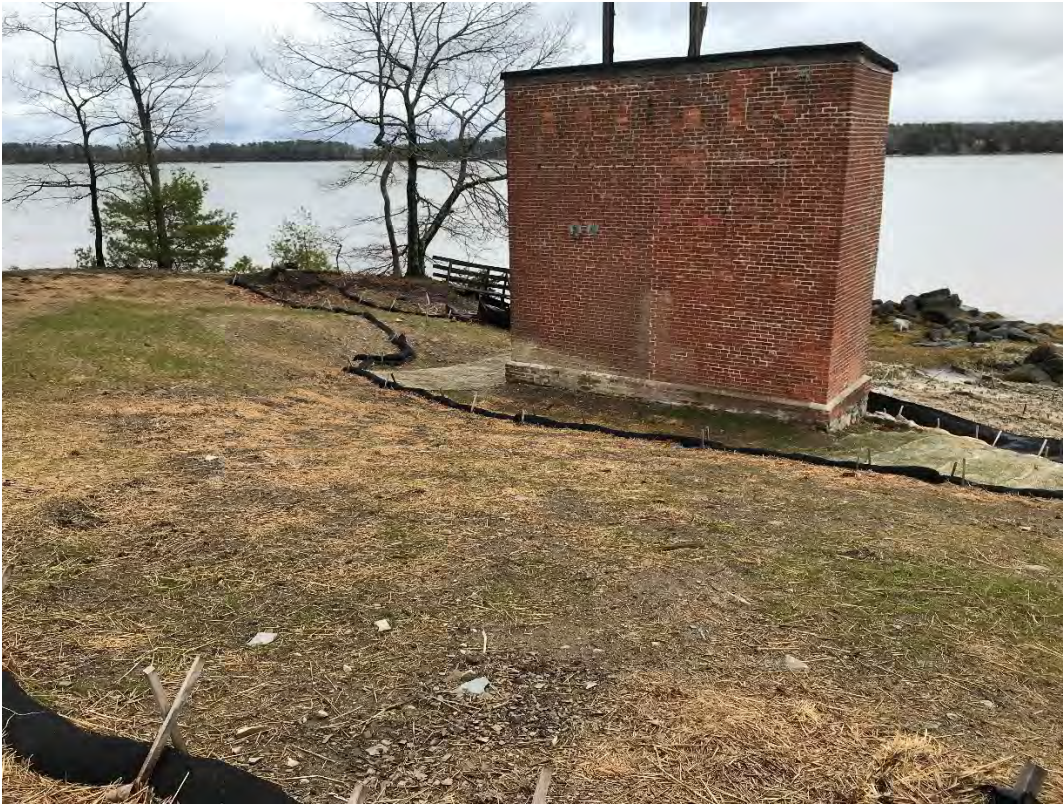
Areas that have been restored and mulched, but have little germination: Hannah Ln, Eversource property/west side of bay, Strs. 89-90

Fig 1: Slope leading down to cable house and salt marsh restoration at the west side of the bay. Viewing northeast. (04-17-21)

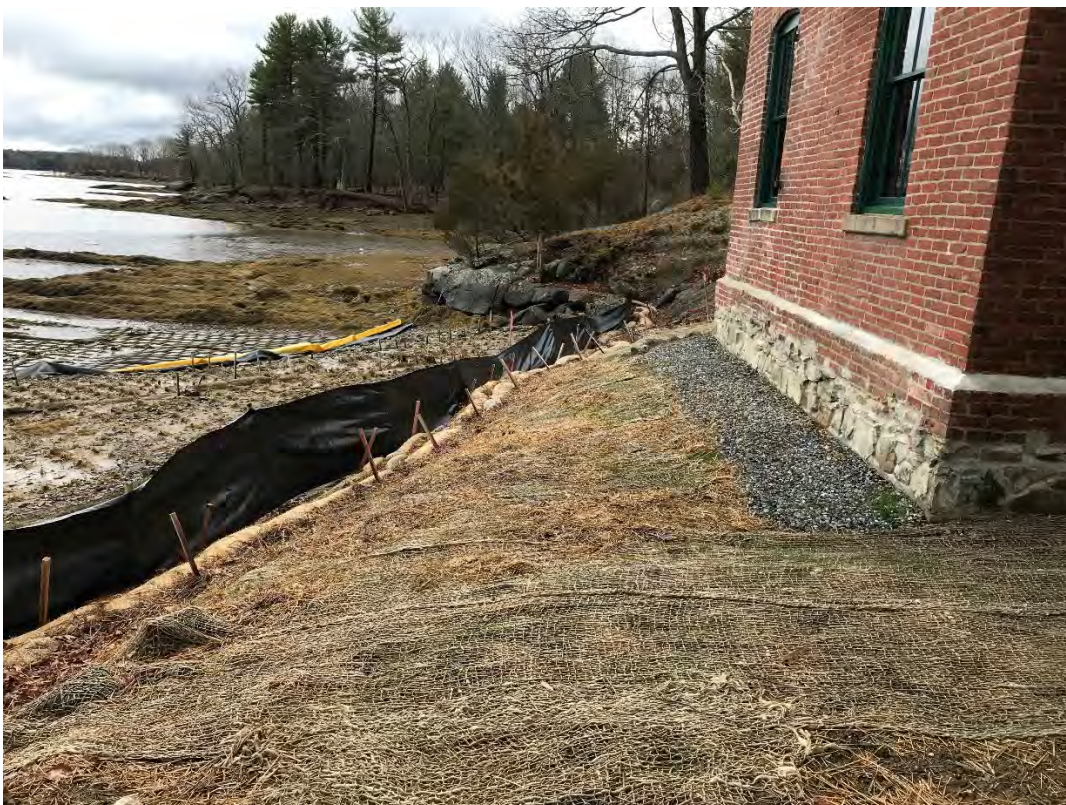
Fig 2: Slope between the cable house and salt marsh restoration at the west side of the bay. Viewing south. (04-17-21)

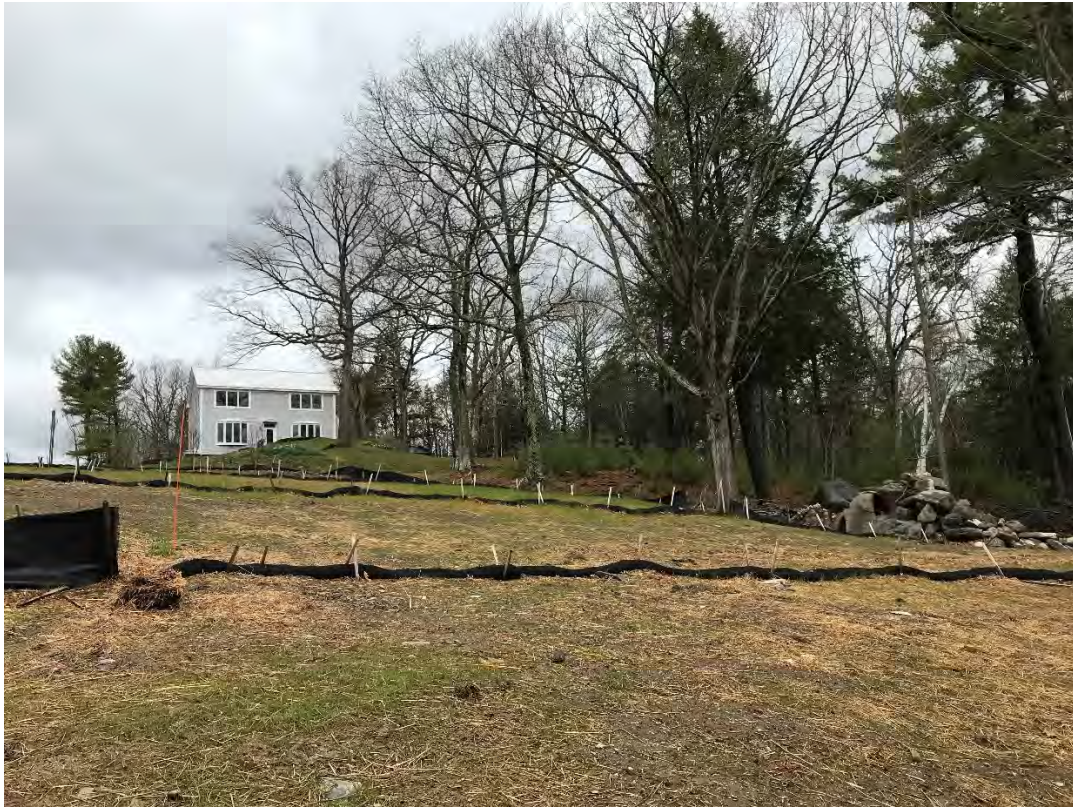
Fig 3: Slope above the cable house at the west side of the bay. Viewing northwest. (04-17-21)

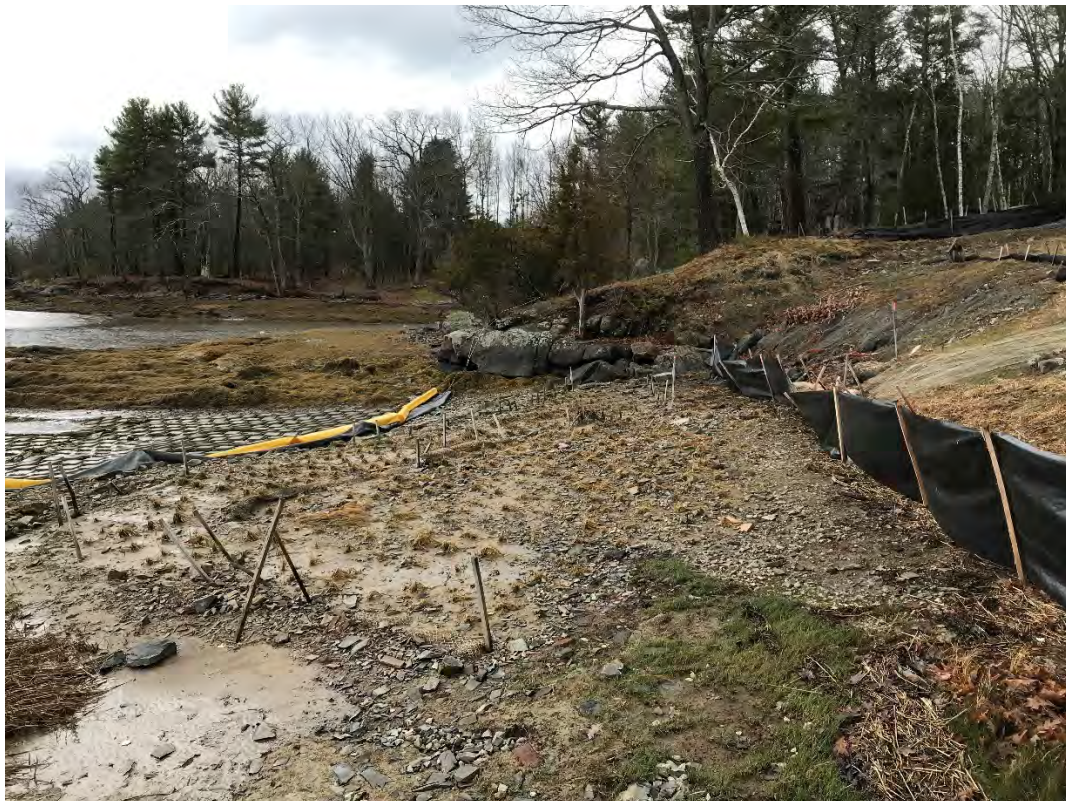
Fig 4: Toe of the slope and salt marsh restoration at the west side of the bay. Viewing south. (04-17-21)

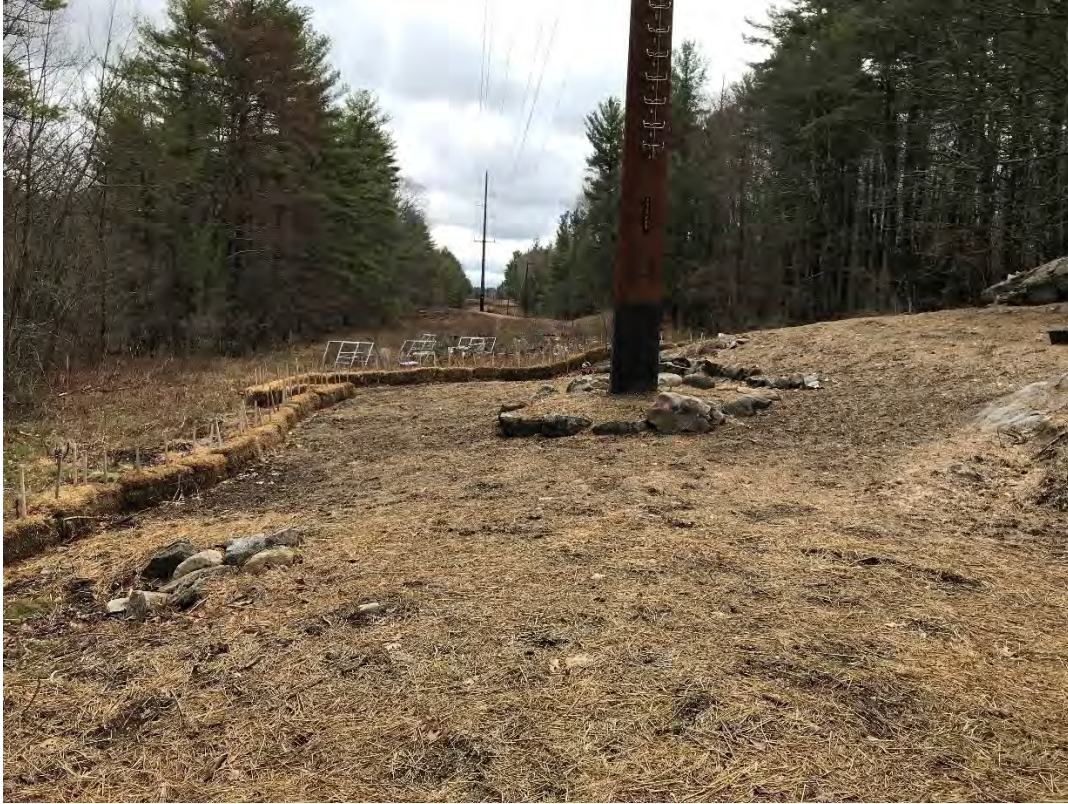
Fig 5: Str. 89 work area. Viewing southeast. (04-17-21)

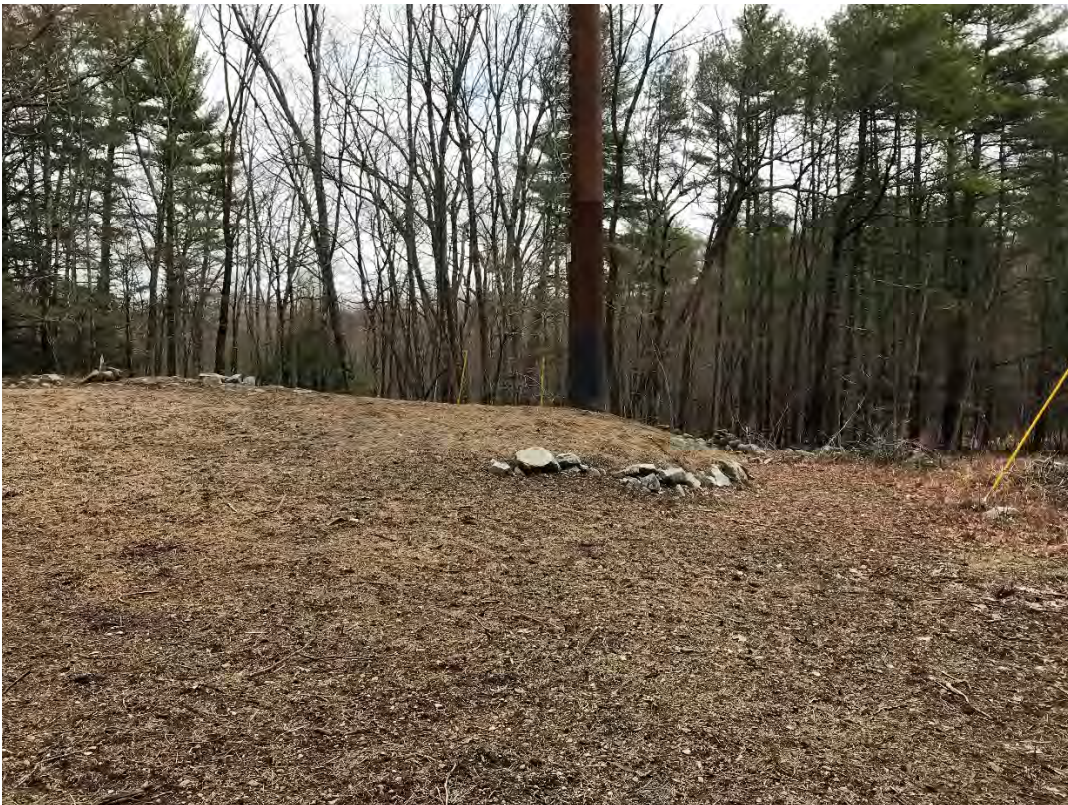
Fig 6: Str. 90 work area. Viewing northeast. (04-17-21)

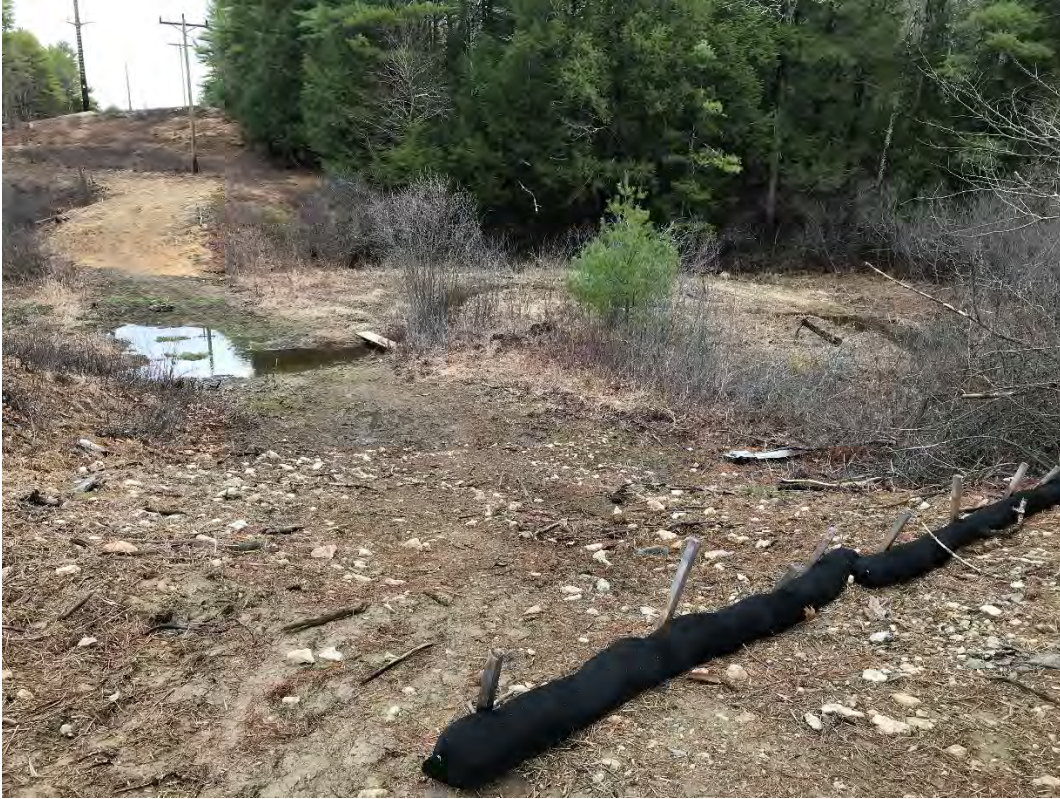
Fig 7: Stream DS46 between Strs. 51 and 52. Viewing northeast. (04-17-21)

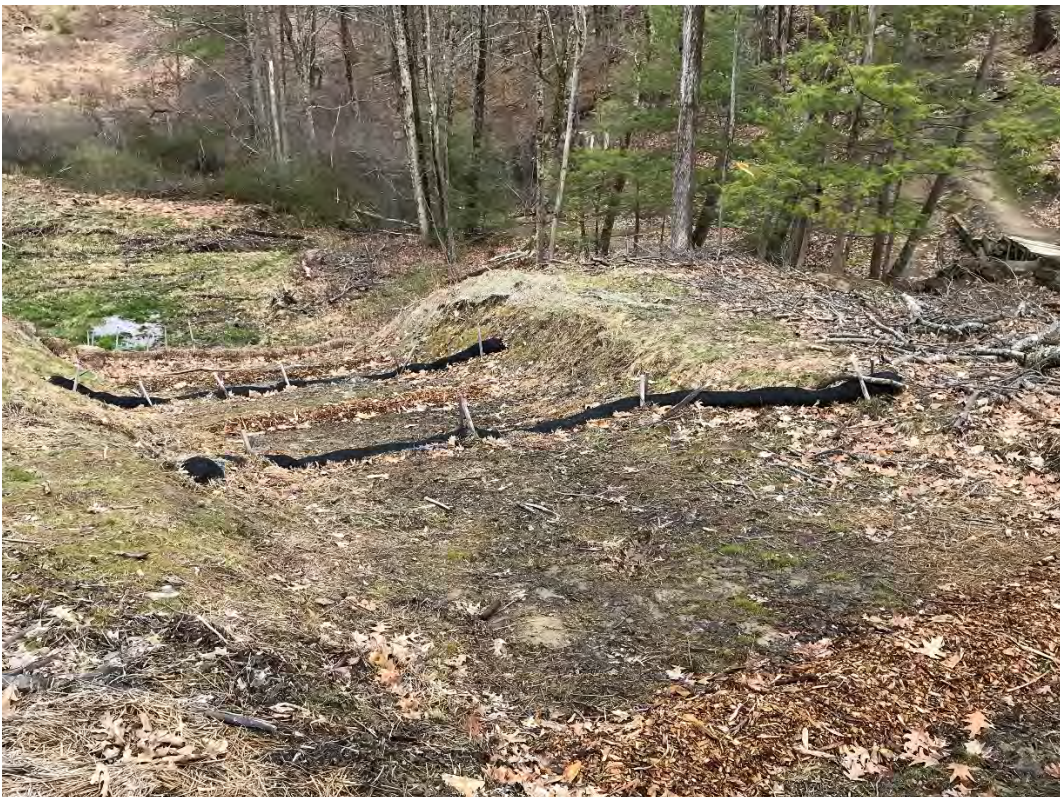
Fig 8: Lower portion of slope between Strs. 28 and 29. Viewing northeast. (04-17-21)

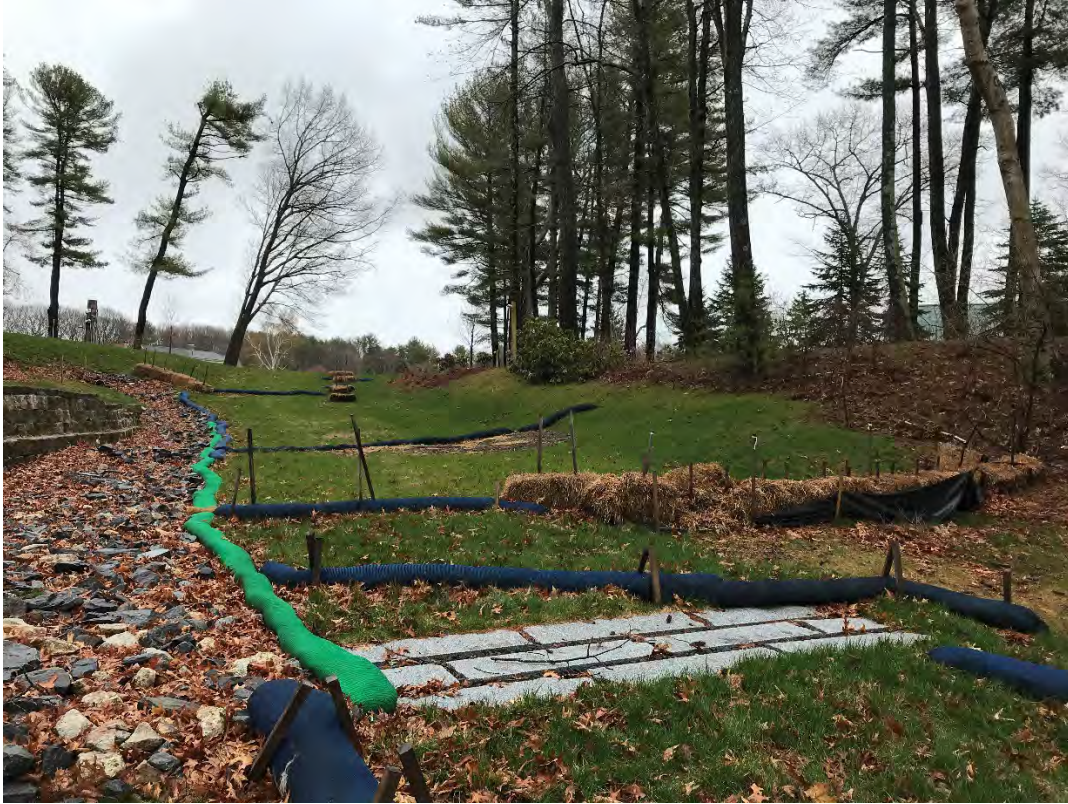
Moderate germination: Strs. 4-6, Strs. 7-21, 25-34, 36-88, 91-101, 107, 109-112, 122-127, 129-130, and Gundalow Landing/east side of bay.

Fig 9: Slope above the manhole at Gundalow Landing/east side of the bay. Viewing east. (04-17-21)

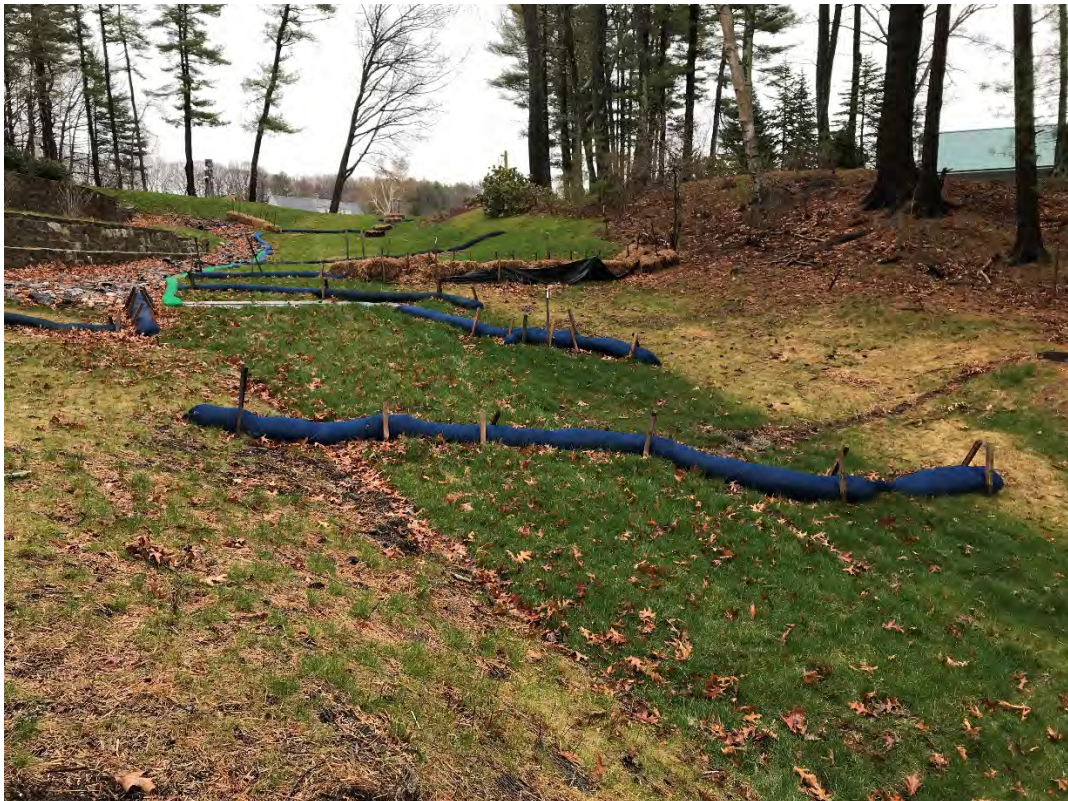
Fig 10: Slope below the manhole at Gundalow Landing/east side of the bay. Viewing east. (04-17-21)

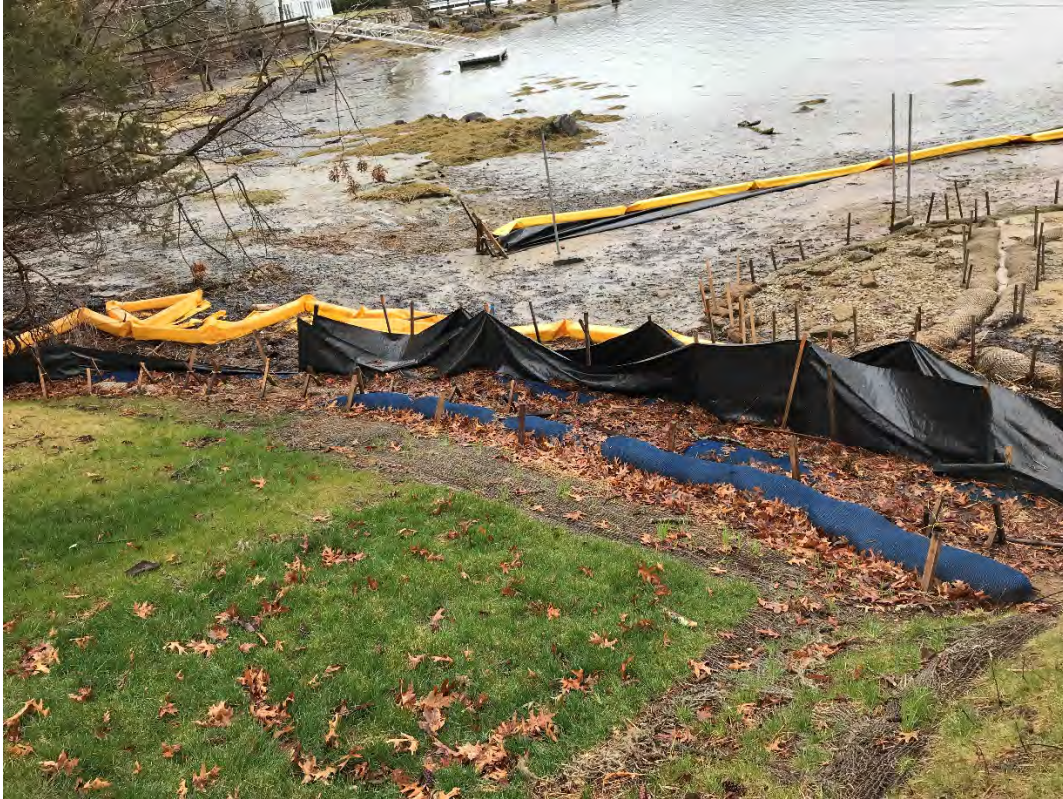
Fig 11: Toe of the slope at Gundalow Landing/east side of the bay. Viewing south. (04-17-21)

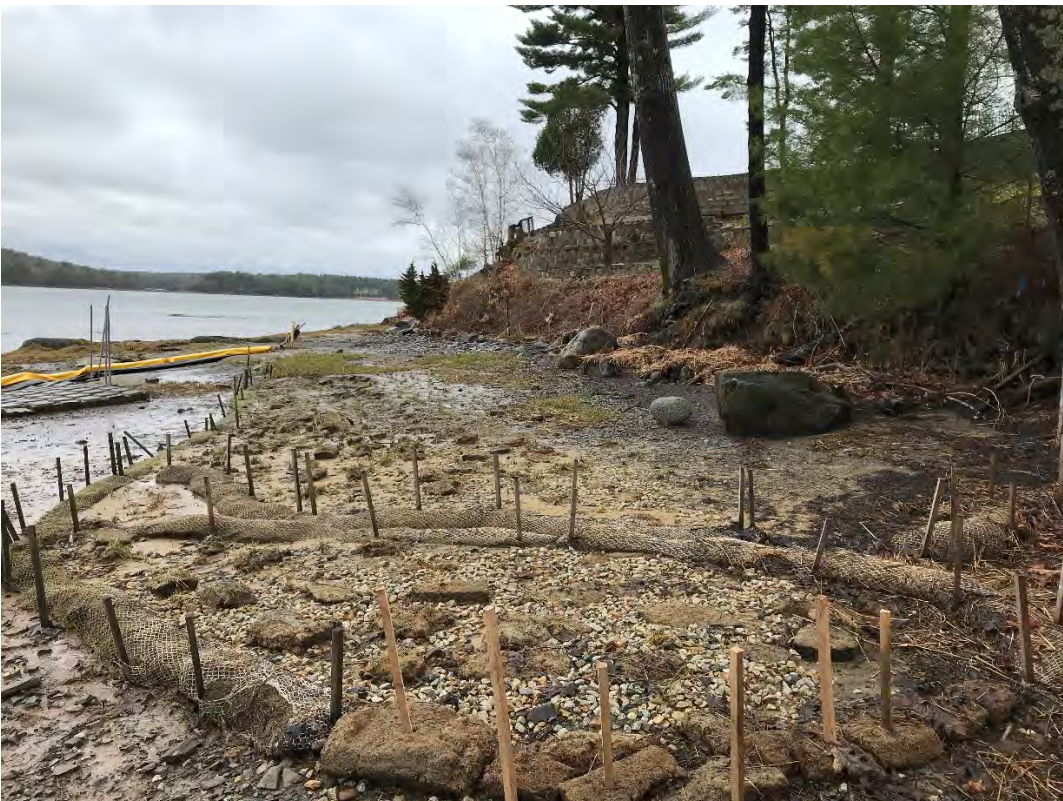
Fig 12: Salt marsh restoration at Gundalow Landing/east side of the bay. Viewing south. (04-17-21)
