DRAINAGE MONITORING REPORT

F107 - Seacoast Reliability Project

Newington, New Hampshire

04.0190967.00

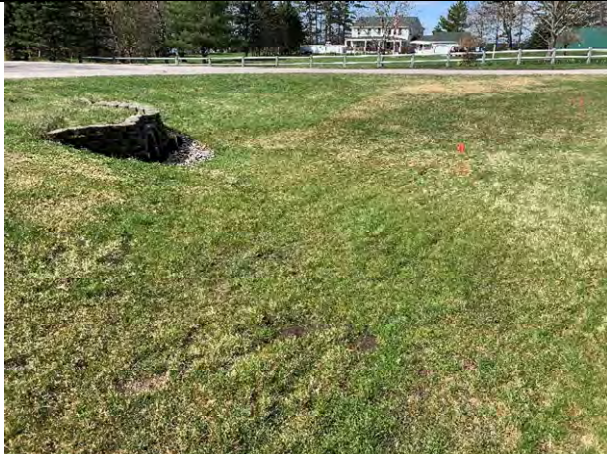
29 Gundalow - 1 (Drainage Area)

Observations/Notes: Soil saturated, not enough standing water to obtain measurement.

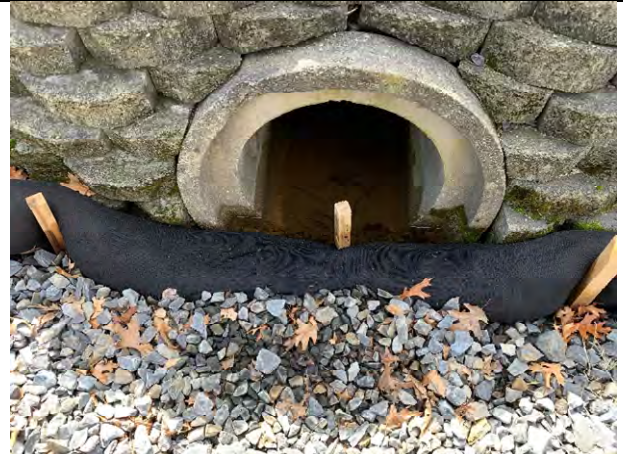
29 Gundalow - 2 (Culvert)

pH: 12.5

Observations/Notes: Approx. 8" of flowing water at culvert inlet.

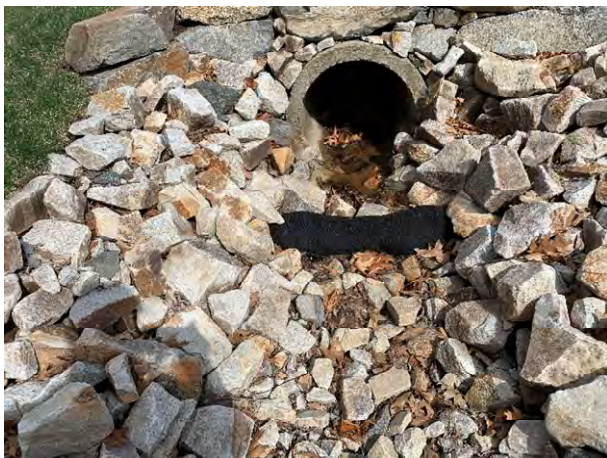
64 Gundalow - 1 (Drainage Course)

pH: 11.7

Observations/Notes: Accessible flowing water extending approx. 14" beyond culvert outlet.

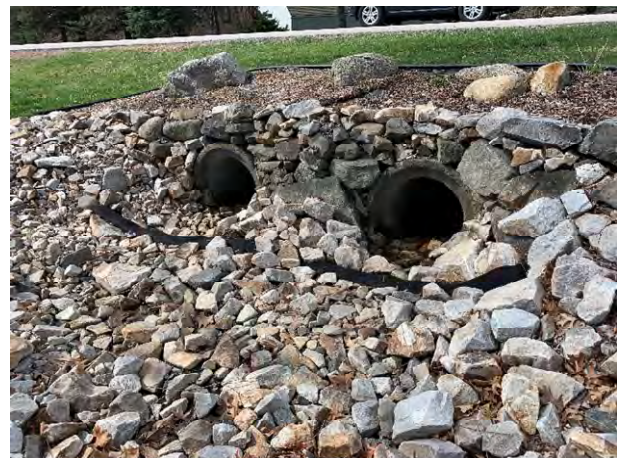
64 Gundalow - 2 (Drainage Course)

pH: 9.2

Observations/Notes: Area of flowing water extending approx. 18" from culvert inlets.

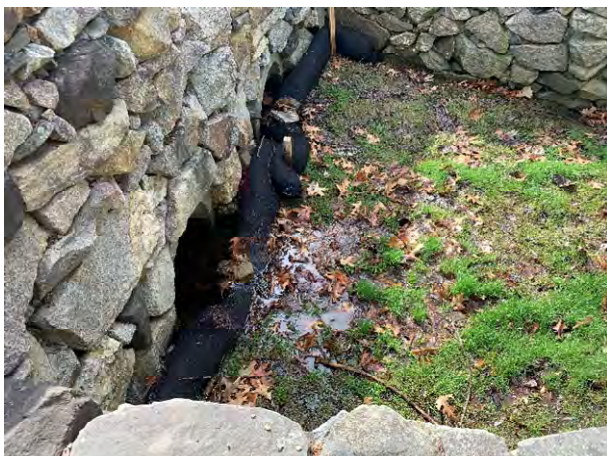
4 Brickyard Circle - 1 (Drainage Course)

pH: 7.7

Observations/Notes: Flowing water in drainage course extending approx. 2.5' from culvert outlets, max depth approx. 8". Flow observed over top of peat moss log.

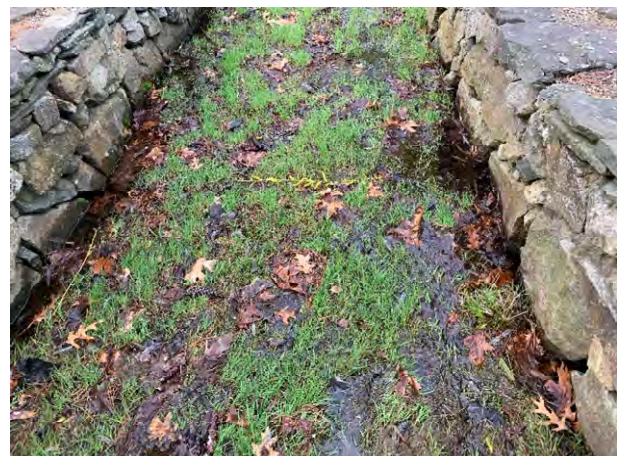
4 Brickyard Circle - 2 (Drainage Course)

pH: 7.6

Observations/Notes: Water flowing approx. 3" deep.

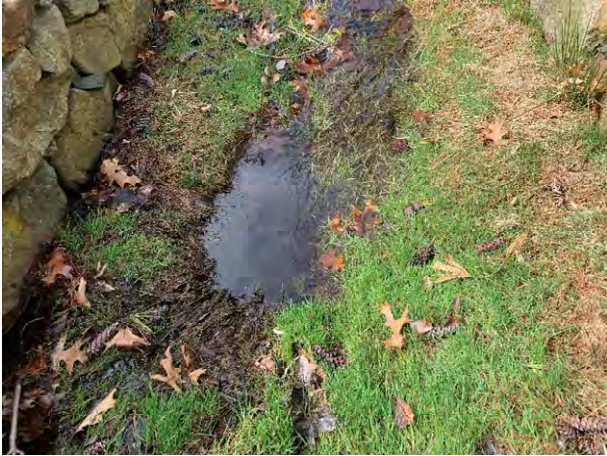
4 Brickyard Circle – 3 (Drainage Course)

pH: 7.5

Observations/Notes: Water flowing approx. 5" deep.

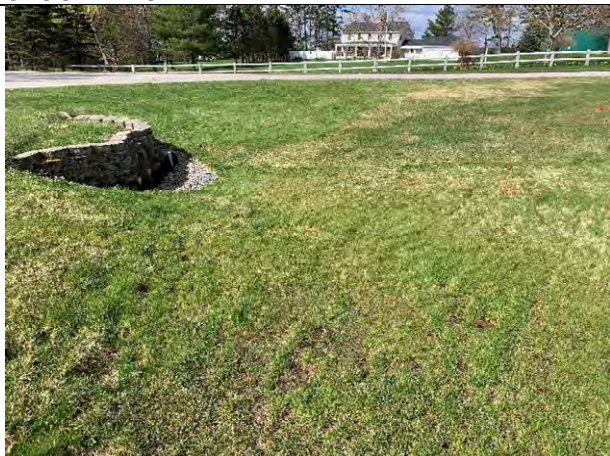
29 Gundalow - 1 (Drainage Area)

Observations/Notes: Soil saturated, not enough standing water to obtain measurement.

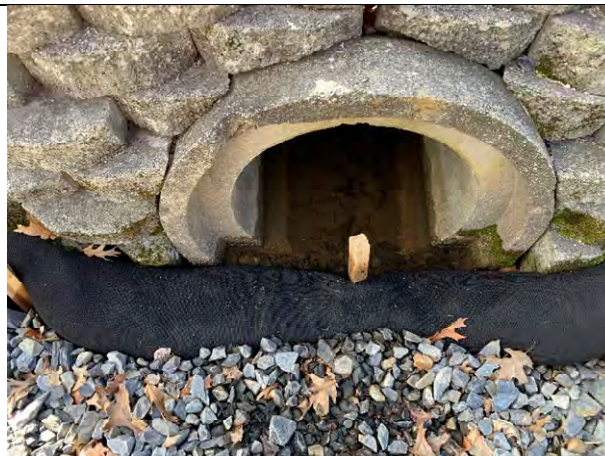
29 Gundalow - 2 (Culvert)

pH: 12.3

Observations/Notes: Approx. 8" of flowing water at culvert inlet.

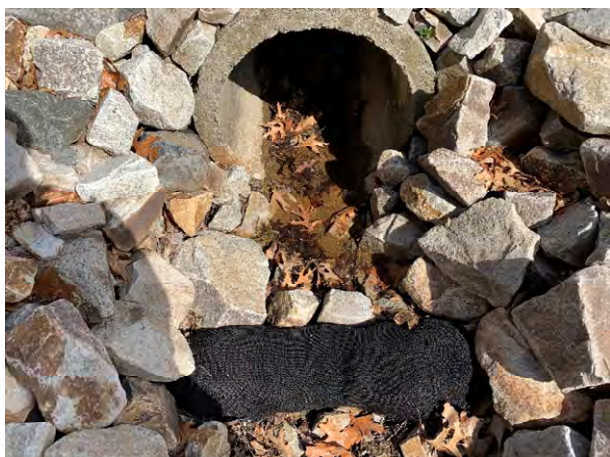
64 Gundalow - 1 (Drainage Course)

pH: 11.4

Observations/Notes: Accessible flowing water extending approx. 14" beyond culvert outlet.

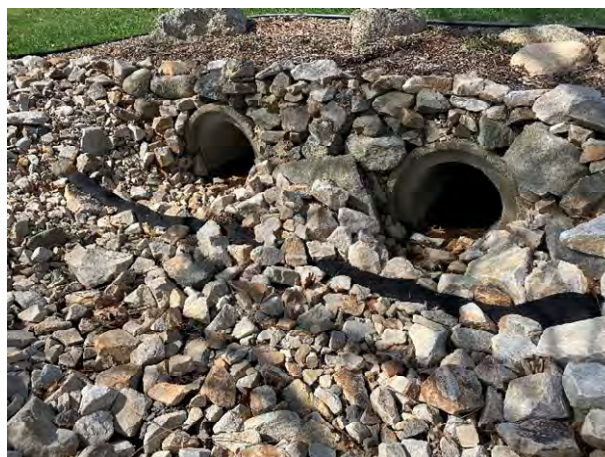
64 Gundalow - 2 (Drainage Course)

pH: 8.0

Observations/Notes: Area of flowing water extending approx. 18" from culvert inlets.

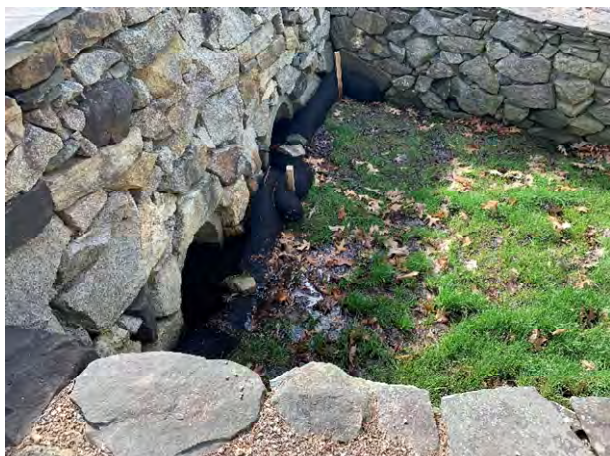
4 Brickyard Circle - 1 (Drainage Course)

pH: 7.0

Observations/Notes: Flowing water in drainage course extending approx. 2.5' from culvert outlets, max depth approx. 8". Flow observed over top of peat moss log.

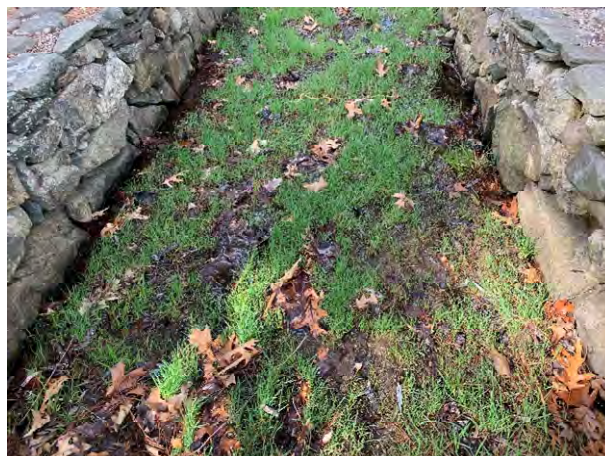
4 Brickyard Circle - 2 (Drainage Course)

pH: 7.3

Observations/Notes: Water flowing approx. 3" deep.

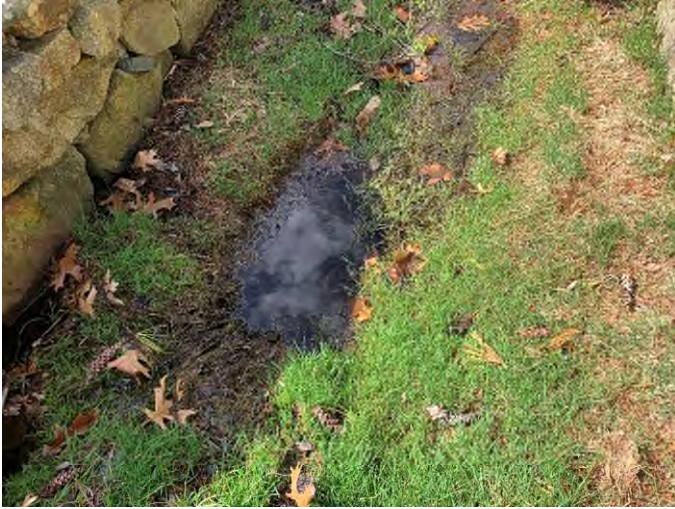
4 Brickyard Circle – 3 (Drainage Course)

pH: 7.2

Observations/Notes: Water flowing approx. 5" deep.
