CONSTRUCTION MONITORING REPORT

Eversource Transmission Lines:
F107

TYPE OF INSPECTION: Weekly Storm Event Incident Corrective Action

NAI Project No:
23840.39

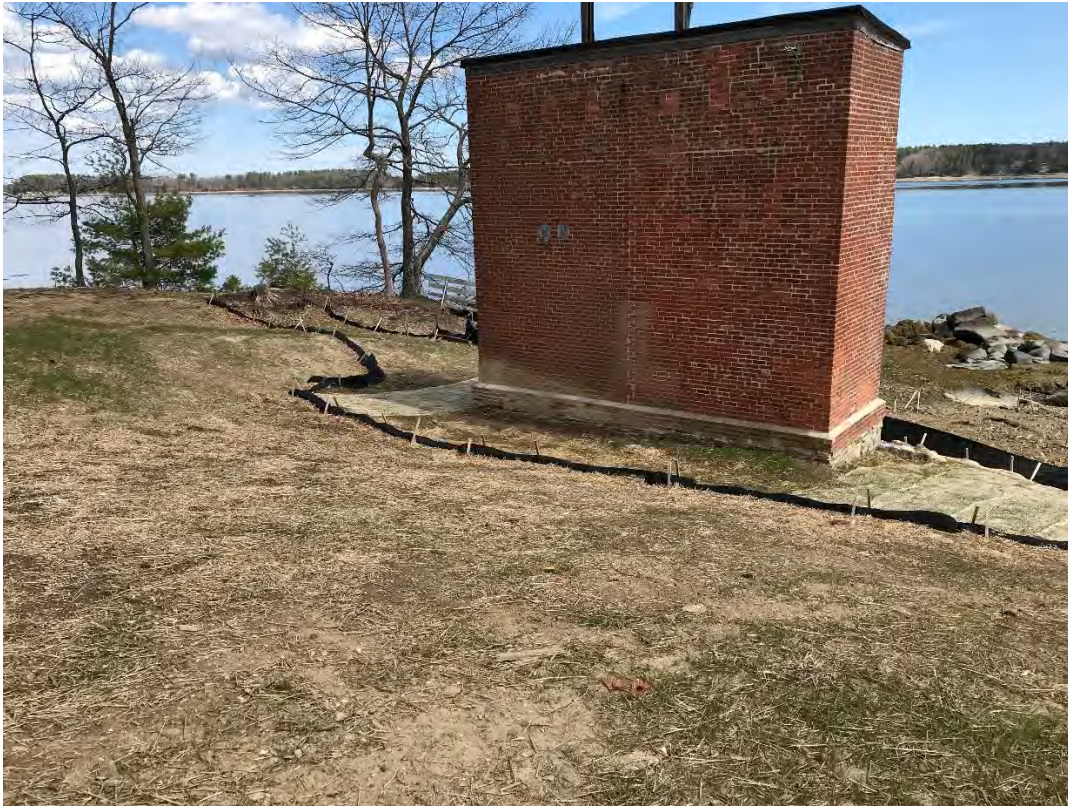
Fig 1: Slope leading down to cable house and salt marsh restoration at the west side of the bay. Viewing northeast. (04-19-21)

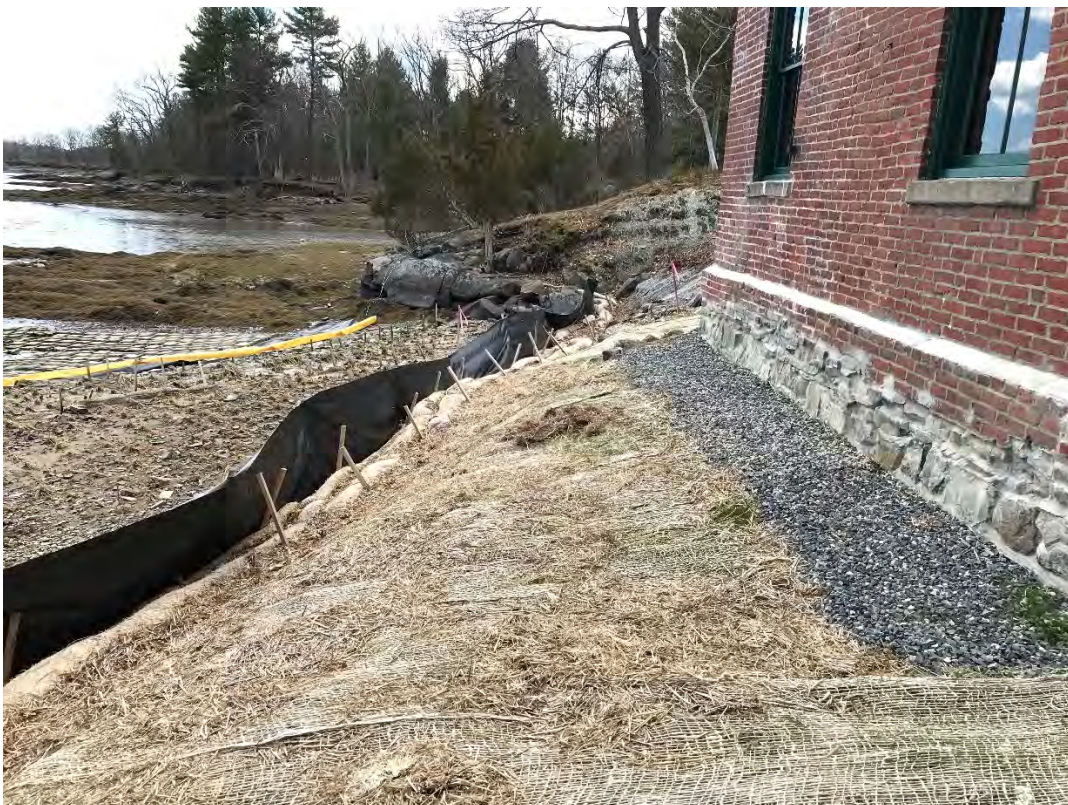
Fig 2: Slope between the cable house and salt marsh restoration at the west side of the bay. Viewing south. (04-19-21)

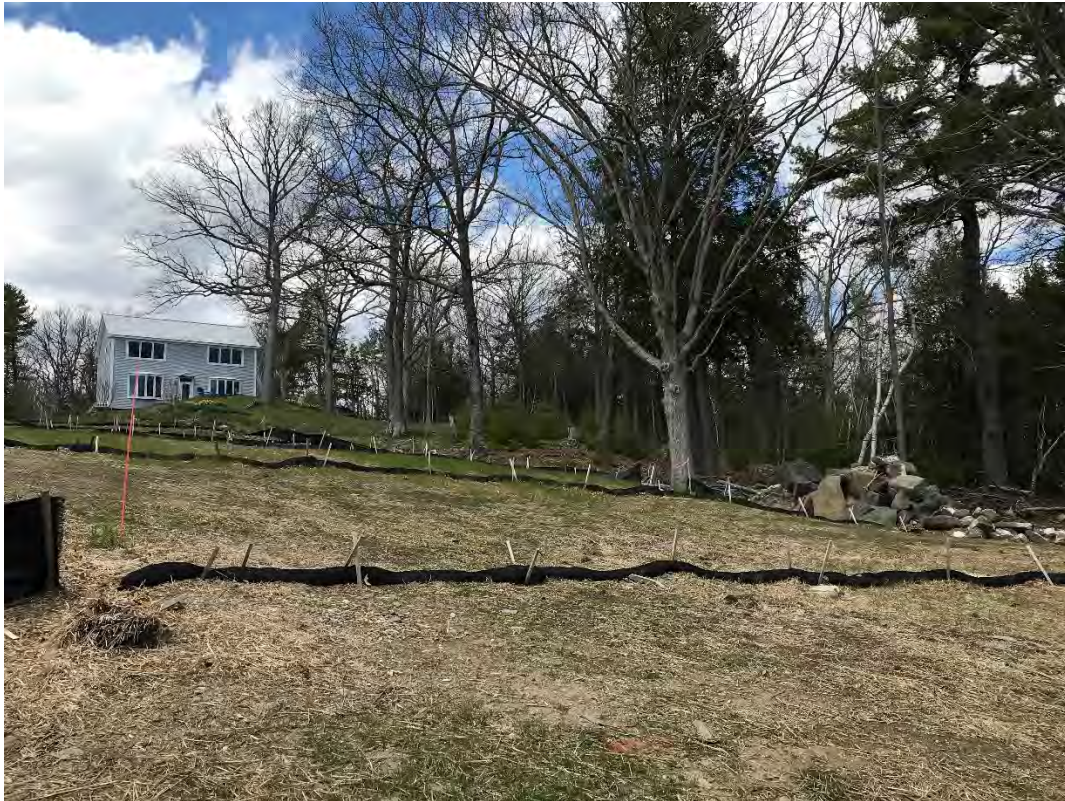
Fig 3: Slope above the cable house at the west side of the bay. Viewing northwest. (04-19-21)

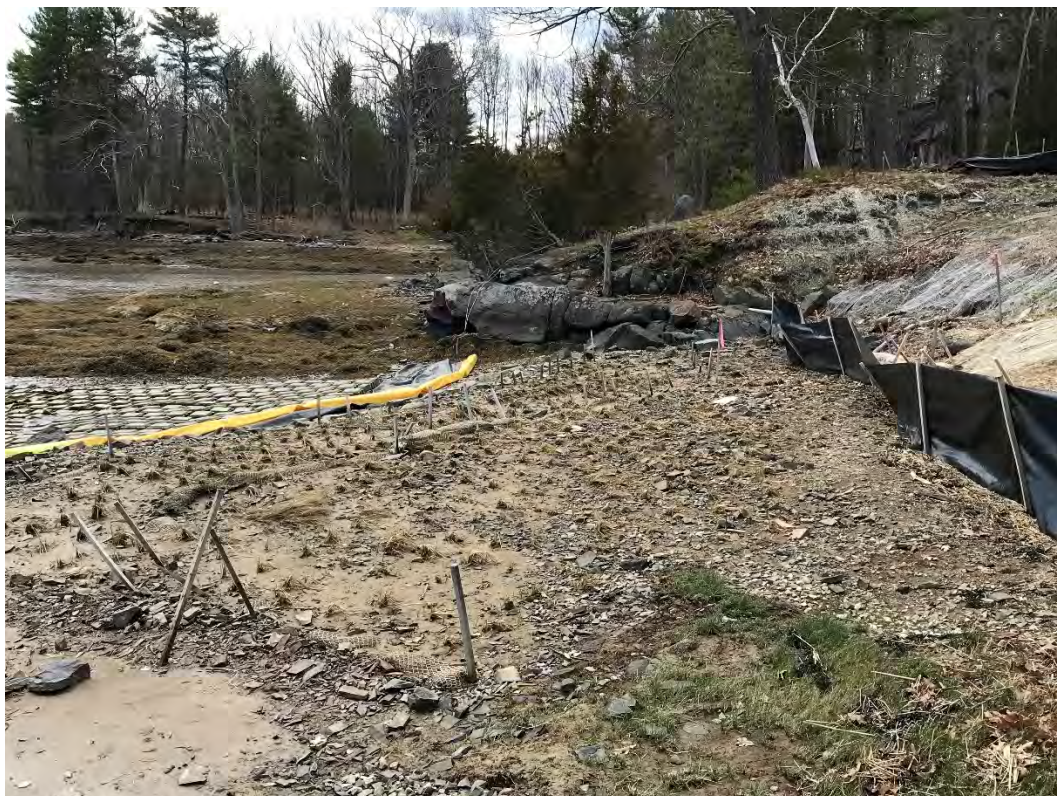
Fig 4: Toe of the slope and salt marsh restoration at the west side of the bay. Viewing south. (04-19-21)

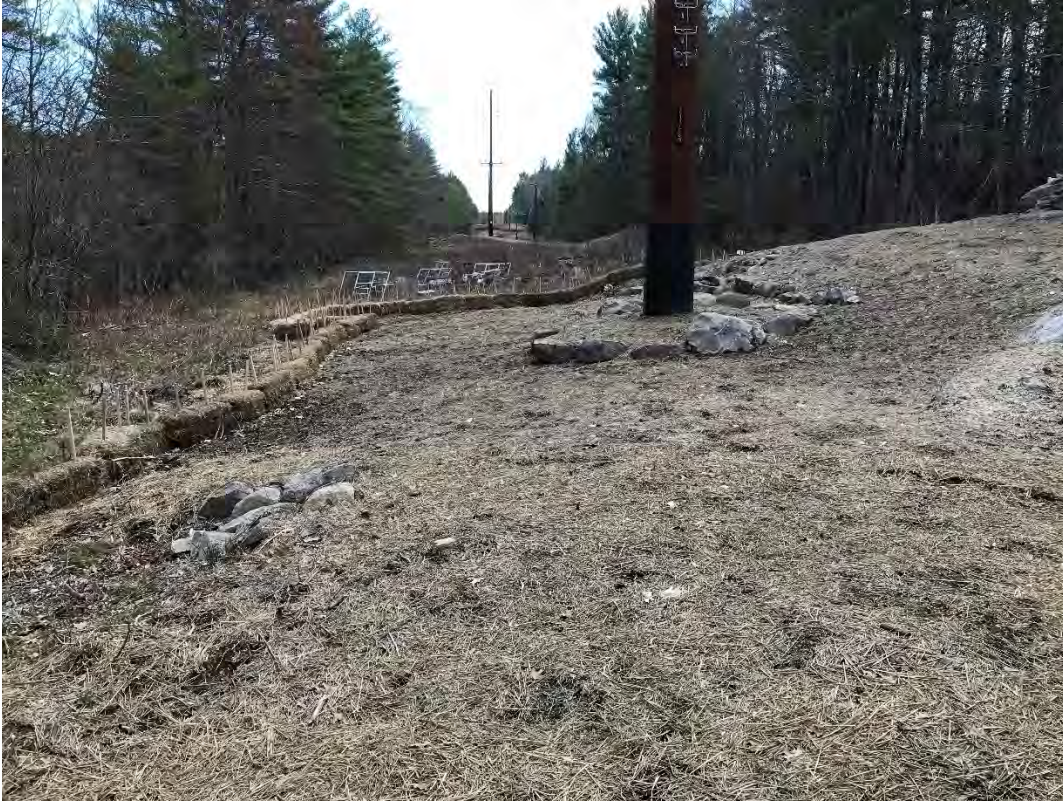
Fig 5: Str. 89 work area. Viewing southeast. (04-19-21)

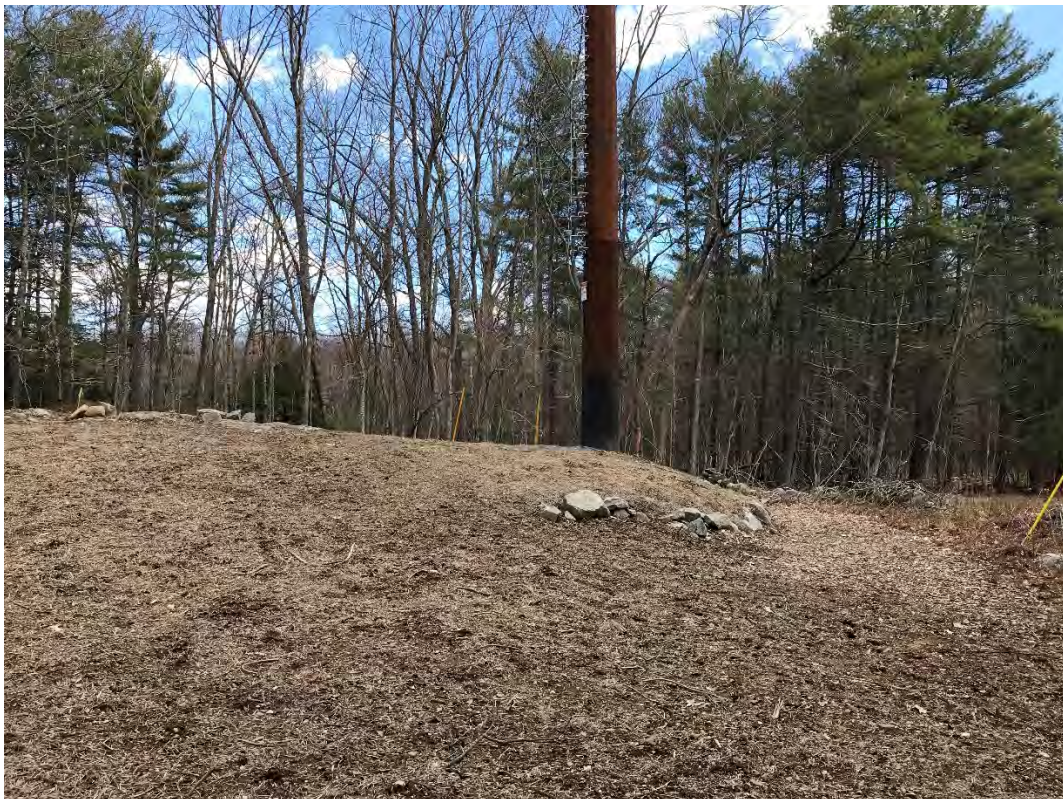
Fig 6: Str. 90 work area. Viewing northeast. (04-19-21)

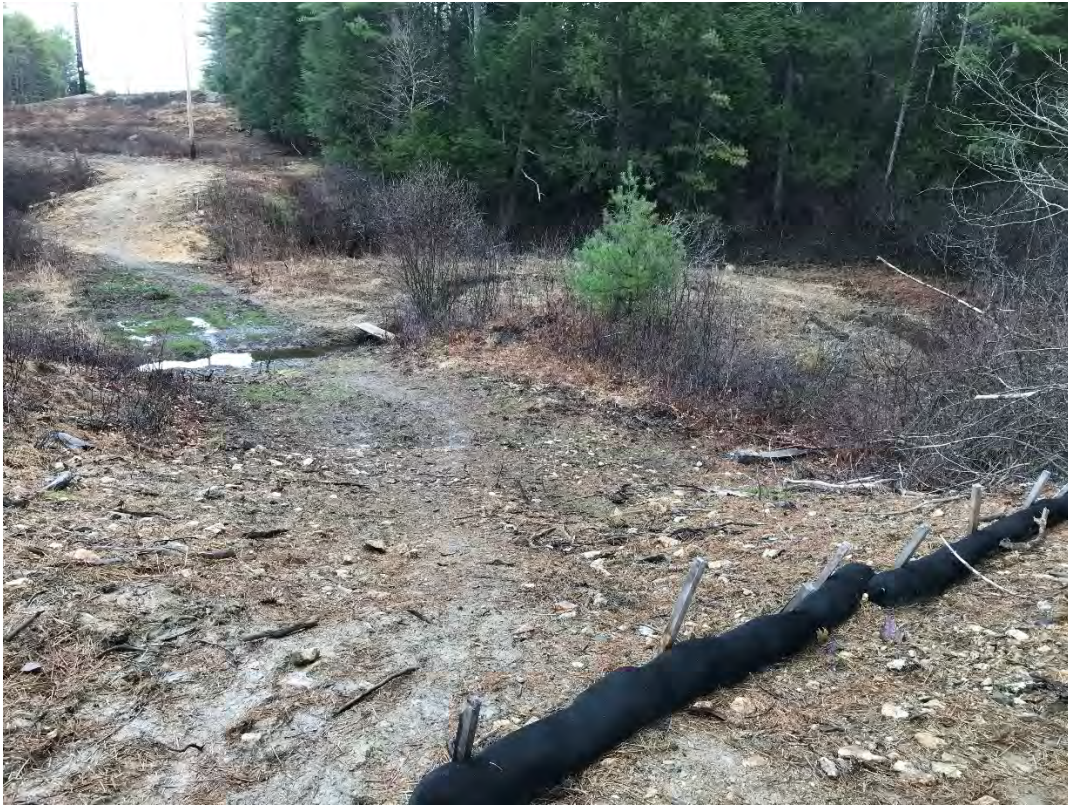
Fig 7: Stream DS46 between Strs. 51 and 52. Viewing northeast. (04-19-21)

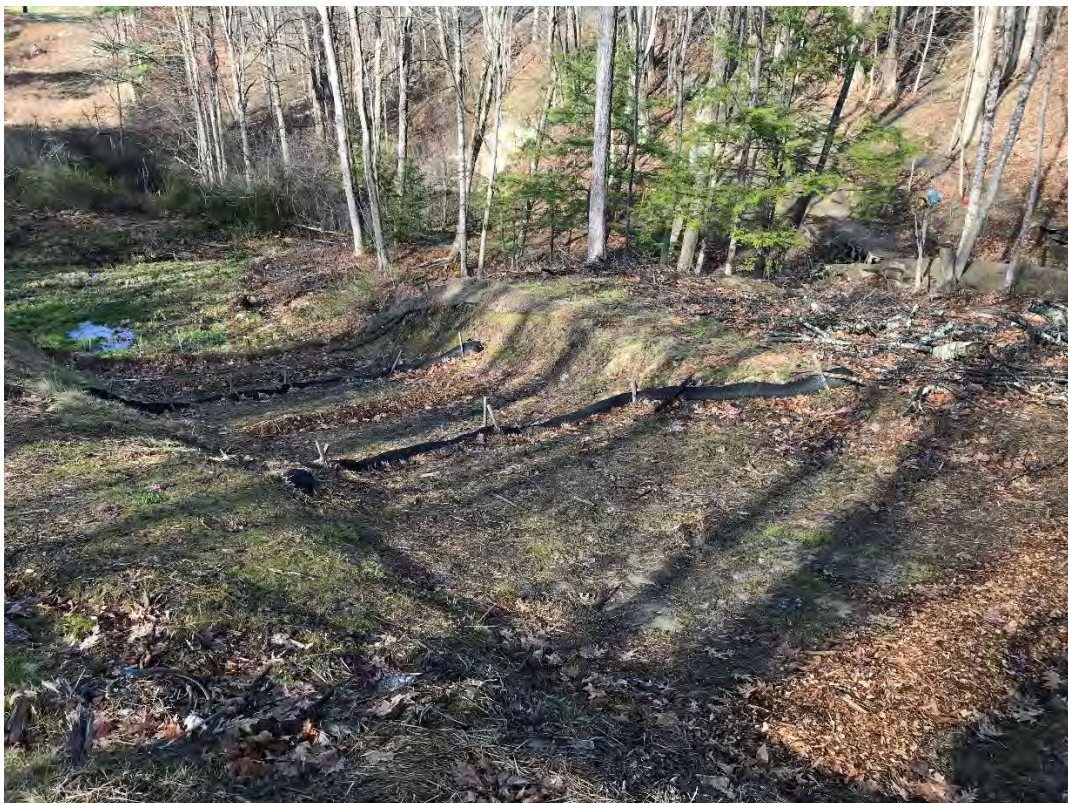
Fig 8: Lower portion of slope between Strs. 28 and 29. Viewing northeast. (04-19-21)

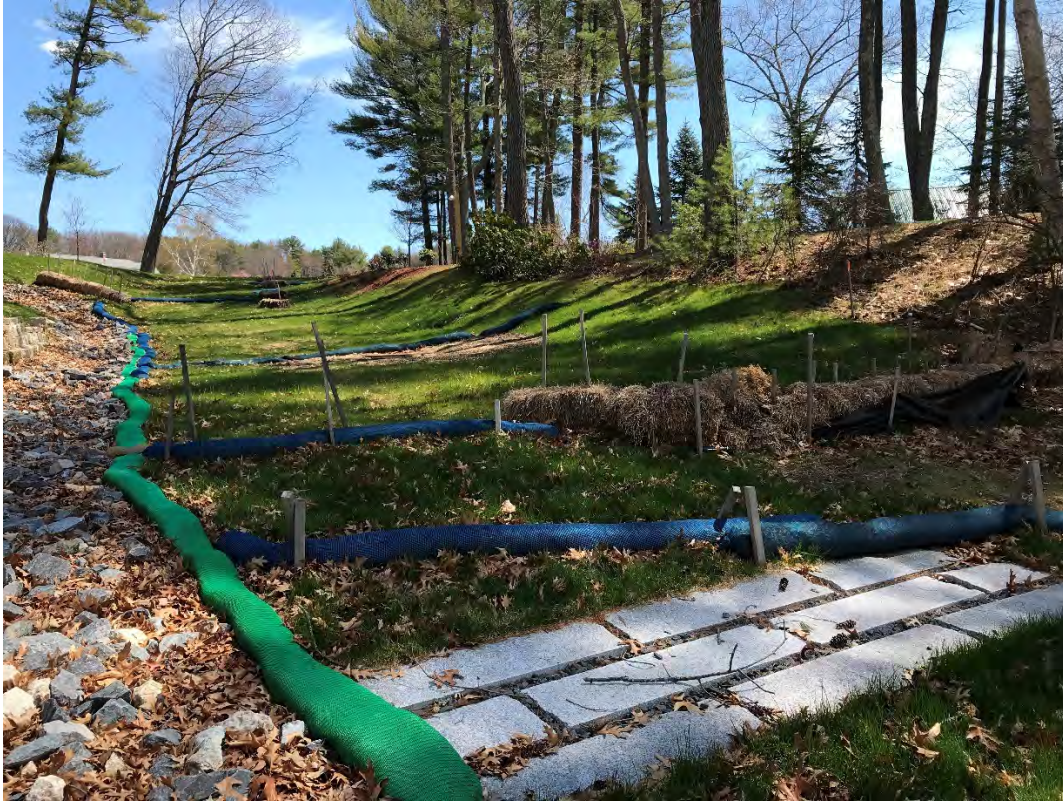
Fig 9: Slope above the manhole at Gundalow Landing/east side of the bay. Viewing east. (04-19-21)

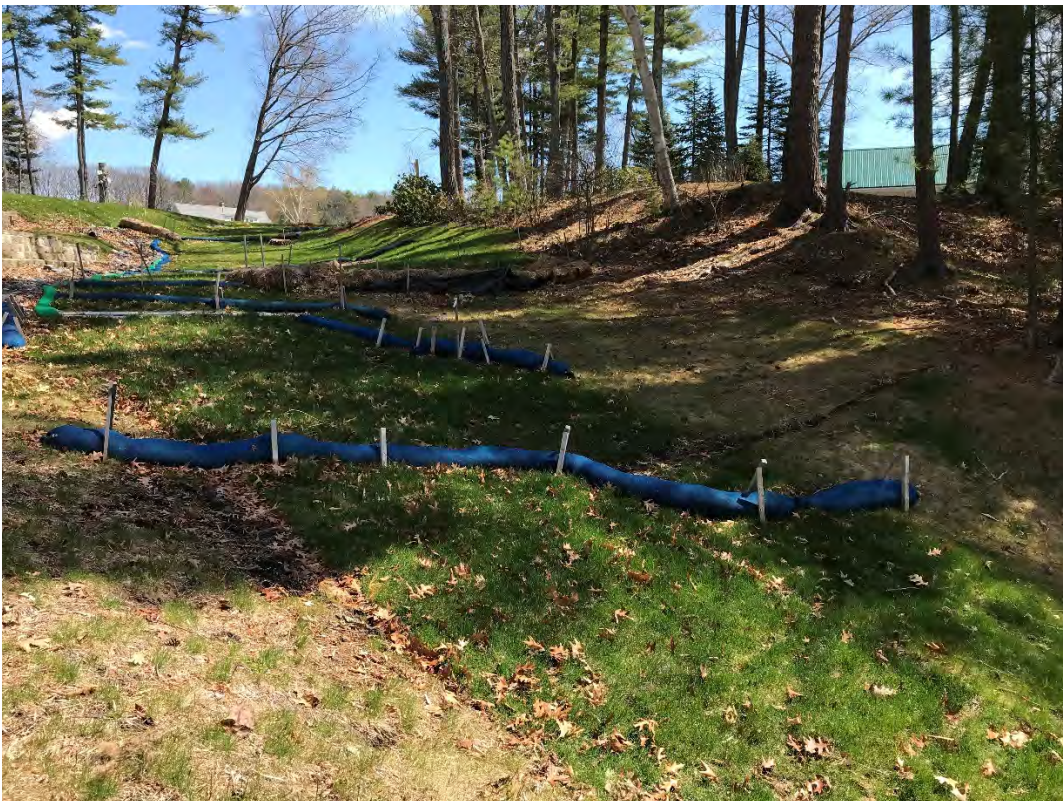
Fig 10: Slope below the manhole at Gundalow Landing/east side of the bay. Viewing east. (04-19-21)

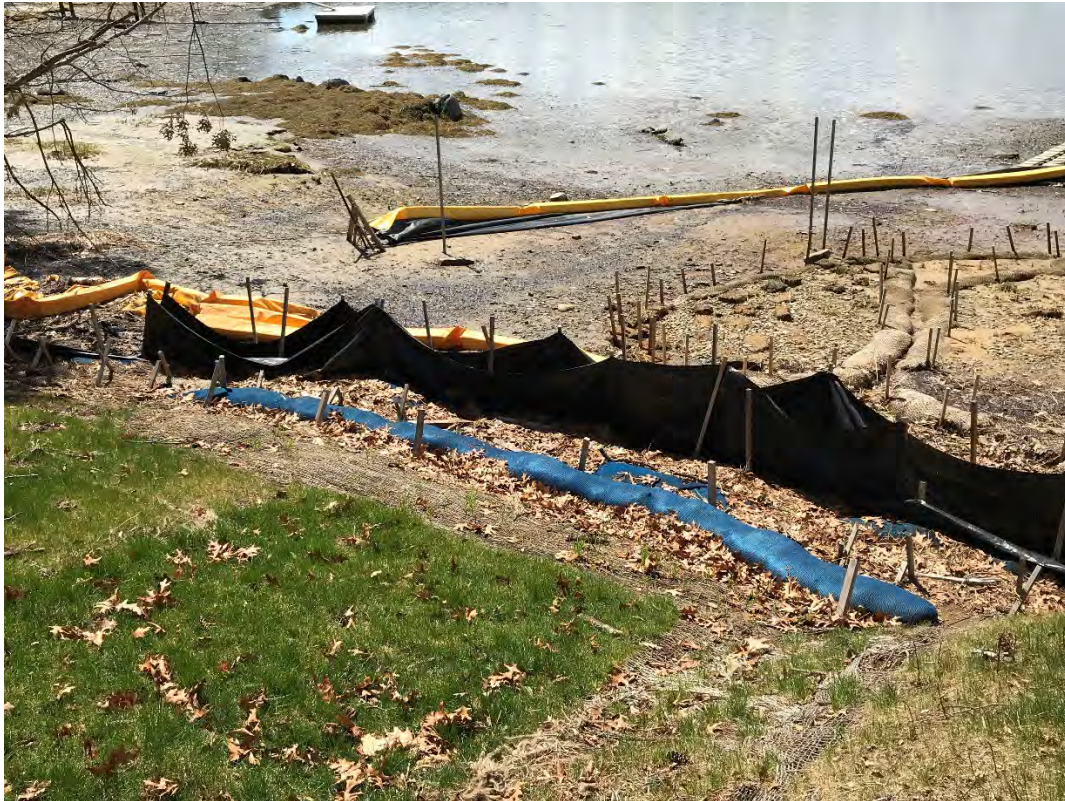
Fig 11: Toe of the slope at Gundalow Landing/east side of the bay. Viewing south. (04-19-21)

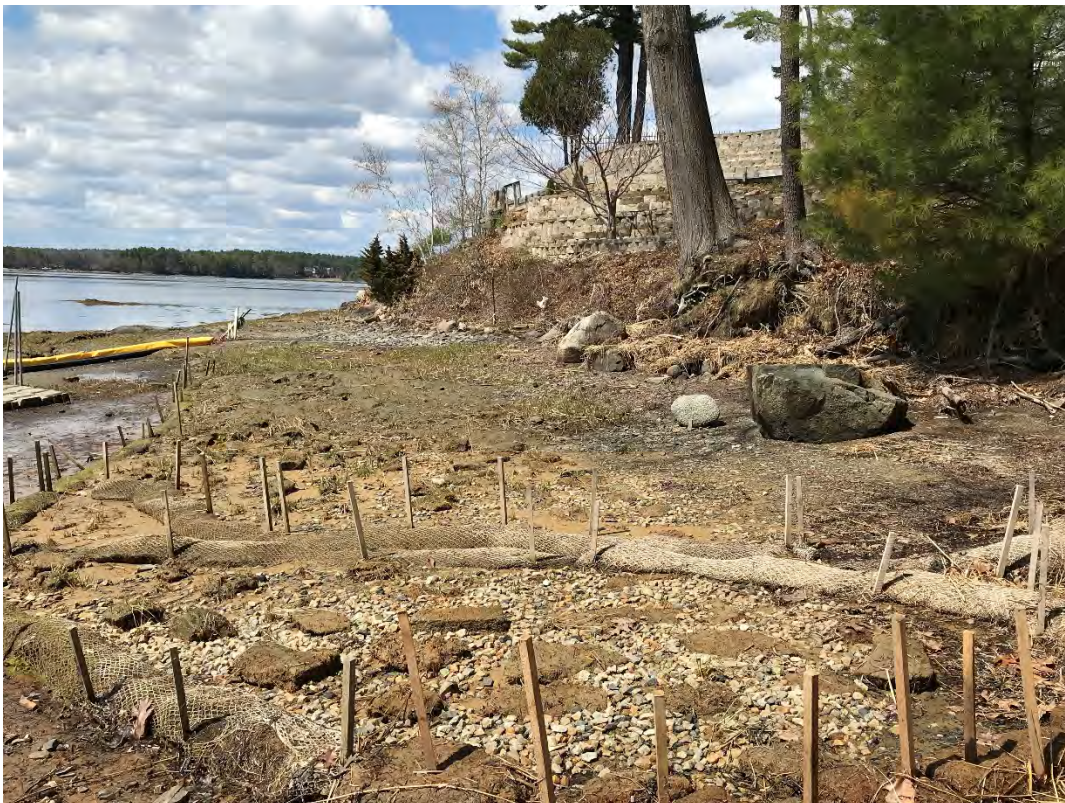
Fig 12: Salt marsh restoration at Gundalow Landing/east side of the bay. Viewing south. (04-19-21)

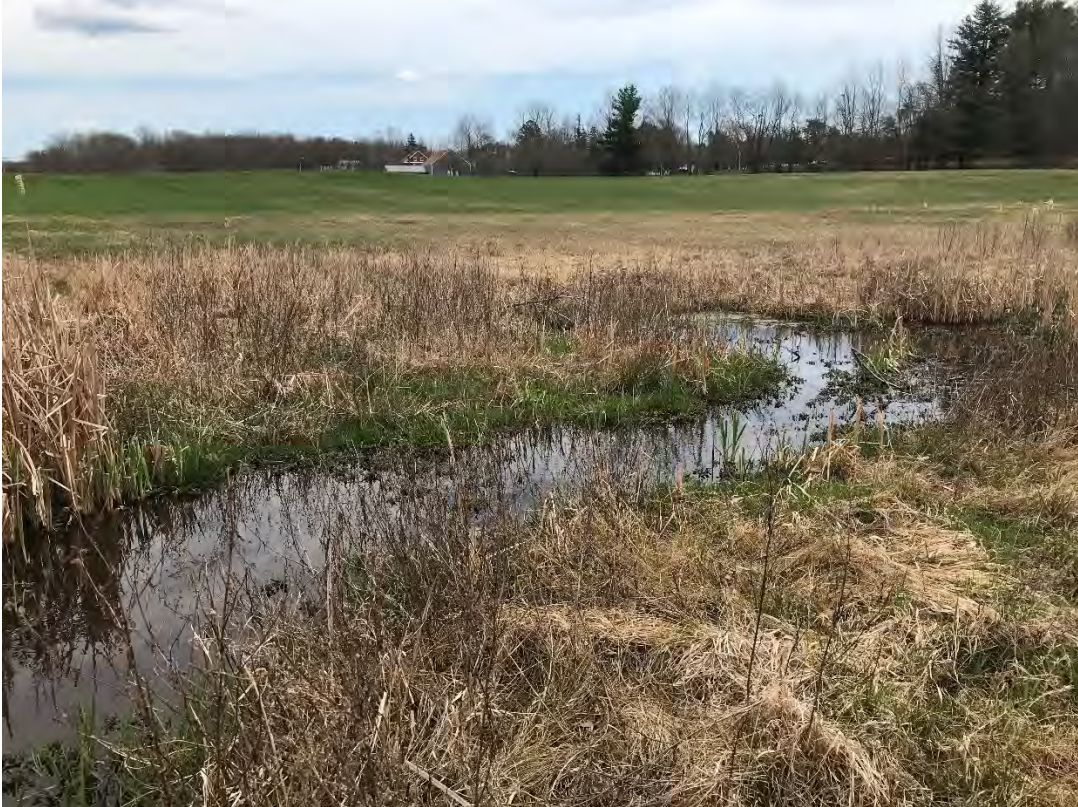
Fig 13: Stream NS107 in wetland NW16 near Str. 106. Viewing east. (04-20-21)

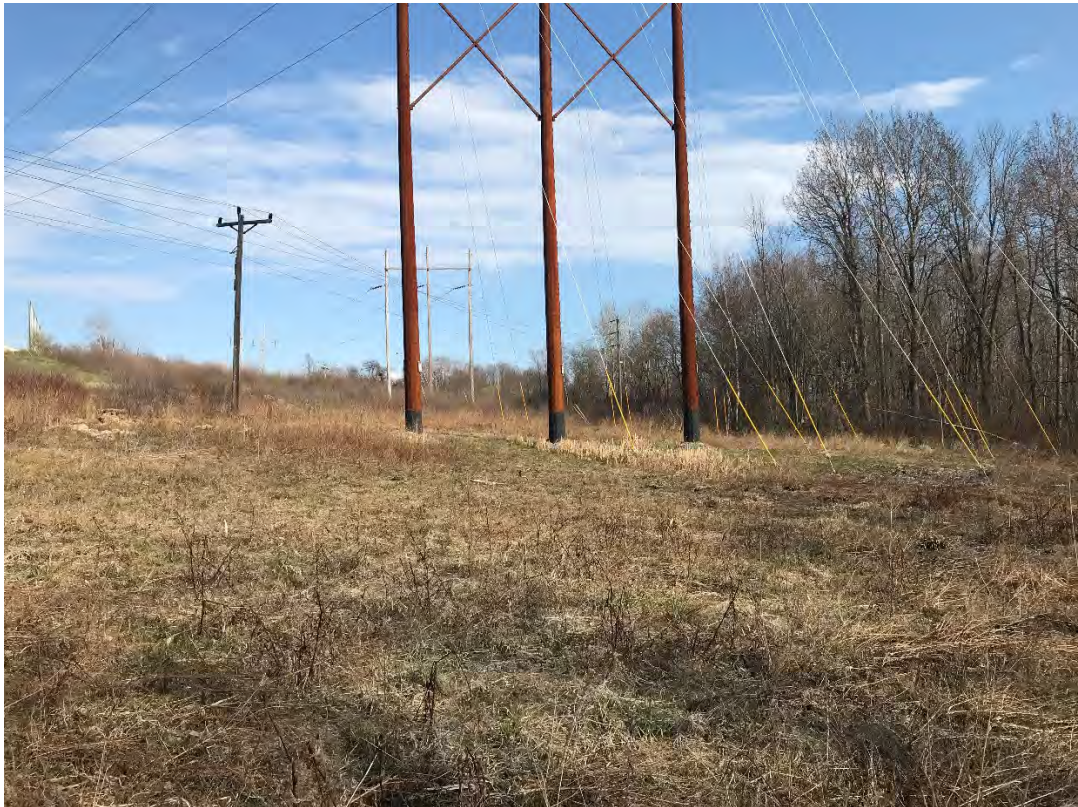
Fig 14: Str. 143 work area. Viewing east. (04-20-21)

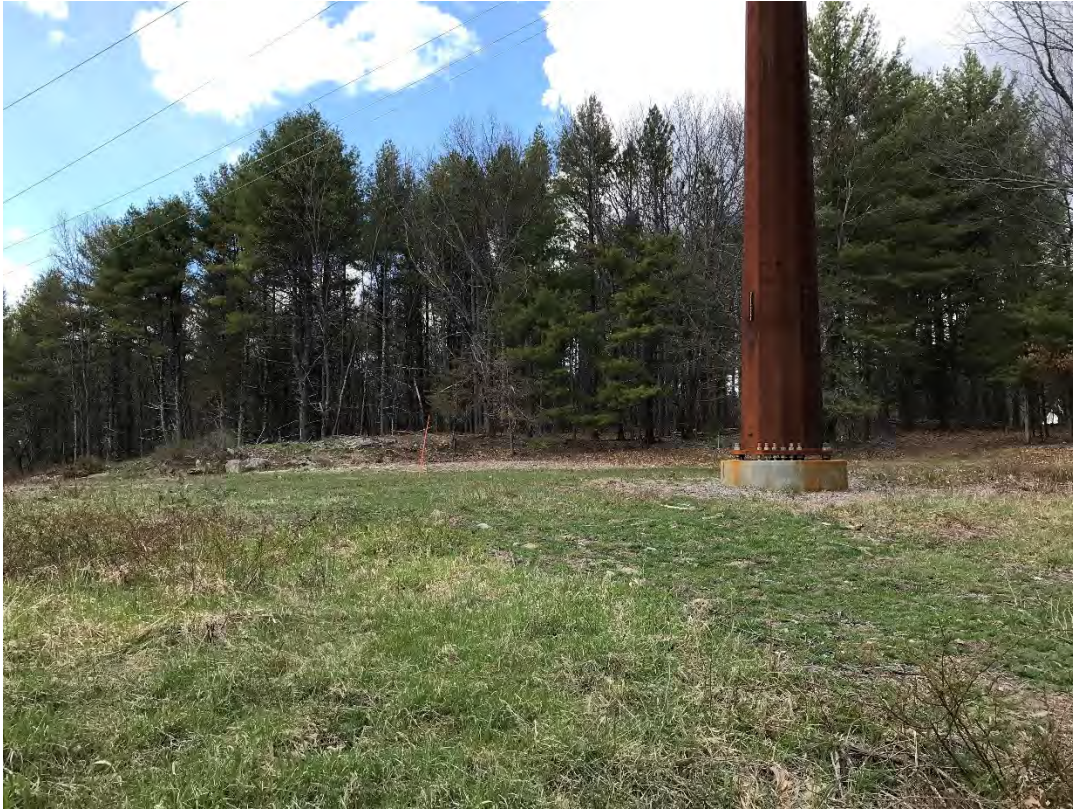
Fig 15: Str. 85 work area. Viewing northwest. (04-19-21)

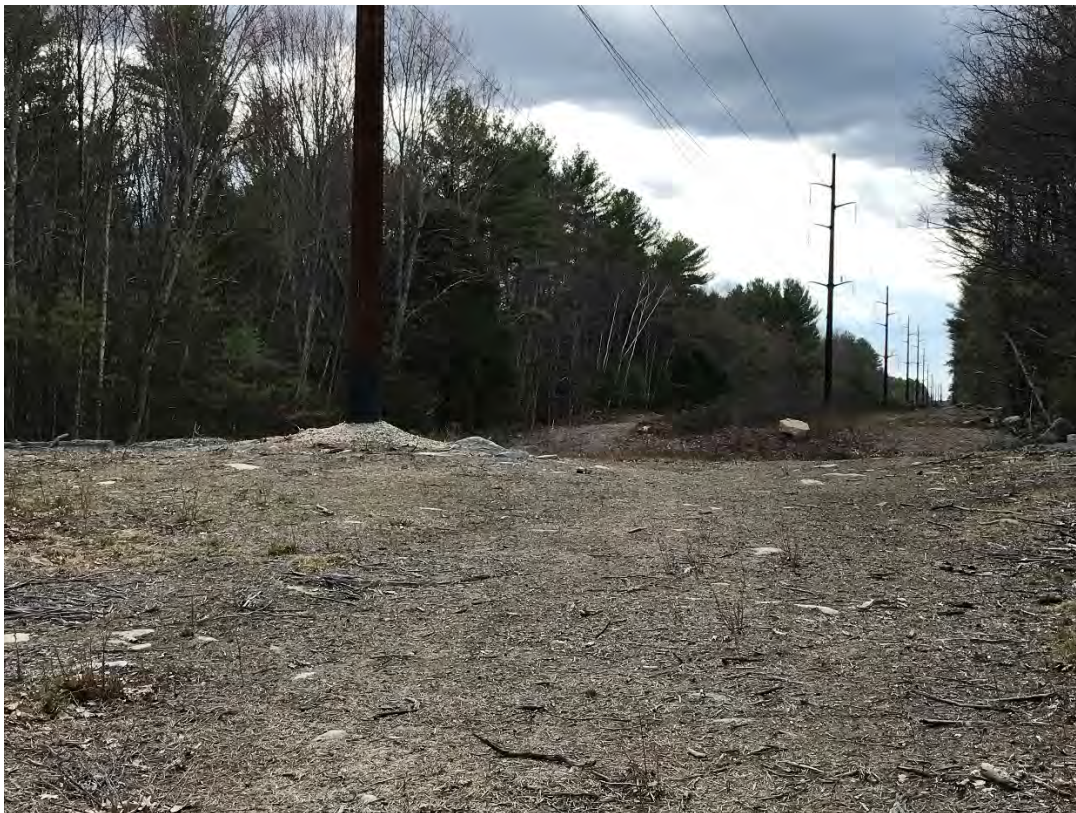
Fig 16: Str. 78 work area. Viewing southwest. (04-19-21)

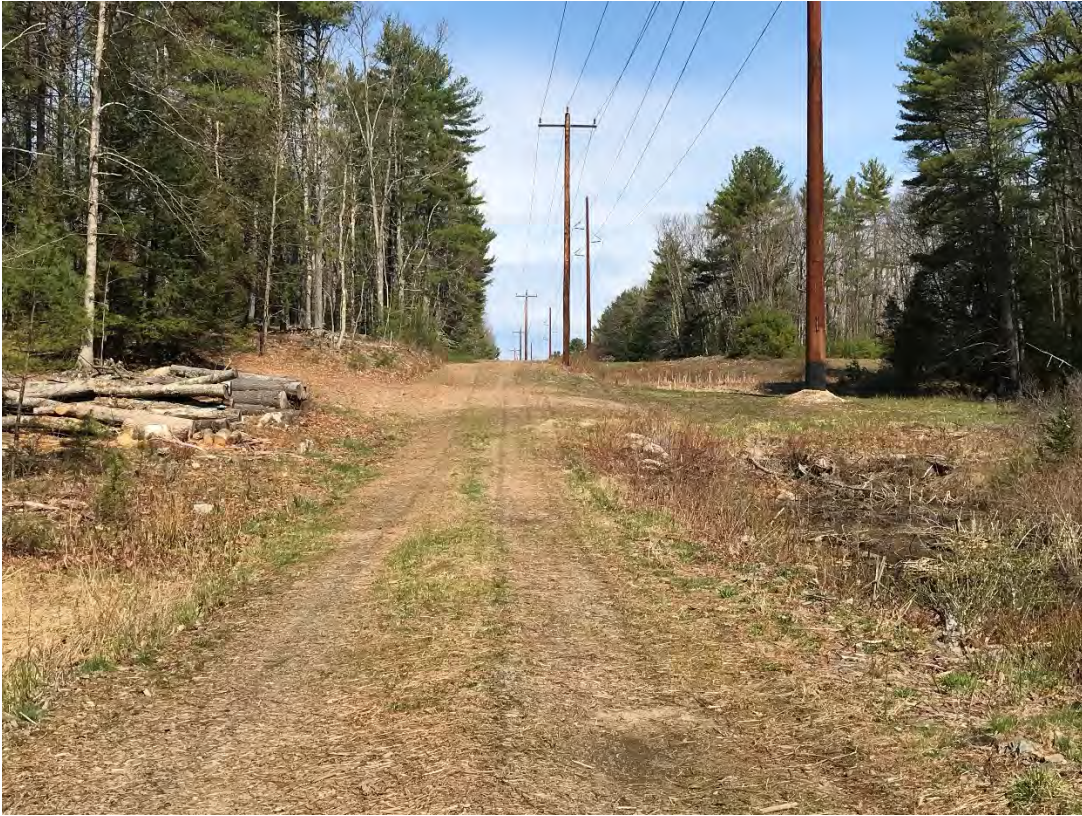
Fig 17: Access leading to Str. 93 work area. Viewing northwest. (04-20-21)

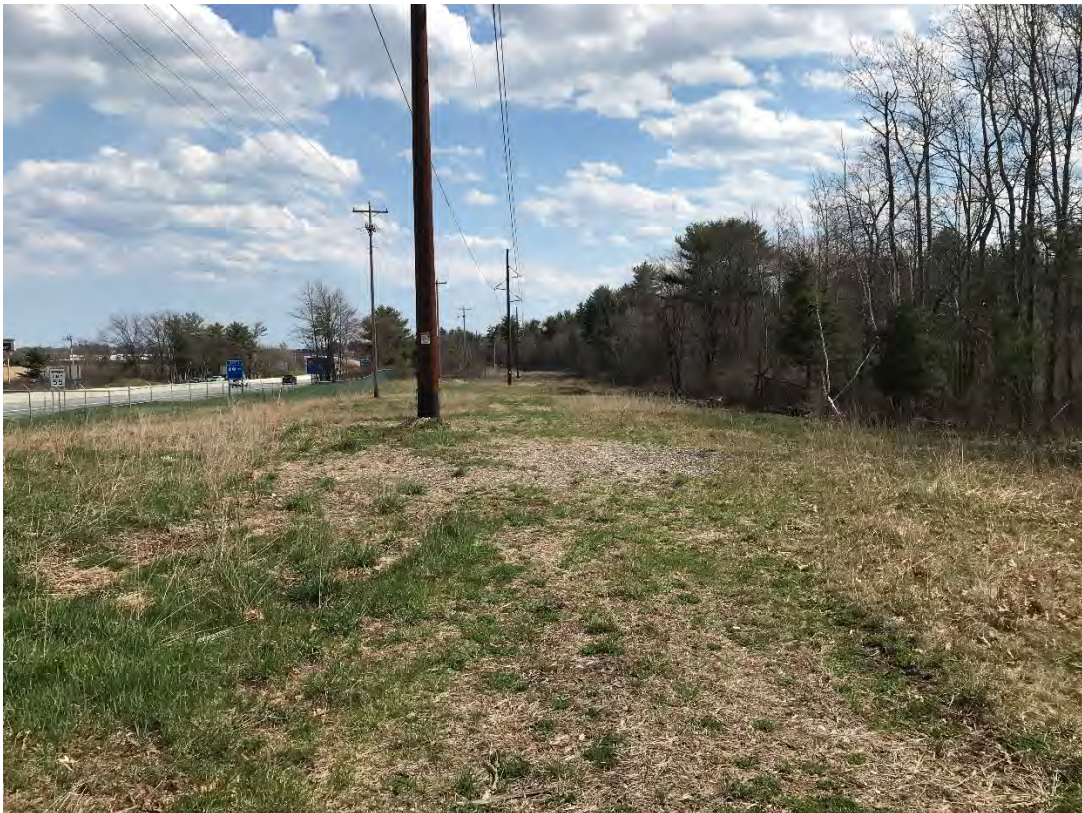
Fig 18: Str. 123 work area. Viewing southeast. (04-20-21)
