CONSTRUCTION MONITORING REPORT

Eversource Transmission Lines:
F107

**Madbury, Durham,
Newington, Portsmouth, NH**

TYPE OF INSPECTION: Weekly Storm Event Incident Corrective Action

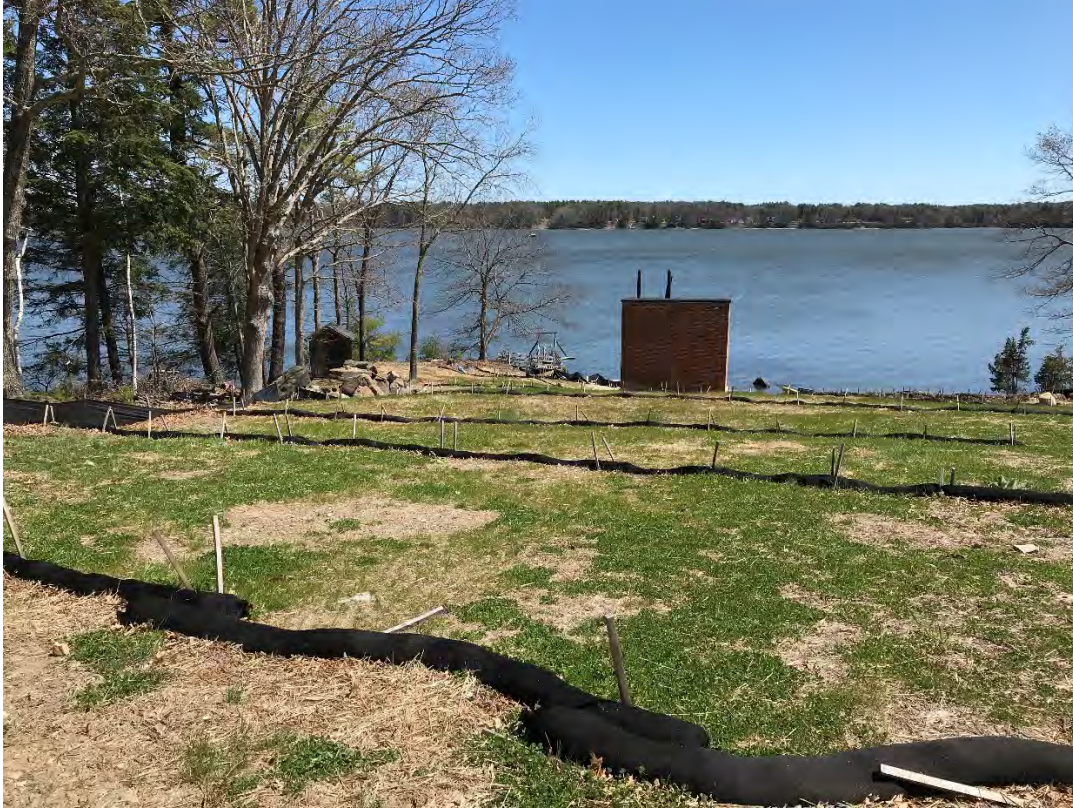
Fig 1: Upper portion of slope leading down to cable house and salt marsh restoration at the west side of the bay. Viewing east. (04-26-21)

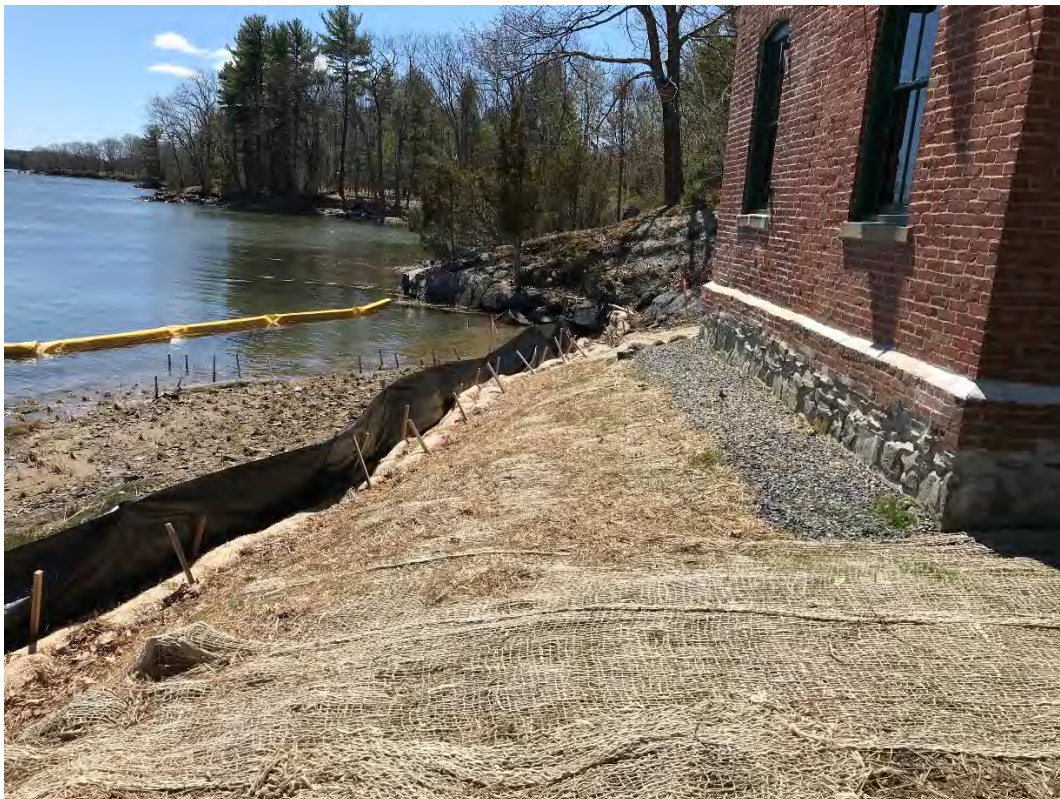
Fig 2: Slope between the cable house and salt marsh restoration at the west side of the bay. Viewing south. (04-26-21)

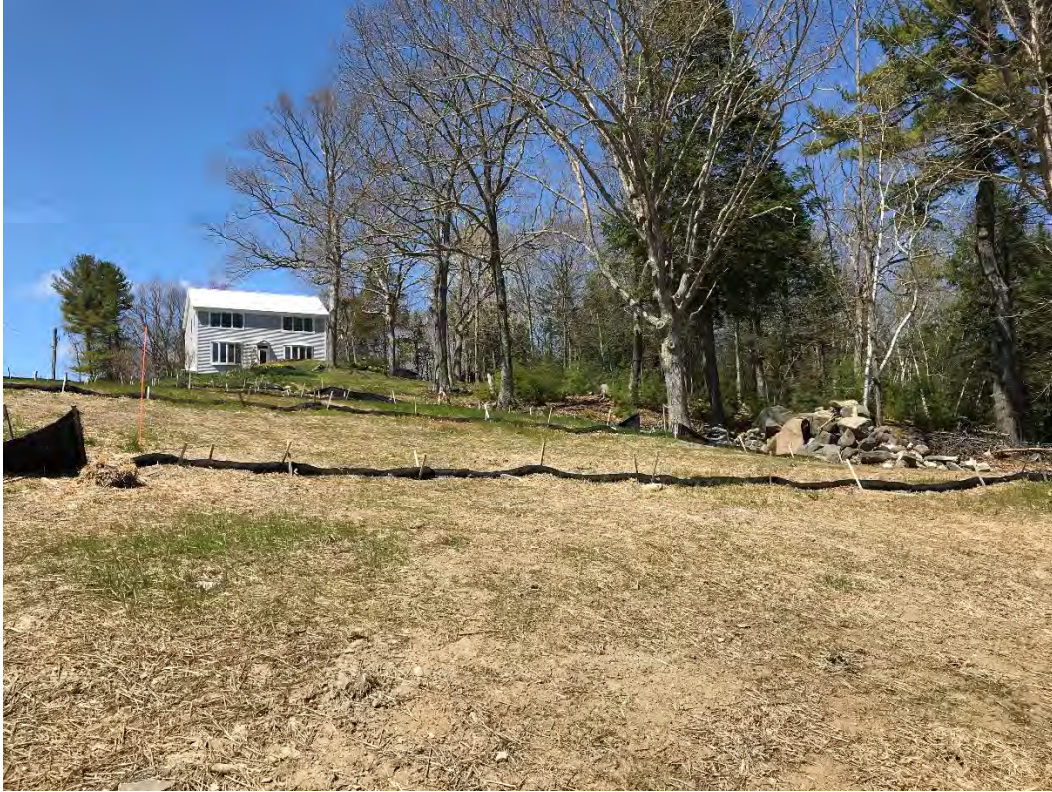
Fig 3: Slope above the cable house at the west side of the bay. Viewing northwest. (04-26-21)

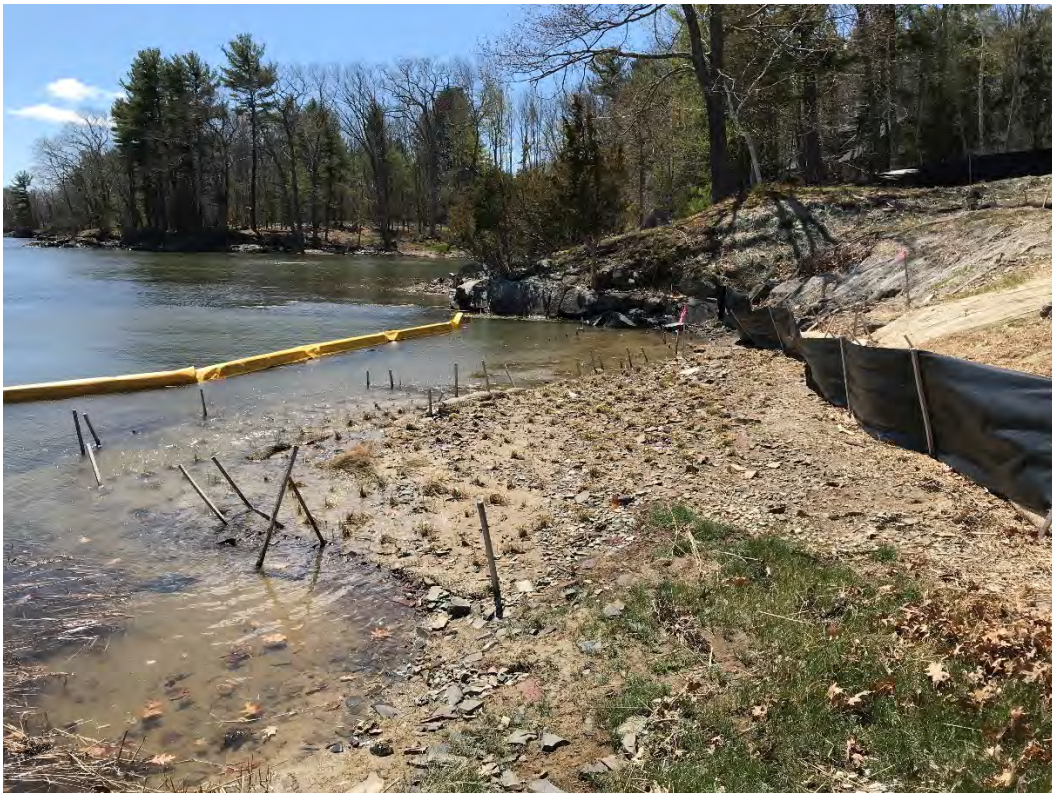
Fig 4: Toe of the slope and salt marsh restoration at the west side of the bay. Viewing south. (04-26-21)

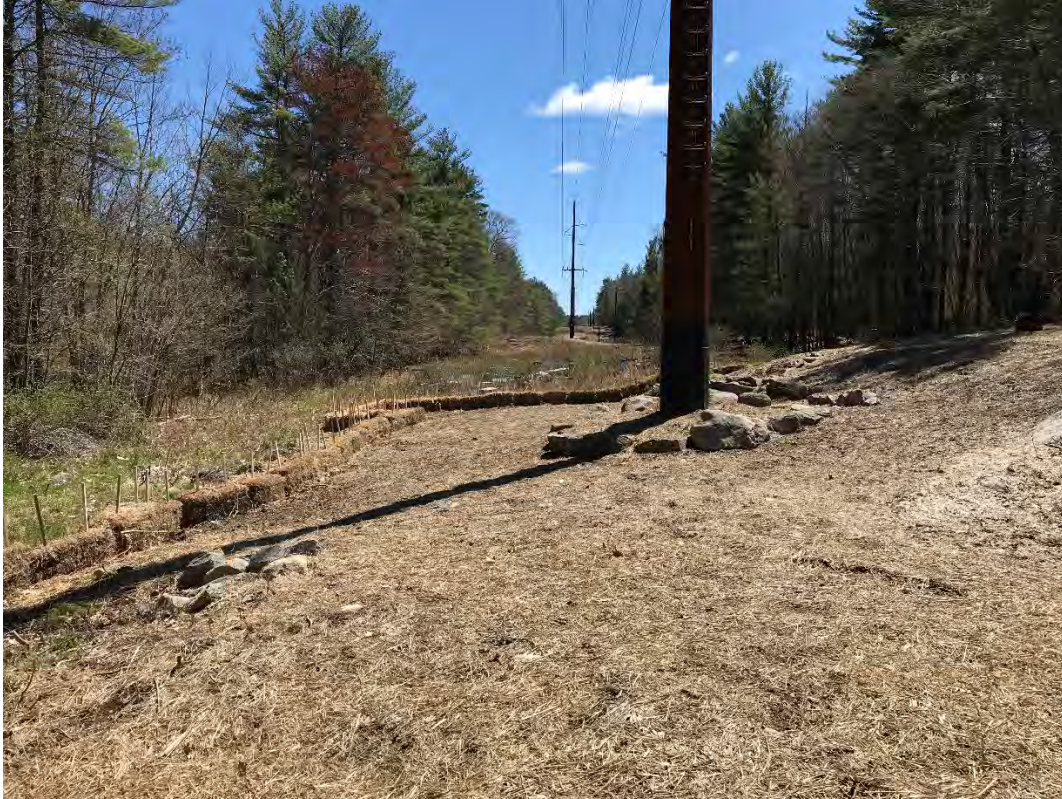
Fig 5: Str. 89 work area. Viewing southeast. (04-26-21)

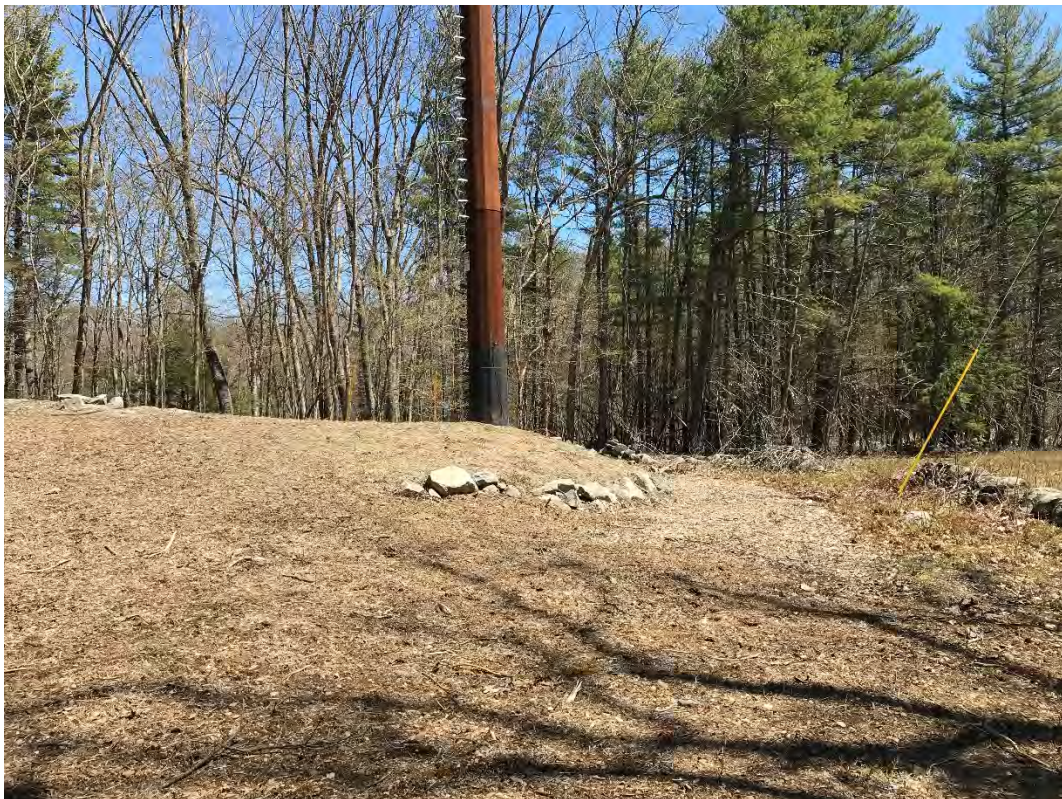
Fig 6: Str. 90 work area. Viewing northeast. (04-26-21)

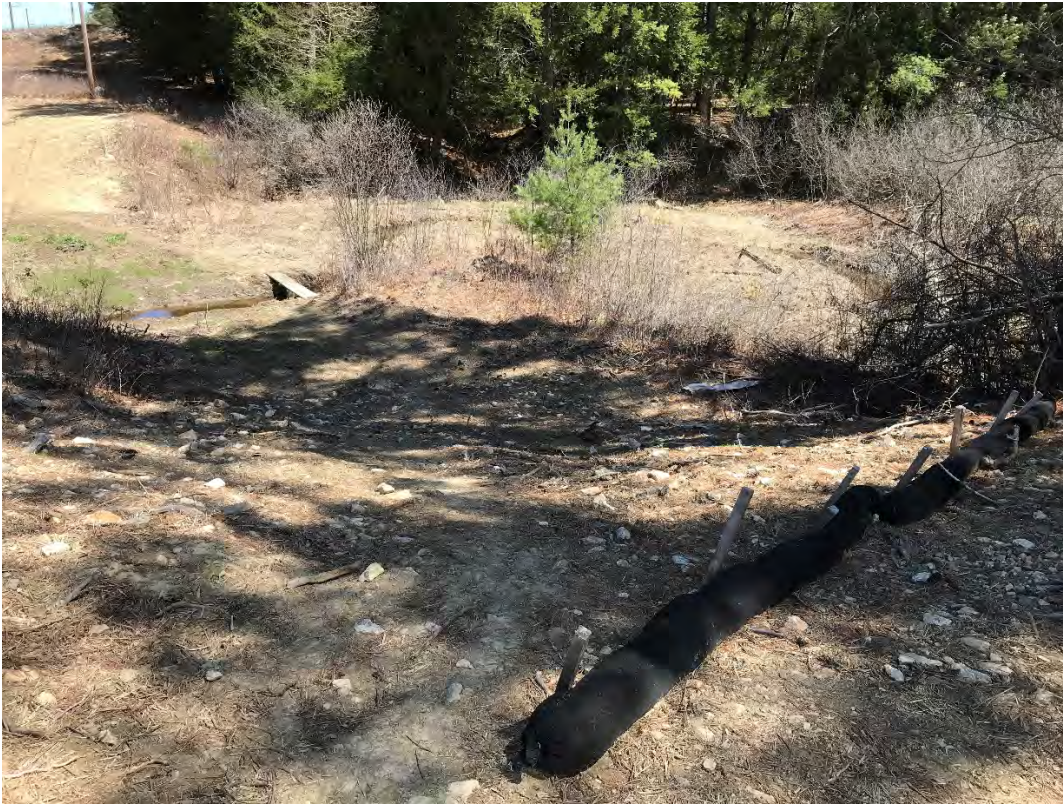
Fig 7: Stream DS46 between Strs. 51 and 52. Viewing northeast. (04-26-21)

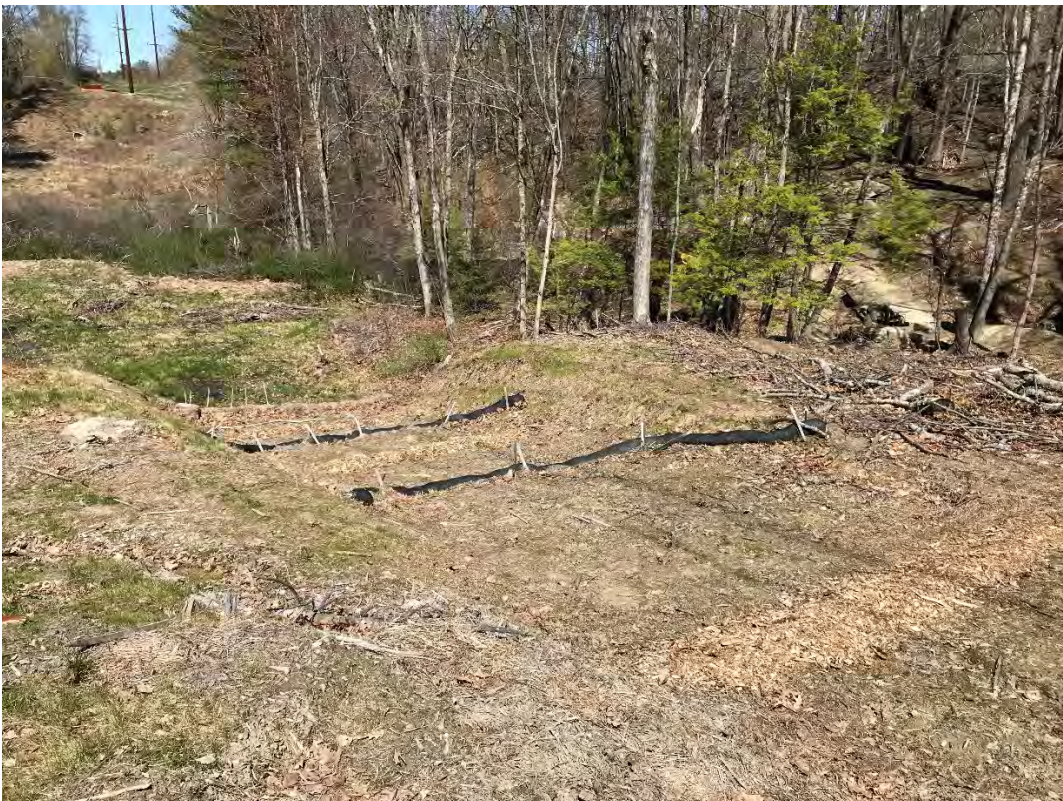
Fig 8: Lower portion of slope between Strs. 28 and 29. Viewing northeast. (04-26-21)

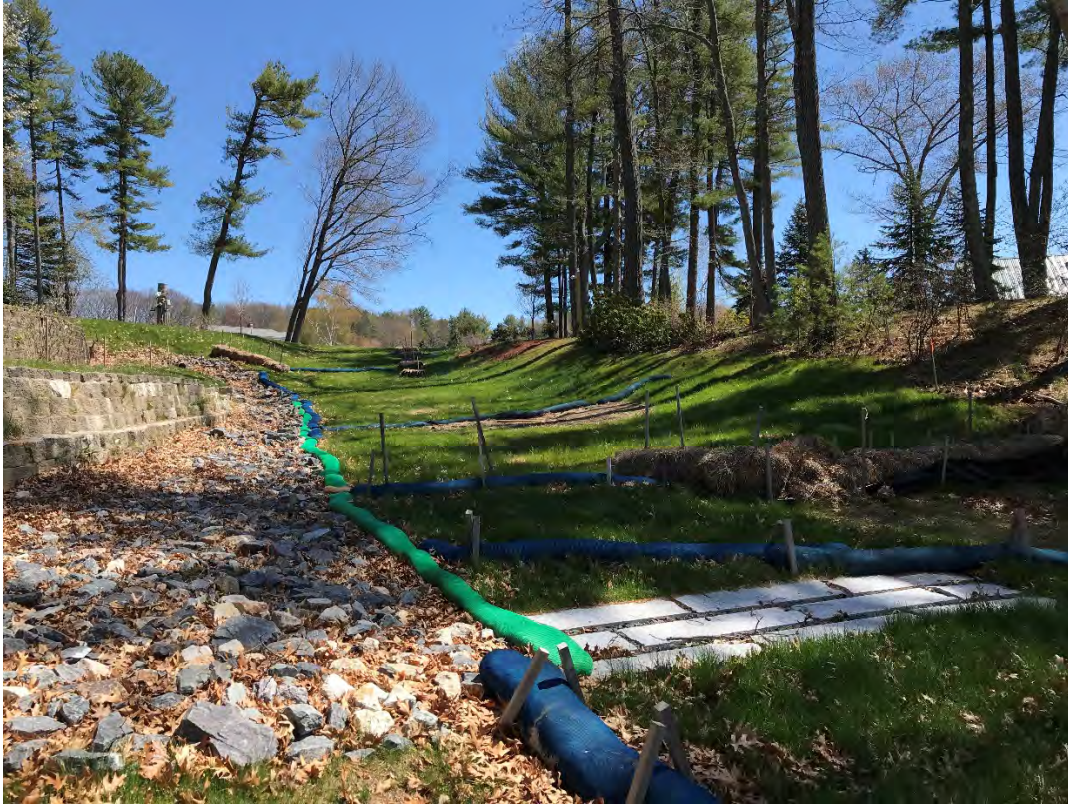
Fig 9: Slope above the manhole at Gundalow Landing/east side of the bay. Viewing east. (04-26-21)

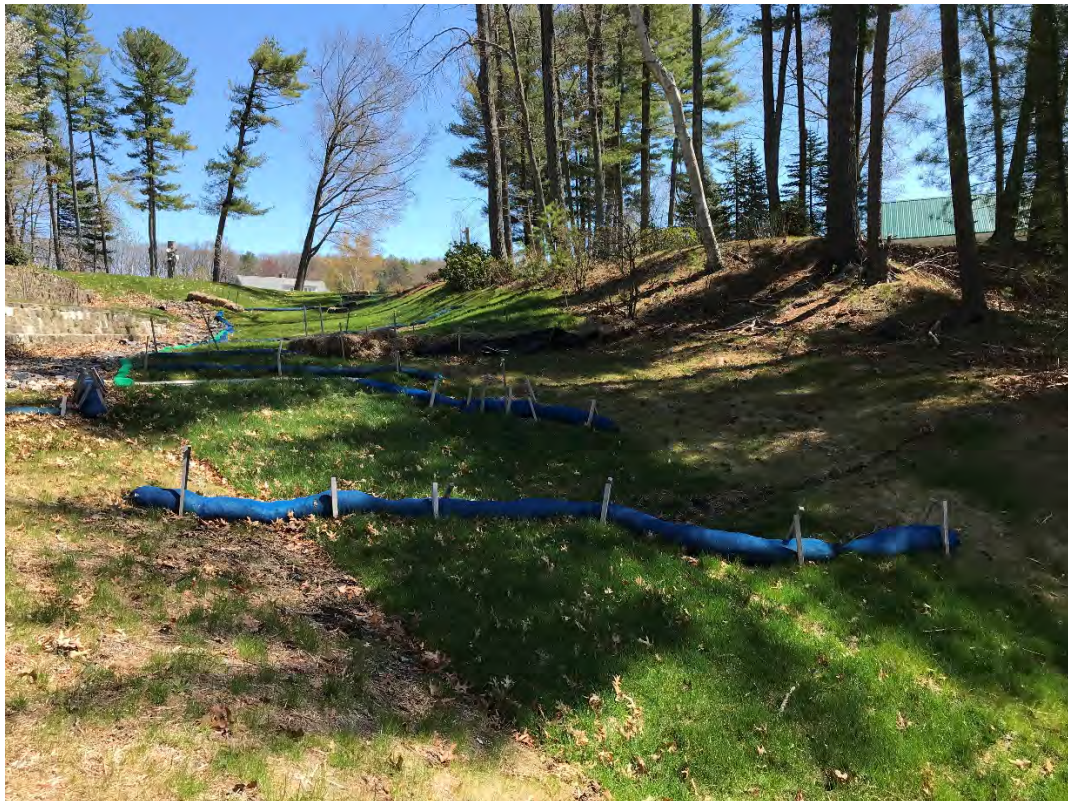
Fig 10: Slope below the manhole at Gundalow Landing/east side of the bay. Viewing east. (04-26-21)

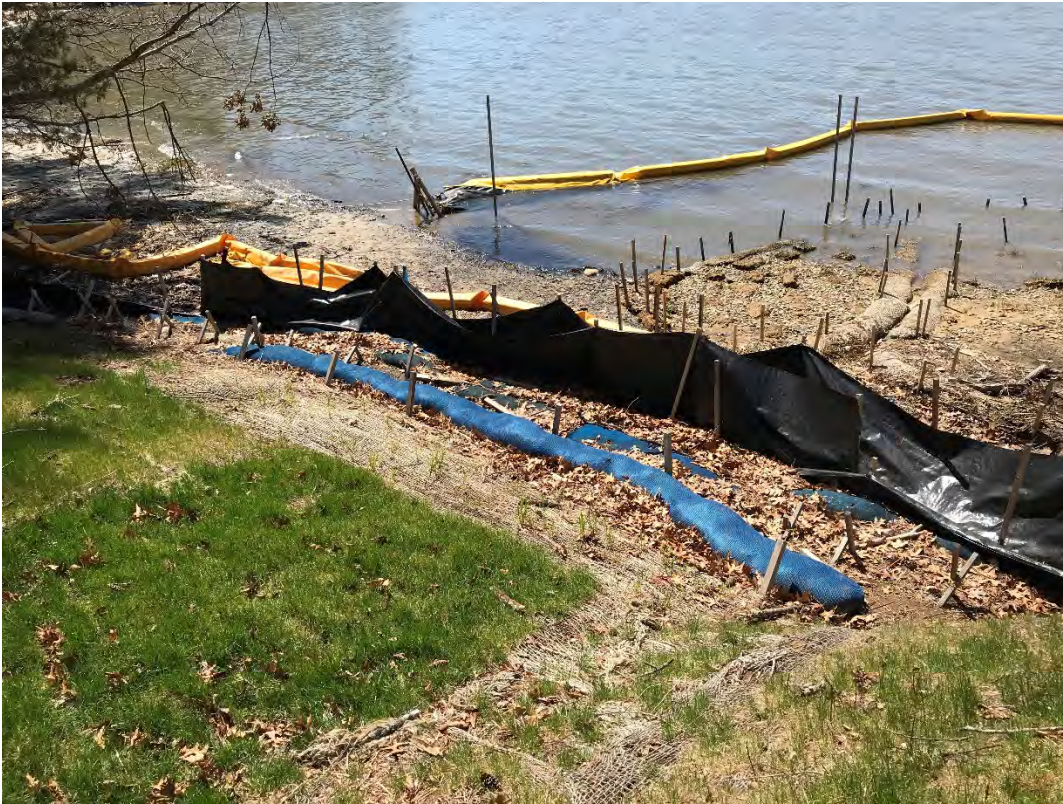
Fig 11: Toe of the slope at Gundalow Landing/east side of the bay. Viewing south. (04-26-21)

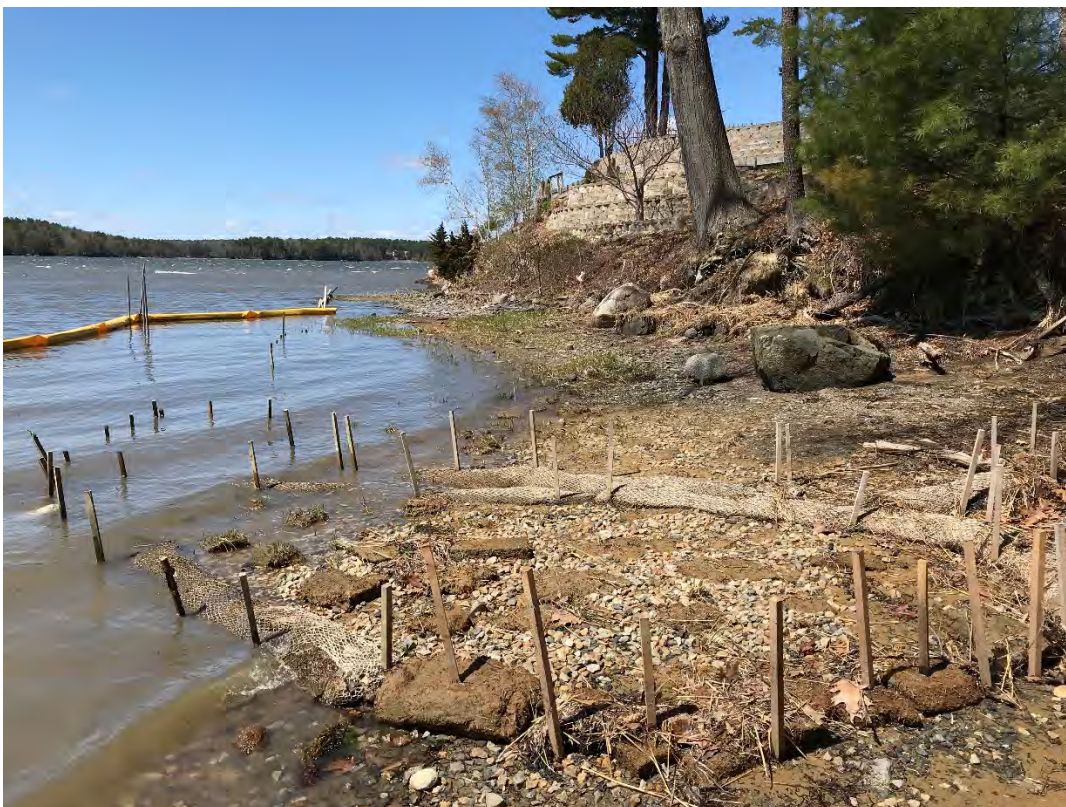
Fig 12: Salt marsh restoration at Gundalow Landing/east side of the bay. Viewing south. (04-26-21)

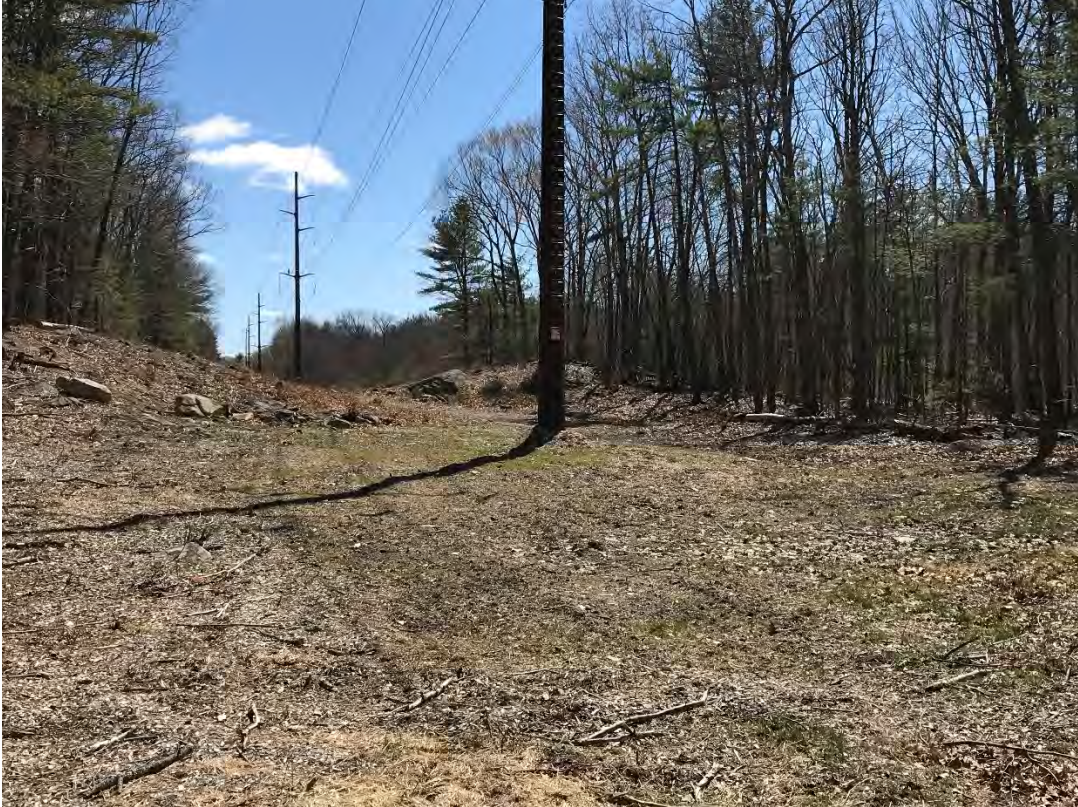
Fig 13: Str. 33 work area. Viewing southwest. (04-26-21)

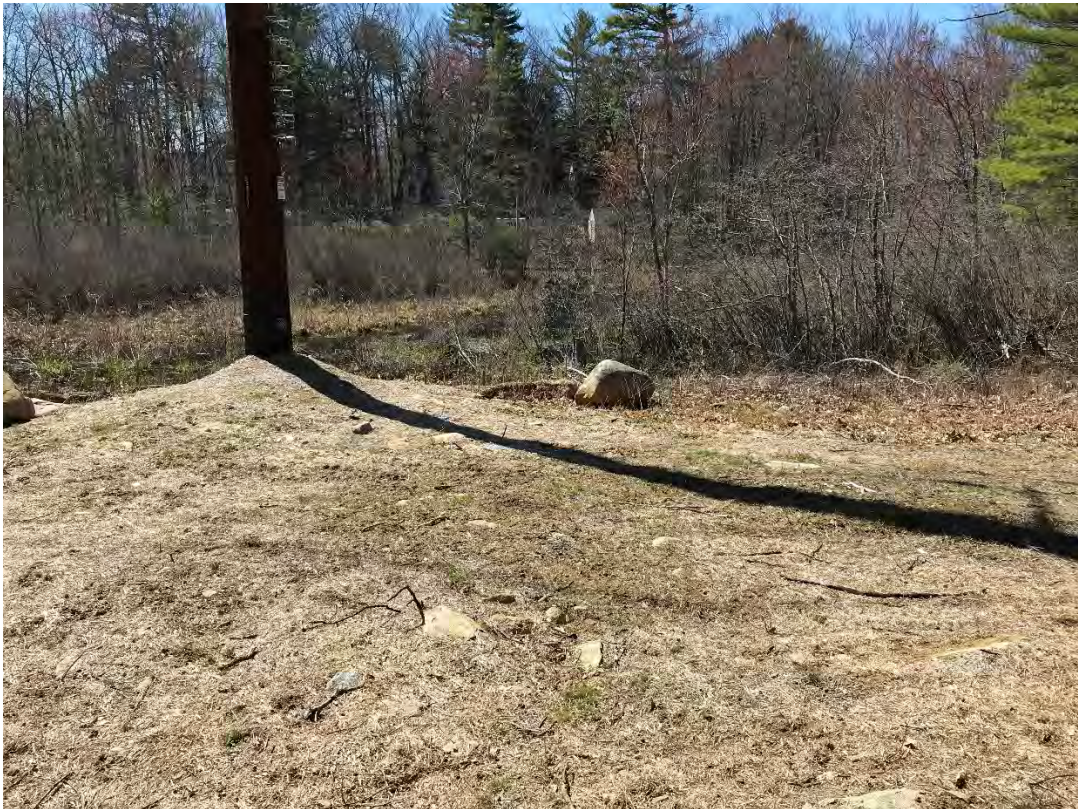
Fig 14: Str. 34 work area. Viewing west. (04-26-21)
