DRAINAGE MONITORING REPORT

F107 - Seacoast Reliability Project

Newington, New Hampshire

Date: **04/30/2021** Time: **0825** ⁺Was this inspection triggered by a 0.25" storm event? Yes No

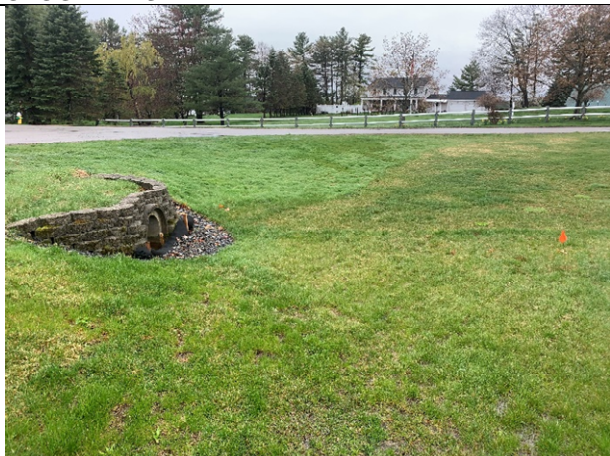
29 Gundalow - 1 (Drainage Area)

Location: 29 Gundalow – 1 (Drainage Area)

pH: **6.2**

Observations/Notes: Intermittent flowing water, max depth approx. 1".

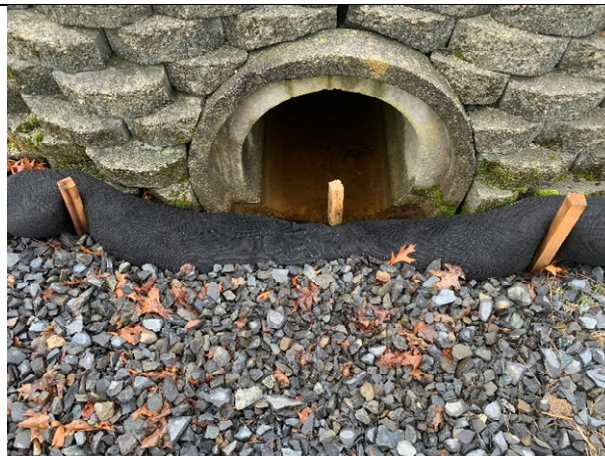
29 Gundalow - 2 (Culvert)

Location: 29 Gundalow – 2 (Culvert)

pH: **12.2**

Observations/Notes: Approx. 8" of flowing water at culvert inlet.

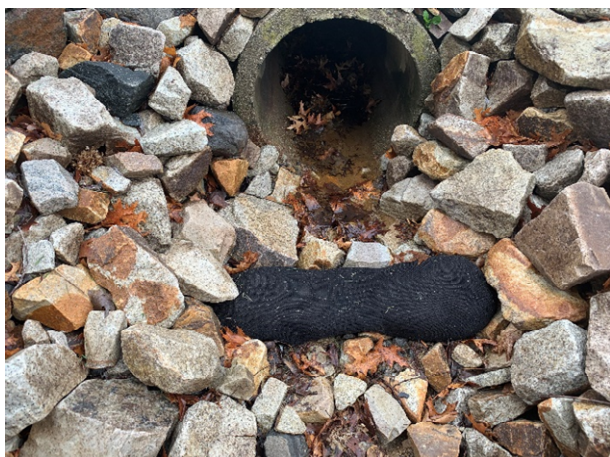
64 Gundalow - 1 (Drainage Course)

Location: 64 Gundalow – 1 (Drainage Course)

pH: **10.7**

Observations/Notes: Accessible flowing water extending approx. 14" beyond culvert outlet.

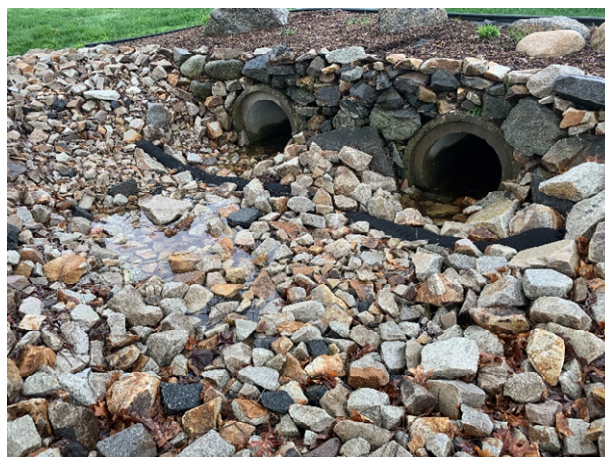
64 Gundalow - 2 (Drainage Course)

Location: 64 Gundalow – 2 (Drainage Course)

pH: **9.2**

Observations/Notes: Intermittent flowing water extending approx. 3' from culvert inlets.

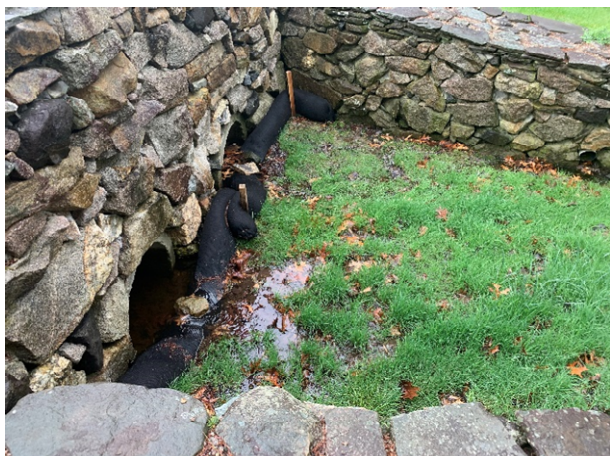
4 Brickyard Circle - 1 (Drainage Course)

Location: 4 Brickyard Circle – 1 (Drainage Course)

pH: **8.1**

Observations/Notes: Flowing water into drainage course, max depth approx. 10". Flow observed over top of peat moss log.

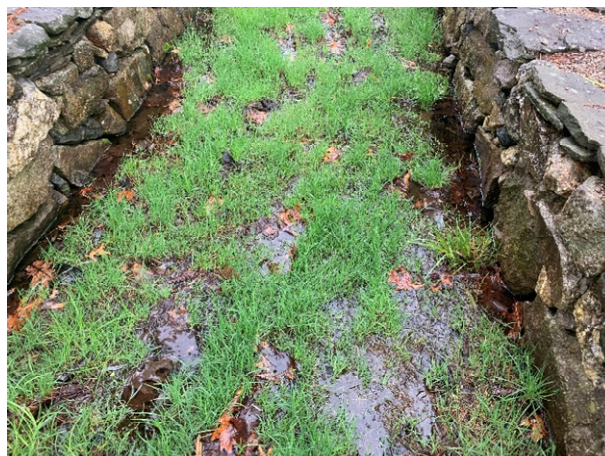
4 Brickyard Circle - 2 (Drainage Course)

Location: 4 Brickyard Circle – 2 (Drainage Course)

pH: **7.5**

Observations/Notes: Water flowing approx. 3" deep.

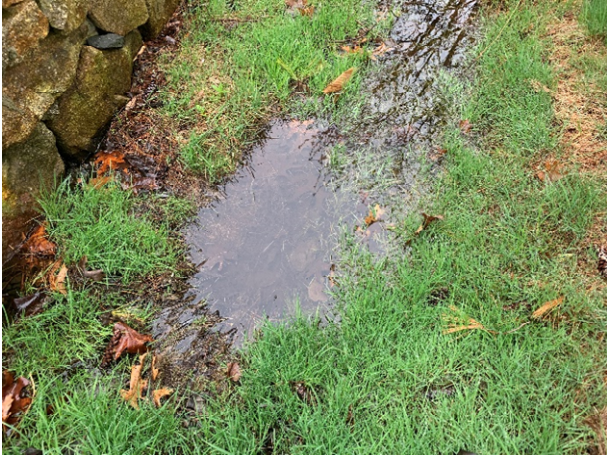
Location: 4 Brickyard Circle – 3 (Drainage Course)

pH: **7.4**

Observations/Notes: Water flowing approx. 6" deep.
