## CONSTRUCTION MONITORING REPORT

Eversource Transmission Lines:  
**F107**

**TYPE OF INSPECTION:**  Weekly  Storm Event  Incident  Corrective Action

Date of inspection: **04/30/21** Start Time: **3:15pm** Previous inspection: **04/26/21**

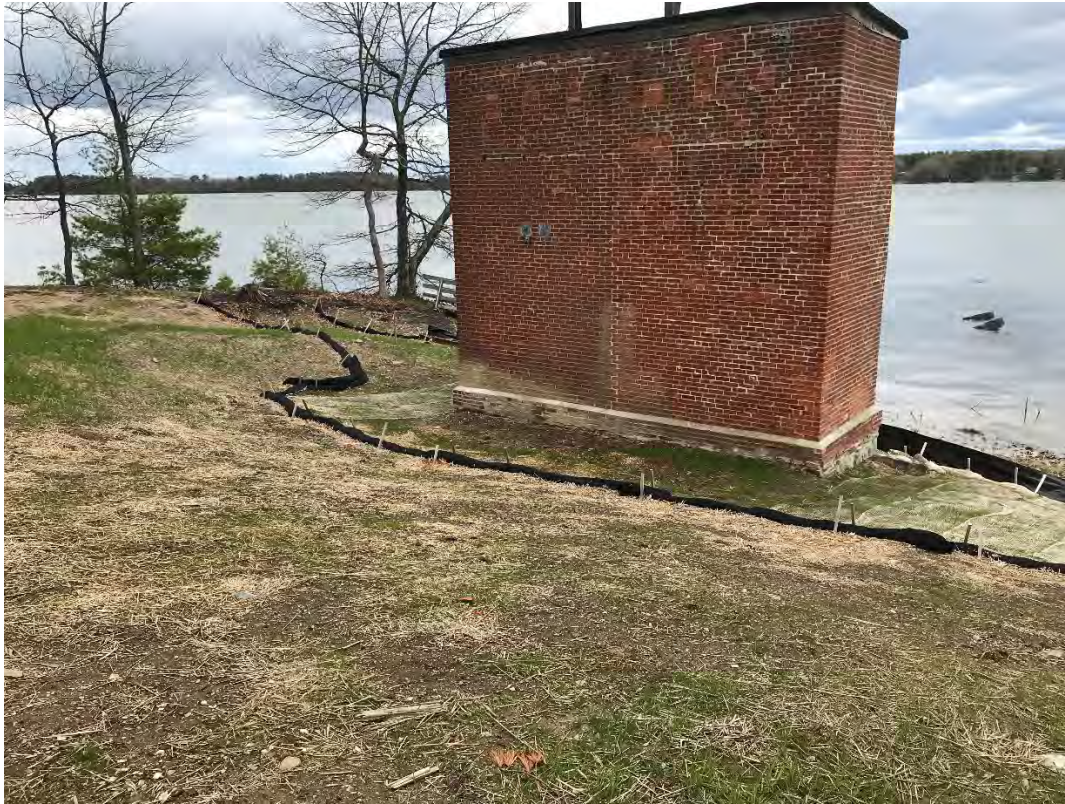
Fig 1: Slope leading down to cable house and salt marsh restoration at the west side of the bay. Viewing northeast. (04-30-21)

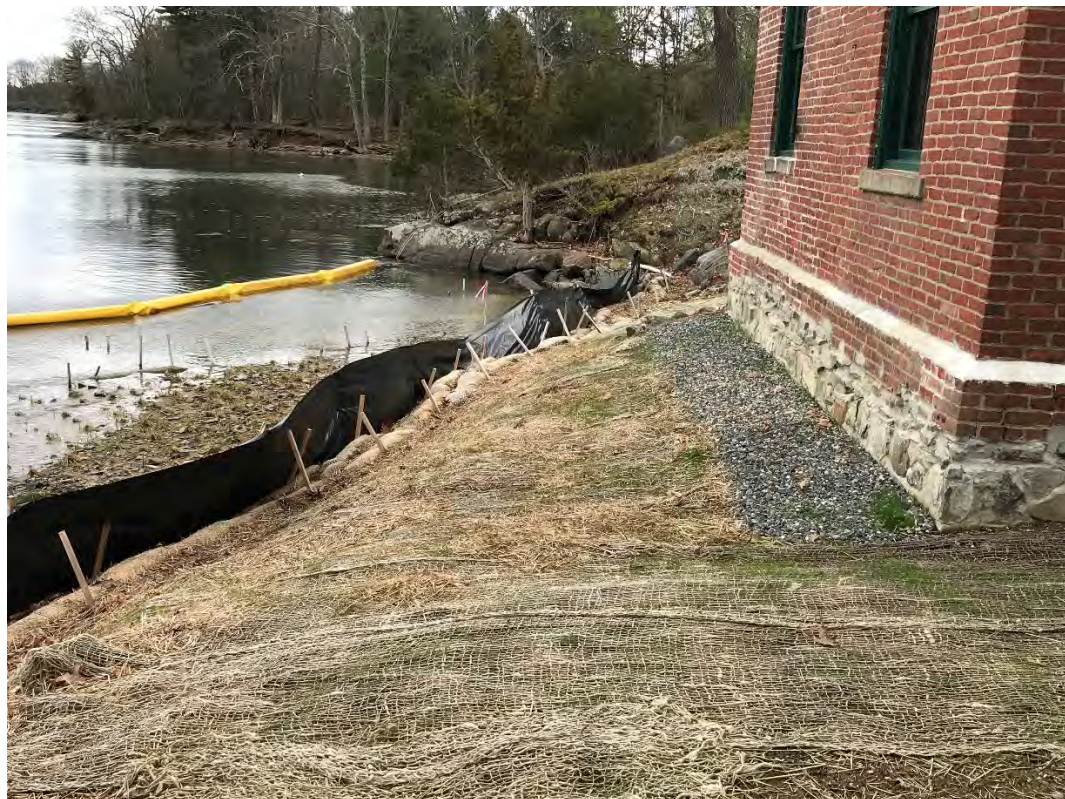
Fig 2: Slope between the cable house and salt marsh restoration at the west side of the bay. Viewing south. (04-30-21)

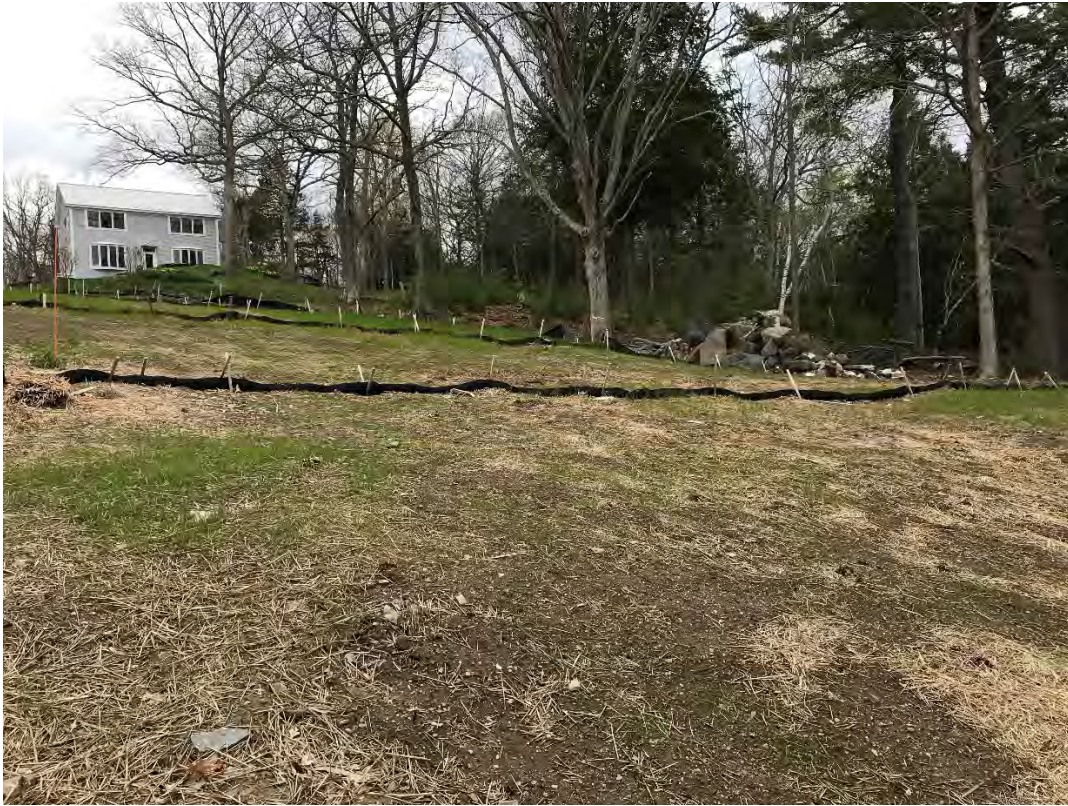
Fig 3: Slope above the cable house at the west side of the bay. Viewing northwest. (04-30-21)

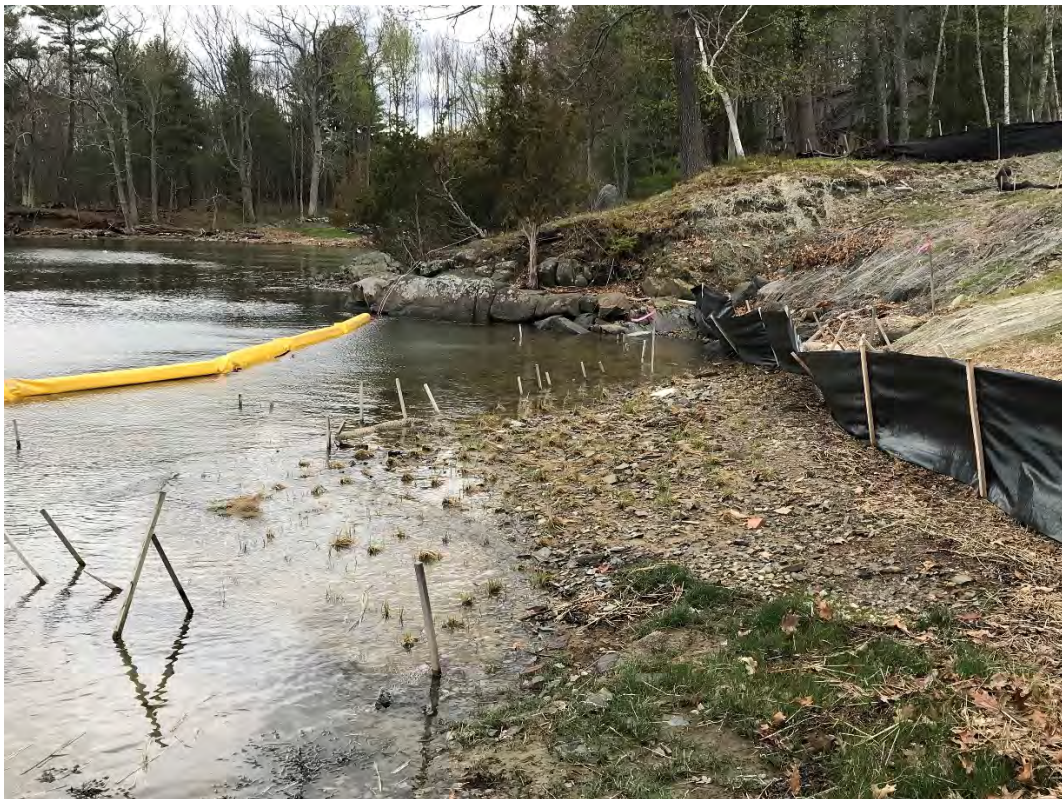
Fig 4: Toe of the slope and salt marsh restoration at the west side of the bay. Viewing south. (04-30-21)

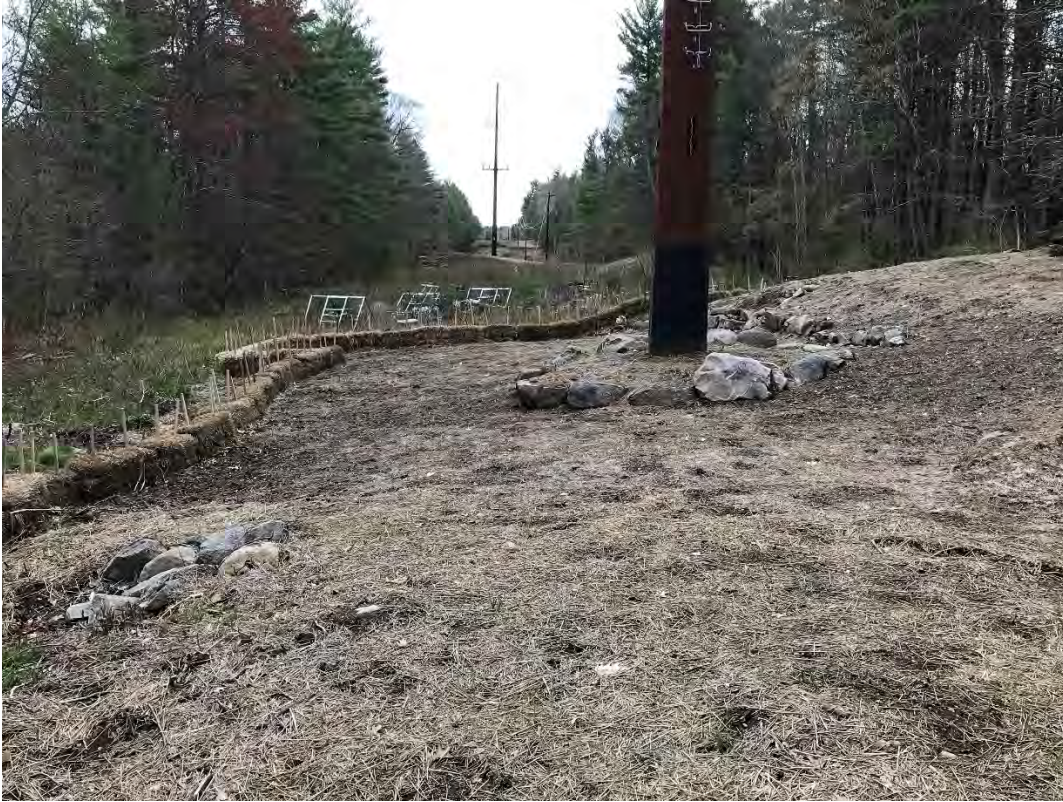
**Areas that have been restored and mulched, but have little germination:** Hannah Ln, Eversource property/west side of bay, Strs. 89-90

Fig 5: Str. 89 work area. Viewing southeast. (04-30-21)

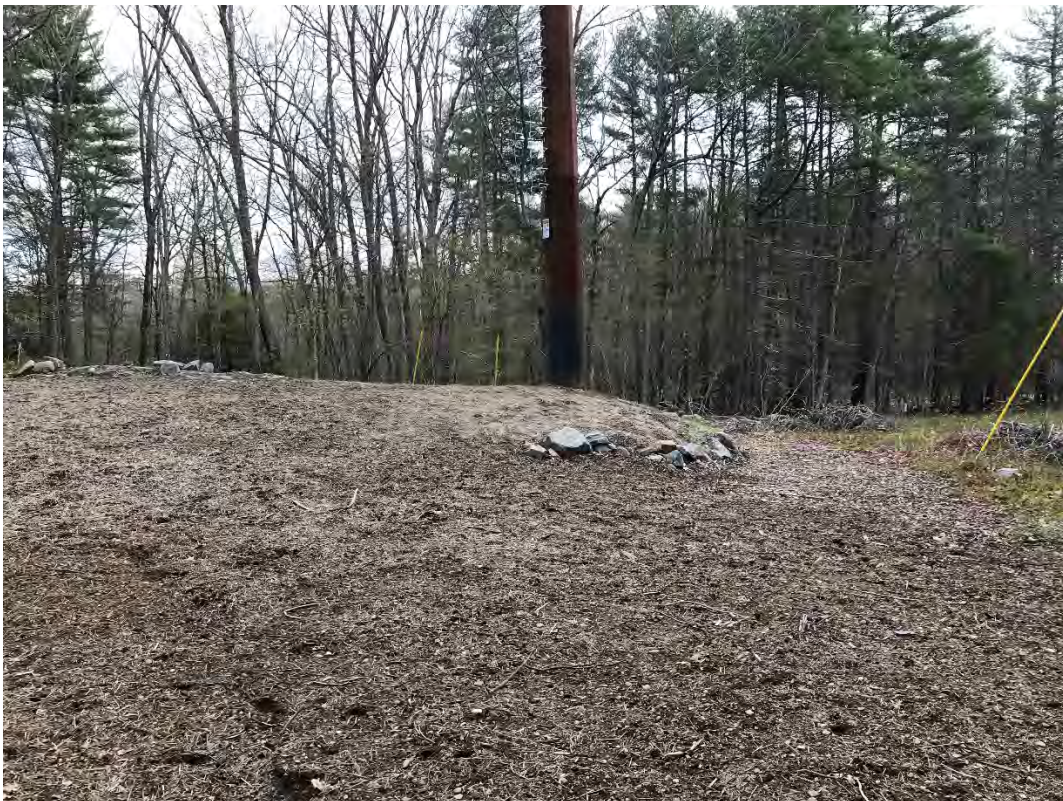
Fig 6: Str. 90 work area. Viewing northeast. (04-30-21)

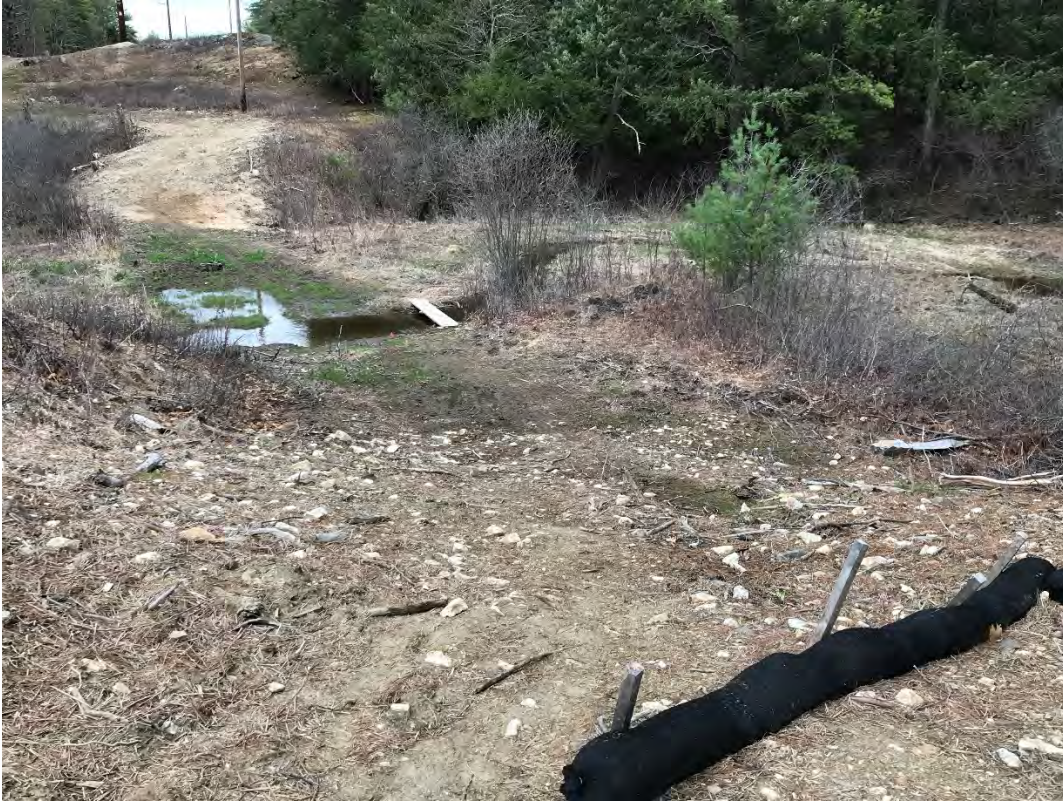
Fig 7: Stream DS46 between Strs. 51 and 52. Viewing northeast. (04-30-21)

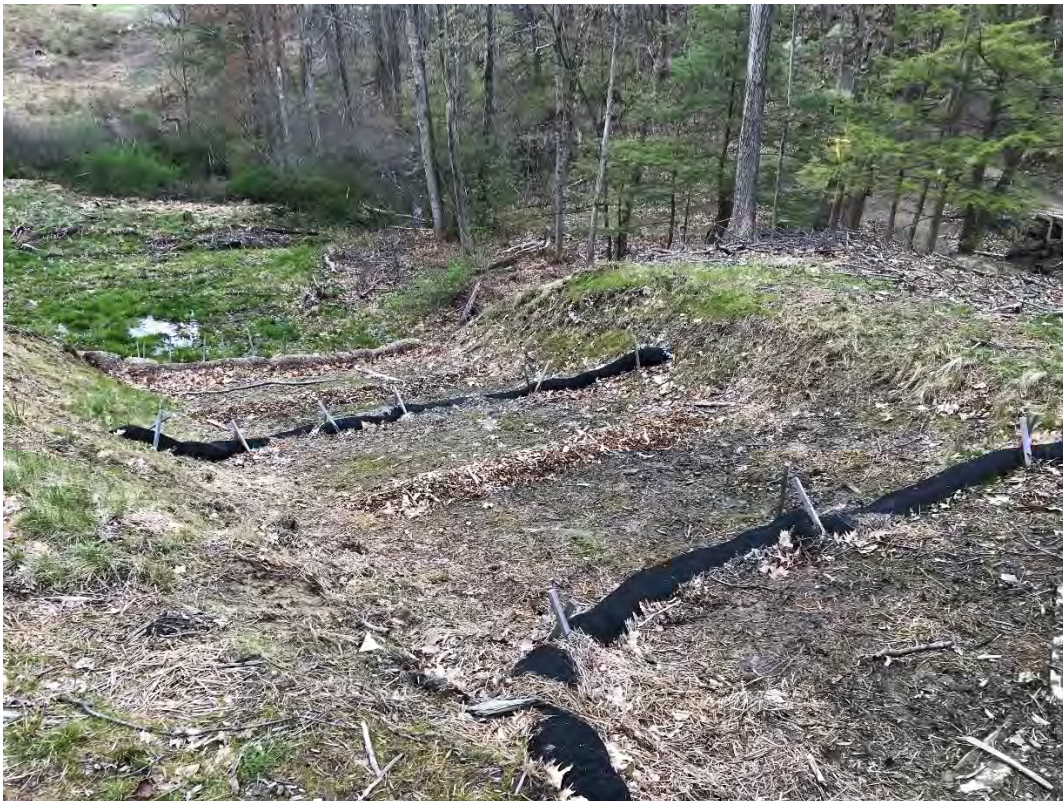
Fig 8: Lower portion of slope between Strs. 28 and 29. Viewing northeast. (04-30-21)

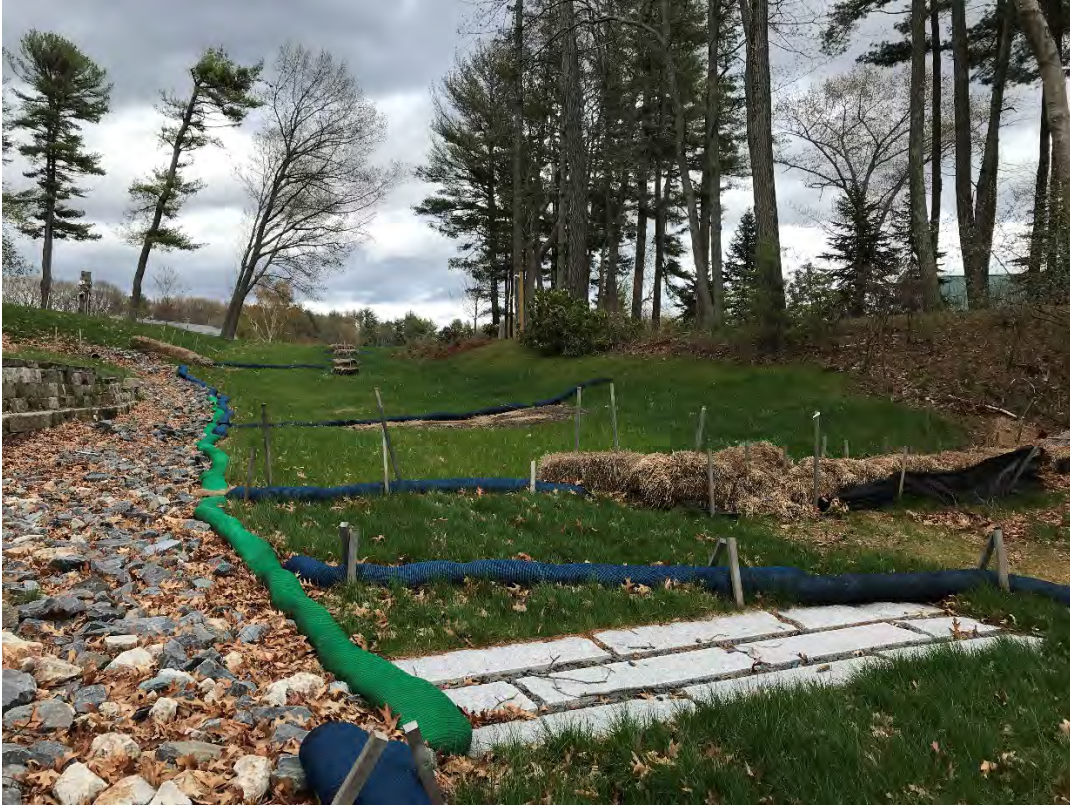
Fig 9: Slope above the manhole at Gundalow Landing/east side of the bay. Viewing east. (04-30-21)

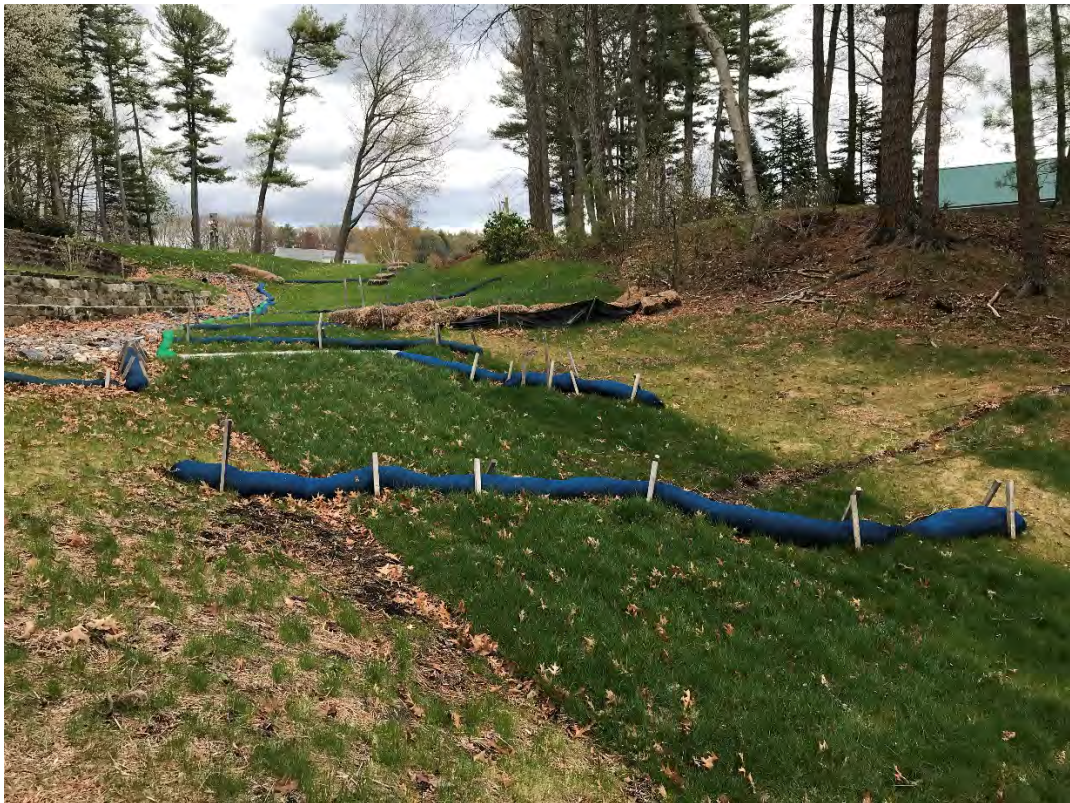
Fig 10: Slope below the manhole at Gundalow Landing/east side of the bay. Viewing east. (04-30-21)

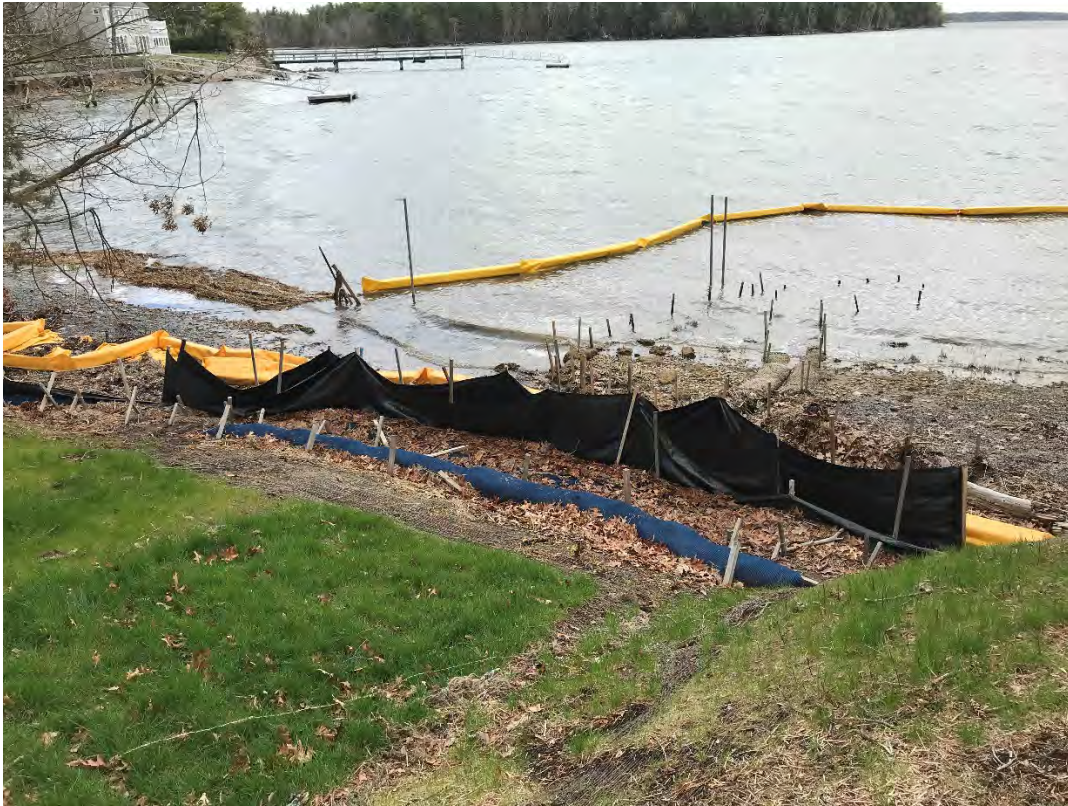
Fig 11: Toe of the slope at Gundalow Landing/east side of the bay. Viewing south. (04-30-21)

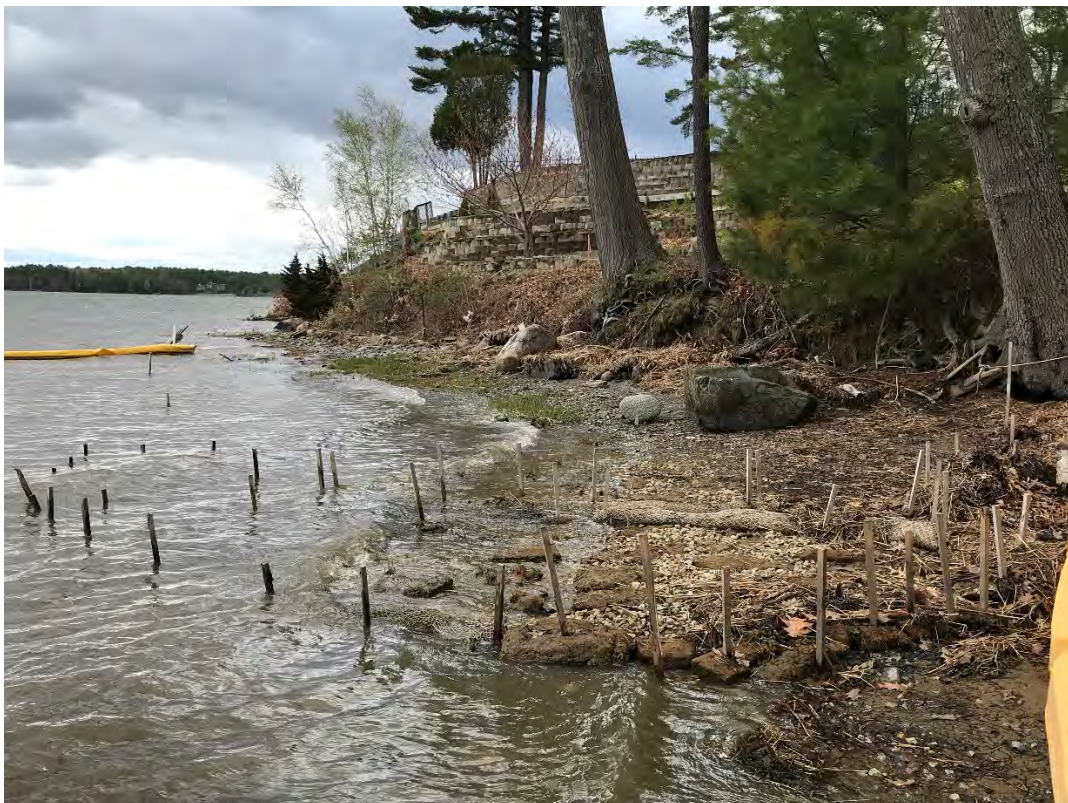
Fig 12: Salt marsh restoration at Gundalow Landing/east side of the bay. Viewing south. (04-30-21)
