CONSTRUCTION MONITORING REPORT

Eversource Transmission Lines:
F107

TYPE OF INSPECTION: Weekly Storm Event Incident Corrective Action

Date of inspection: **05/04/21** Start Time: **1:45pm** Previous inspection: **04/26/21**

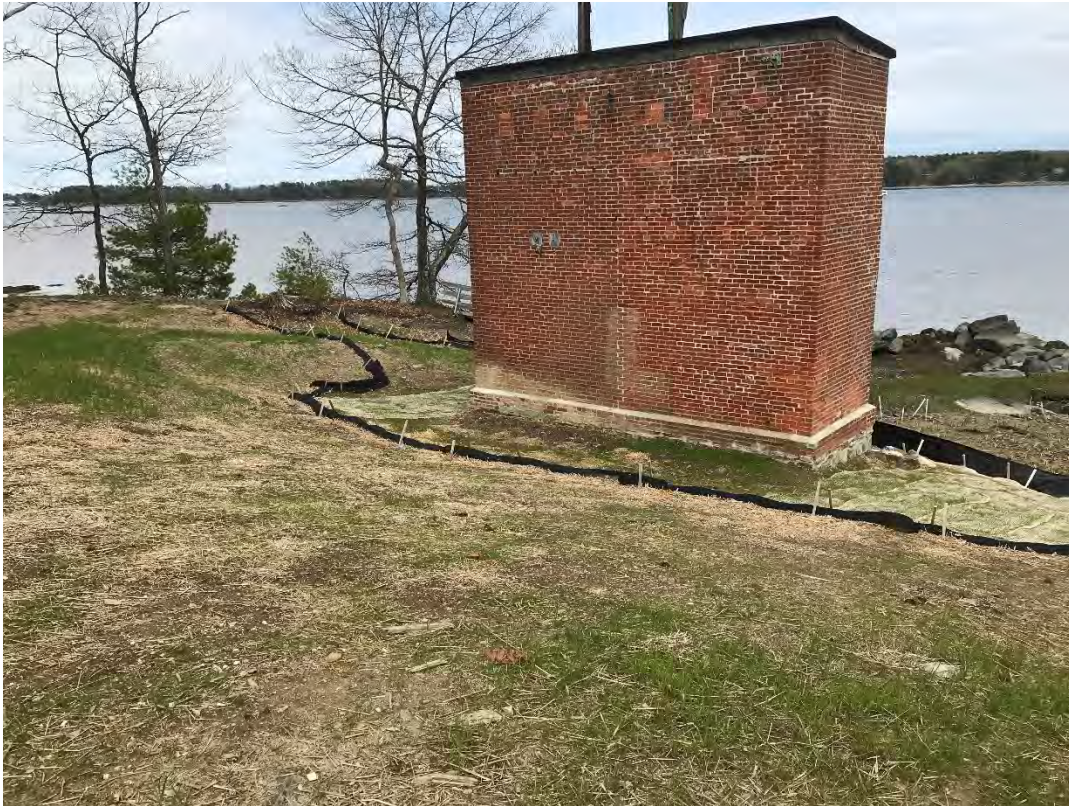
Fig 1: Slope leading down to cable house and salt marsh restoration at the west side of the bay. Viewing northeast. (05-04-21)

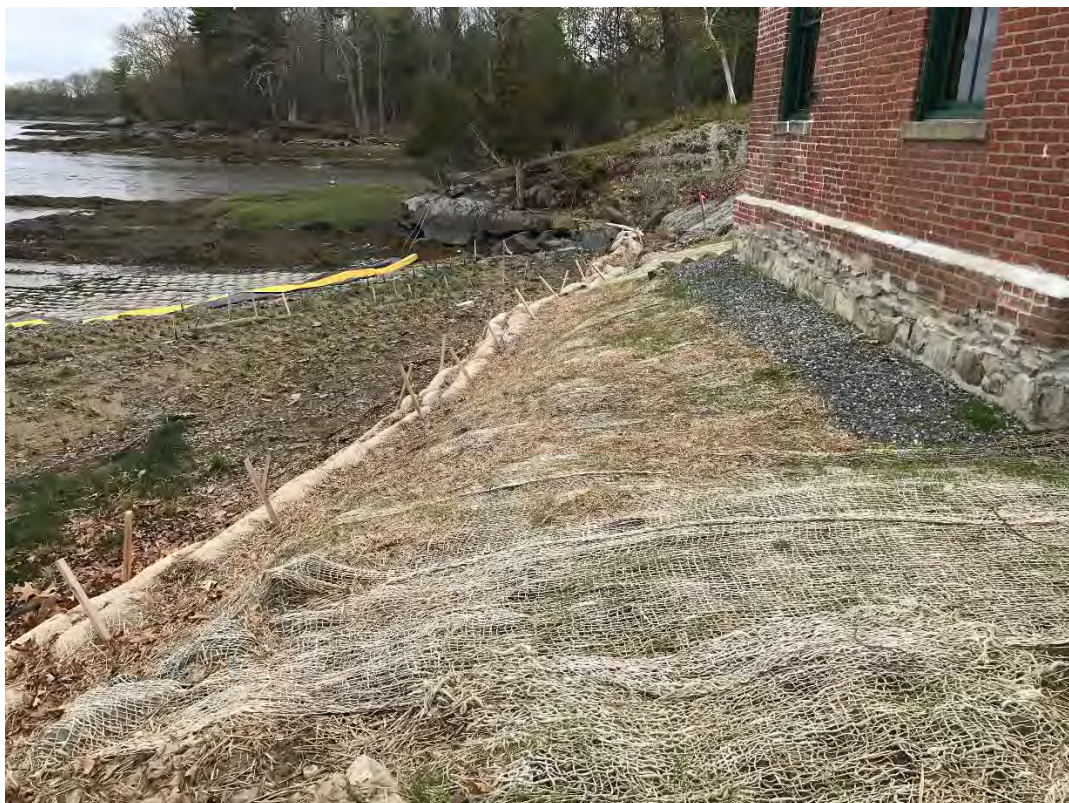
Fig 2: Slope between the cable house and salt marsh restoration at the west side of the bay. Viewing south. (05-04-21)

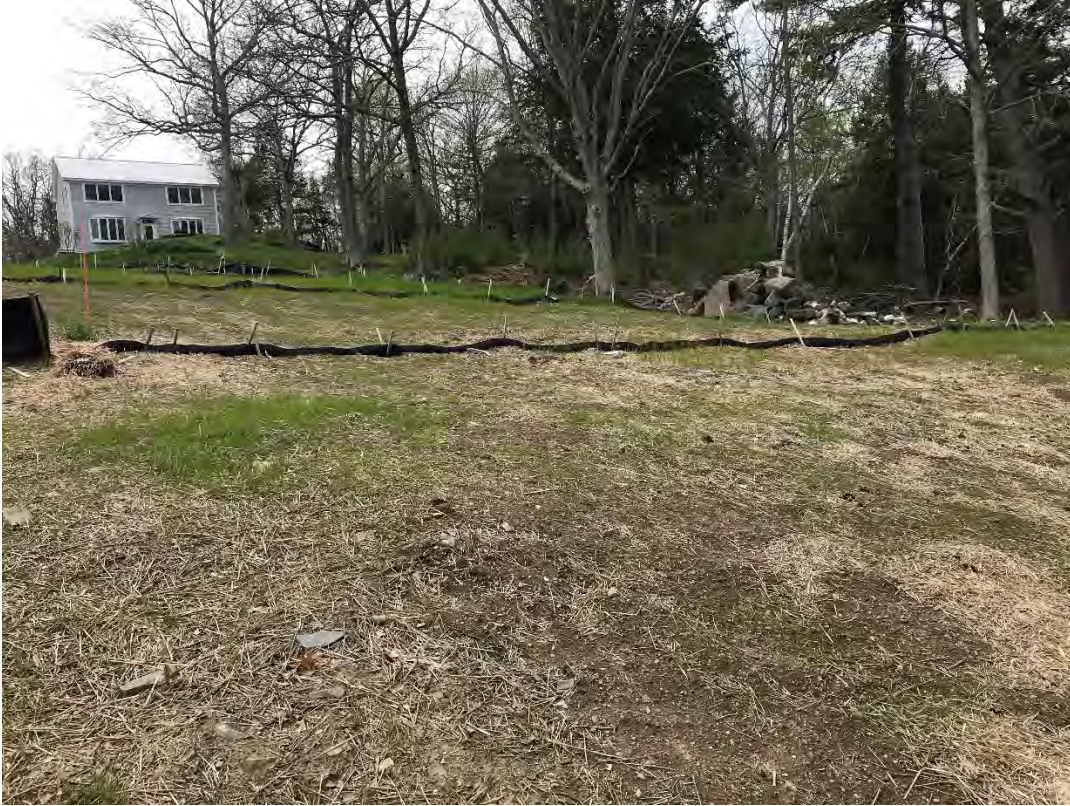
Fig 3: Slope above the cable house at the west side of the bay. Viewing northwest. (05-04-21)

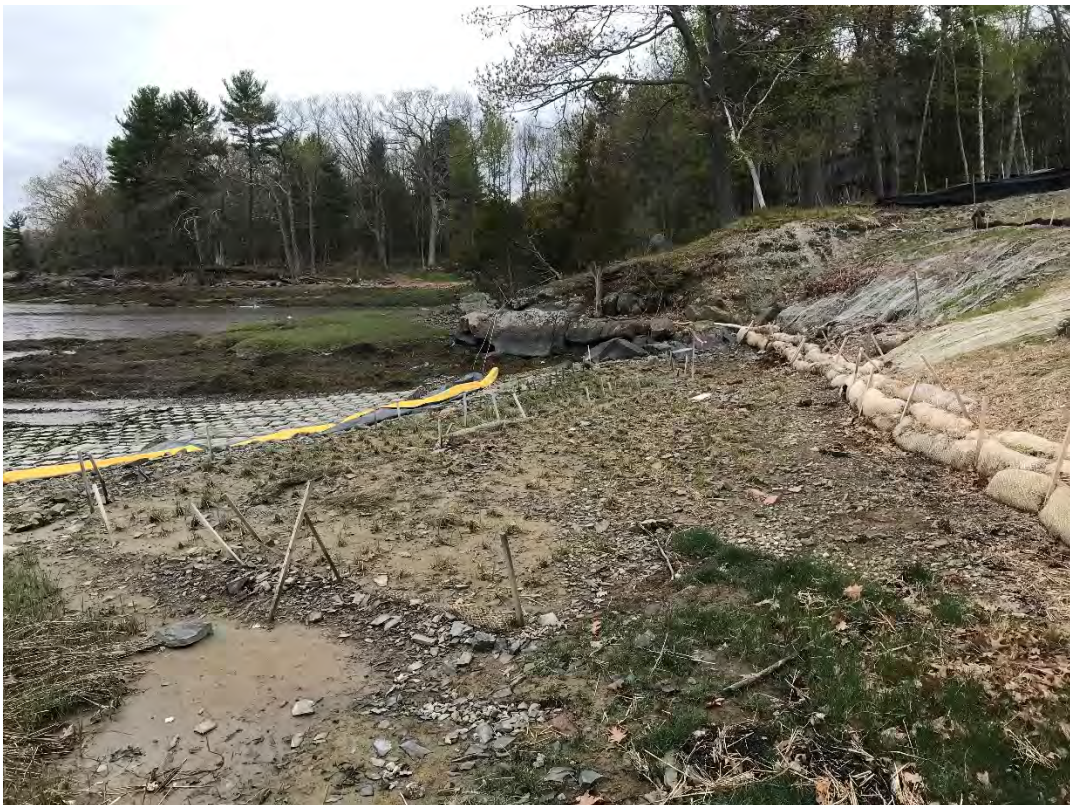
Fig 4: Toe of the slope and salt marsh restoration at the west side of the bay. Viewing south. (05-04-21)

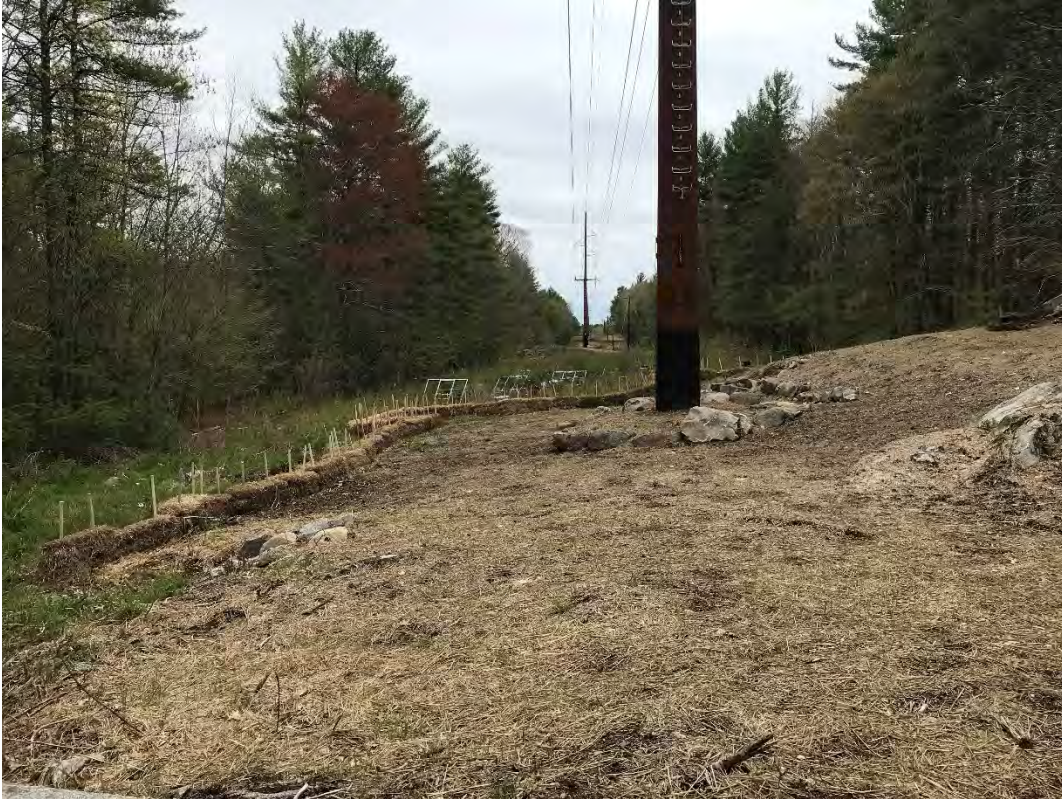
Fig 5: Str. 89 work area. Viewing southeast. (05-04-21)

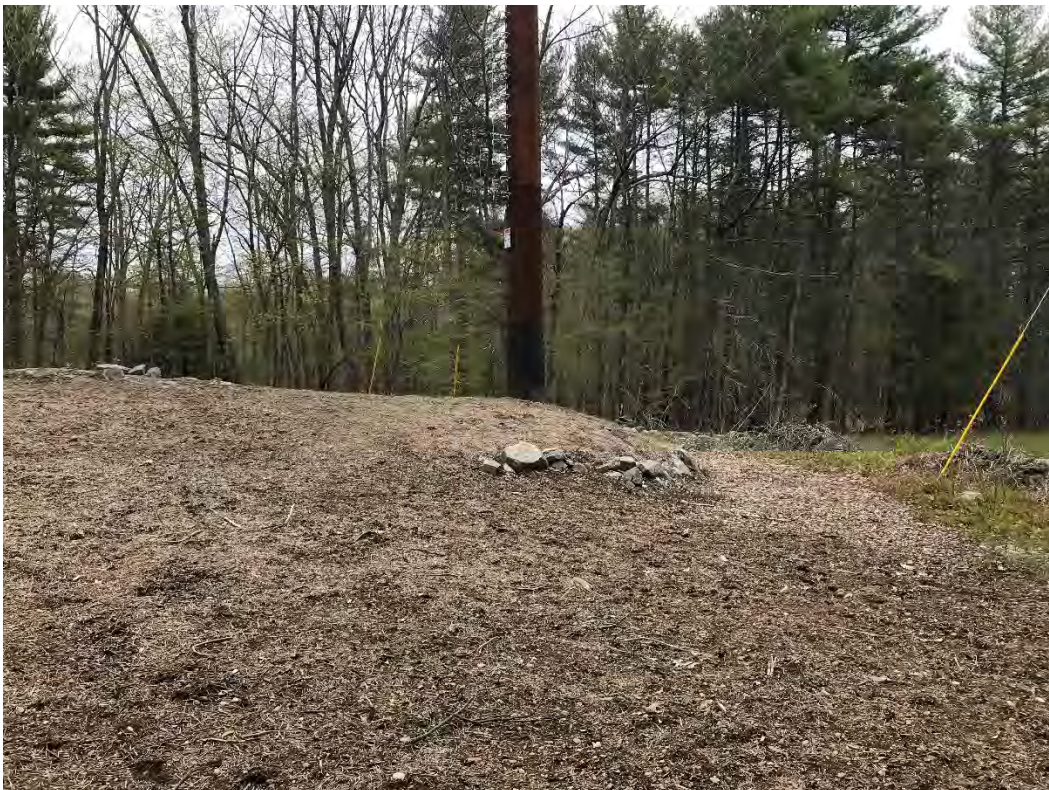
Fig 6: Str. 90 work area. Viewing northeast. (05-04-21)

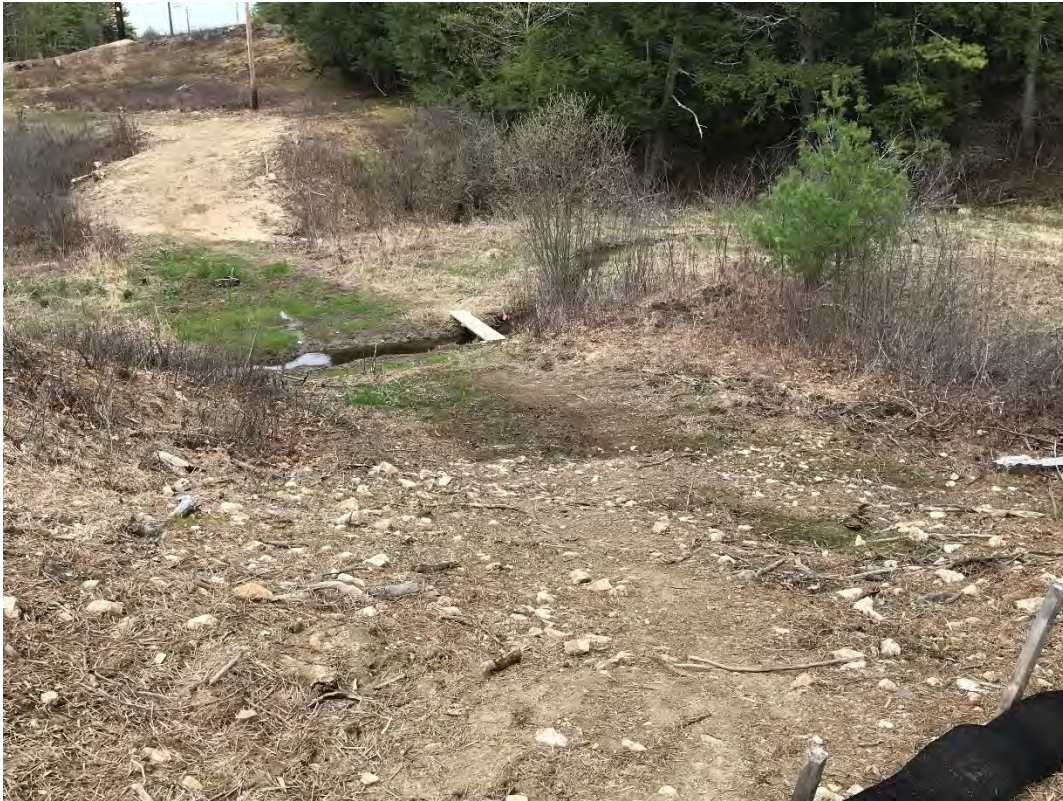
Fig 7: Stream DS46 between Strs. 51 and 52. Viewing northeast. (05-04-21)

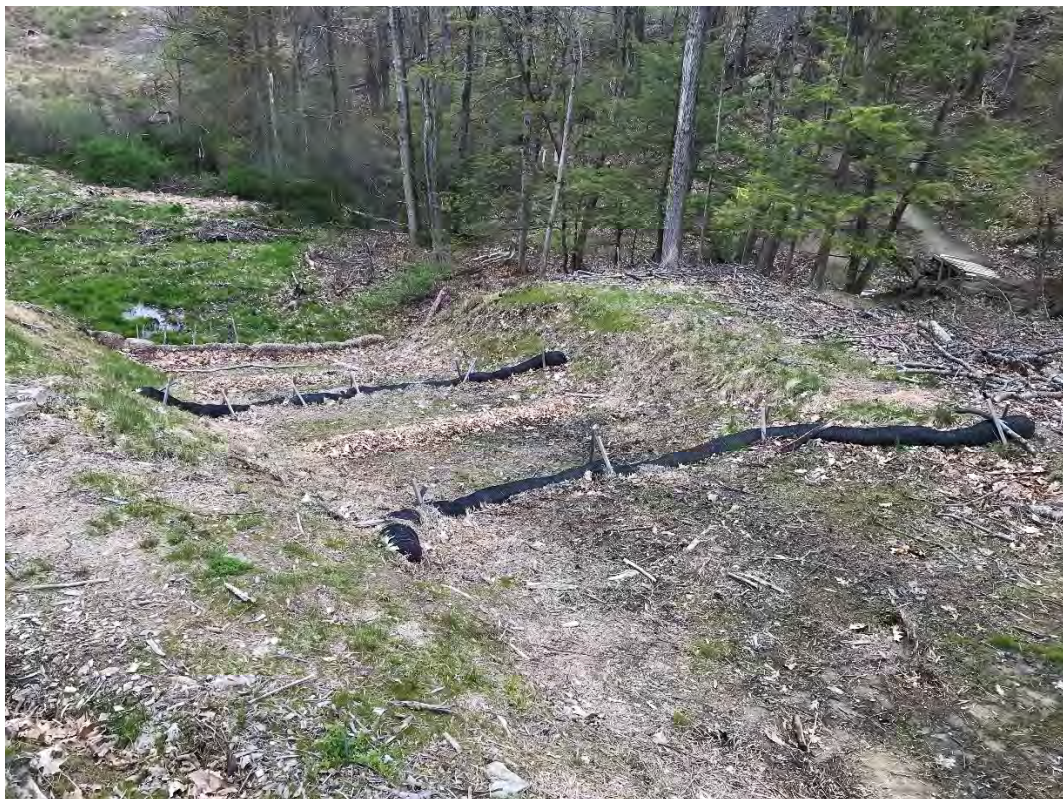
Fig 8: Lower portion of slope between Strs. 28 and 29. Viewing northeast. (05-04-21)

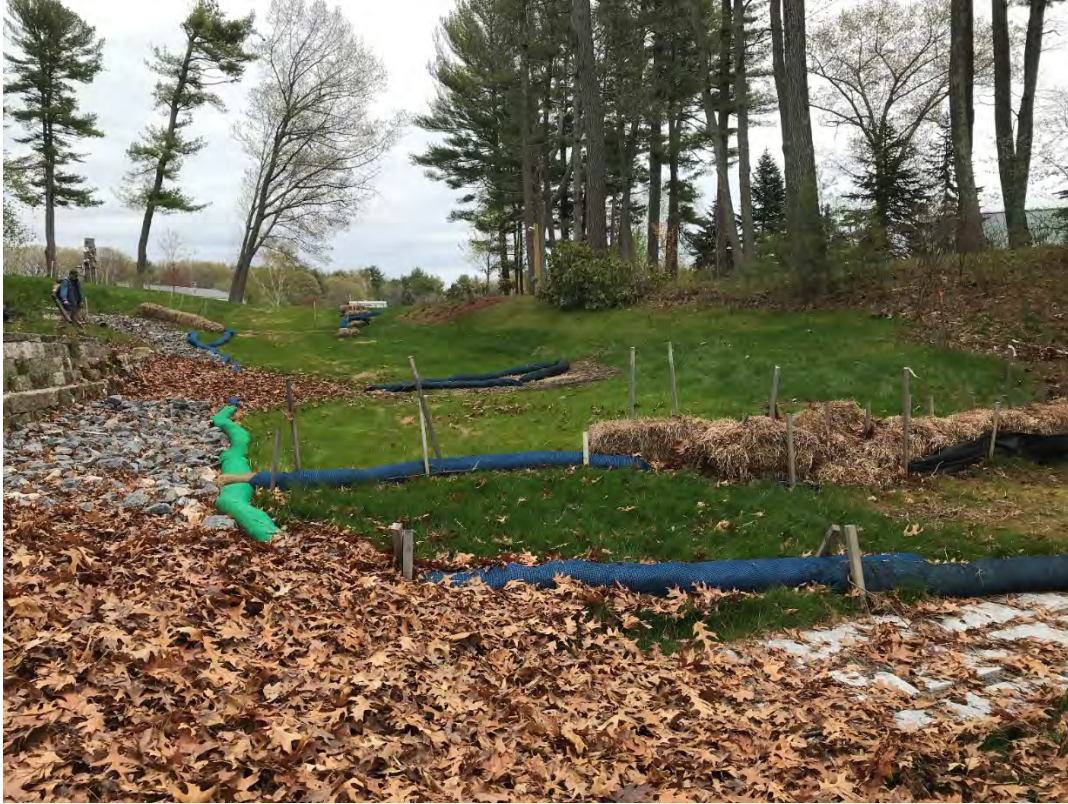
Fig 9: Slope above the manhole at Gundalow Landing/east side of the bay. Viewing east. (05-04-21)

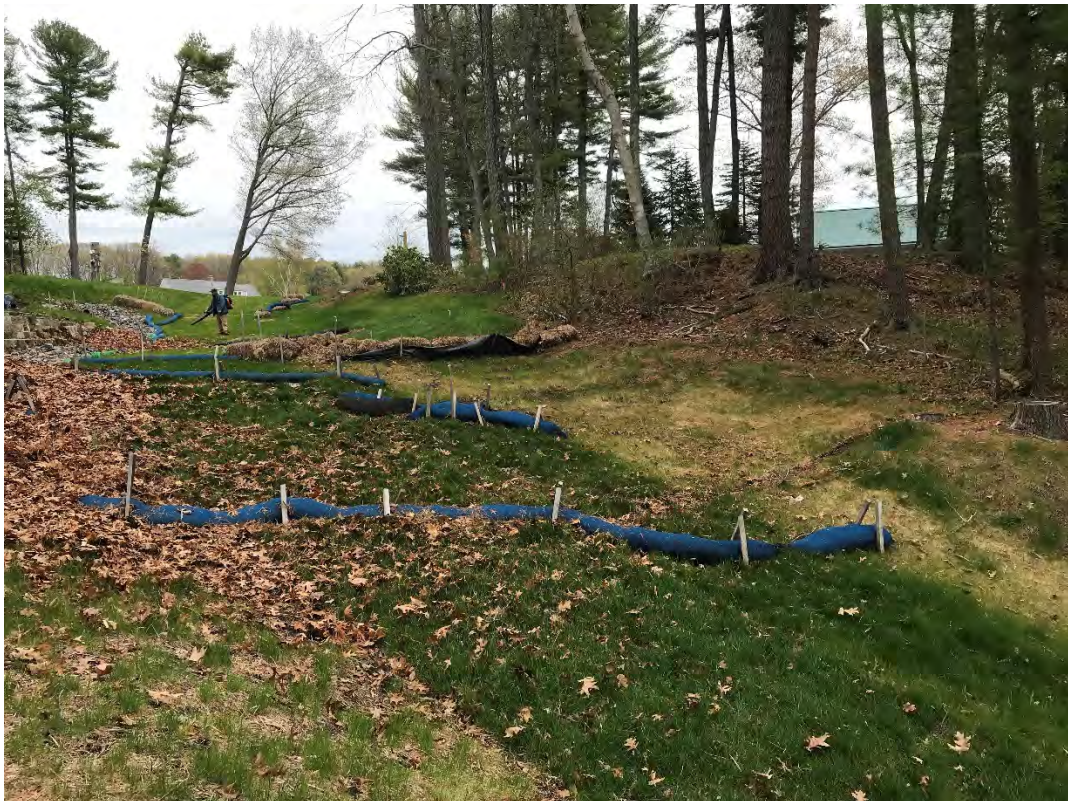
Fig 10: Slope below the manhole at Gundalow Landing/east side of the bay. Viewing east. (05-04-21)

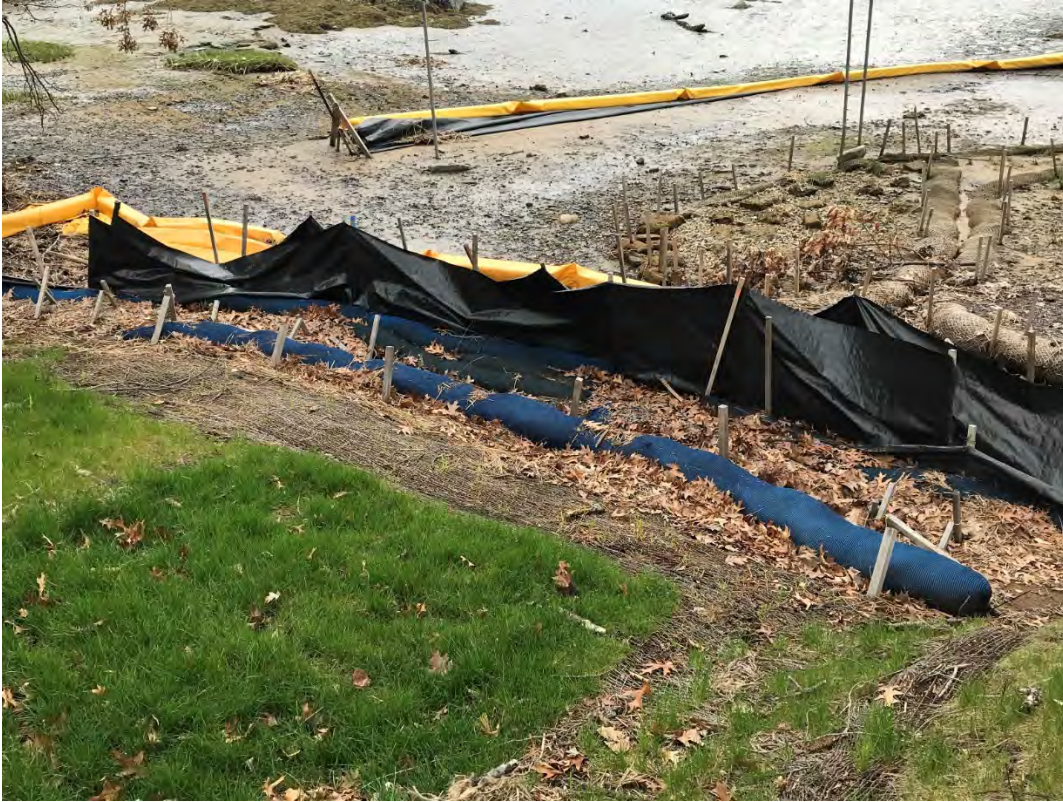
Fig 11: Toe of the slope at Gundalow Landing/east side of the bay. Viewing south. (05-04-21)

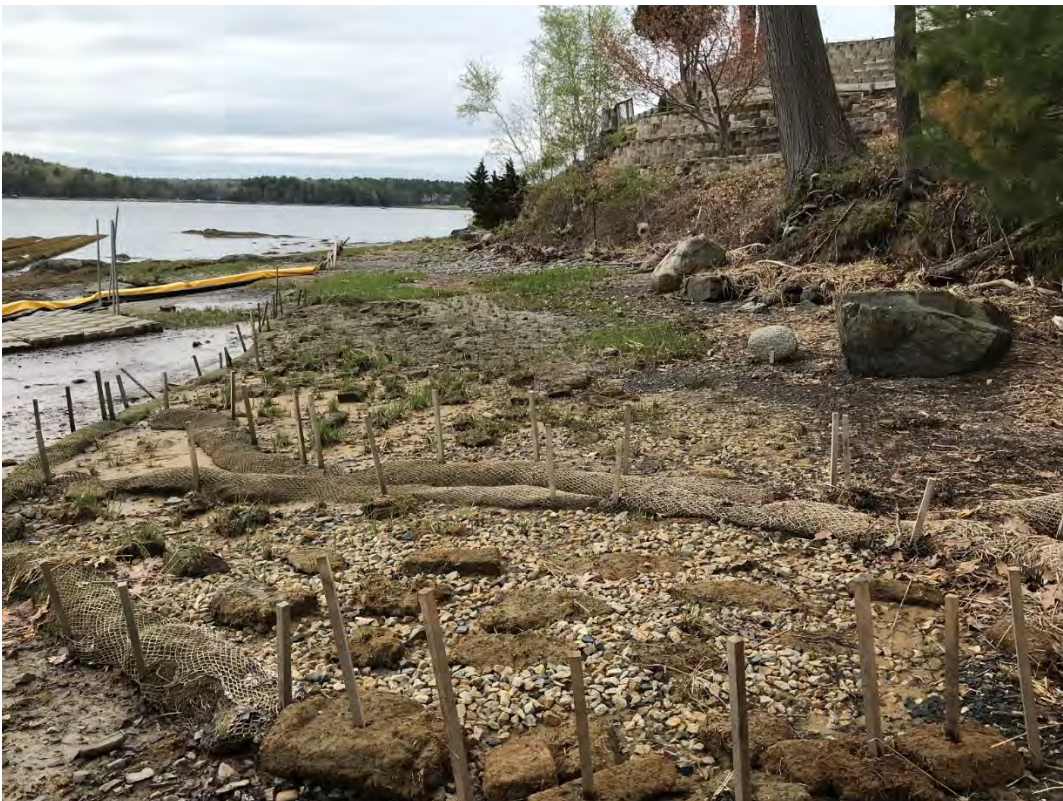
Fig 12: Salt marsh restoration at Gundalow Landing/east side of the bay. Viewing south. (05-04-21)

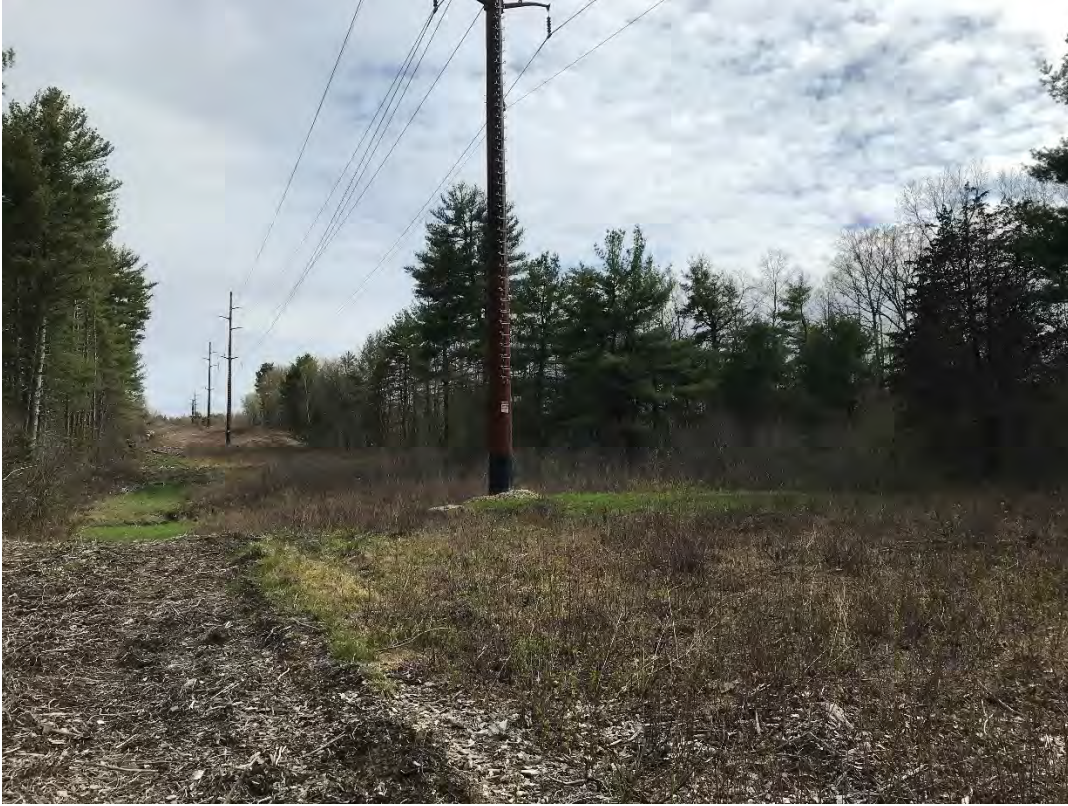
Fig 13: Str. 44 work area with adjacent access route and stream DS60. Viewing south. (05-04-21)

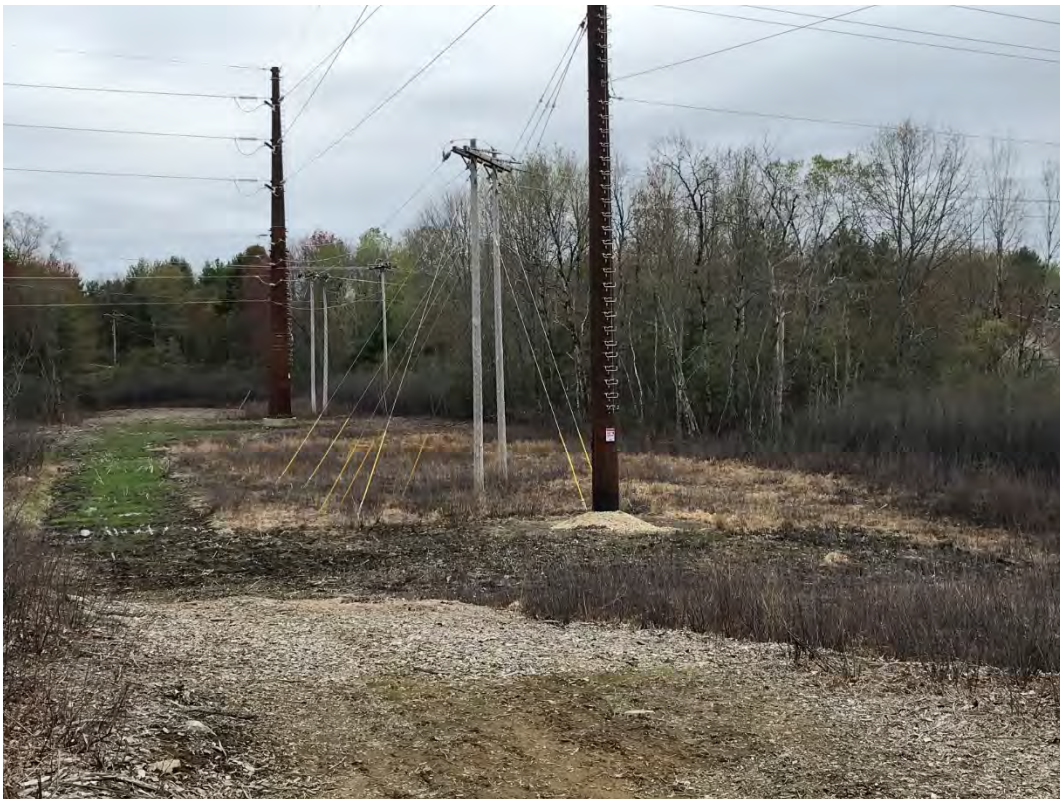
Fig 14: Str. 47 work area with adjacent access route, wetland DW56, and Str. 48 work area in background. Viewing south. (05-04-21)
