DRAINAGE MONITORING REPORT

F107 - Seacoast Reliability Project

Newington, New Hampshire

04.0190967.00

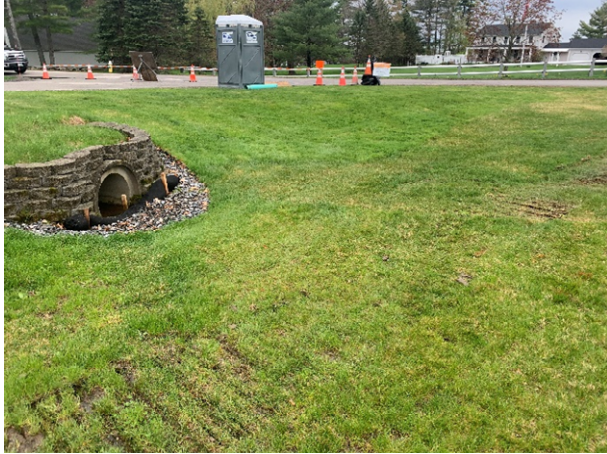
29 Gundalow - 1 (Drainage Area)

Observations/Notes: Saturated soil but no standing water.

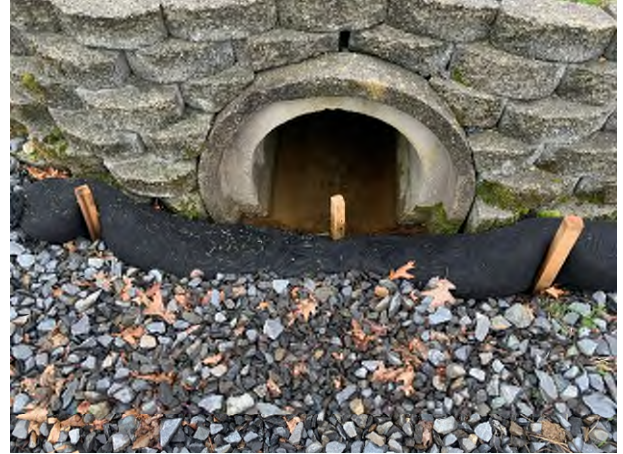
29 Gundalow - 2 (Culvert)

pH: 12.2

Observations/Notes: Approx. 8" of flowing water at culvert inlet.

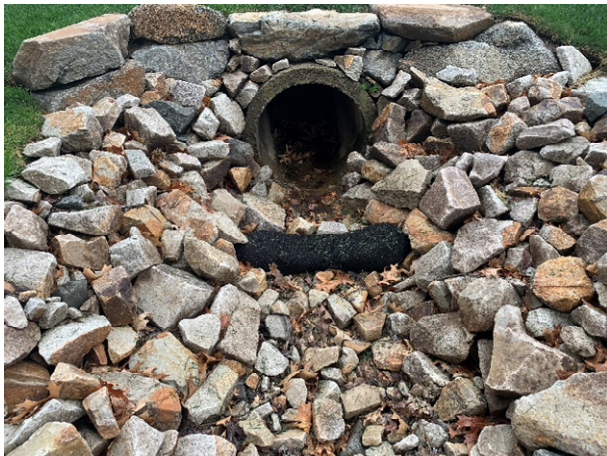
64 Gundalow - 1 (Drainage Course)

pH: 11.7

Observations/Notes: Accessible flowing water extending approx. 14" beyond culvert outlet.

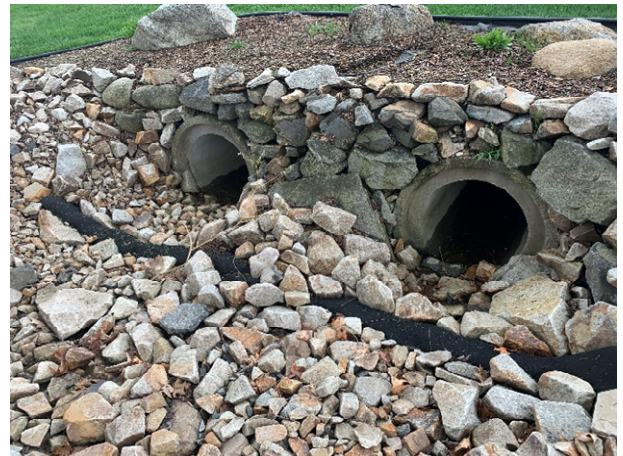
64 Gundalow - 2 (Drainage Course)

pH: 8.0

Observations/Notes: Intermittent flowing water extending approx. 3' from culvert inlets.

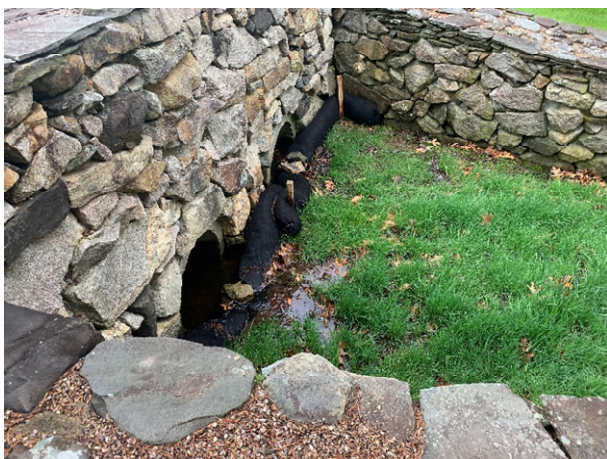
4 Brickyard Circle - 1 (Drainage Course)

pH: 7.3

Observations/Notes: Flowing water into drainage course, max depth approx. 10". Flow observed over top of peat moss log.

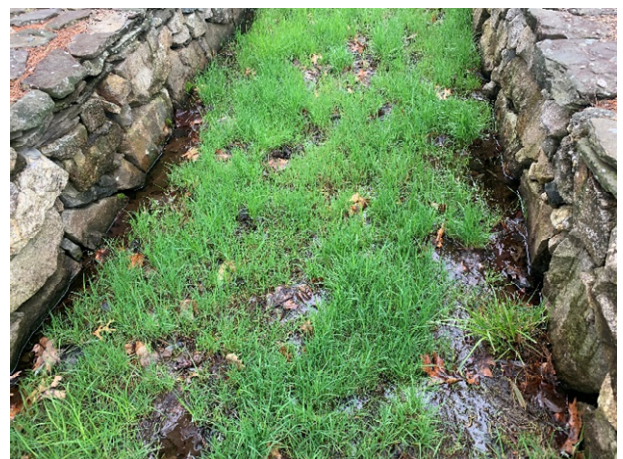
4 Brickyard Circle - 2 (Drainage Course)

pH: 7.2

Observations/Notes: Water flowing approx. 3" deep.

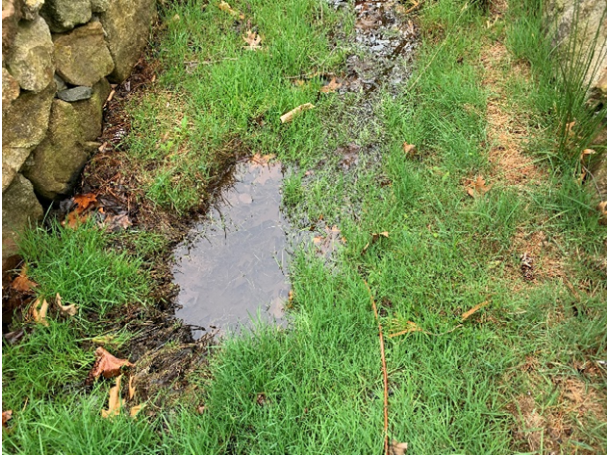
4 Brickyard Circle – 3 (Drainage Course)

pH: 7.3

Observations/Notes: Water flowing approx. 6" deep.
