#### CONSTRUCTION MONITORING REPORT

Eversource Transmission Lines: F107

Eversource Seacoast Reliability Project

#### Construction Monitoring Report #132

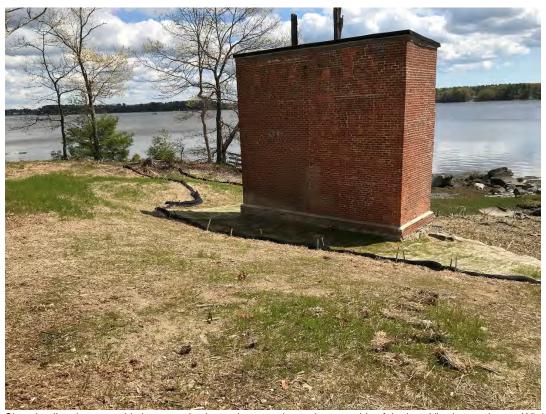
Fig 1: Slope leading down to cable house and salt marsh restoration at the west side of the bay. Viewing northeast. (05-11-21)

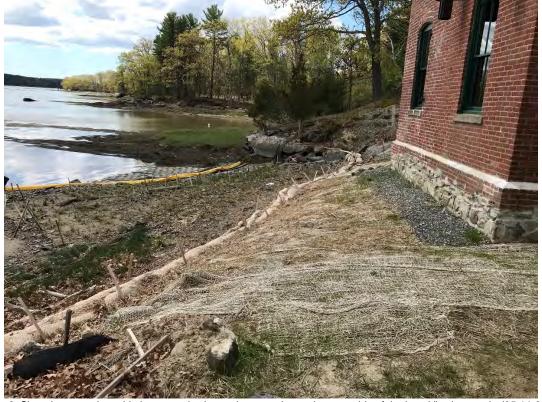
Fig 2: Slope between the cable house and salt marsh restoration at the west side of the bay. Viewing south. (05-11-21)

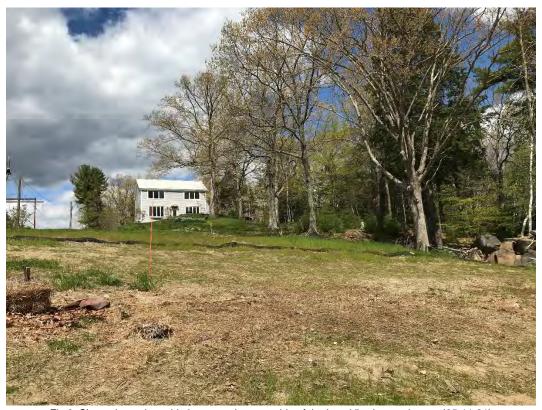
Fig 3: Slope above the cable house at the west side of the bay. Viewing northwest. (05-11-21)

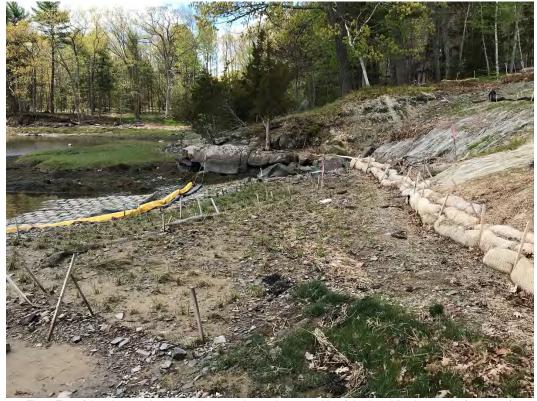
Fig 4: Toe of the slope and salt marsh restoration at the west side of the bay. Viewing south. (05-11-21)

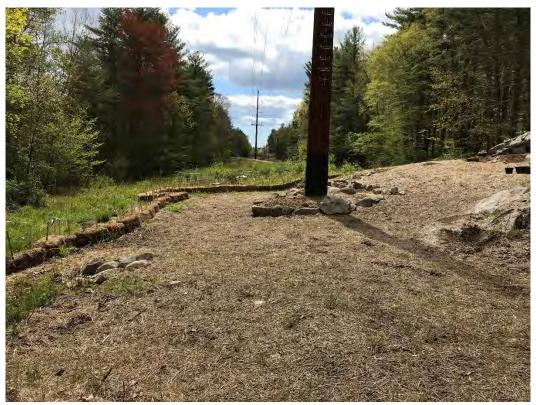
Fig 5: Str. 89 work area. Viewing southeast. (05-11-21)

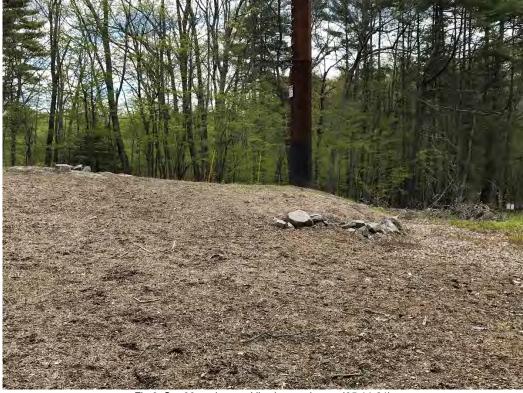
Fig 6: Str. 90 work area. Viewing northeast. (05-11-21)

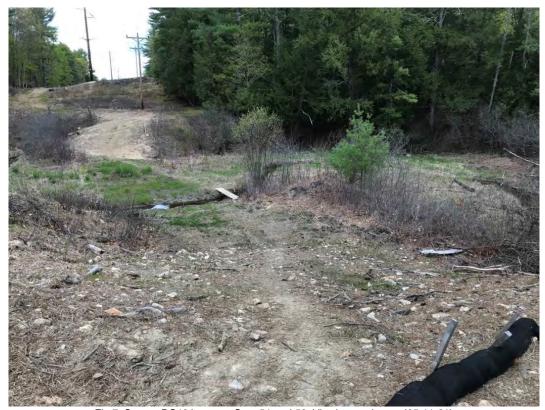
Fig 7: Stream DS46 between Strs. 51 and 52. Viewing northeast. (05-11-21)

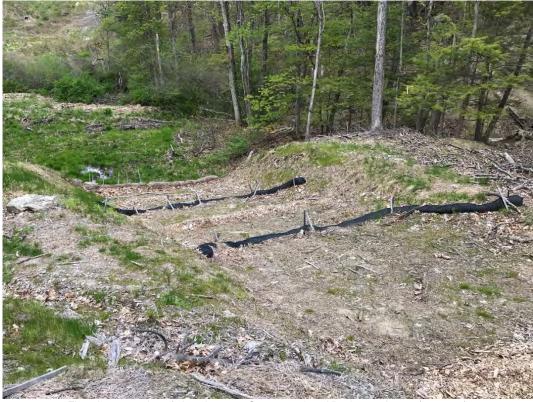
Fig 8: Lower portion of slope between Strs. 28 and 29. Viewing northeast. (05-11-21)

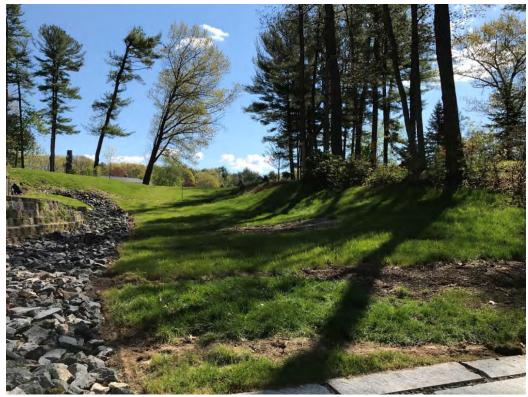
Fig 9: Slope above the manhole at Gundalow Landing/east side of the bay. Viewing east. (05-11-21)

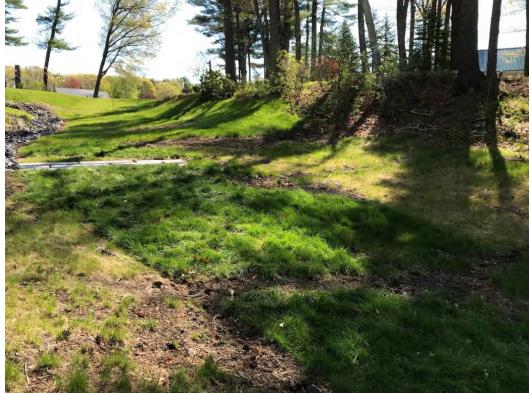
Fig 10: Slope below the manhole at Gundalow Landing/east side of the bay. Viewing east. (05-11-21)

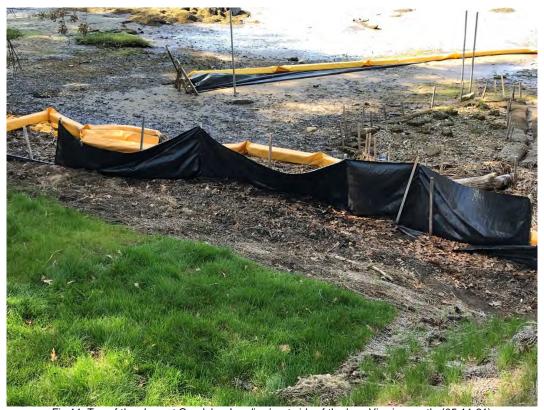
Fig 11: Toe of the slope at Gundalow Landing/east side of the bay. Viewing south. (05-11-21)

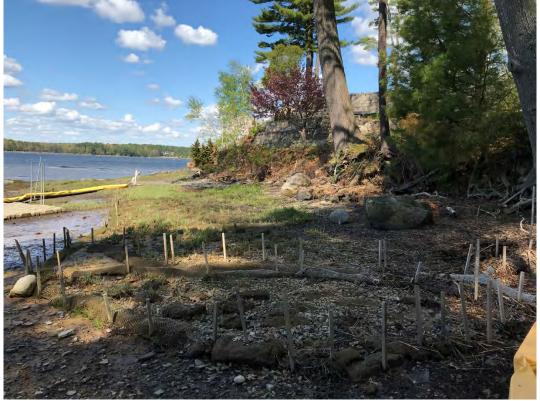
Fig 12: Toe of the slope at Gundalow Landing/east side of the bay. Viewing northwest. (05-11-21)

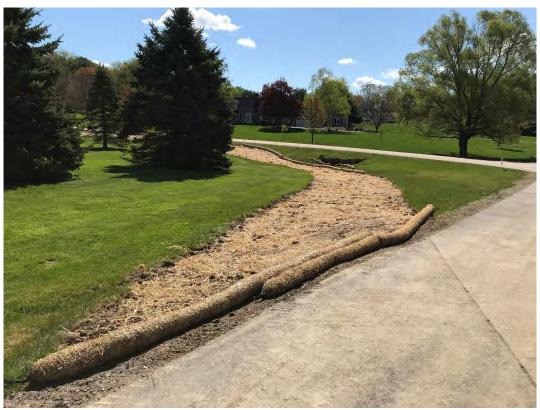
Fig 13: Remediation of flowable fill work site at Gundalow Landing. Viewing southeast. (05-11-21)

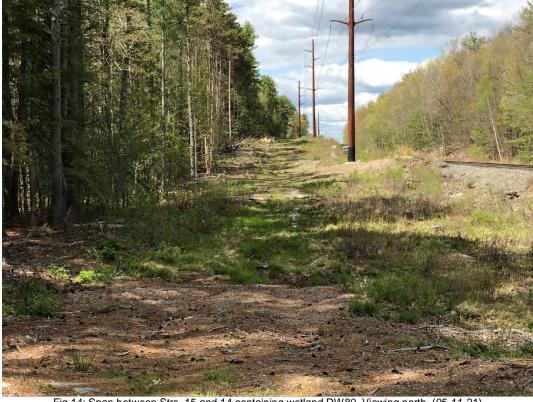
Fig 14: Span between Strs. 15 and 14 containing wetland DW80. Viewing north. (05-11-21)
