# DRAINAGE MONITORING REPORT

## F107 - Seacoast Reliability Project

### Newington, New Hampshire

04.0190967.00

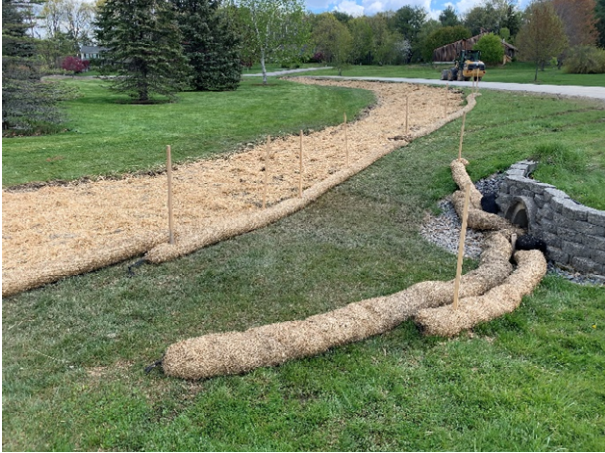
29 Gundalow - 1 (Drainage Area)

Observations/Notes: Saturated soil but no standing water.

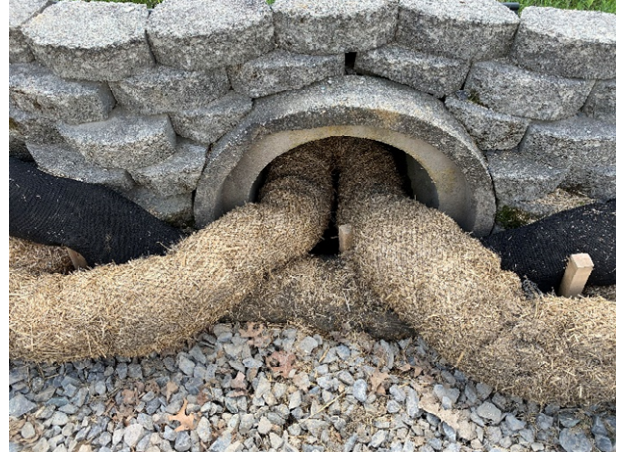
29 Gundalow - 2 (Culvert)

pH: 10.0

Observations/Notes: Approx. 6" of flowing water at culvert inlet. Straw wattles placed in culvert.

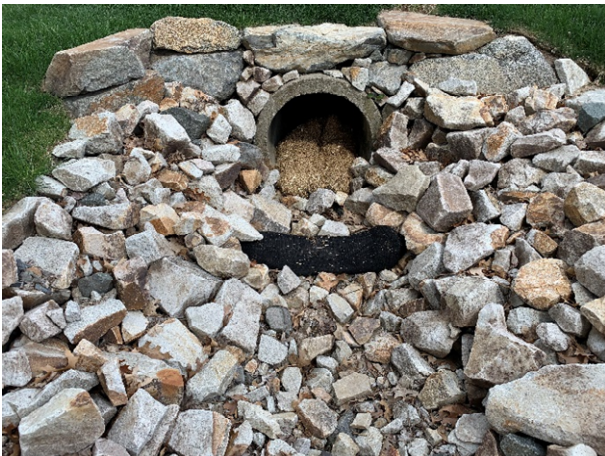
64 Gundalow - 1 (Drainage Course)

pH: 9.3

Observations/Notes: Very small area of accessible flowing water at culvert outlet approx. 0.5" deep. Straw wattles placed in culvert.

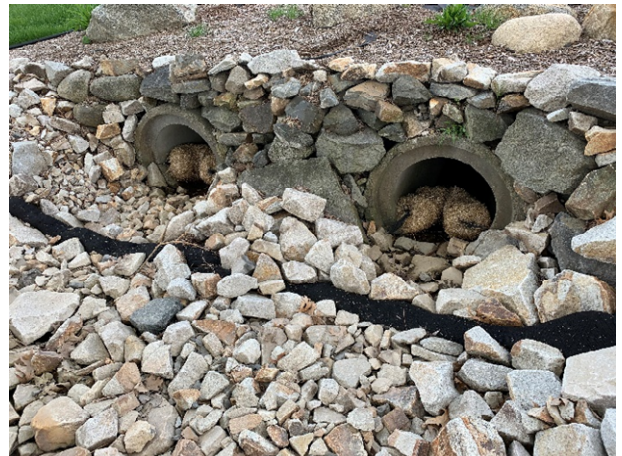
64 Gundalow - 2 (Drainage Course)

pH: 7.5

Observations/Notes: Intermittent flowing water extending approx. 12" from culvert inlets. Straw wattles placed in culverts.

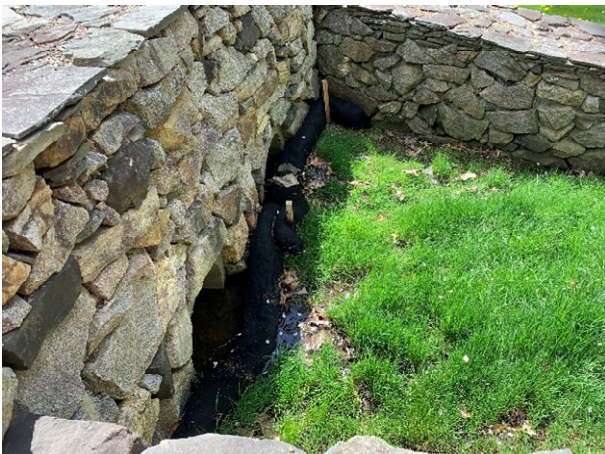
4 Brickyard Circle - 1 (Drainage Course)

pH: 7.0

Observations/Notes: Flowing water into drainage course, max depth approx. 8".

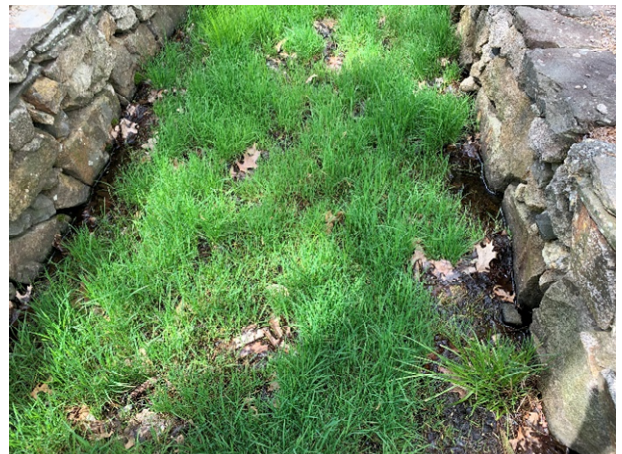
4 Brickyard Circle - 2 (Drainage Course)

pH: 7.1

Observations/Notes: Water flowing approx. 2" deep.

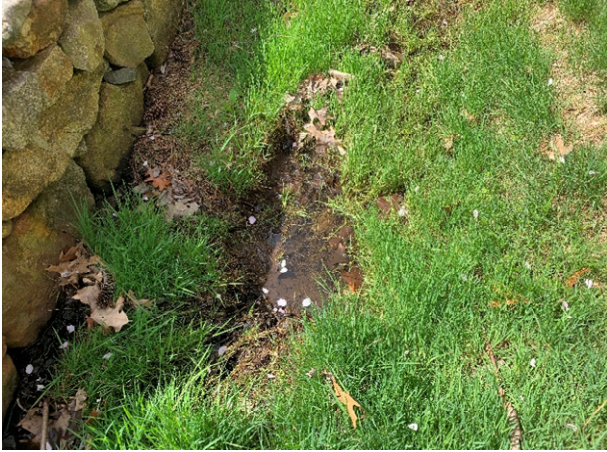
4 Brickyard Circle – 3 (Drainage Course)

pH: 7.1

Observations/Notes: Water flowing approx. 4" deep.
