DRAINAGE MONITORING REPORT

F107 - Seacoast Reliability Project

Newington, New Hampshire

04.0190967.00

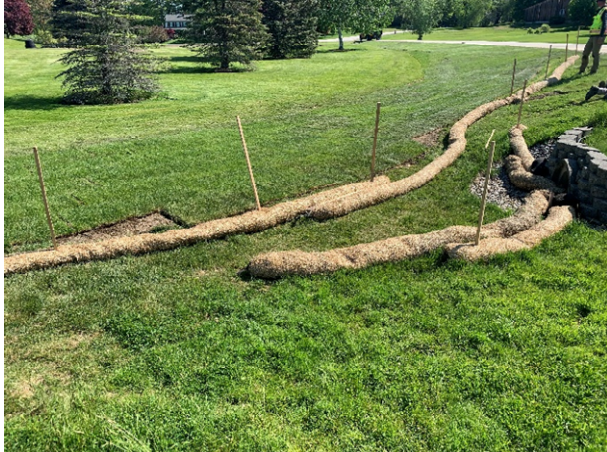
29 Gundalow - 1 (Drainage Area)

Observations/Notes: Sod being installed in area of 29 Gundalow – 1 at time of inspection.

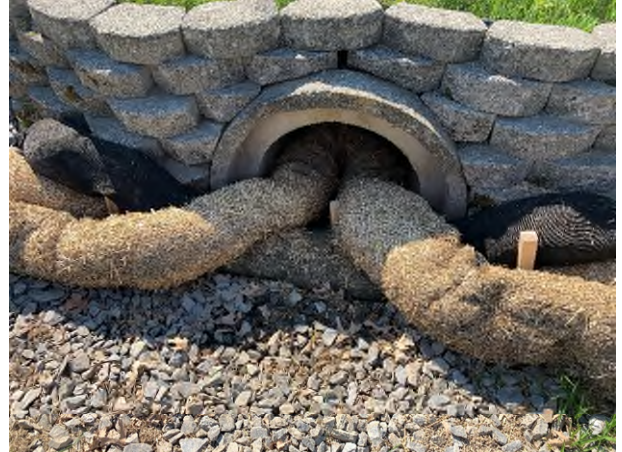
29 Gundalow - 2 (Culvert)

pH: 10.9

Observations/Notes: Approx. 5" of water at culvert inlet. Straw wattles observed in culvert.

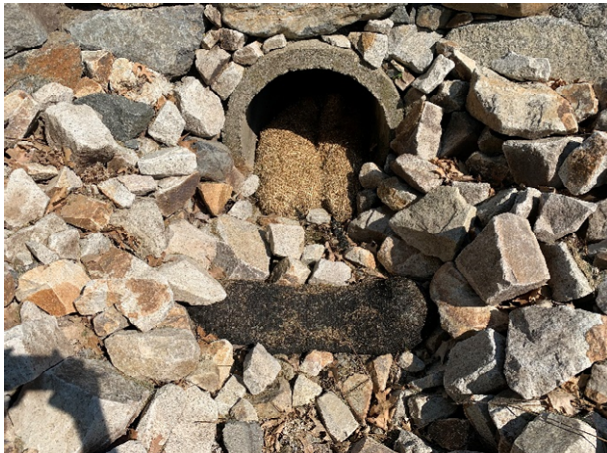
64 Gundalow - 1 (Drainage Course)

pH: 8.9

Observations/Notes: Very small area of accessible water at culvert outlet approx. 0.5" deep. Straw wattles observed in culvert.

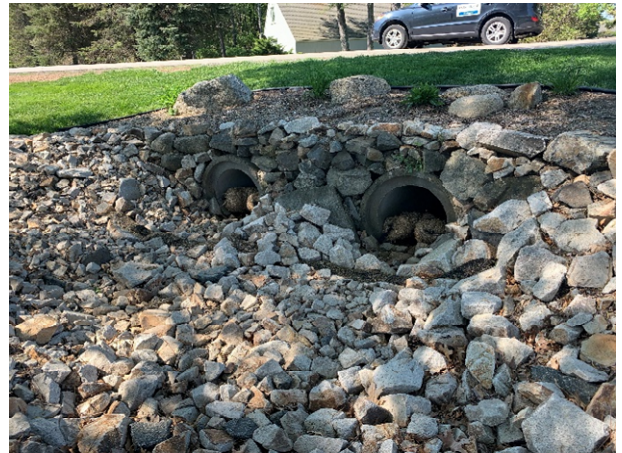
64 Gundalow - 2 (Drainage Course)

pH: 7.0

Observations/Notes: Small areas of standing water adjacent to culvert inlets. Straw wattles observed in culverts.

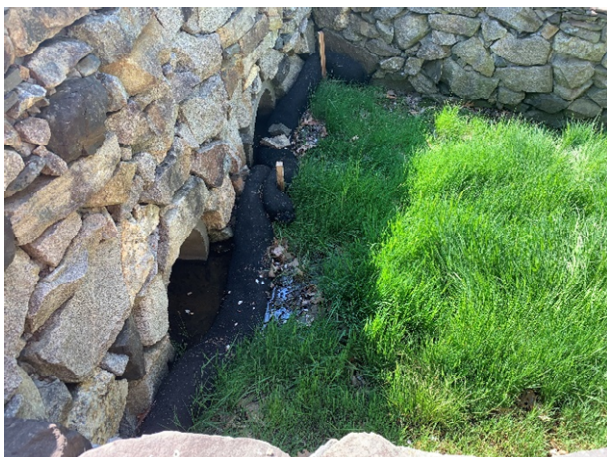
4 Brickyard Circle - 1 (Drainage Course)

pH: 7.1

Observations/Notes: Flowing water into drainage course, max depth approx. 6".

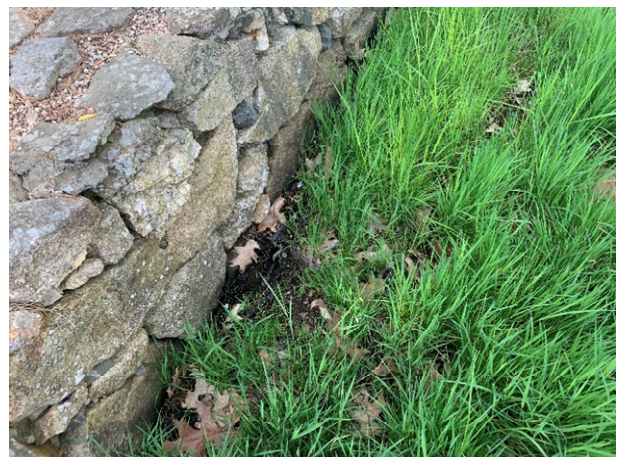
4 Brickyard Circle - 2 (Drainage Course)

pH: 7.1

Observations/Notes: Water flowing approx. 1" deep.

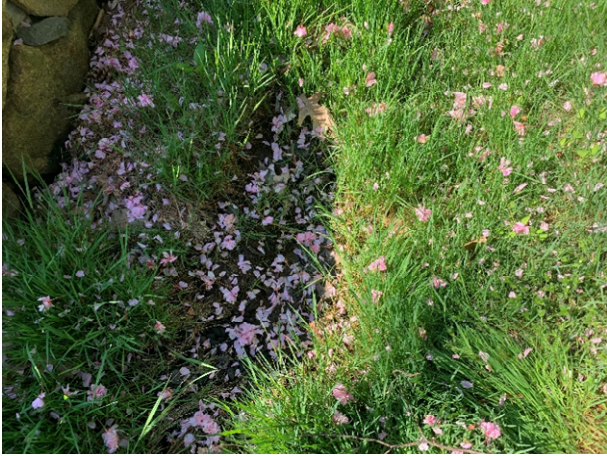
4 Brickyard Circle – 3 (Drainage Course)

Observations/Notes: Soil saturated, no standing water.
