# CONSTRUCTION MONITORING REPORT

Eversource	Transmission Lines
	<u>F107</u>

NAI Project No: 23840.39

Eversource Seacoast Reliability Project

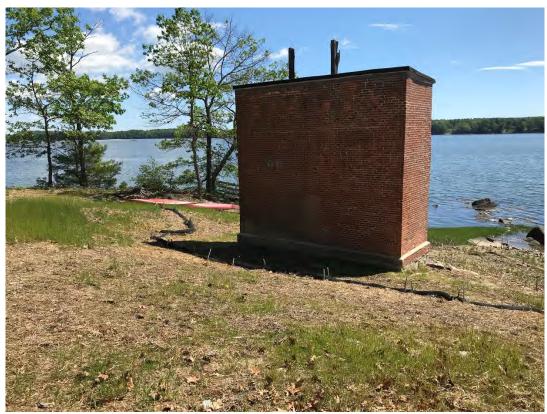
Fig 1: Slope leading down to cable house and salt marsh restoration at the west side of the bay. Viewing northeast. (05-24-21)

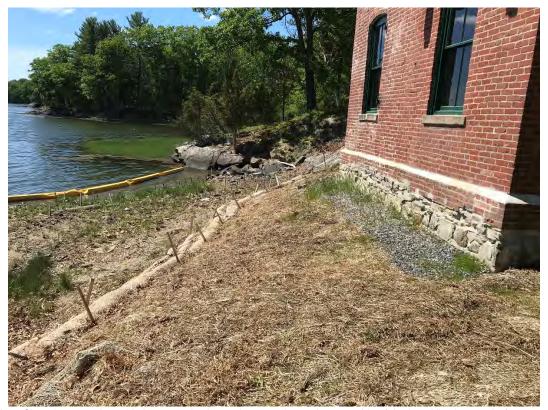
Fig 2: Slope between the cable house and salt marsh restoration at the west side of the bay. Viewing south. (05-24-21)

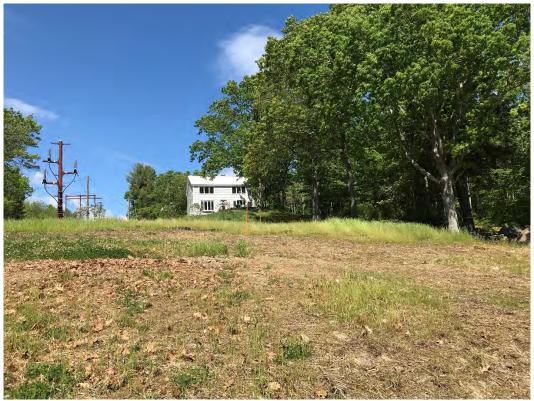
Fig 3: Slope above the cable house at the west side of the bay. Viewing northwest. (05-24-21)

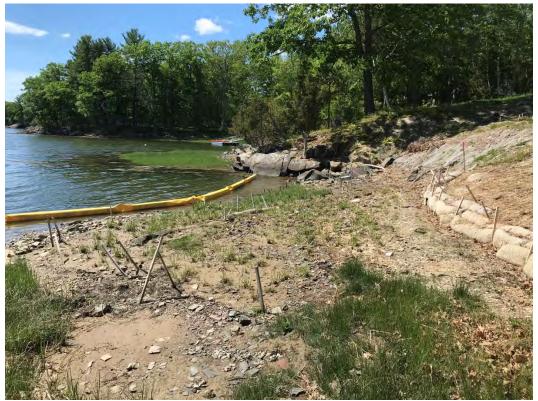
Fig 4: Toe of the slope and salt marsh restoration at the west side of the bay. Viewing south. (05-24-21)

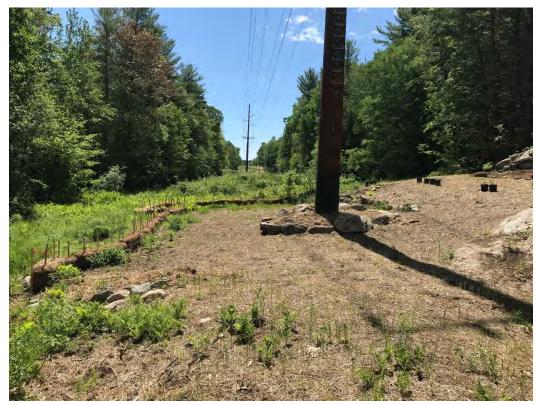
Fig 5: Str. 89 work area. Viewing southeast. (05-24-21)

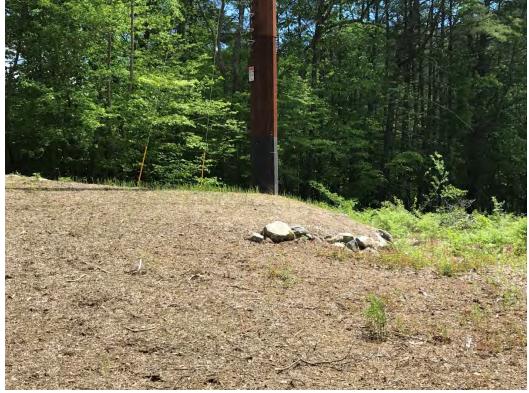
Fig 6: Str. 90 work area. Viewing northeast. (05-24-21)

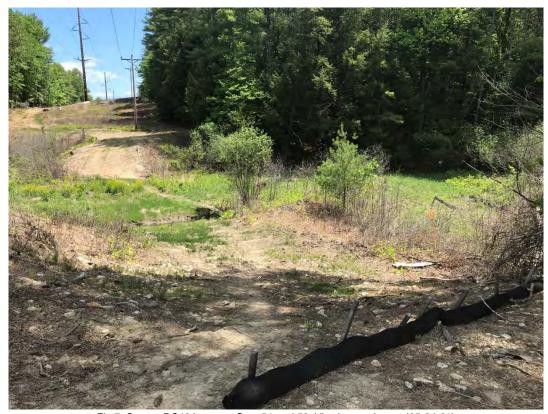
Fig 7: Stream DS46 between Strs. 51 and 52. Viewing northeast. (05-24-21)

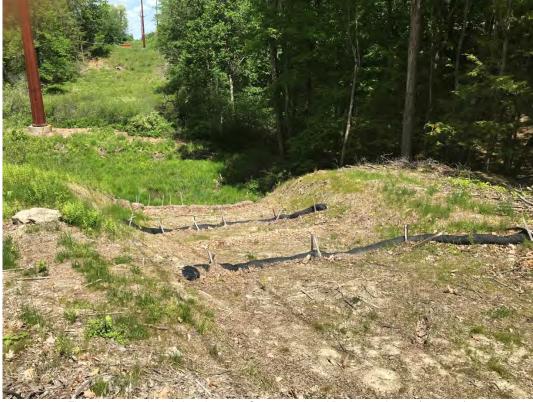
Fig 8: Lower portion of slope between Strs. 28 and 29. Viewing northeast. (05-24-21)

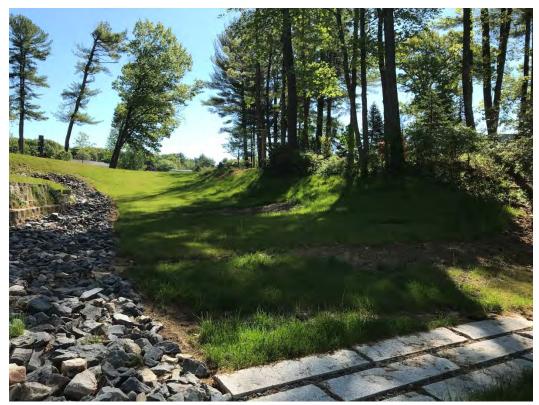
Fig 9: Slope above the manhole at Gundalow Landing/east side of the bay. Viewing east. (05-24-21)

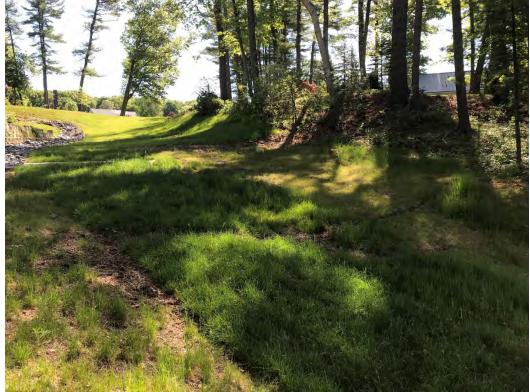
Fig 10: Slope below the manhole at Gundalow Landing/east side of the bay. Viewing east. (05-24-21)

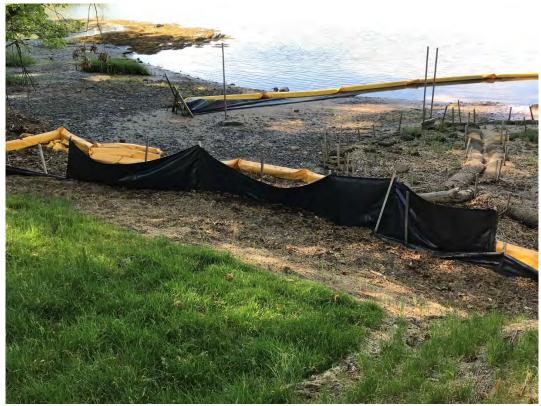
Fig 11: Toe of the slope at Gundalow Landing/east side of the bay. Viewing south. (05-24-21)

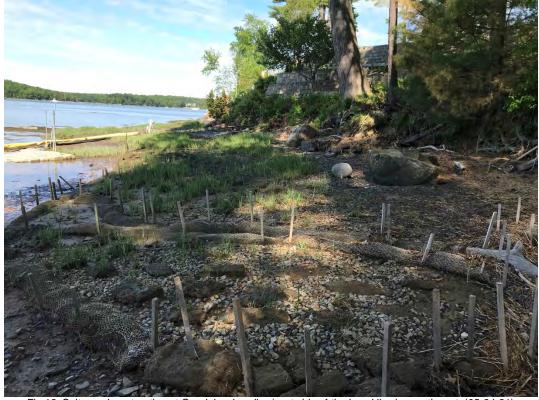
Fig 12: Salt marsh restoration at Gundalow Landing/east side of the bay. Viewing northwest. (05-24-21)

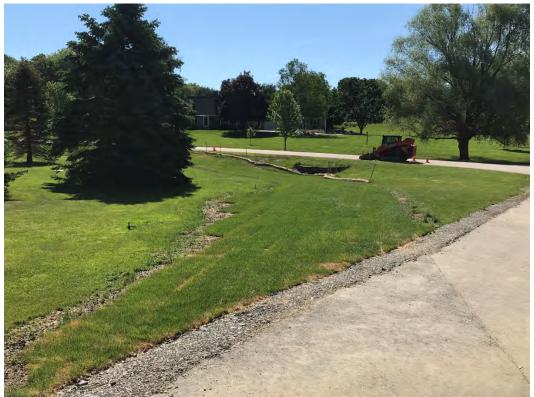
Fig 13: Sod applied over loam and flowable fill at 29 Gundalow Landing. Viewing east. (05-24-21)

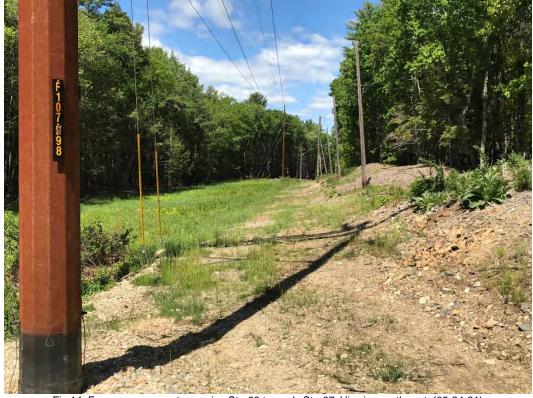
Fig 14: Former access route passing Str. 98 towards Str. 97. Viewing northwest. (05-24-21)

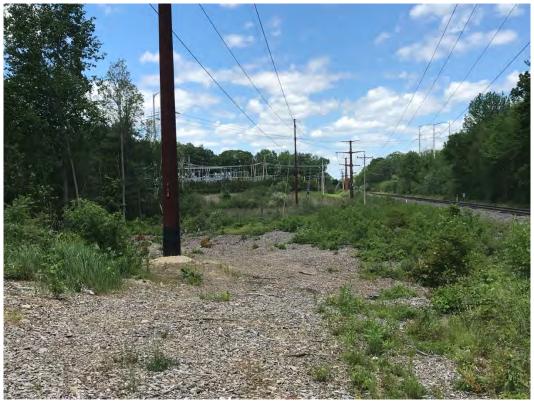
Fig 15: Str. 4 work area. Viewing north. (05-24-21)

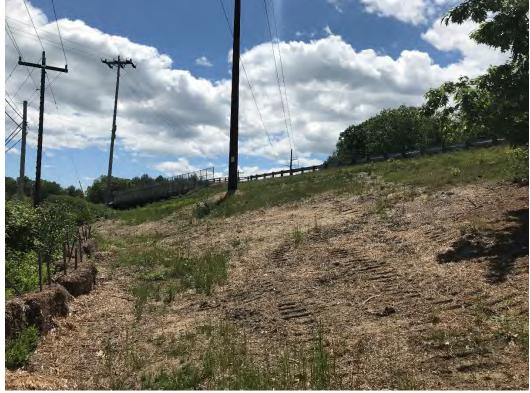
Fig 16: Str. 6 work area. Viewing southwest. (05-24-21)
