DRAINAGE MONITORING REPORT

F107 - Seacoast Reliability Project

Newington, New Hampshire

04.0190967.00

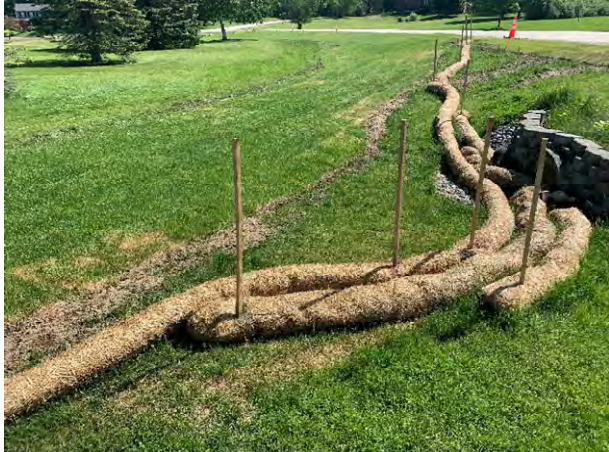
29 Gundalow - 1 (Drainage Area)

Status of surface water at the time of inspection? Dry Standing Flowing

pH: --

Observations/Notes: Sod being installed in area of 29 Gundalow – 1 at time of inspection.

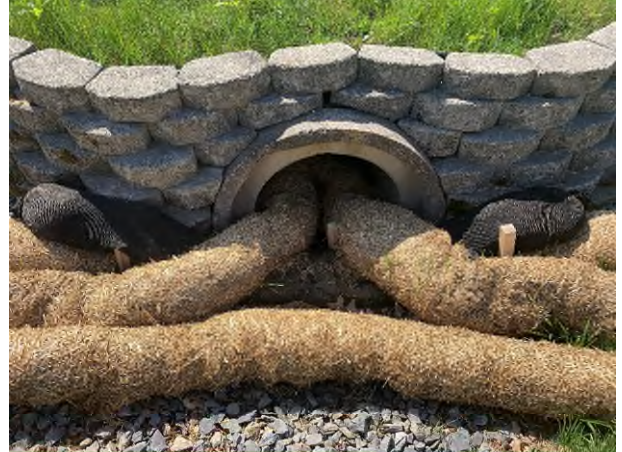
29 Gundalow - 2 (Culvert)

Status of surface water at the time of inspection? Dry Standing Flowing

pH: 11.2

Observations/Notes: Approx. 5" of water at culvert inlet. Straw wattles observed in culvert.

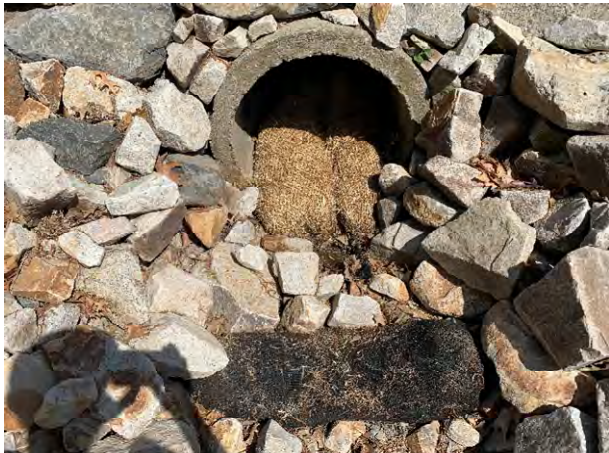
64 Gundalow - 1 (Drainage Course)

Status of surface water at the time of inspection? Dry Standing Flowing

pH: 8.9

Observations/Notes: Very small area of accessible water at culvert outlet approx. 0.5" deep. Straw wattles observed in culvert.

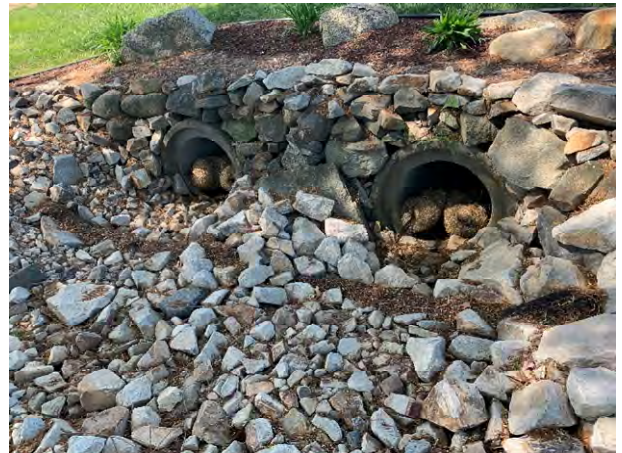
64 Gundalow - 2 (Drainage Course)

Status of surface water at the time of inspection? Dry Standing Flowing

pH: 7.2

Observations/Notes: Small areas of standing water adjacent to culvert inlets. Straw wattles observed in culverts.

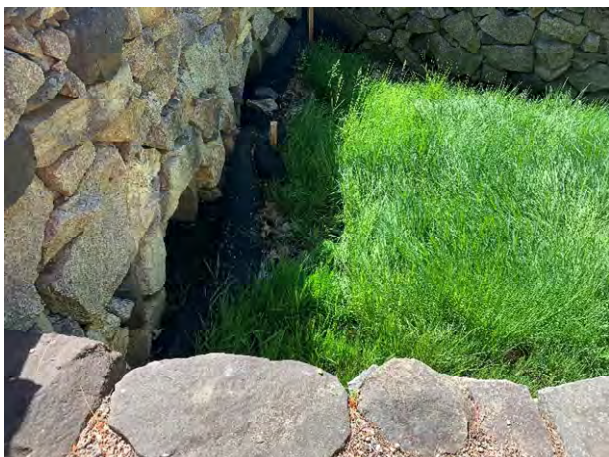
4 Brickyard Circle - 1 (Drainage Course)

Status of surface water at the time of inspection? Dry Standing Flowing

pH: 7.8

Observations/Notes: Standing water at culvert outlet, max depth approx. 6".

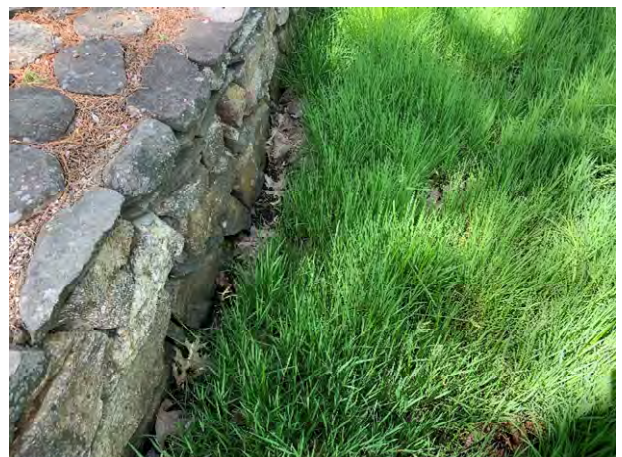
4 Brickyard Circle - 2 (Drainage Course)

Status of surface water at the time of inspection? Dry Standing Flowing

pH: --

Observations/Notes: Soil saturated, no standing water.

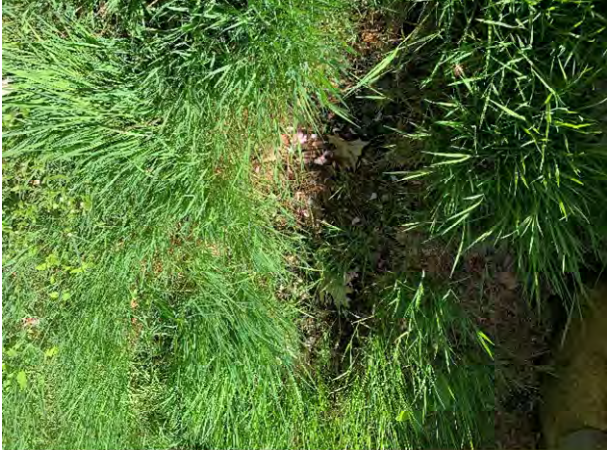
4 Brickyard Circle – 3 (Drainage Course)

Status of surface water at the time of inspection? Dry Standing Flowing

pH: --

Observations/Notes: Soil saturated, no standing water.

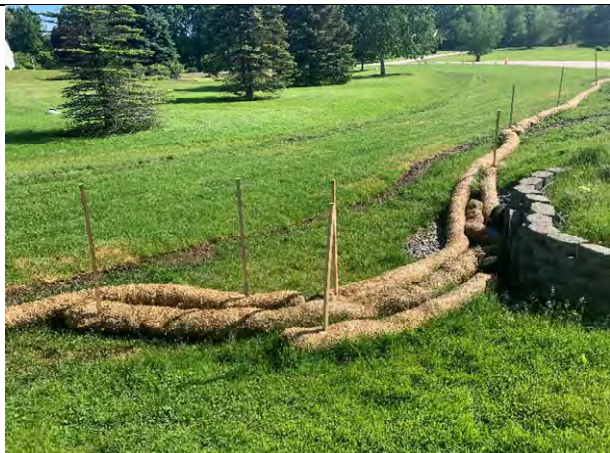
29 Gundalow - 1 (Drainage Area)

Status of surface water at the time of inspection? Dry Standing Flowing

pH: --

Observations/Notes: Soil saturated, no standing water.

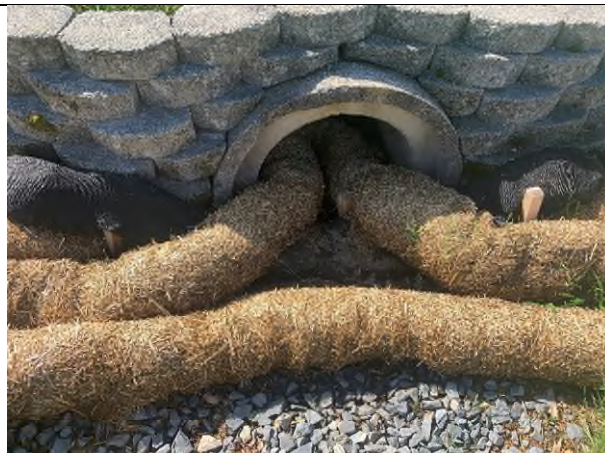
29 Gundalow - 2 (Culvert)

Status of surface water at the time of inspection? Dry Standing Flowing

pH: 10.7

Observations/Notes: Approx. 5" of water at culvert inlet. Straw wattles observed in culvert.

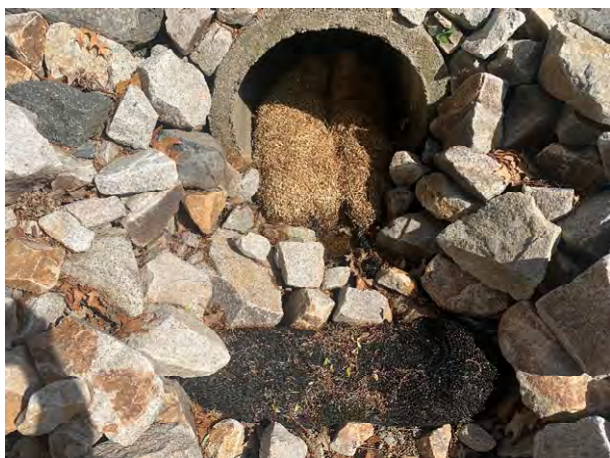
64 Gundalow - 1 (Drainage Course)

Status of surface water at the time of inspection? Dry Standing Flowing

pH: 9.4

Observations/Notes: Small area of accessible water at culvert outlet approx. 1" deep. Straw wattles observed in culvert.

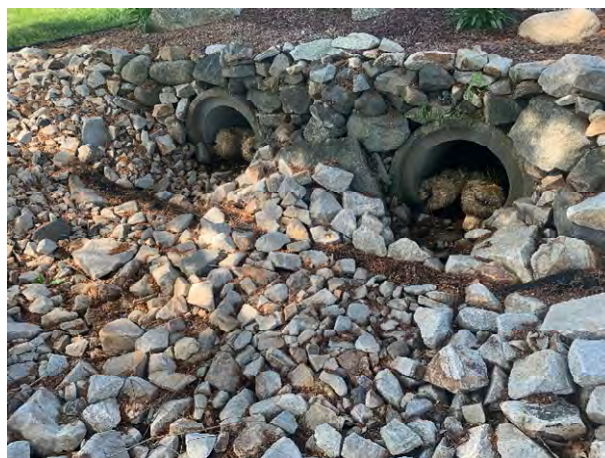
64 Gundalow - 2 (Drainage Course)

Status of surface water at the time of inspection? Dry Standing Flowing

pH: 8.5

Observations/Notes: Areas of standing water adjacent to culvert inlets. Straw wattles observed in culverts.

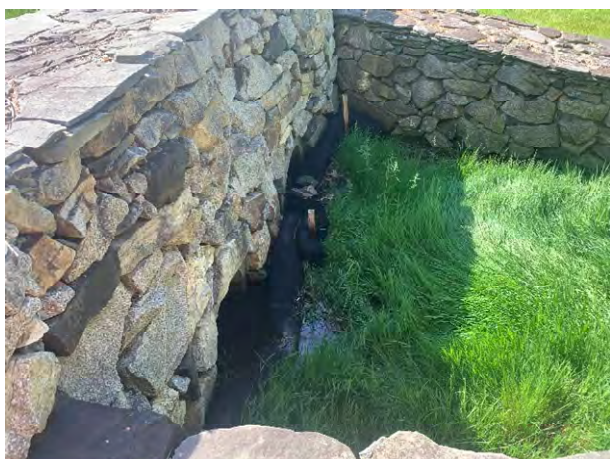
4 Brickyard Circle - 1 (Drainage Course)

Status of surface water at the time of inspection? Dry Standing Flowing

pH: 7.8

Observations/Notes: Flowing water into drainage course, max depth approx. 6".

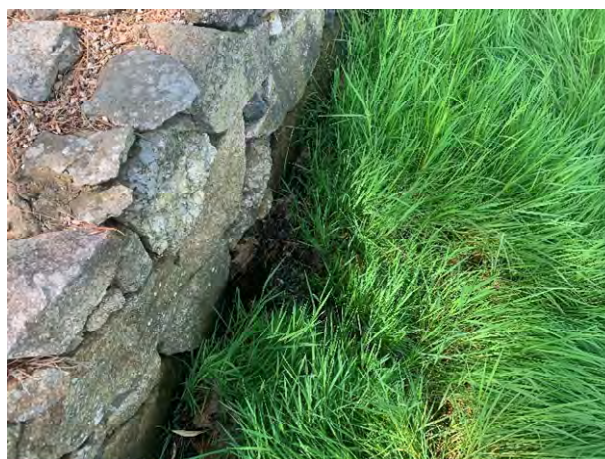
4 Brickyard Circle - 2 (Drainage Course)

Status of surface water at the time of inspection? Dry Standing Flowing

pH: 7.3

Observations/Notes: Flowing water against wall of raceway, approx. 1" deep.

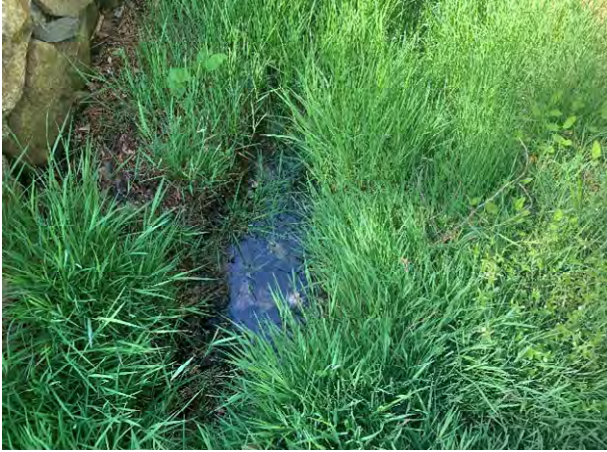
4 Brickyard Circle – 3 (Drainage Course)

Status of surface water at the time of inspection? Dry Standing Flowing

pH: 7.1

Observations/Notes: Flowing water pooled in center of raceway, approx. 3" deep.
