CONSTRUCTION MONITORING REPORT

Eversource Transmission Lines:
F107

TYPE OF INSPECTION: Weekly Storm Event Incident Corrective Action

Date of inspection: **06/01/21** Start Time: **9:15am** Previous inspection: **05/24/21**

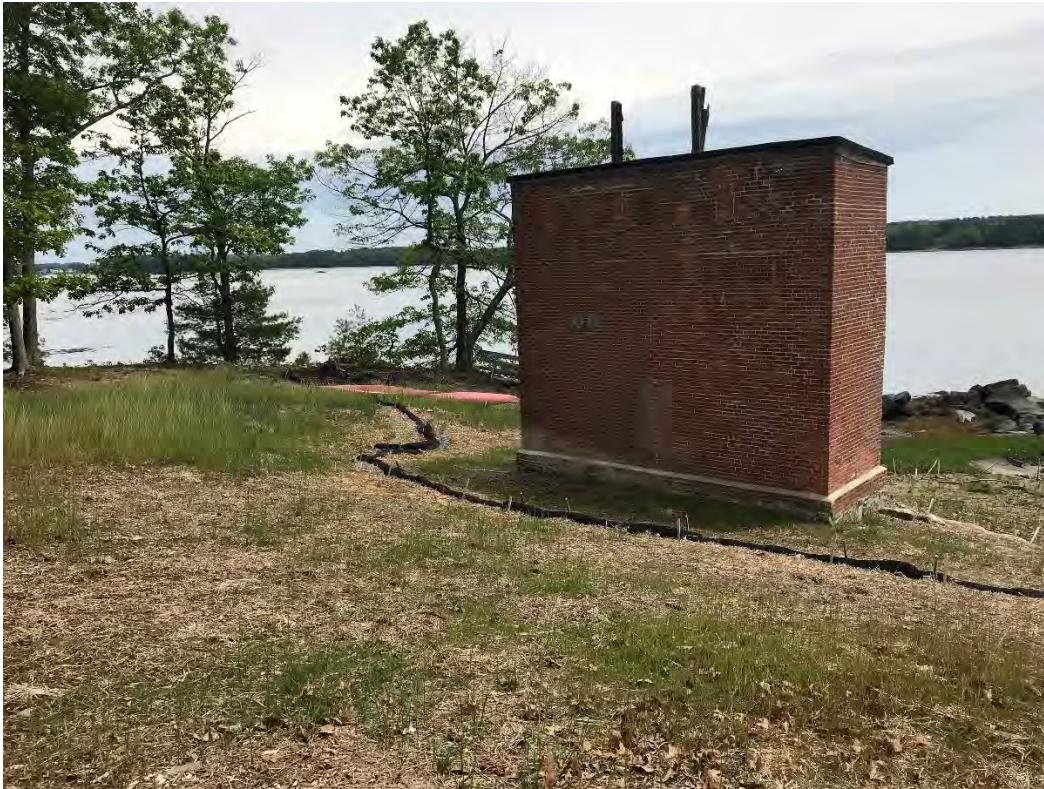
Fig 1: Slope leading down to cable house and salt marsh restoration at the west side of the bay. Viewing northeast. (06-01-21)

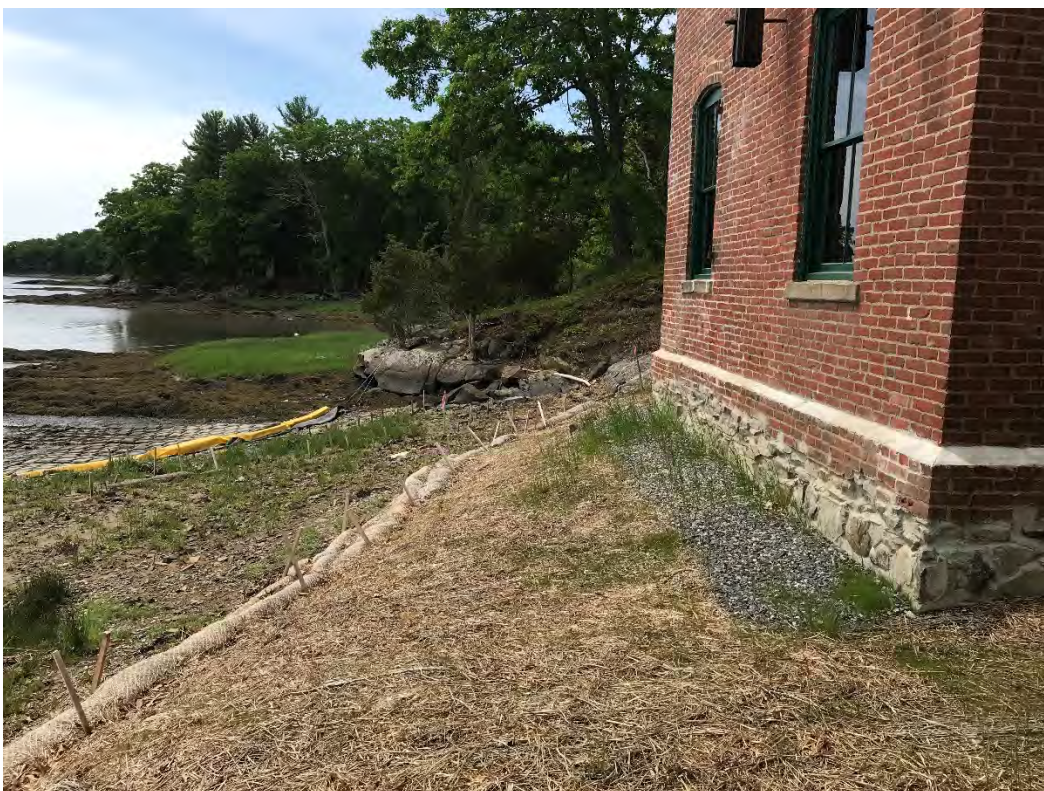
Fig 2: Slope between the cable house and salt marsh restoration at the west side of the bay. Viewing south. (06-01-21)

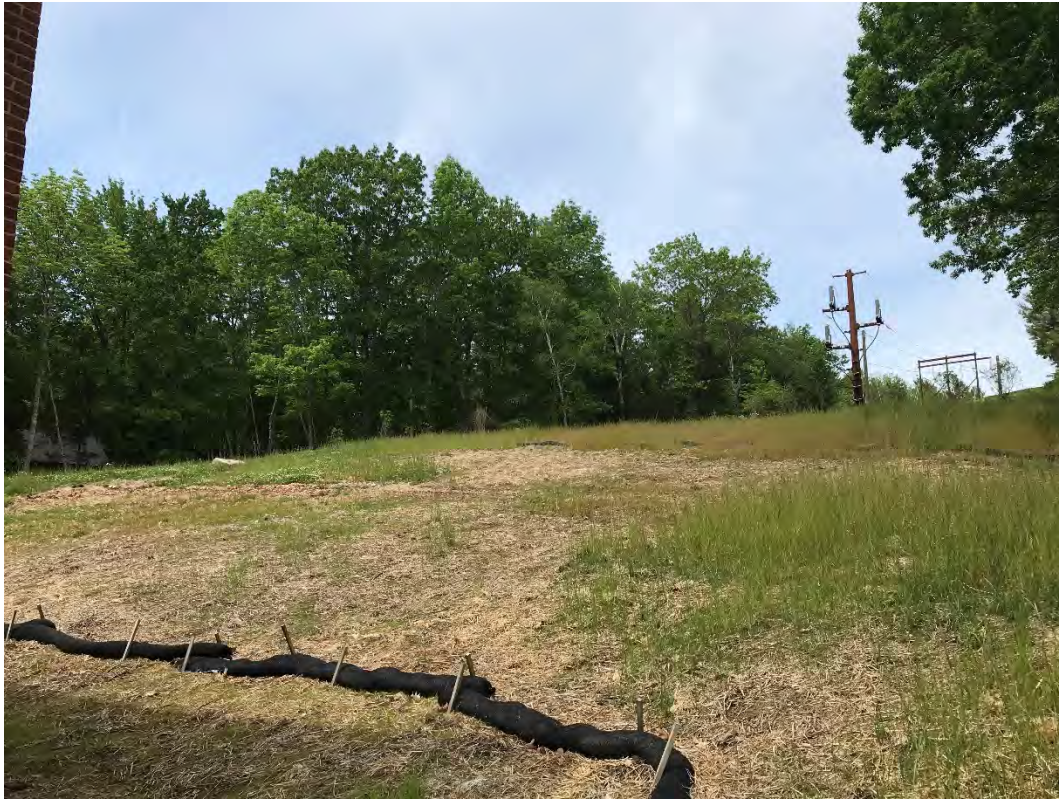
Fig 3: Slope above the cable house at the west side of the bay. Viewing southwest. (06-01-21)

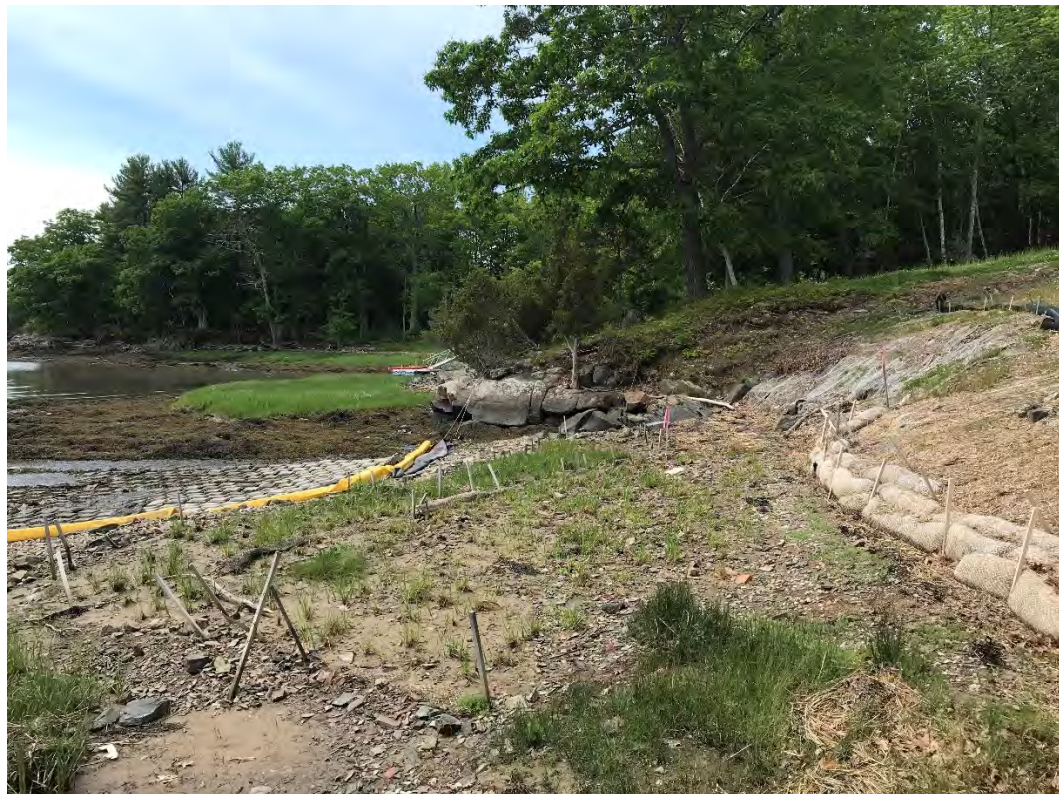
Fig 4: Toe of the slope and salt marsh restoration at the west side of the bay. Viewing south. (06-01-21)

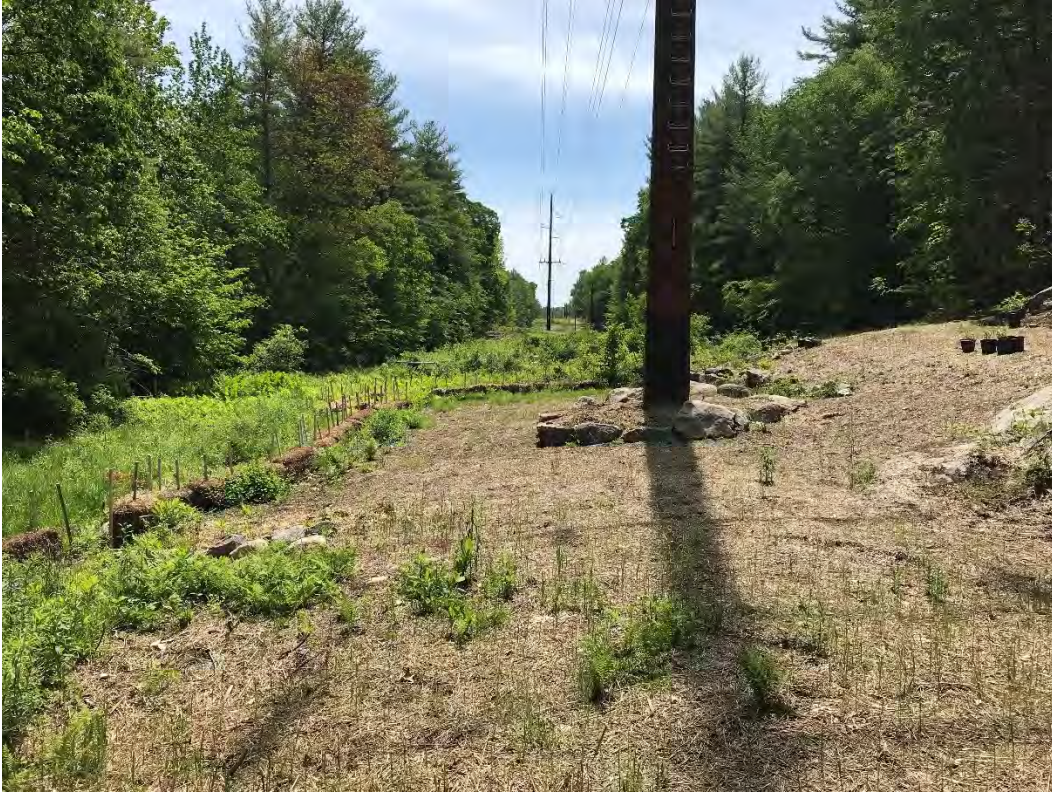
Areas that have been restored and mulched, but have little germination: Strs. 89-90

Fig 5: Str. 89 work area. Viewing southeast. (06-01-21)

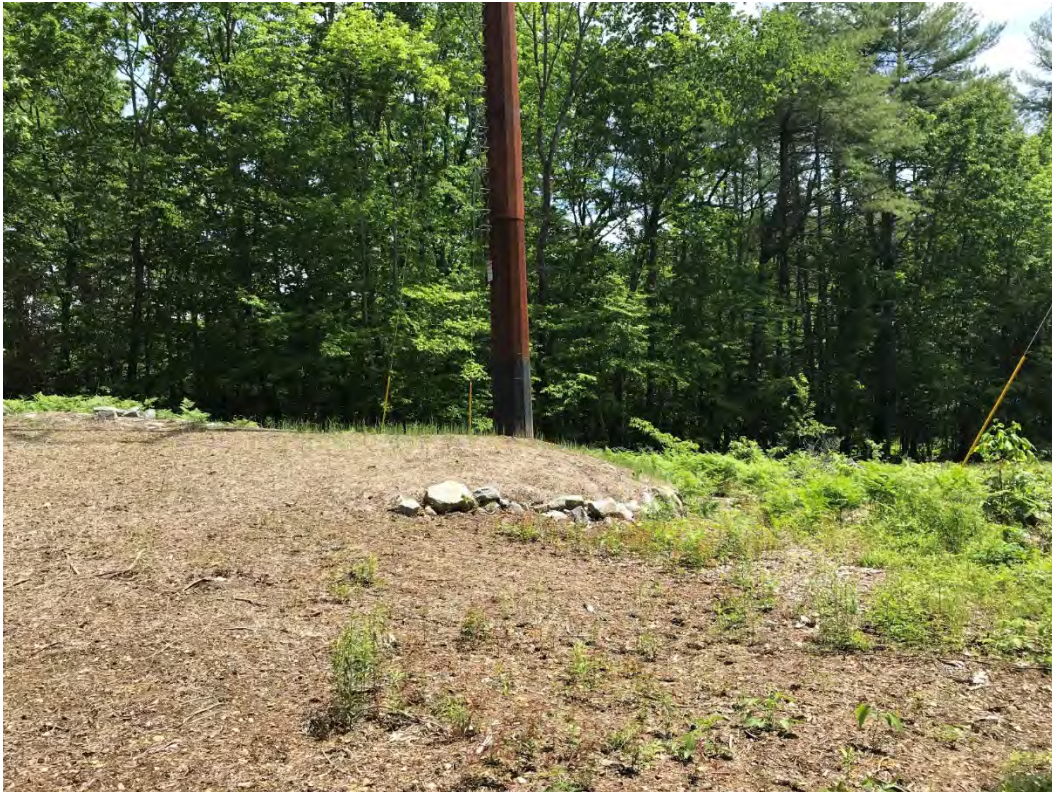
Fig 6: Str. 90 work area. Viewing northeast. (06-01-21)

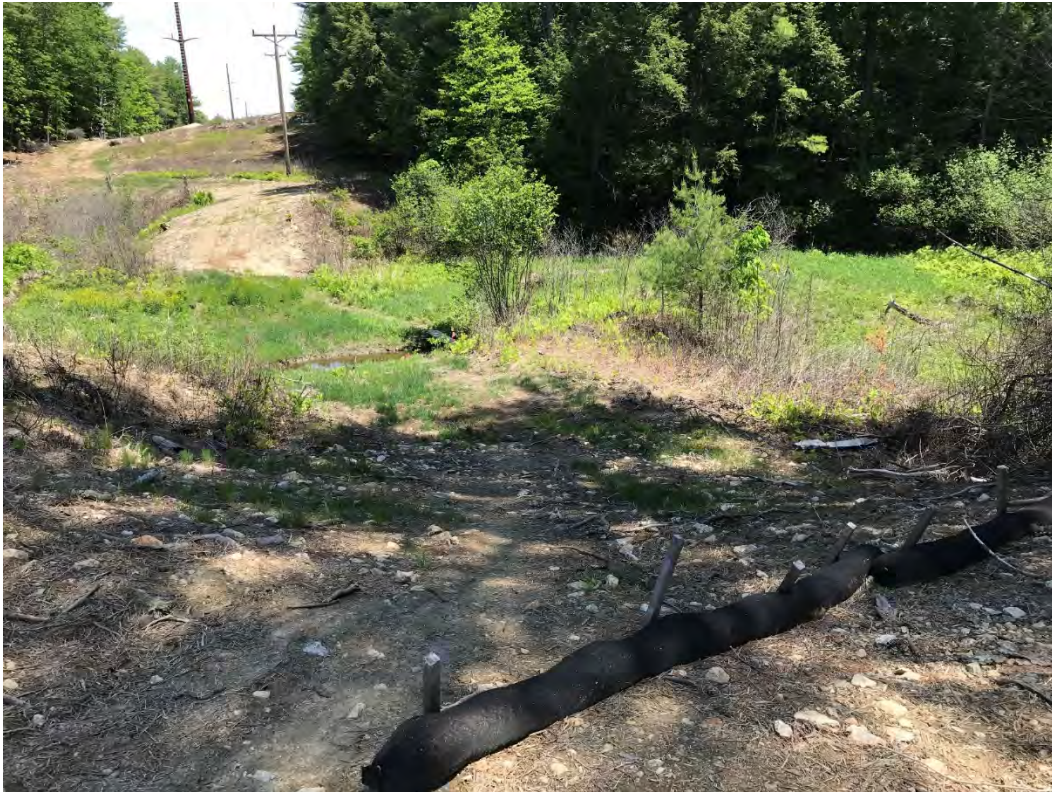
Fig 7: Stream DS46 between Strs. 51 and 52. Viewing northeast. (06-01-21)

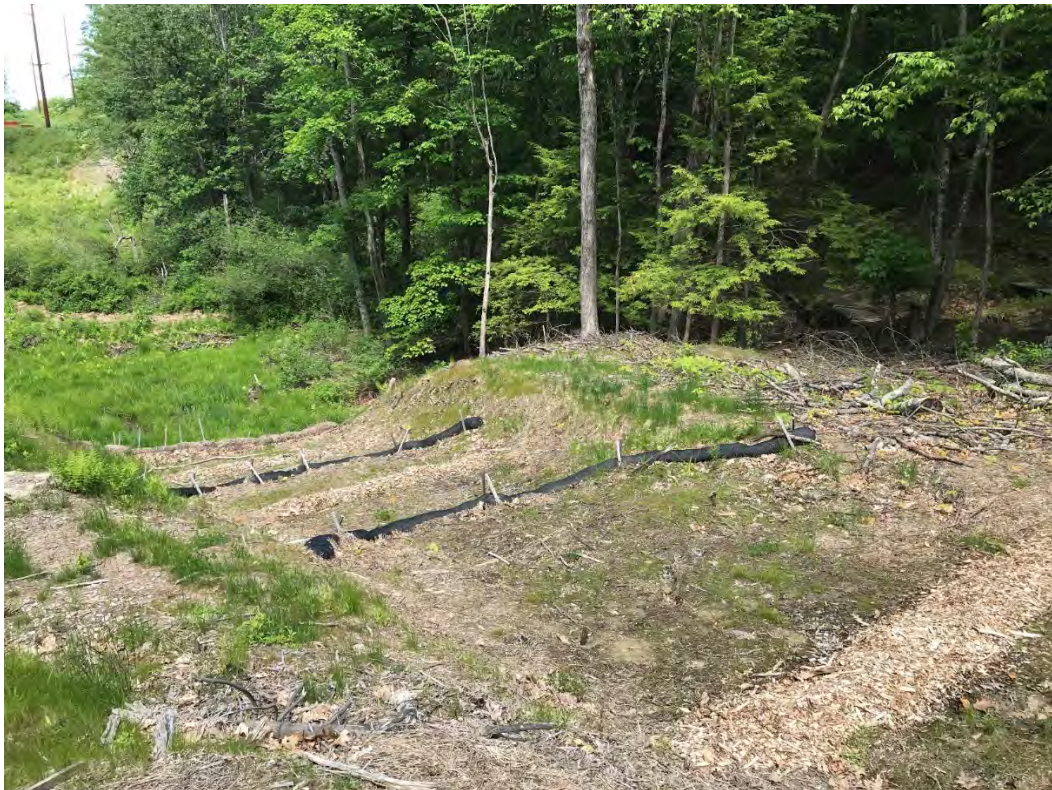
Fig 8: Lower portion of slope between Strs. 28 and 29. Viewing northeast. (06-01-21)

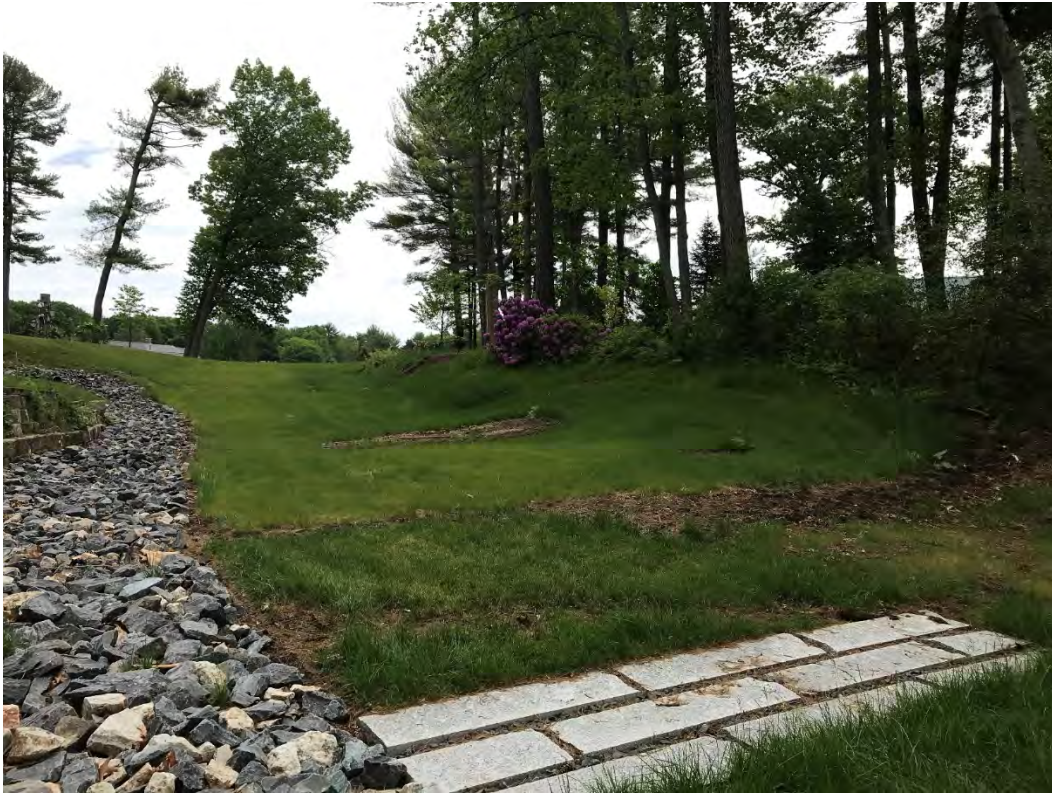
Fig 9: Slope above the manhole at Gundalow Landing/east side of the bay. Viewing east. (06-01-21)

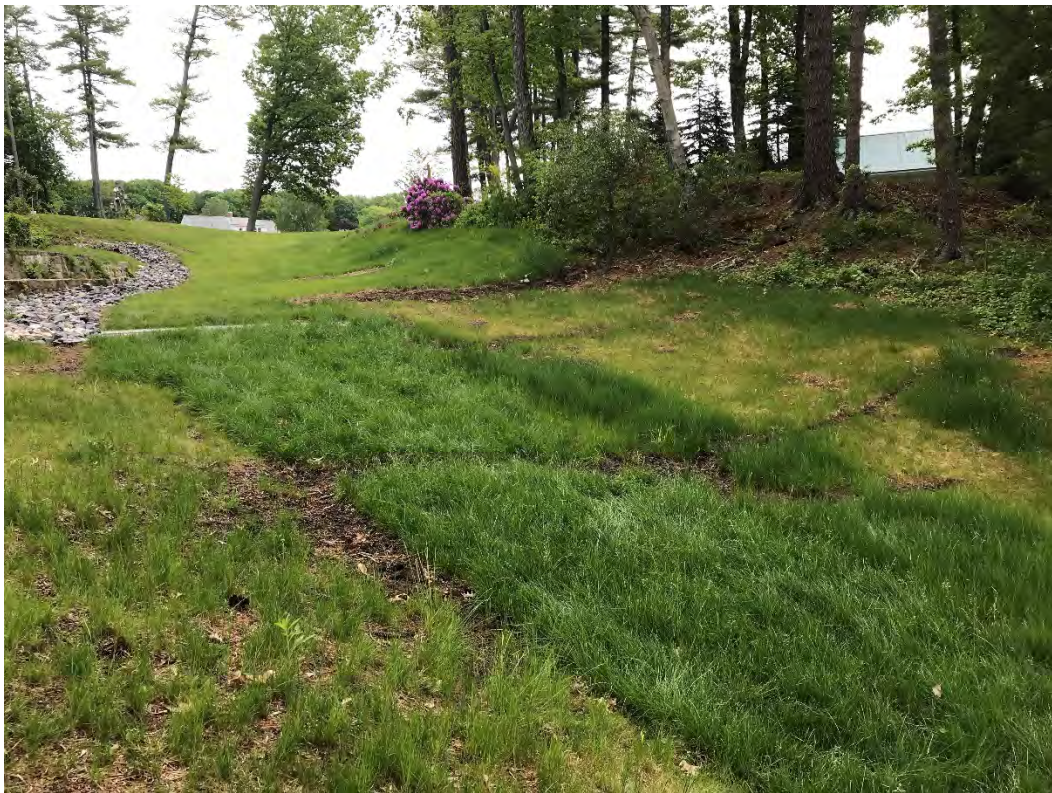
Fig 10: Slope below the manhole at Gundalow Landing/east side of the bay. Viewing east. (06-01-21)

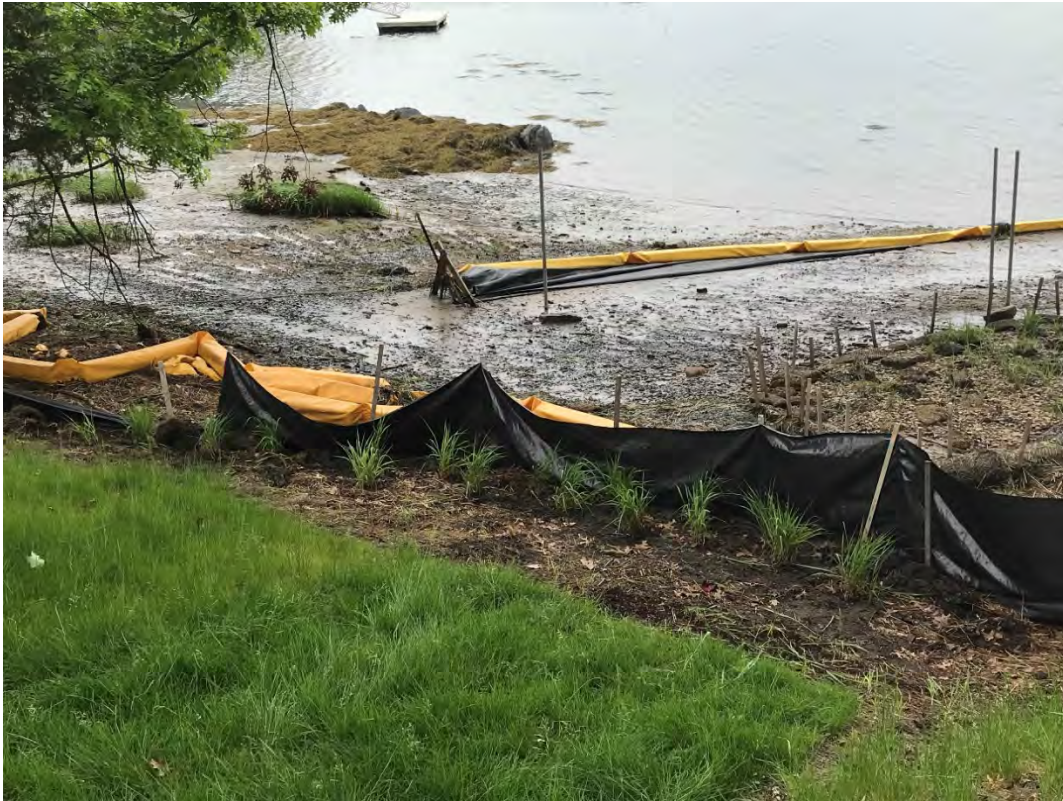
Fig 11: Plugs installed at the toe of slope at Gundalow Landing/east side of the bay. Viewing south. (06-01-21)

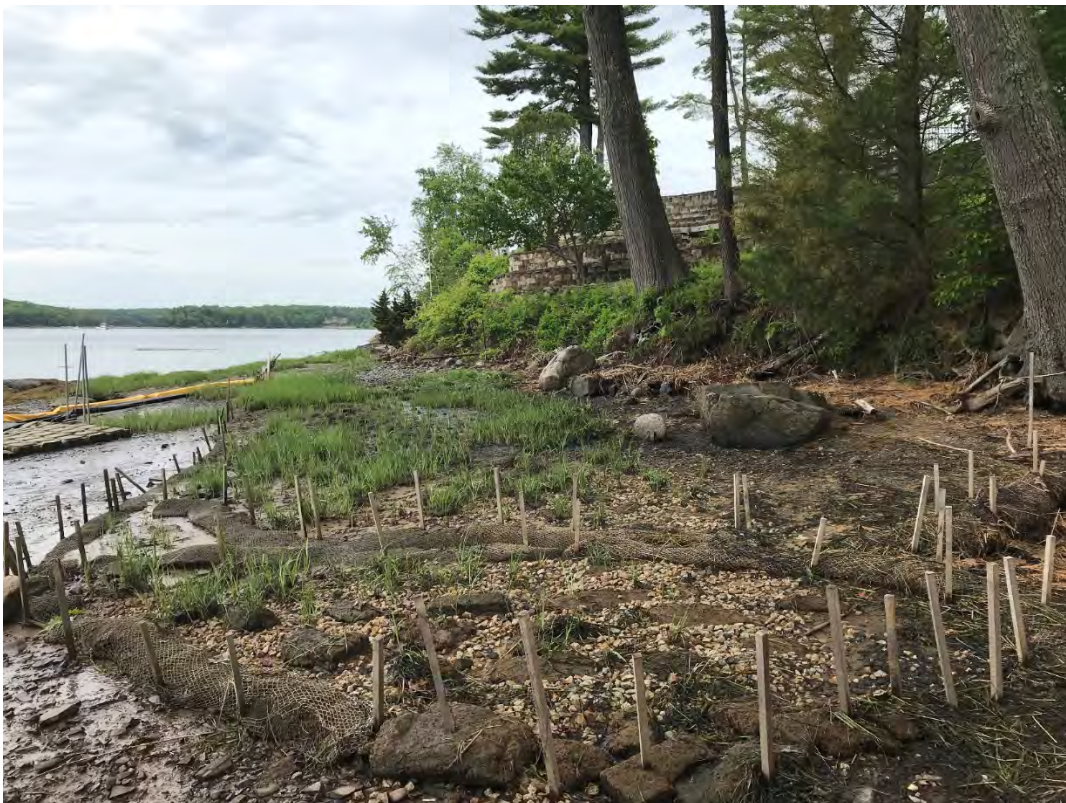
Fig 12: Salt marsh restoration at Gundalow Landing/east side of the bay. Viewing northwest. (06-01-21)

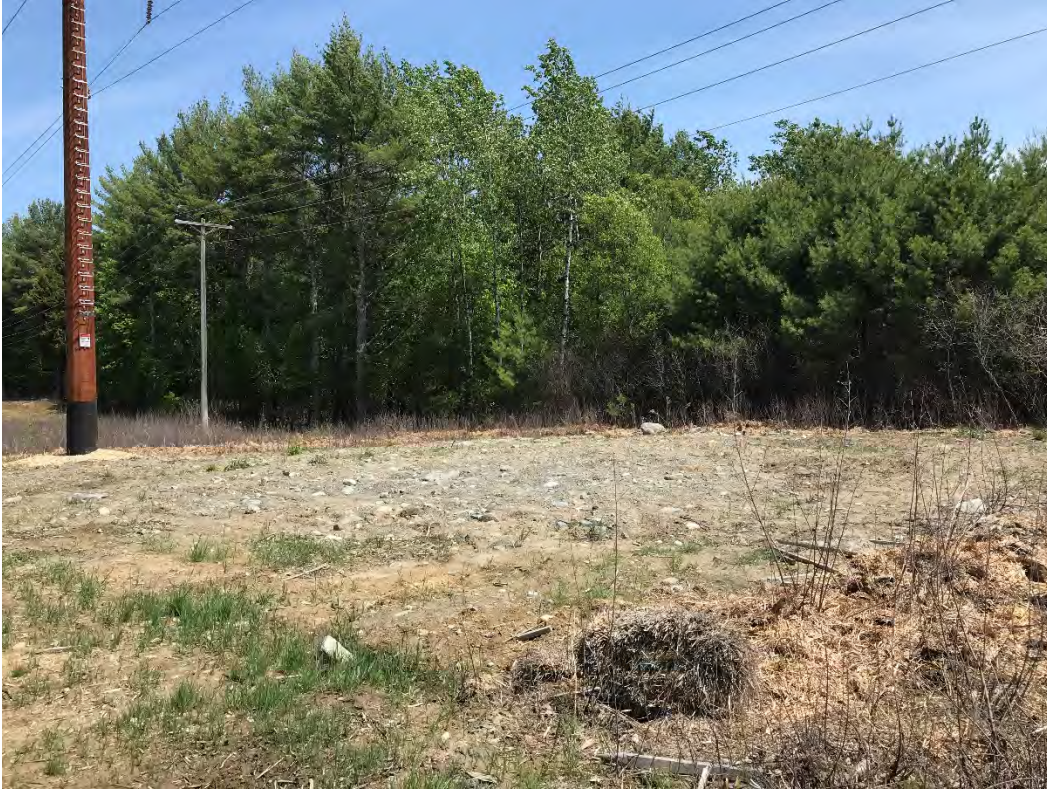
Fig 13: Turtle nesting area next to Str. 49. Viewing east. (06-01-21)

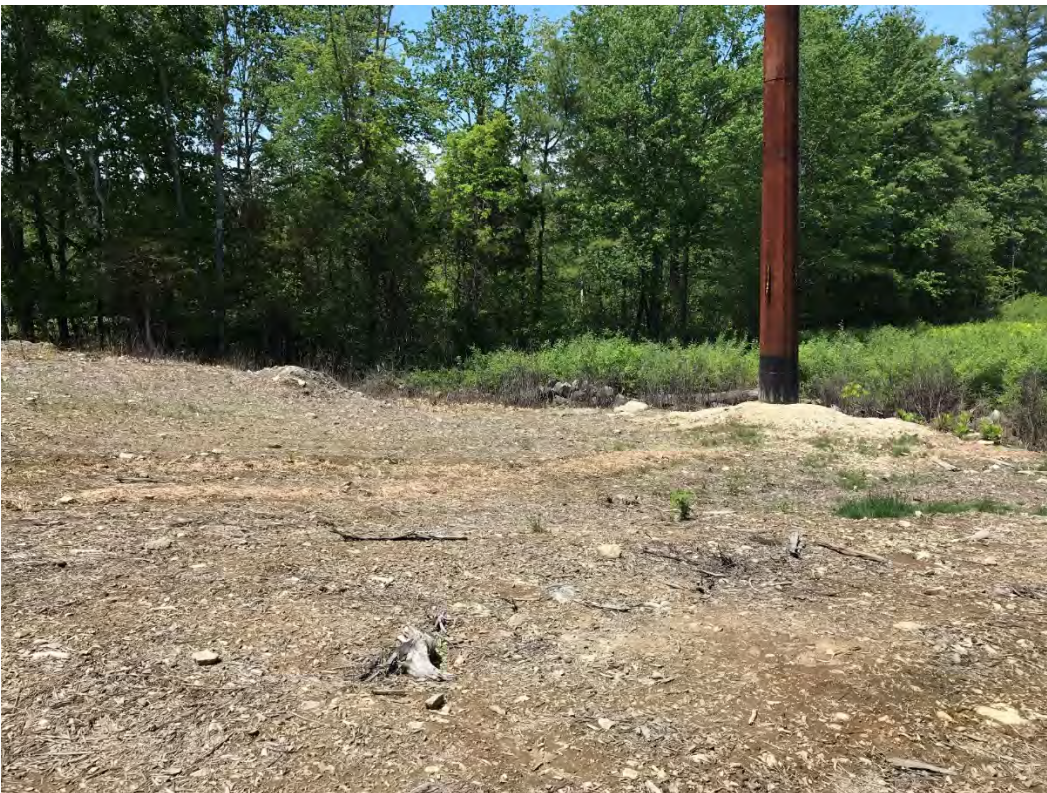
Fig 14: Str. 45 work area. Viewing west. (06-01-21)

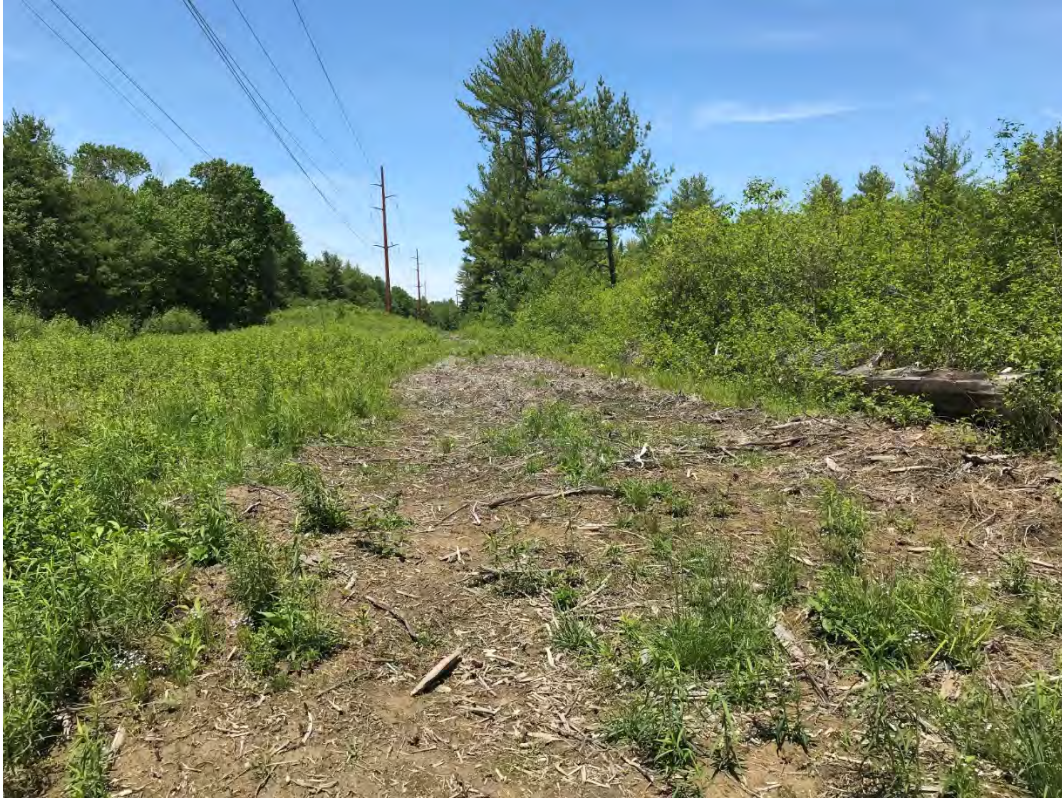
Fig 15: Former access route between Strs. 43 and 44, passing the northern portion of wetland DW58. Viewing north. (06-01-21)

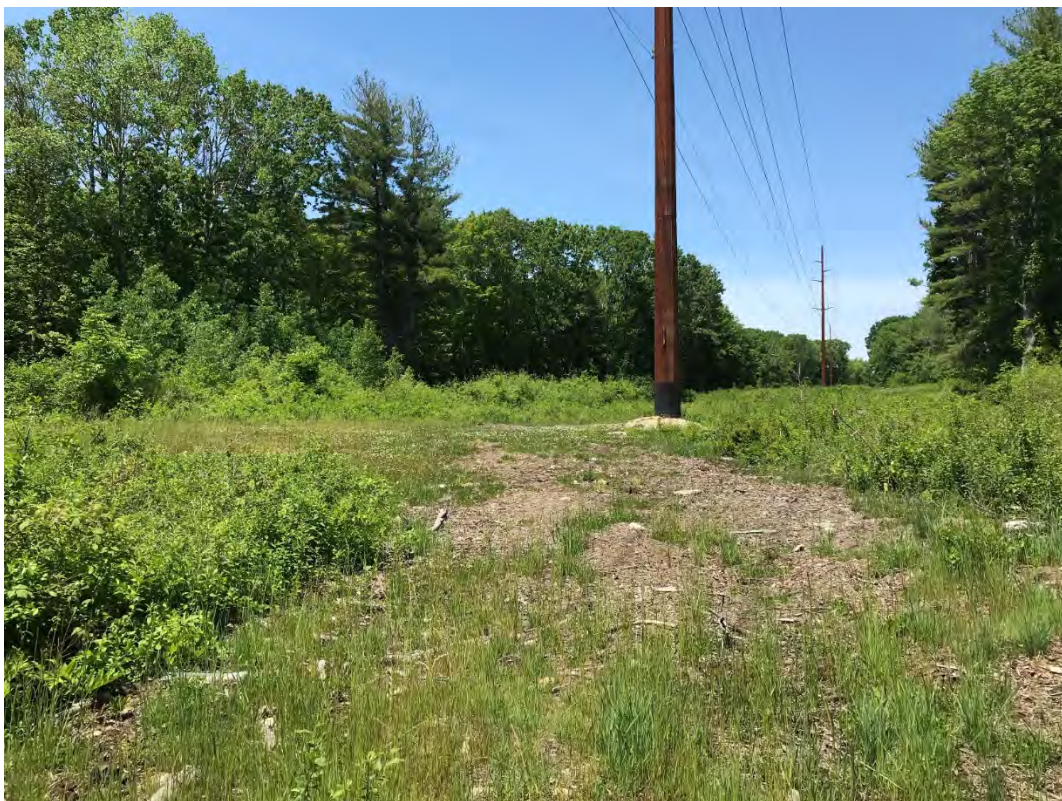
Fig 16: Former access route leading to the Str. 39 work area. Viewing northwest. (06-01-21)
