**From:** Nelson, Kurt I <[kurt.nelson@eversource.com](mailto:kurt.nelson@eversource.com)>  
**Sent:** Friday, May 22, 2020 3:50 PM  
**To:** Price, David <[David.Price@des.nh.gov](mailto:David.Price@des.nh.gov)>; Comstock, Gregg <[Gregg.Comstock@des.nh.gov](mailto:Gregg.Comstock@des.nh.gov)>  
**Cc:** Champy, Dena M <[dena.champy@eversource.com](mailto:dena.champy@eversource.com)>; Bartone, Denise M <[denise.bartone@eversource.com](mailto:denise.bartone@eversource.com)>; Waldrip, Matthew A <[matthew.waldrip@eversource.com](mailto:matthew.waldrip@eversource.com)>; Dumville, Adam <[adam.dumville@mclane.com](mailto:adam.dumville@mclane.com)>  
**Subject:** SRP flow fill drainage issues

### **Veitas Property Gundalow Landing Newington**

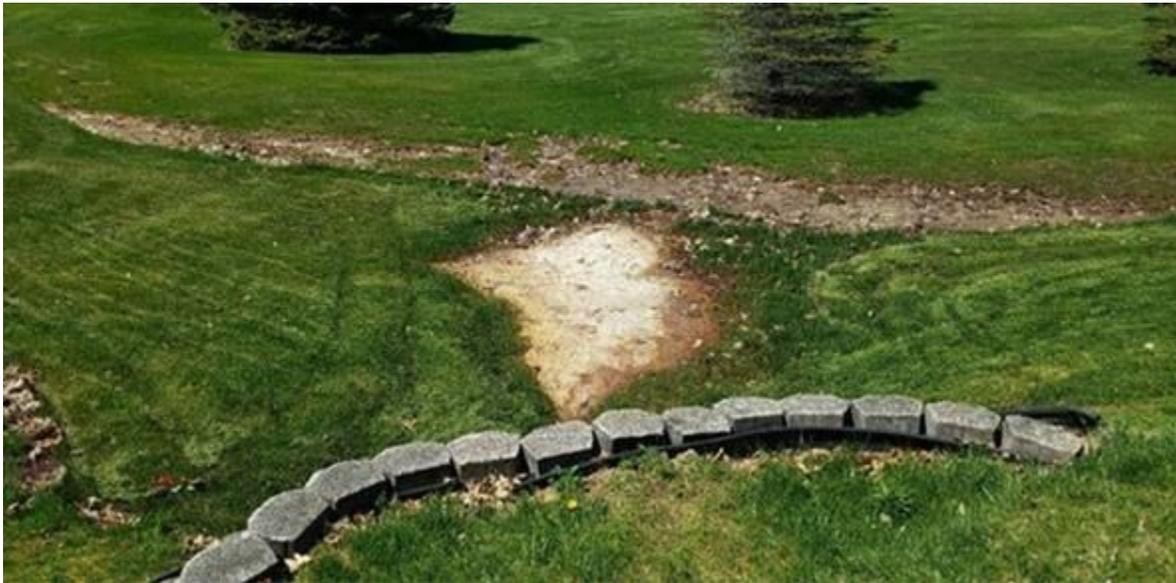
In the area of the Veitas property located at Gundalow Landing in Newington, it appears that the drainage patterns have shifted and a white precipitate from groundwater seepage has accumulated over time on the sod in an approximately 10 x 20 ft area above the cable duct bank (which is also in the vicinity of a stormwater culvert). Eversource has removed the precipitate from the ground surface and we are monitoring the area.

Eversource sampled the precipitate and confirmed it to be primarily Calcium Carbonate ( $\text{CaCO}_3$ ). To assess water quality in the vicinity of the seepage, we sampled and have continued to monitor pH at this location. According to our investigation, the seepage that pooled in this area had an elevated pH (as high as 12.5). We also have been monitoring standing water at two locations approximately 50' and 100' downstream in the drainage course; pH levels significantly decline further down the drainage course. As a result of our investigation, we have determined that there is no continuous flow in the drainage course, and therefore, we are confident that the high pH levels from the seepage are localized and have not impacted groundwater or any surface water. The data is provided below.

While this drainage course interfaces with Little Bay approximately 400' downstream, we have not identified any releases of water with elevated pH to Little Bay or any other surface water.

We have developed a plan to mitigate the seepage and reduce elevated pH levels. Eversource plans to (1) excavate the tight soils and flowable fill in the identified area to a depth of 2' below grade, (2) install a permeable sand and gravel layer in place of the flowable fill; and (3) construct a subdrain to improve drainage. Eversource plans to undertake these activities on Tuesday May 26. We are confident that removing a portion of the flowable fill and improving drainage in the area will reduce contact time with the remaining flowable fill and will improve conditions. We will continue to monitor pH at this location and we will have a contingency in place to recover a seepage if water with elevated pH is discovered onsite.

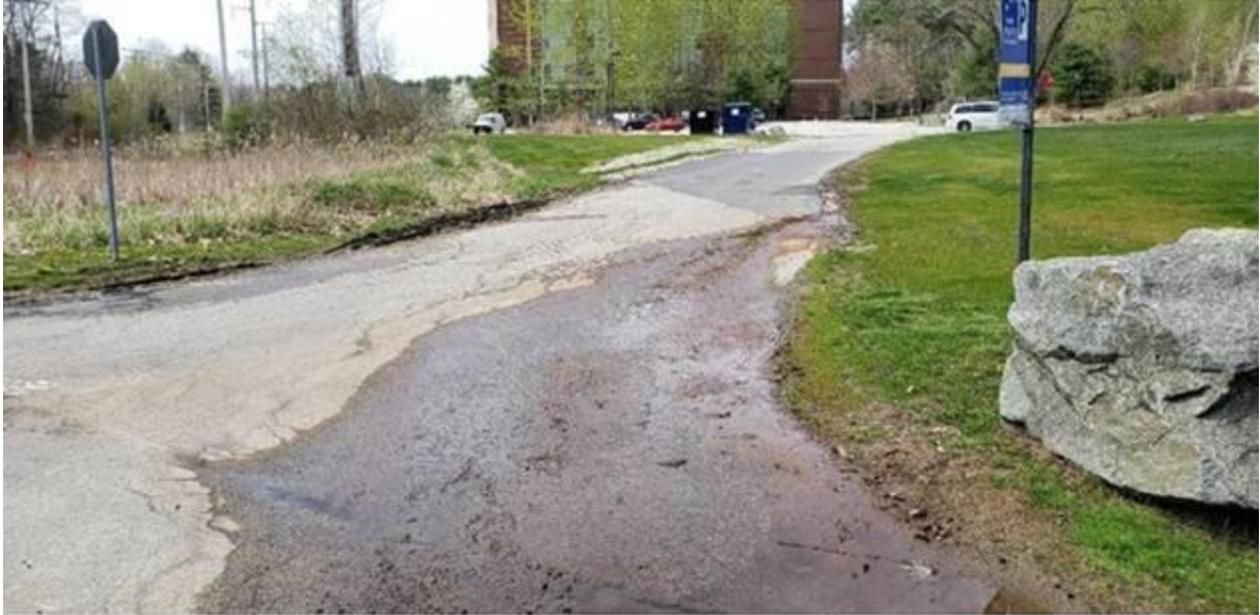
**Waterworks Road Area - UNH**

UNH has recently alerted us that there has been an altered drainage pattern in the vicinity of Waterworks Road and the Gregg's Hall access Road. From our investigation, it appears that shallow groundwater has been discharging to the ground surface at the edge of the roadway. In cooperation with UNH, and after receiving approval from the University, Eversource has installed a subdrain to alleviate the seepage that previously occurred in this area. To date, it appears that the restoration activities at this site have corrected the drainage pattern. In addition, we monitored and continue to monitor for pH to confirm that there are no elevated pH discharges entering the stormwater drainage system or to any surface waters in the vicinity.
