CONSTRUCTION MONITORING REPORT

Eversource Transmission Lines:
F107

**Madbury, Durham,
Newington, Portsmouth, NH**

TYPE OF INSPECTION: Weekly Storm Event Incident Corrective Action

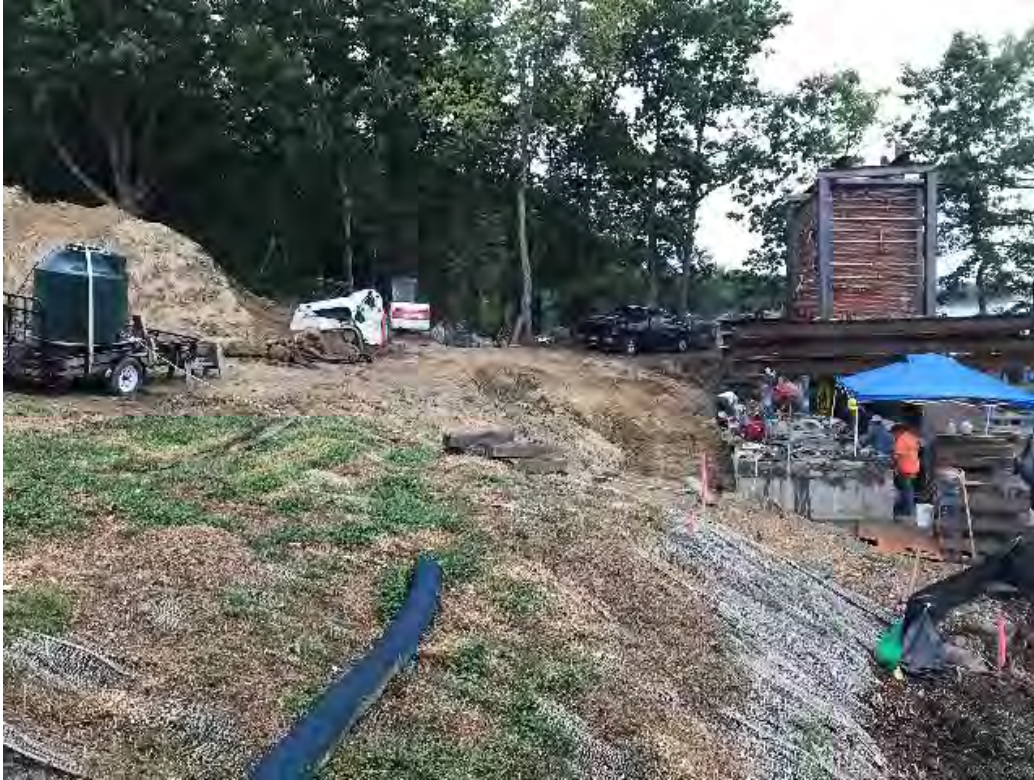
Fig 1: Installation of a stone façade on the new cable house foundation and backfilling along its western side at the Eversource property/west side of the bay. Viewing north. (08-27-20).

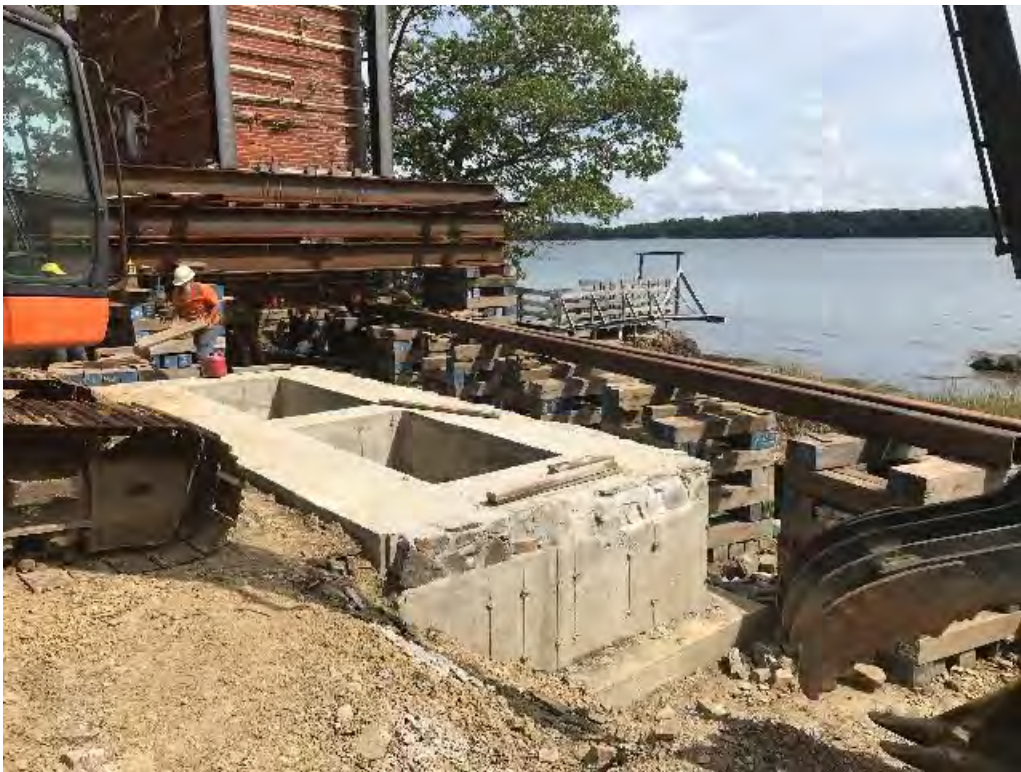
Fig 2: Continued preparation of the system to move the cable house to its new location at the Eversource property/west side of the bay. Viewing northeast. (09-01-20).

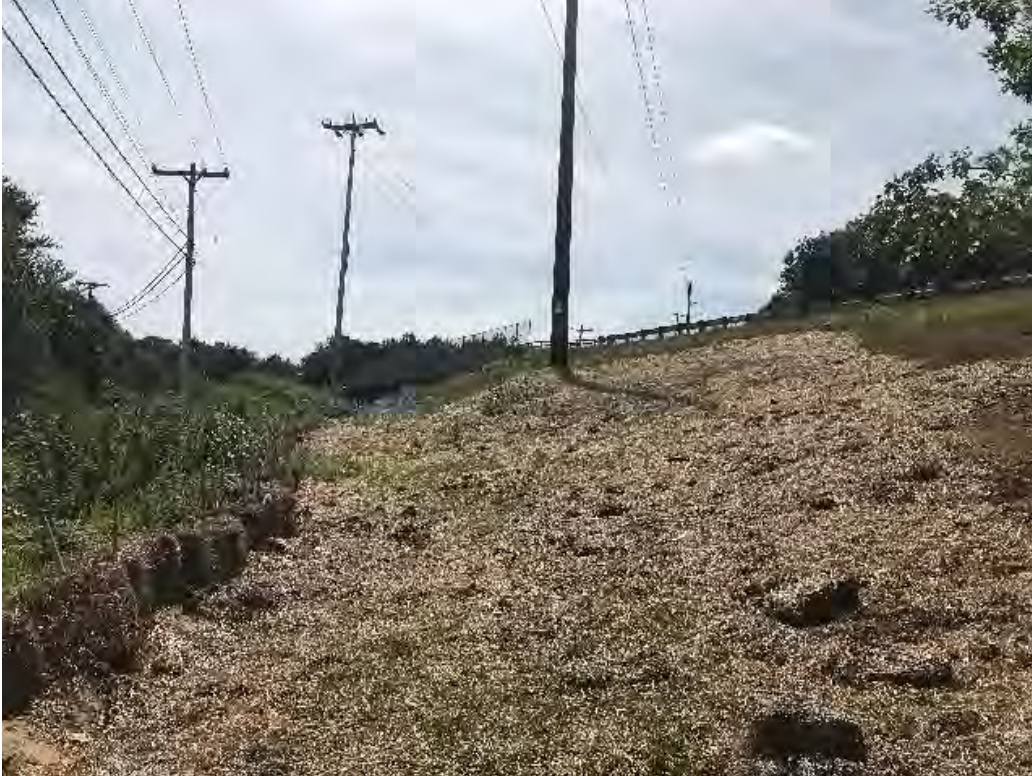
Fig 3: Str. 6 work area is revegetating, but straw bales shall remain in place for now. Viewing southwest. (09-01-20).

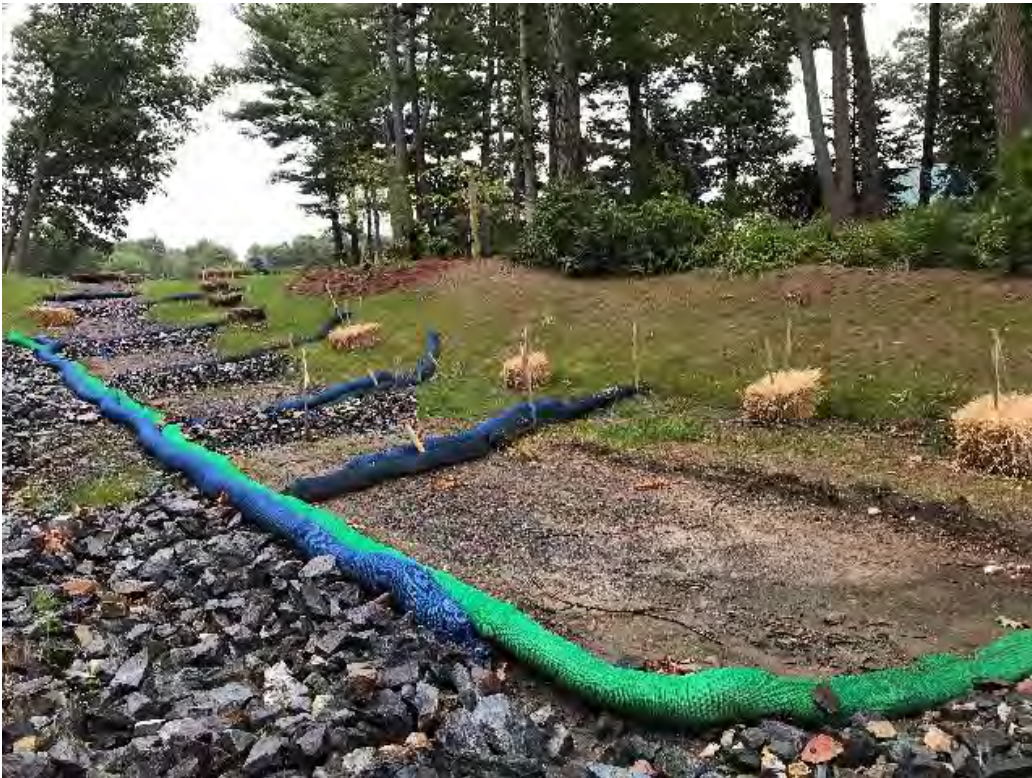
Fig 4: Slope above the manhole at Gundalow Landing/east side of the bay. Viewing east. (09-02-20).

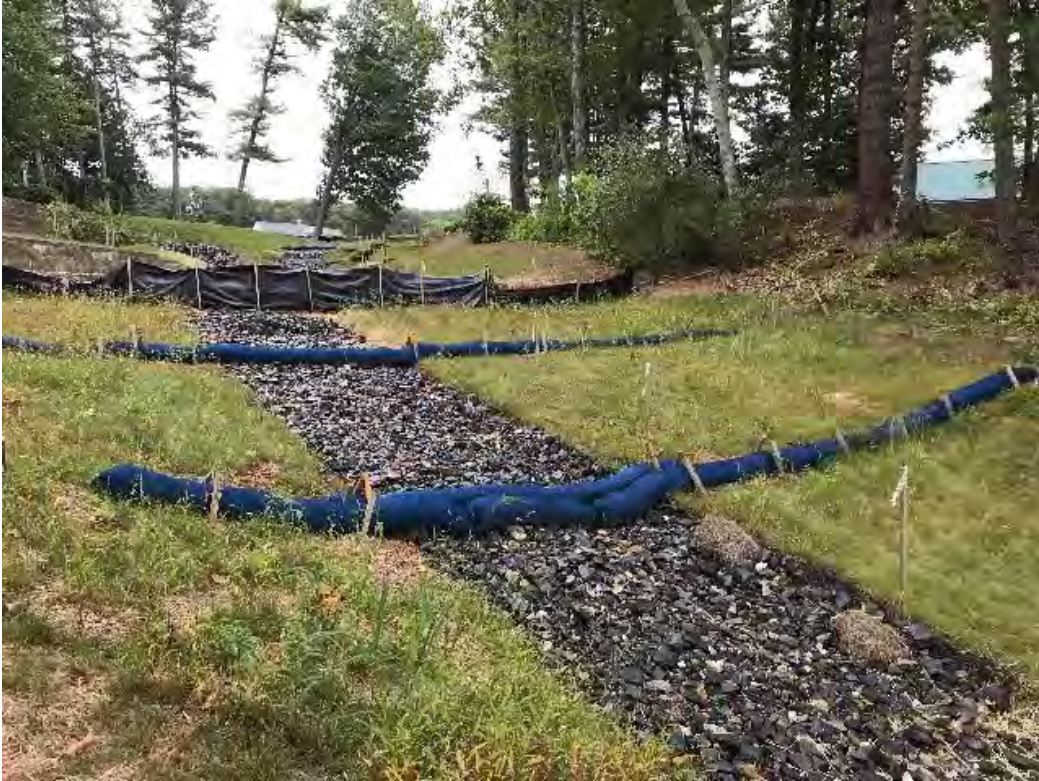
Fig 5: Slope below the manhole at Gundalow Landing/east side of the bay. Viewing east. (09-02-20).

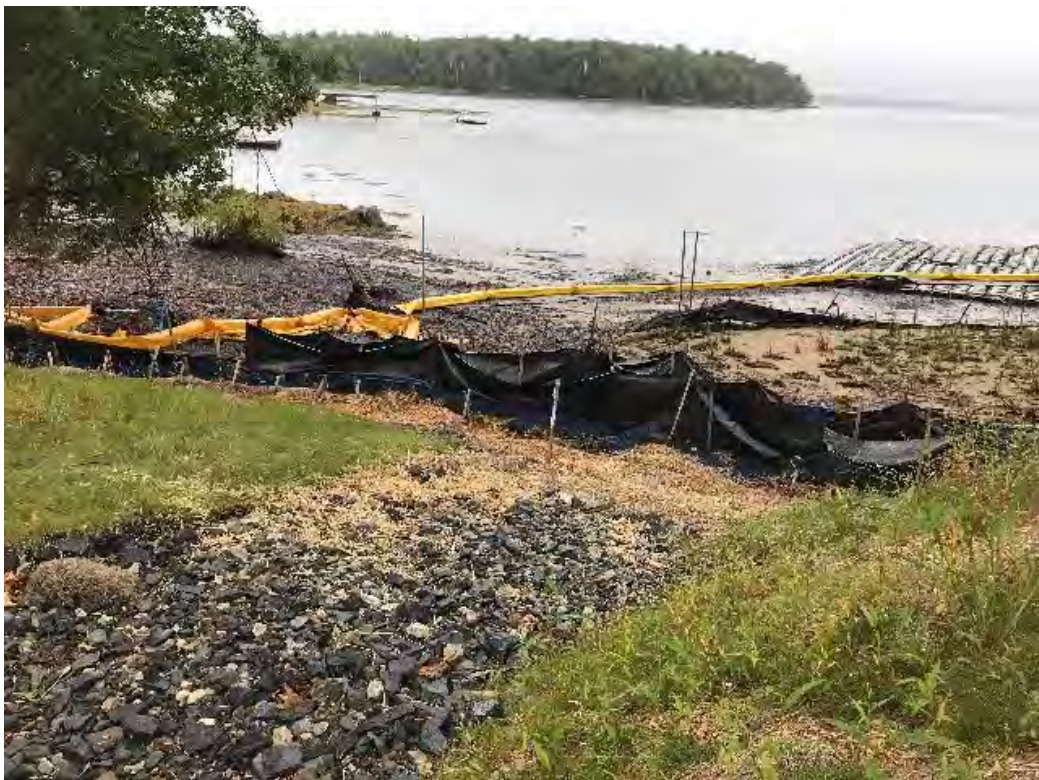
Fig 6: Toe of the slope below the manhole at Gundalow Landing/east side of the bay. Viewing south. (09-02-20).

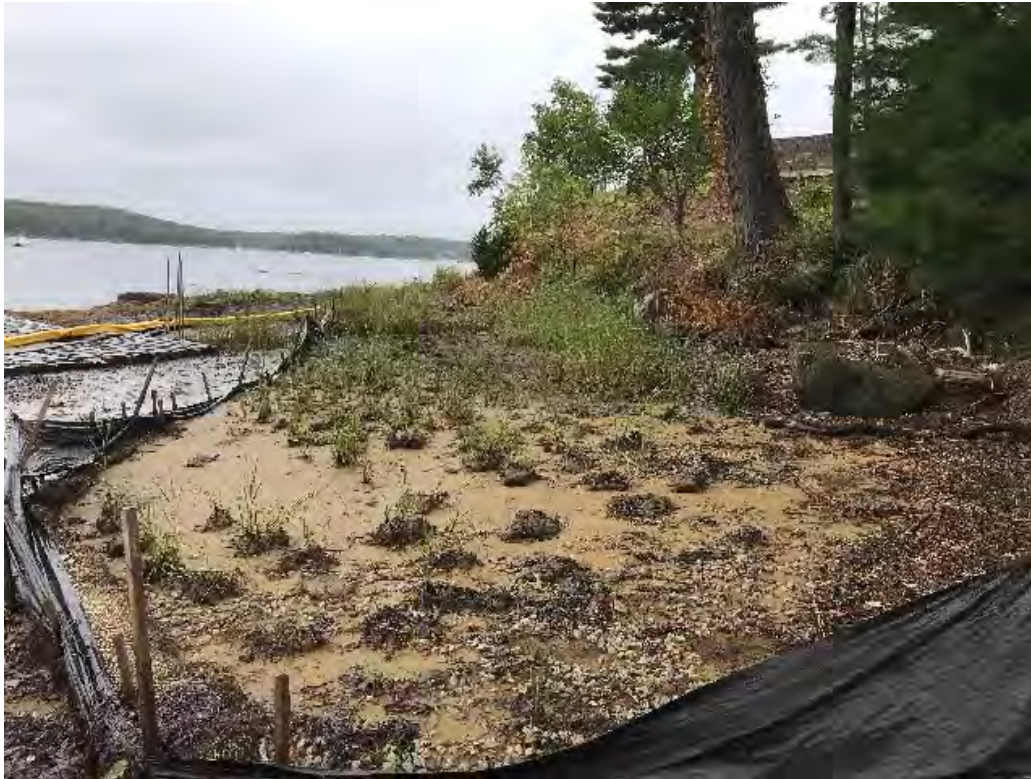
Fig 7: Salt marsh restoration at Gundalow Landing/east side of the bay. Viewing northwest. (09-02-20).

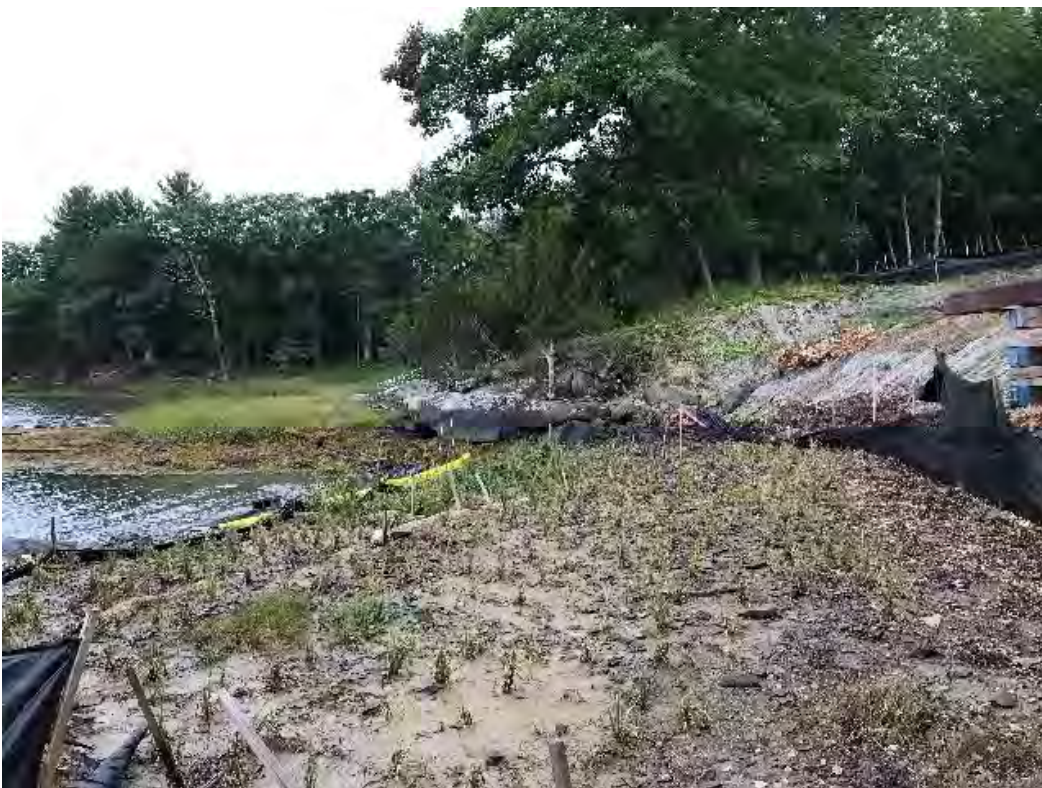
Fig 8: Salt marsh restoration at Eversource property/west side of the bay. Viewing south. (09-02-20).

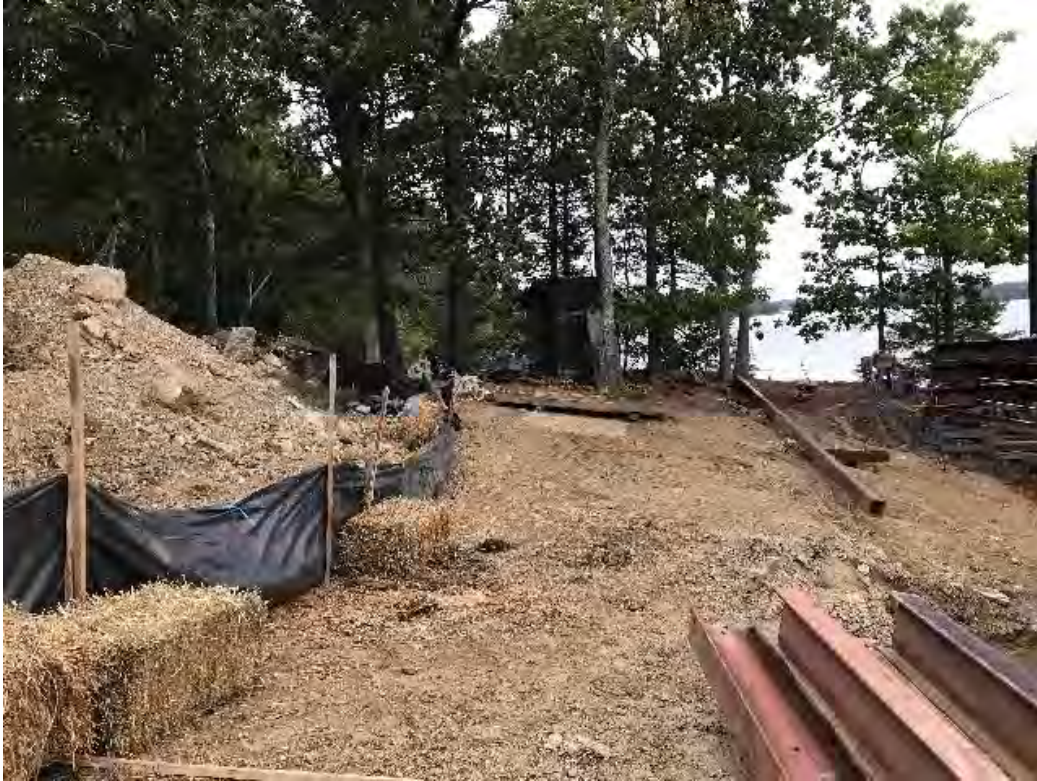
Fig 9: Silt fence stabilizing the soil stockpile at the Eversource property/west side of the bay is functioning. (09-02-20).

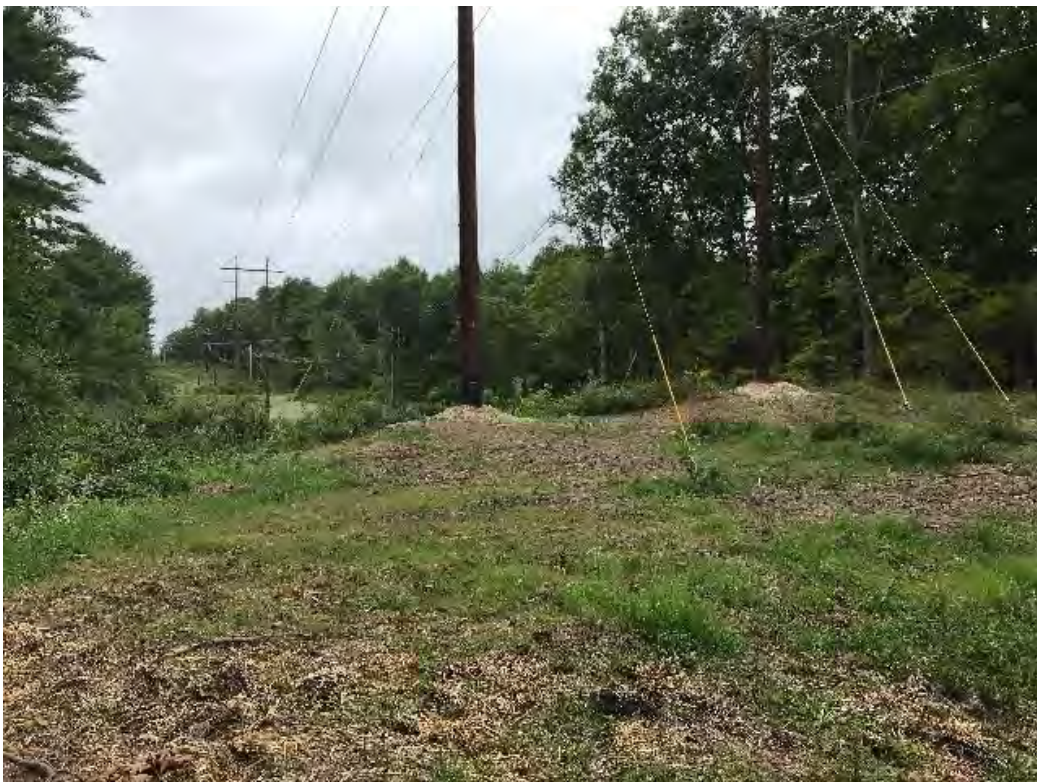
Fig 10: Str. 61 work area is revegetating. Viewing west. (09-02-20).
