CONSTRUCTION MONITORING REPORT

Eversource Transmission Lines:
F107

**Madbury, Durham,
Newington, Portsmouth, NH**

TYPE OF INSPECTION: Weekly Storm Event Incident Corrective Action

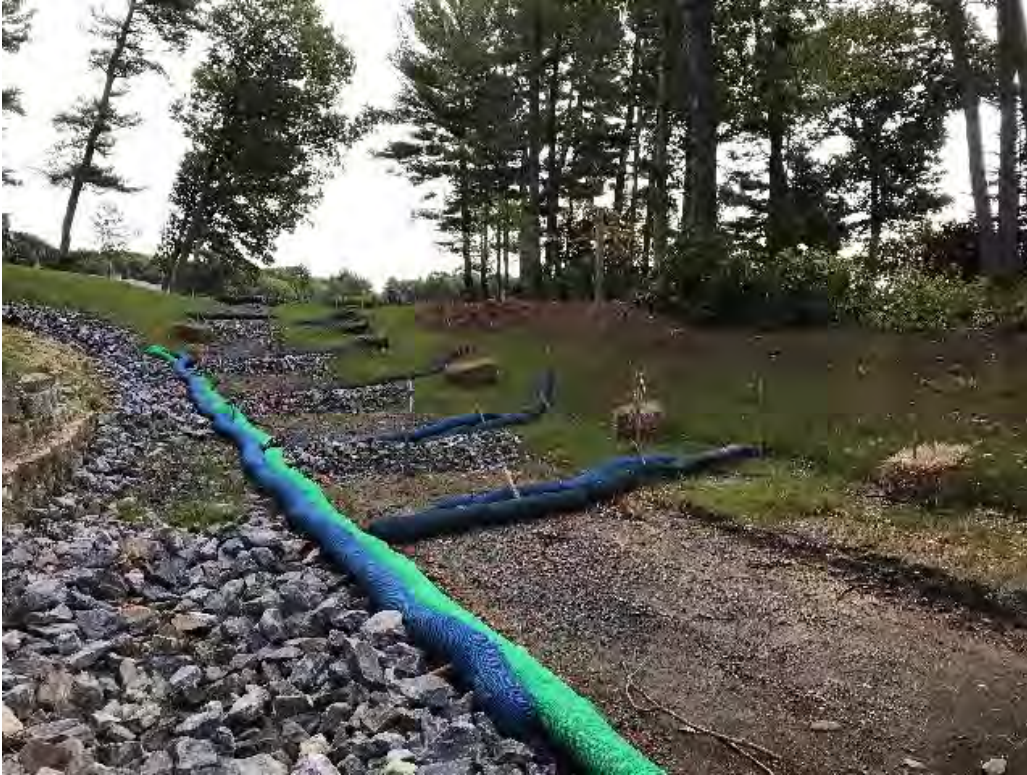
Fig 1: Slope above the manhole at Gundalow Landing/east side of the bay. Viewing east. (09-14-20)

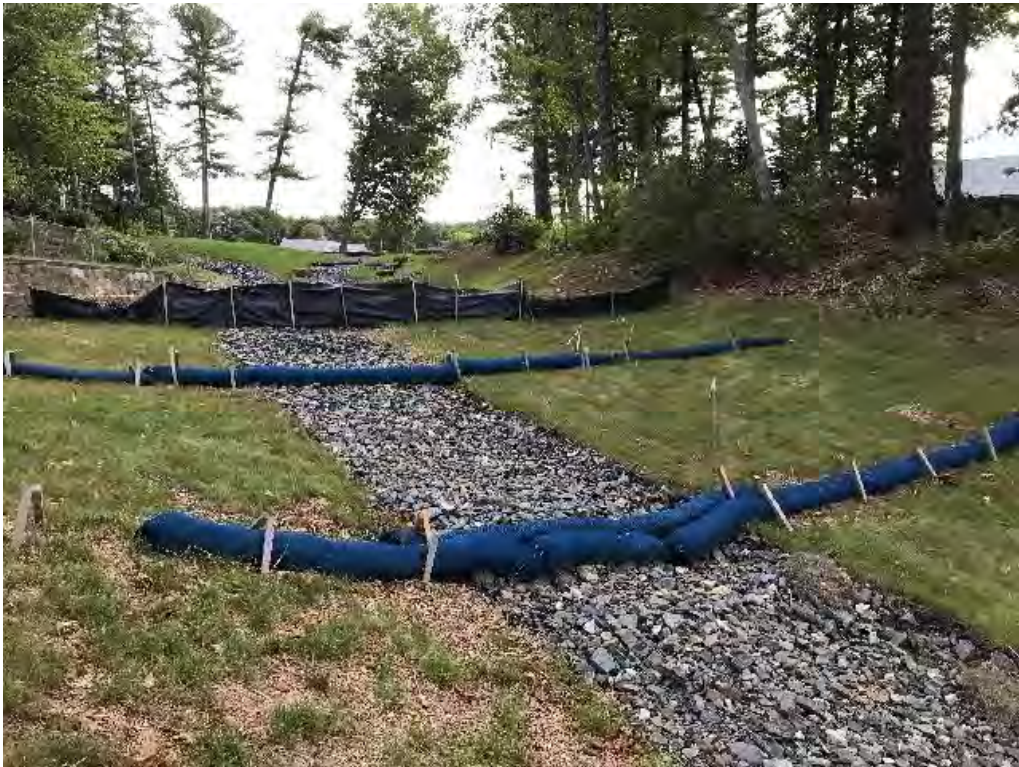
Fig 2: Slope below the manhole at Gundalow Landing/east side of the bay. Viewing east. (09-14-20)

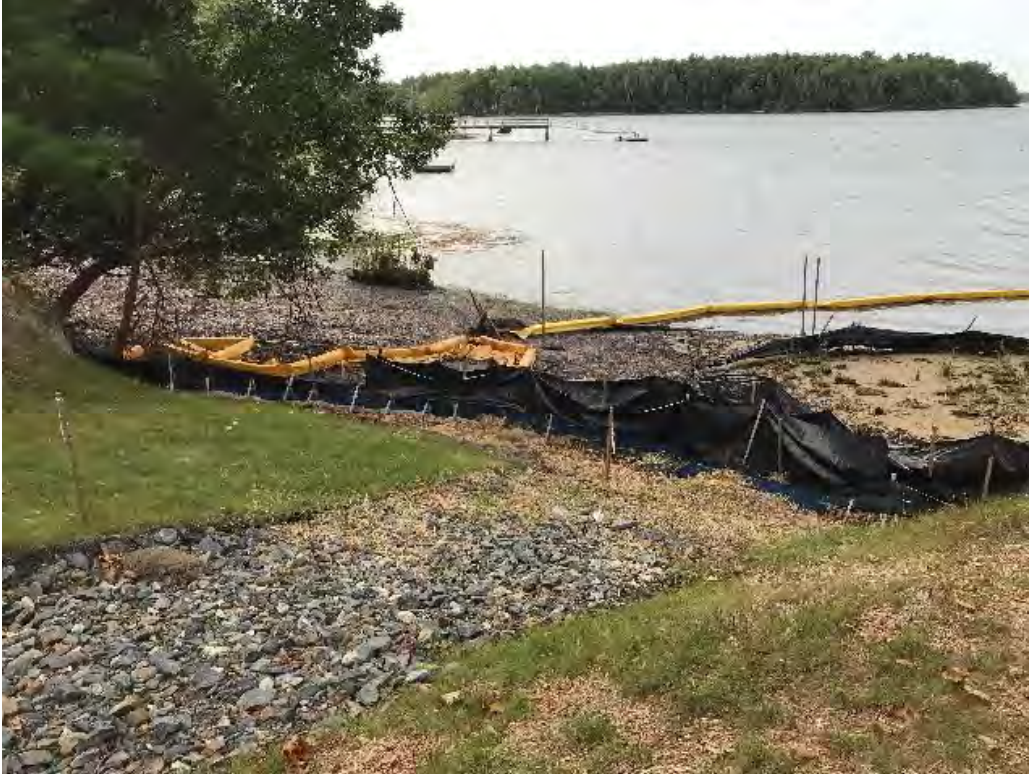
Fig 3: Toe of the slope below the manhole at Gundalow Landing/east side of the bay. Viewing south. (09-14-20)

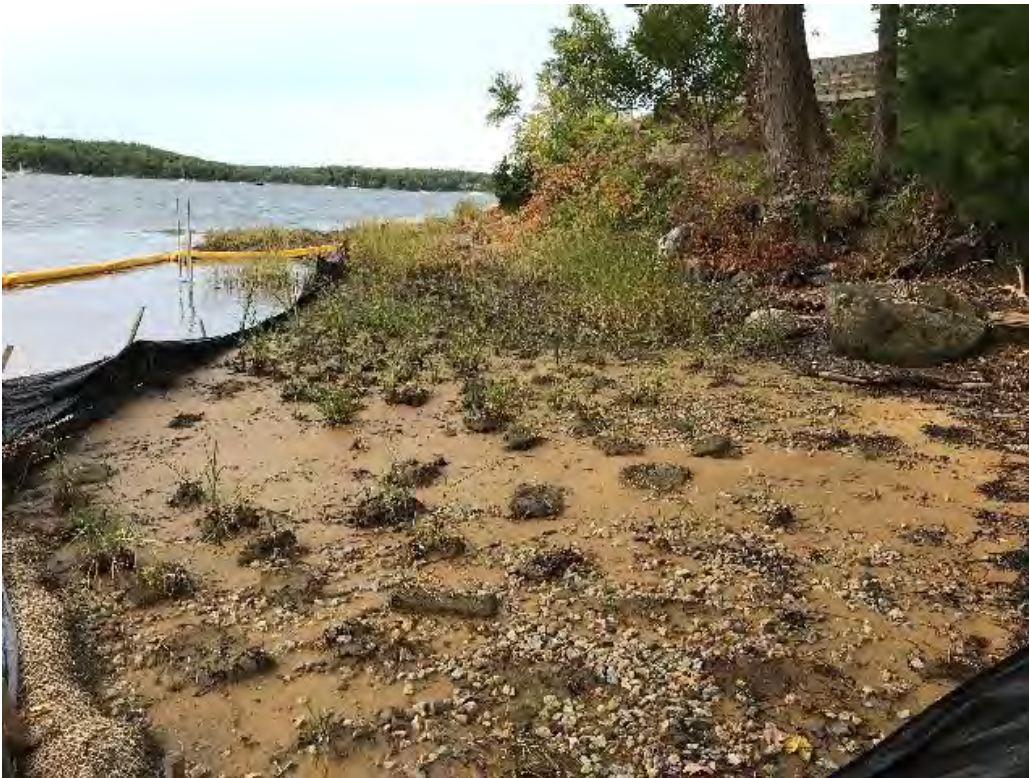
Fig 4: Salt marsh restoration at Gundalow Landing/east side of the bay. Viewing northwest. (09-14-20)

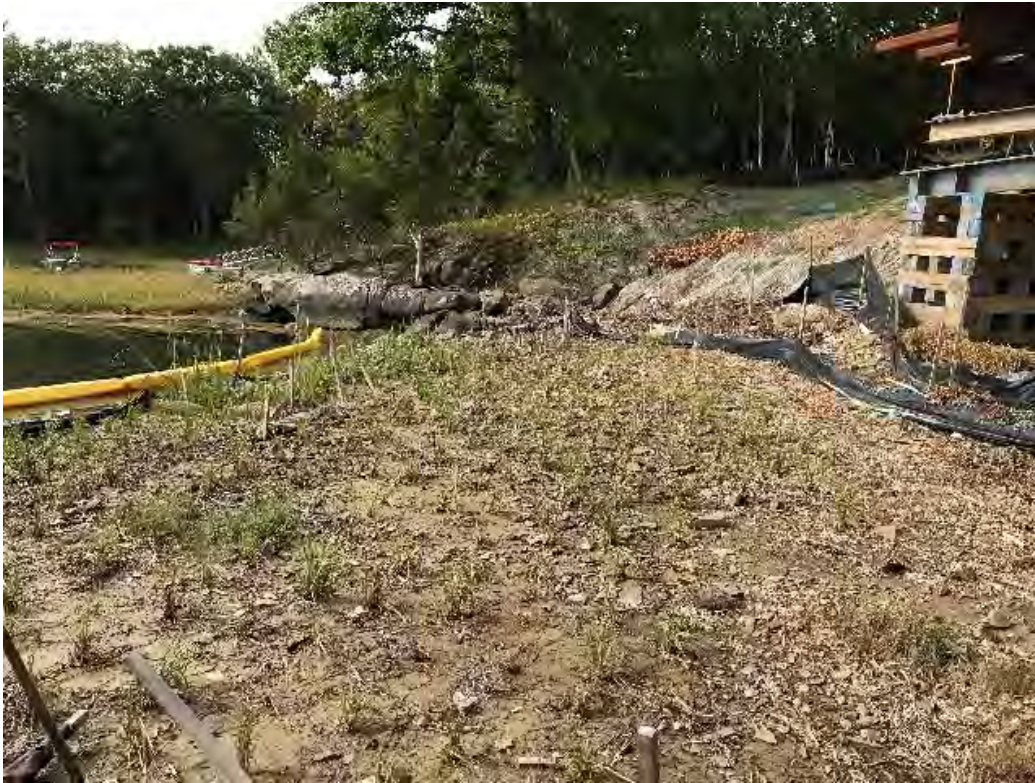
Fig 5: Salt marsh restoration at the Eversource property/west side of the bay. Viewing south. (09-14-20)

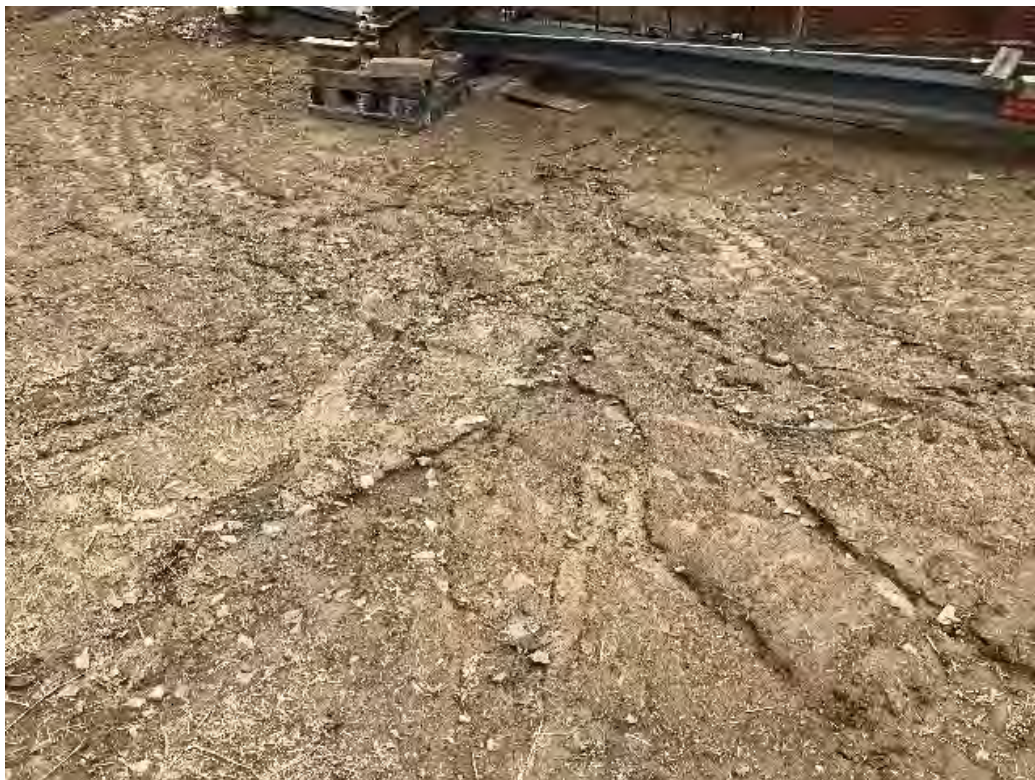
- **BMPs**
 - All remaining BMPs should be left in place until the sites are determined to be stabilized by the environmental monitor.
 - Rills formed on the slope above the new cable house foundation during the 09/10/2020 storm event (See Photo 6). The slope was repaired by AM Graton.
 - Erosion was observed around the southwestern corner of the cable house foundation on 09/14/2020 (See Photo 7). AM Graton was made aware of this erosion and indicated the area would be backfilled this week.

Fig 6: Rills observed upslope of the cable house foundation at the Eversource property/west side of the bay. Viewing east. (09-11-20)

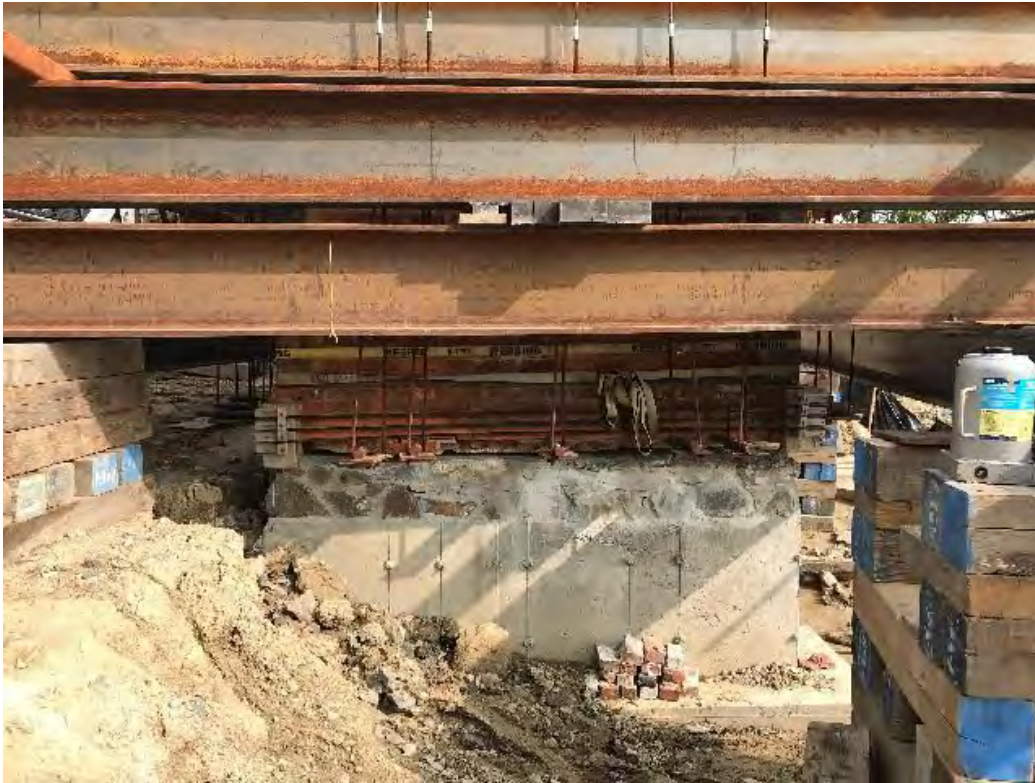
Fig 7: Cable house positioned over the foundation at the Eversource property/west side of the bay. Viewing north. (09-14-20)

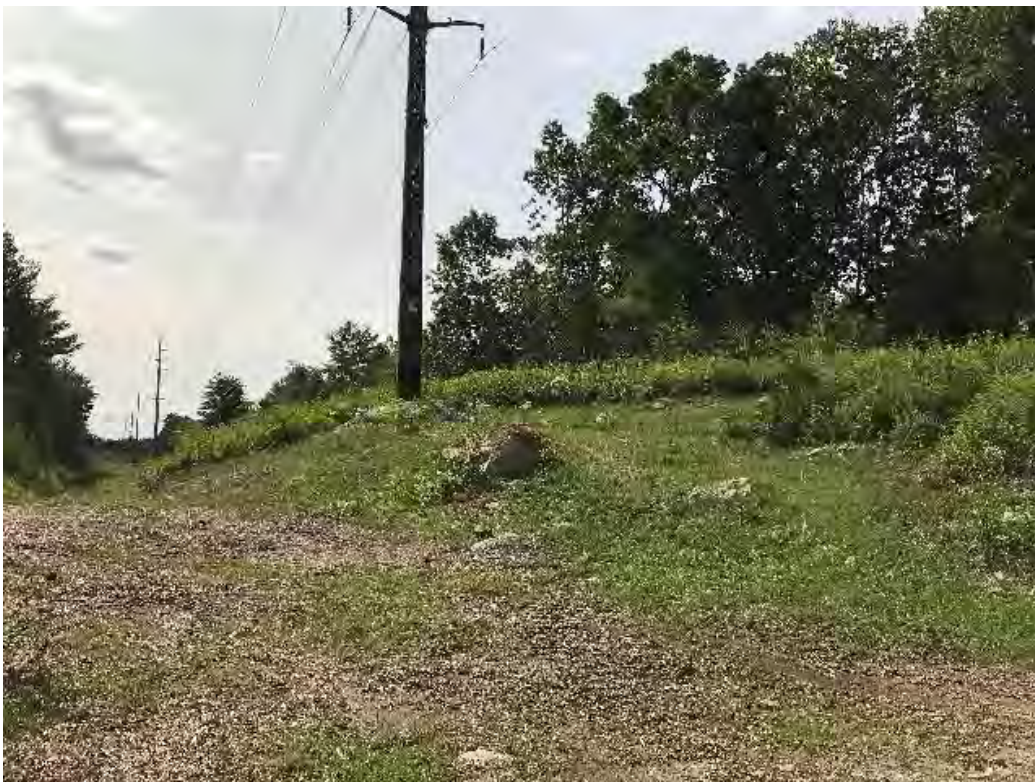
Fig 8: Str. 43 work area and portions of the adjacent access roads are revegetating. Viewing southwest. (09-14-20)

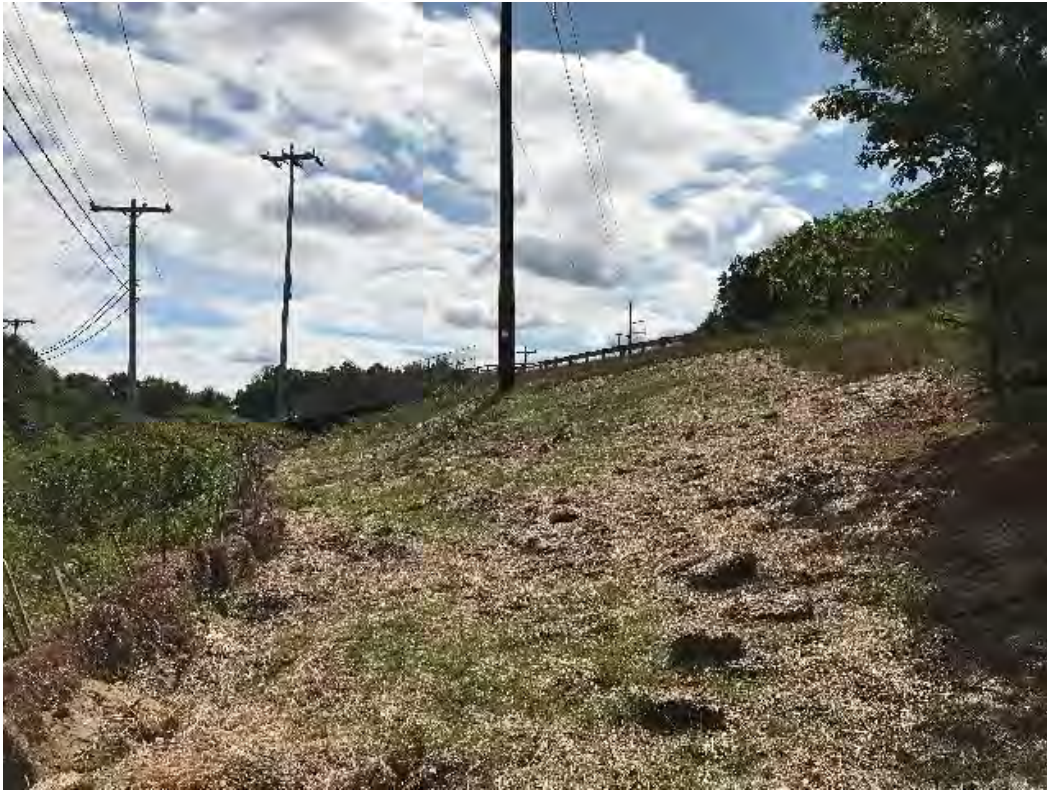
Fig 9: Str. 6 work area and portions of the adjacent access roads are revegetating. Viewing southeast. (09-11-20)

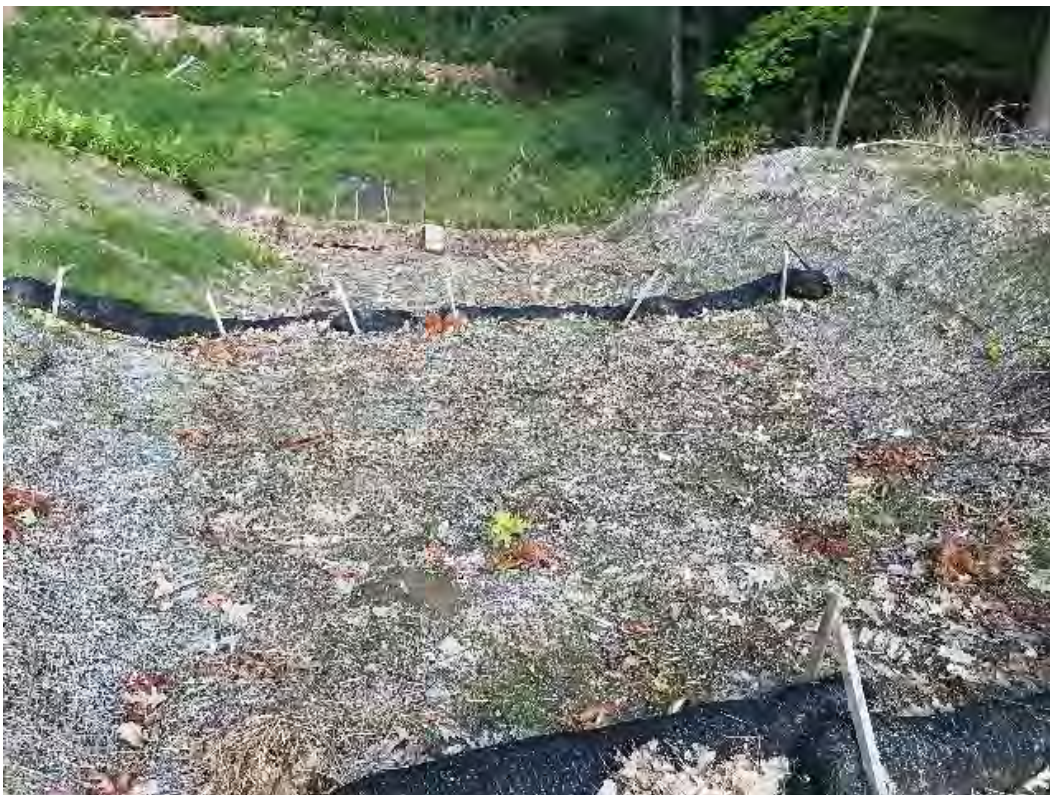
Fig 10: Swale between Strs. 28 and 29 remains stable. Viewing north. (09-11-20)
