# DRAINAGE MONITORING REPORT

## F107 - Seacoast Reliability Project

### Newington, New Hampshire

04.0190967.00

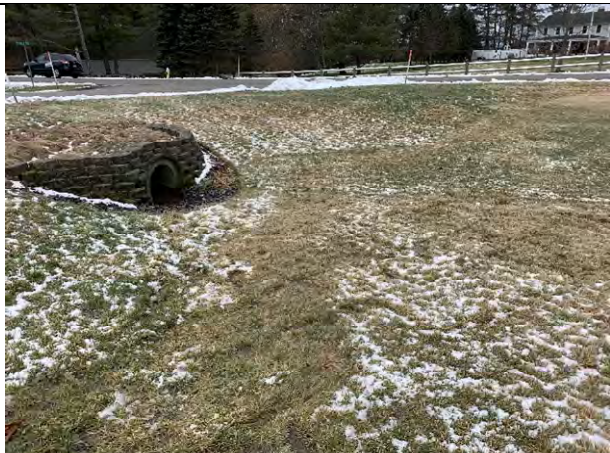
29 Gundalow - 1 (Drainage Area)

Observations/Notes: Ground surface frozen

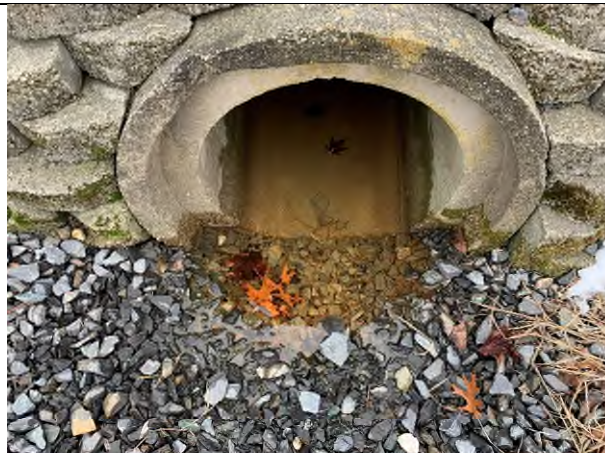
29 Gundalow - 2 (Culvert)

pH: 12.6

Observations/Notes: Water extending approx. 12" beyond culvert inlet into stone area, approx. max depth 4". Flow visible through culvert.

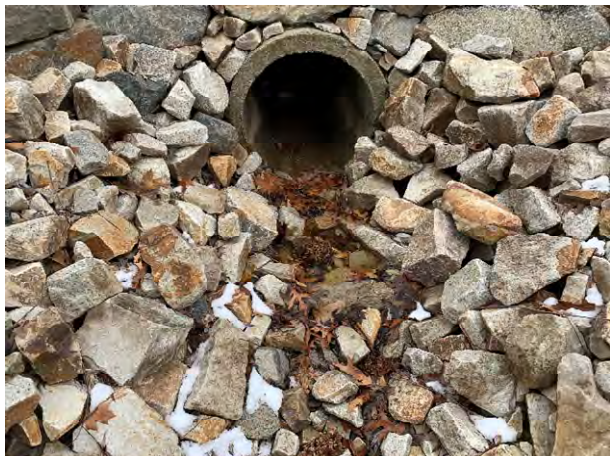
64 Gundalow - 1 (Drainage Course)

pH: 12.3

Observations/Notes: Flowing water extending approx. 18" beyond culvert outlet, approx. 1" deep.

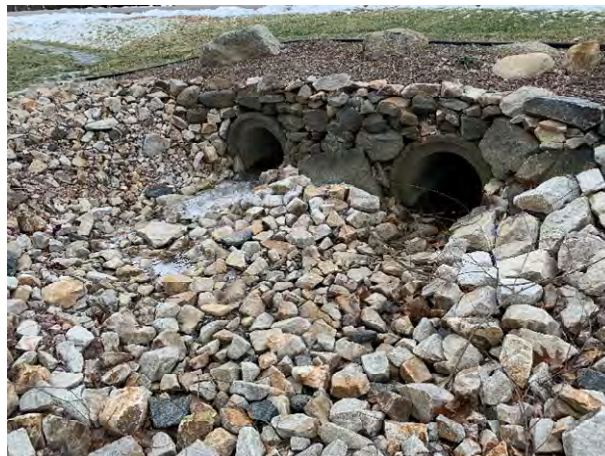
64 Gundalow - 2 (Drainage Course)

pH: 10.3

Observations/Notes: Flowing water extending approx. 6" beyond culvert inlet, approx. 1" deep.

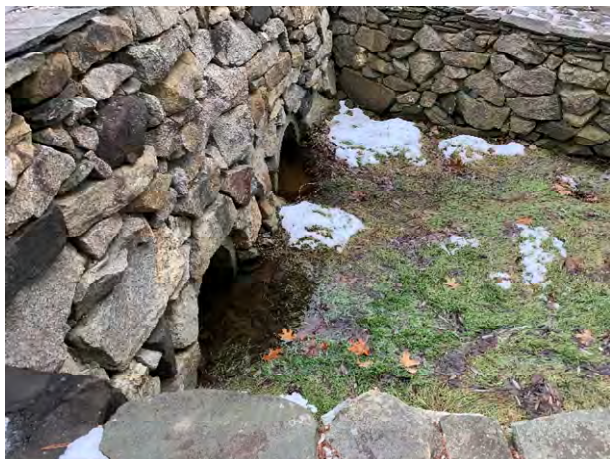
4 Brickyard Circle - 1 (Drainage Course)

pH: 9.7

Observations/Notes: Standing water extending approx. 18" from outlet, max depth approx. 8".

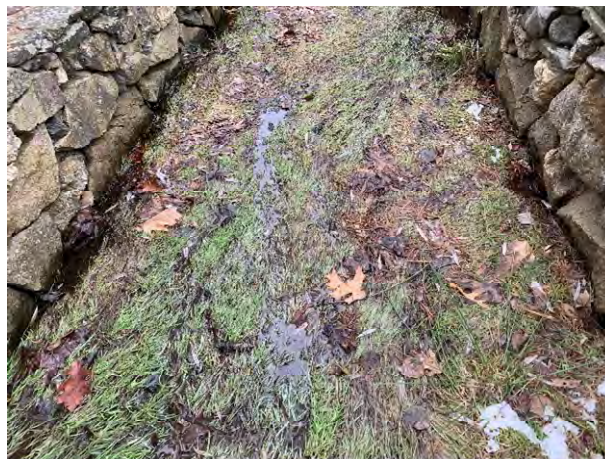
4 Brickyard Circle - 2 (Drainage Course)

pH: 7.9

Observations/Notes: Flowing water adjacent to east wall of raceway, approx. 1" deep.

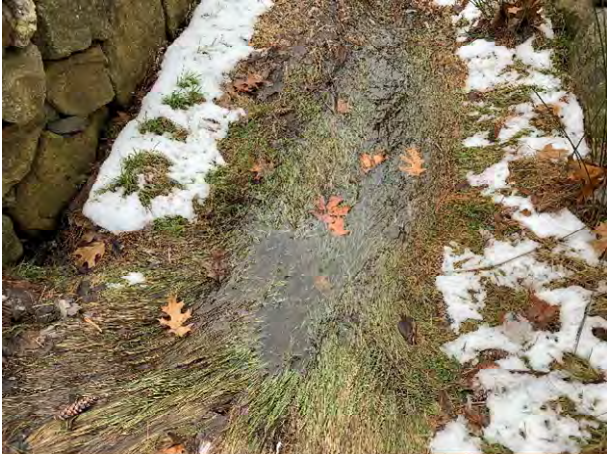
4 Brickyard Circle – 3 (Drainage Course)

pH: 7.6

Observations/Notes: Flowing water in center of raceway, approx. 2" deep.

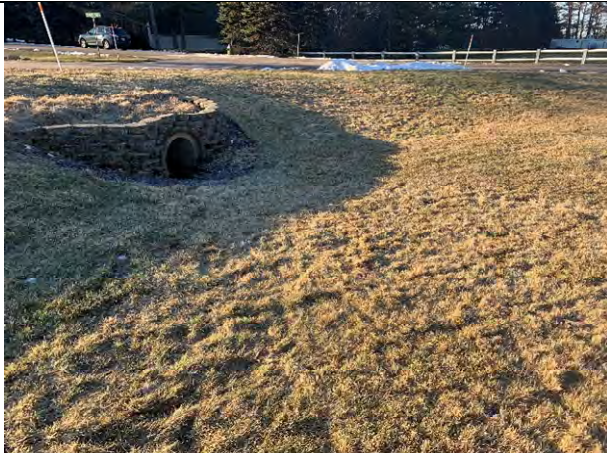
29 Gundalow - 1 (Drainage Area)

Observations/Notes: Ground surface frozen

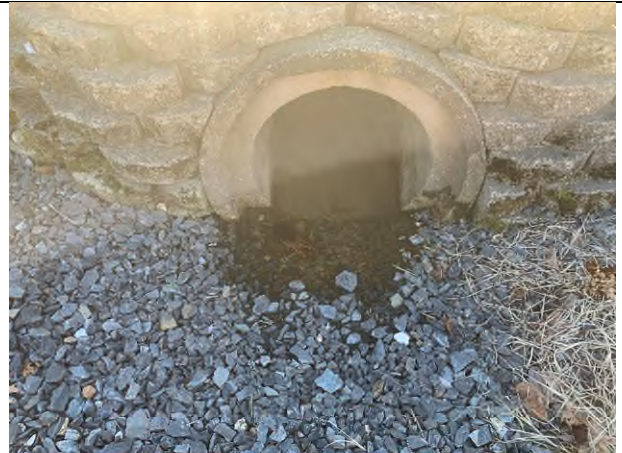
29 Gundalow - 2 (Culvert)

pH: 12.7

Observations/Notes: Water extending approx. 12" beyond culvert inlet into stone area, approx. max depth 4". Flow visible through culvert.

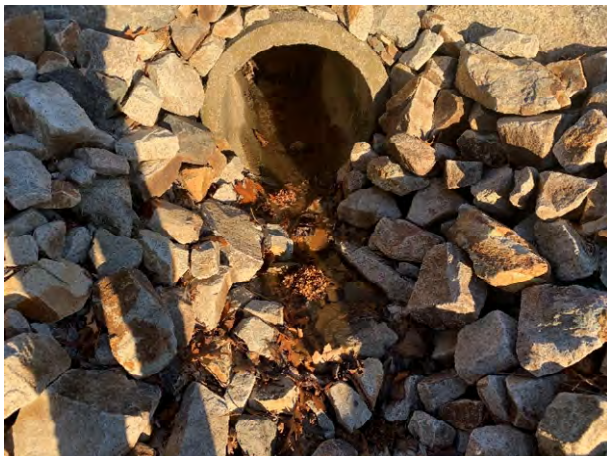
64 Gundalow - 1 (Drainage Course)

pH: 12.3

Observations/Notes: Flowing water extending approx. 18" beyond culvert outlet, approx. 1" deep.

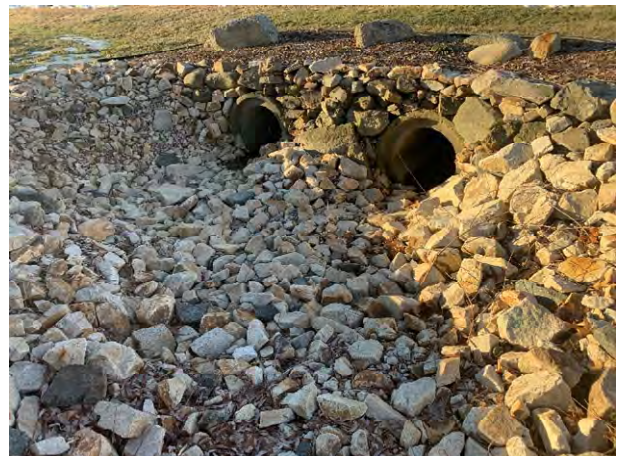
64 Gundalow - 2 (Drainage Course)

pH: 10.5

Observations/Notes: Flowing water extending approx. 6" beyond culvert inlet, approx. 1" deep.

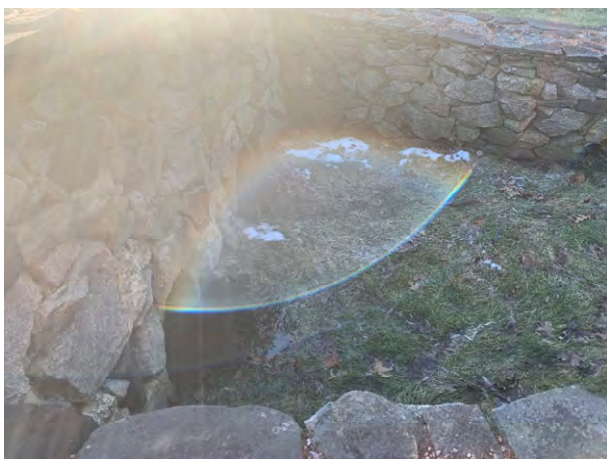
4 Brickyard Circle - 1 (Drainage Course)

pH: 9.8

Observations/Notes: Standing water extending approx. 18" from outlet, max depth approx. 8".

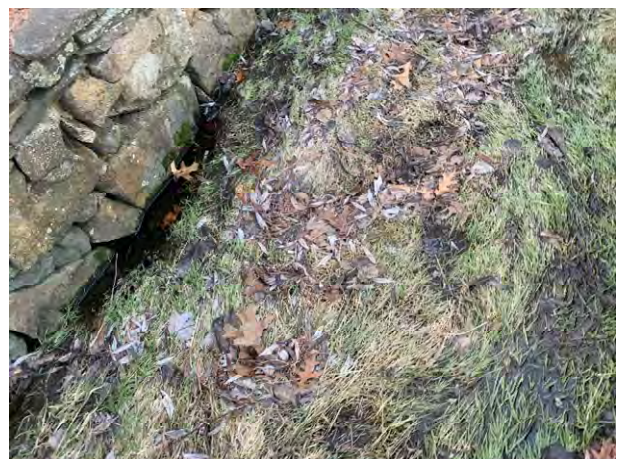
4 Brickyard Circle - 2 (Drainage Course)

pH: 7.8

Observations/Notes: Flowing water adjacent to east wall of raceway, approx. 1" deep.

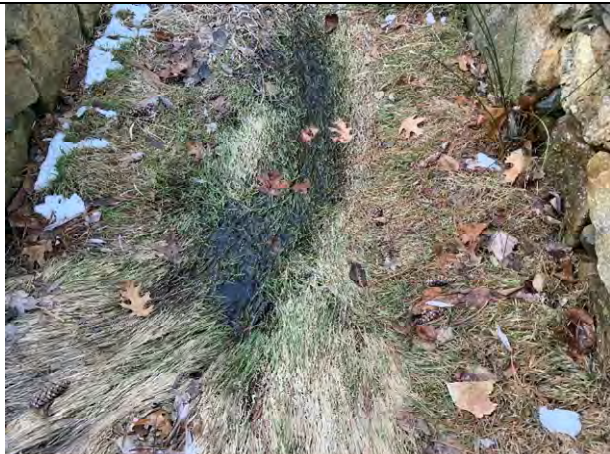
4 Brickyard Circle – 3 (Drainage Course)

pH: 7.5

Observations/Notes: Flowing water in center of raceway, approx. 2" deep.
