DRAINAGE MONITORING REPORT

Eversource Transmission
Line:

F107 - Seacoast Reliability Project

Newington, New Hampshire

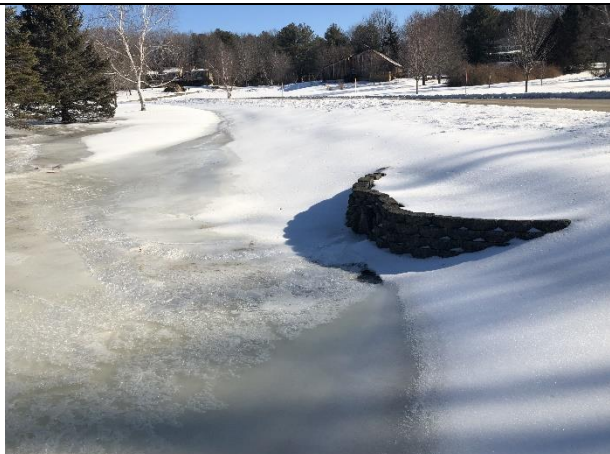
29 Gundalow - 1 (Drainage Area)

Location: 29 Gundalow – 1 (Drainage Area)

pH: **Frozen**

Observations/Notes: Water frozen through to substrate.

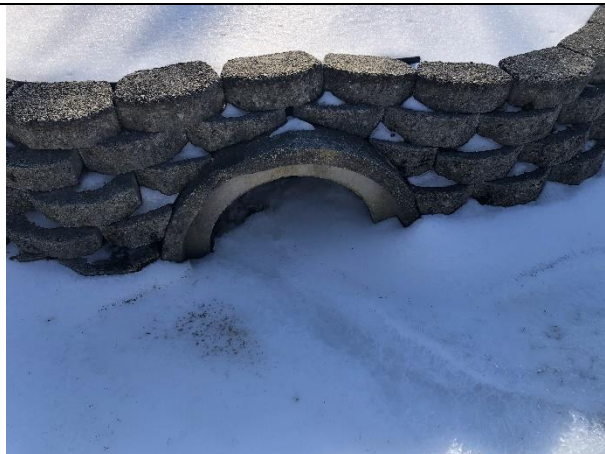
29 Gundalow - 2 (Culvert)

Location: 29 Gundalow – 2 (Culvert)

pH: **Frozen**

Observations/Notes: Water frozen through to substrate.

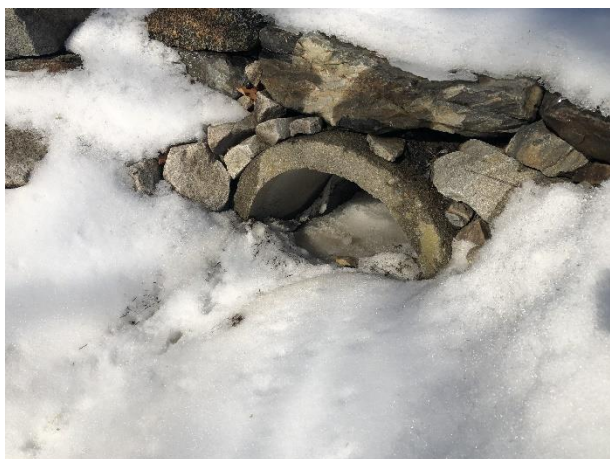
64 Gundalow - 1 (Drainage Course)

Location: 64 Gundalow – 1 (Drainage Course)

pH: **Frozen**

Observations/Notes: Water frozen through to substrate.

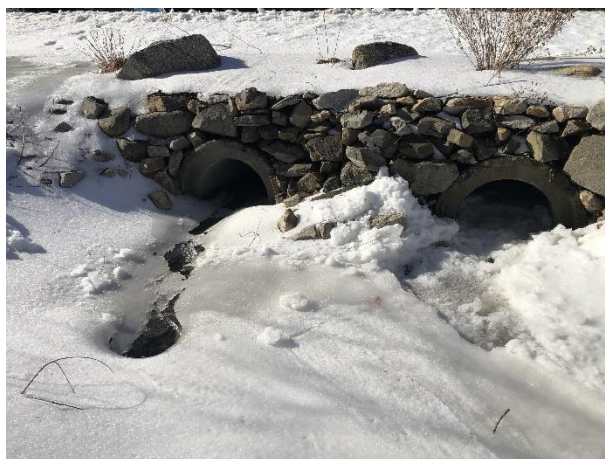
64 Gundalow - 2 (Drainage Course)

Location: 64 Gundalow – 2 (Drainage Course)

pH: **Frozen**

Observations/Notes: Partially frozen conditions in front of culvert inlets. Ice depth of approx. 4" to substrate with evidence of flow in channels within ice.

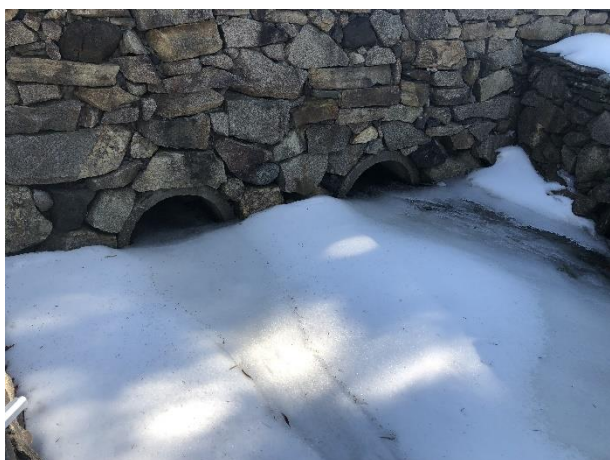
4 Brickyard Circle - 1 (Drainage Course)

Location: 4 Brickyard Circle – 1 (Drainage Course)

pH: **Frozen**

Observations/Notes: Partially frozen conditions in area adjacent to culvert outlets. Ice depth of approx. 4" to substrate with evidence of flow in channels within ice.

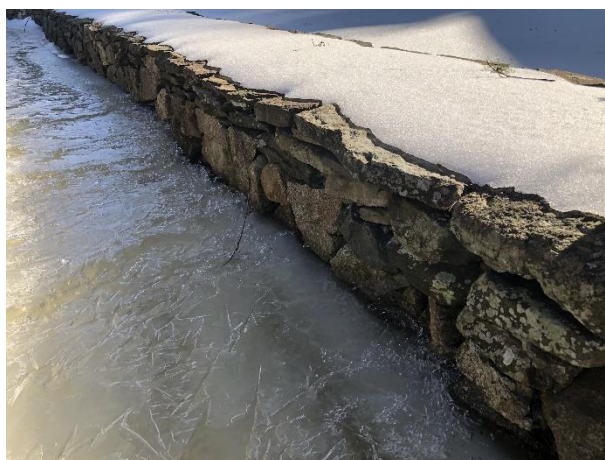
4 Brickyard Circle - 2 (Drainage Course)

Location: 4 Brickyard Circle – 2 (Drainage Course)

pH: **7.0**

Observations/Notes: Partially frozen conditions. Area of water above ice along south wall of raceway and max depth approx. 2.0". Ice depth of approx. 4" to substrate.

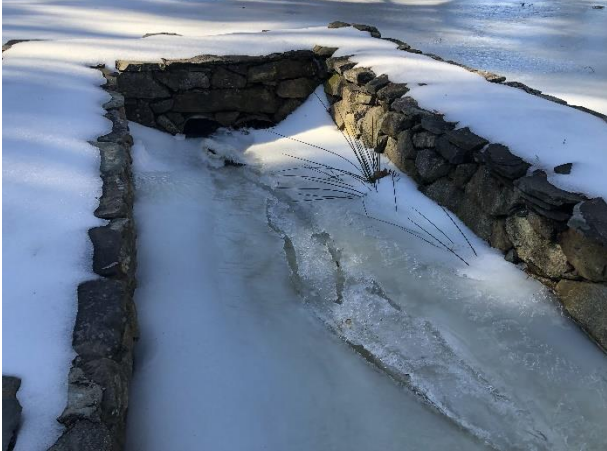
Location: 4 Brickyard Circle – 3 (Drainage Course)

pH: **6.8**

Observations/Notes: Partially frozen conditions. Area of water with flow along center of raceway and max depth approx. 1.5". Ice depth of approx. 4" to substrate.
