# DRAINAGE MONITORING REPORT

## F107 - Seacoast Reliability Project

**Newington, New  
Hampshire**

**04.0190999.81**

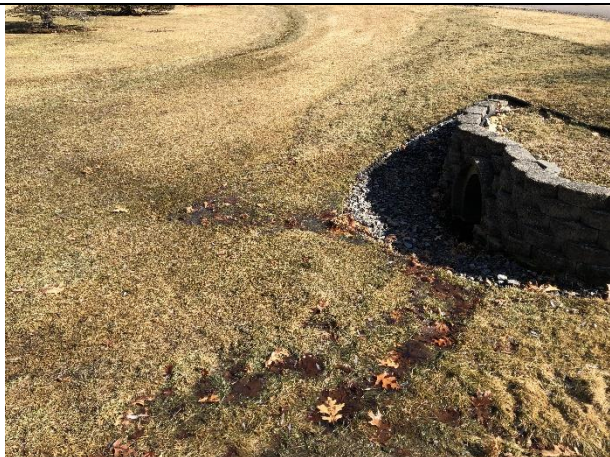
29 Gundalow - 1 (Drainage Area)

Status of surface water at the time of inspection? ☐ Dry ☐ Standing ☒ Flowing

pH: **7.9**

Observations/Notes: Saturated conditions with low flow and max. depth approx. 1.5".

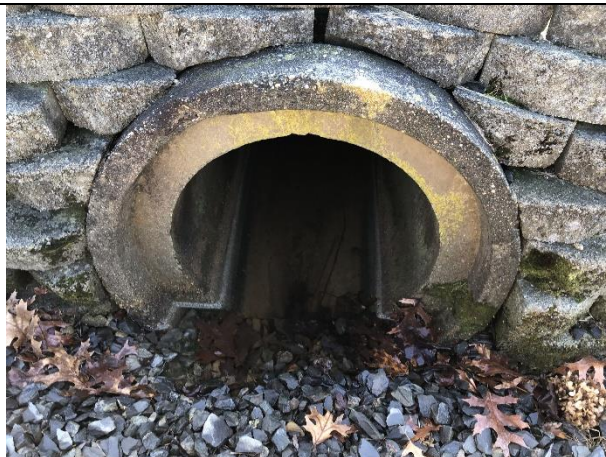
29 Gundalow - 2 (Culvert)

Status of surface water at the time of inspection? ☐ Dry ☐ Standing ☒ Flowing

pH: **8.9**

Observations/Notes: Water at culvert inlet, approx. max depth 3".

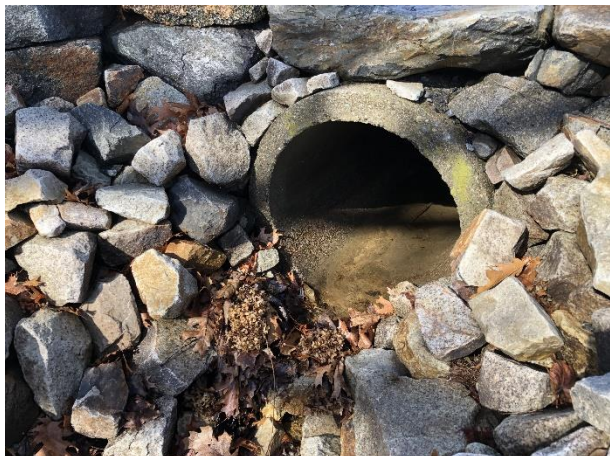
64 Gundalow - 1 (Drainage Course)

Status of surface water at the time of inspection? ☐ Dry ☐ Standing ☒ Flowing

pH: **9.5**

Observations/Notes: Water flowing from culvert, approx. max depth 2".

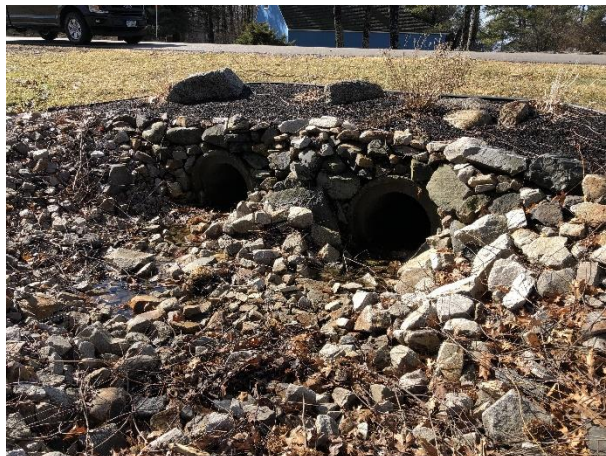
64 Gundalow - 2 (Drainage Course)

Status of surface water at the time of inspection? ☐ Dry ☐ Standing ☒ Flowing

pH: **6.8**

Observations/Notes: Area of water in front of culvert inlets, approx. max depth 3.75".

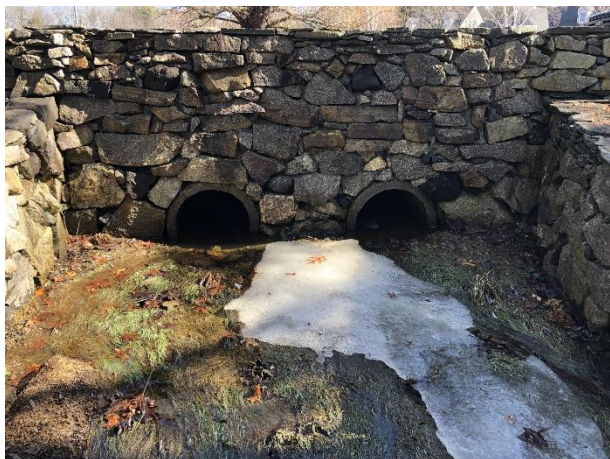
4 Brickyard Circle - 1 (Drainage Course)

Status of surface water at the time of inspection? ☐ Dry ☐ Standing ☒ Flowing

pH: **7.0**

Observations/Notes: Area of water adjacent to culvert outlets, approx. max depth 7".

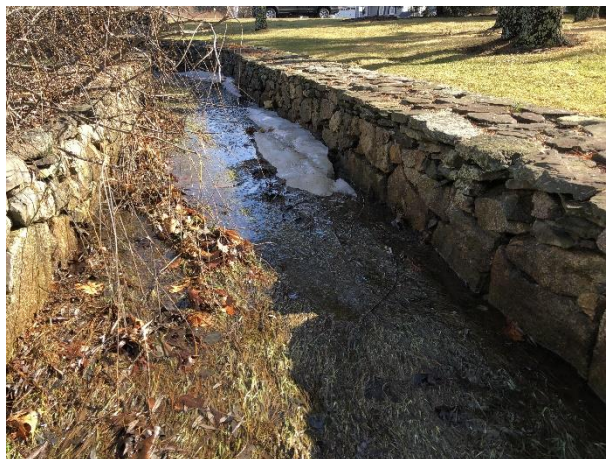
4 Brickyard Circle - 2 (Drainage Course)

Status of surface water at the time of inspection? ☐ Dry ☐ Standing ☒ Flowing

pH: **7.0**

Observations/Notes: Area of water adjacent to south wall of raceway, approx. max depth 2.5".

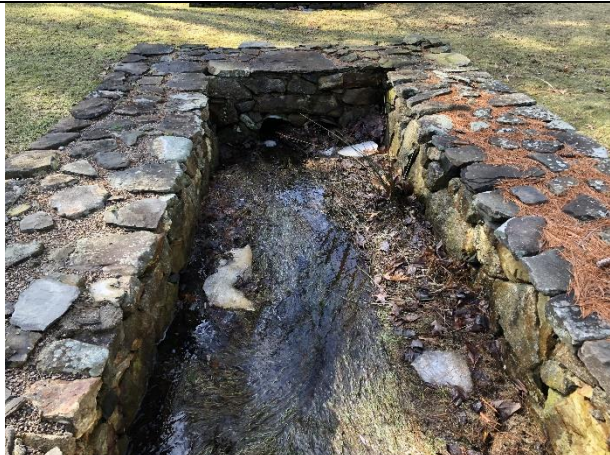
4 Brickyard Circle – 3 (Drainage Course)

Status of surface water at the time of inspection? ☐ Dry ☐ Standing ☒ Flowing

pH: **7.0**

Observations/Notes: Area of water in center of raceway, approx. max depth 4".
