**Subject: Granite Reliable Power, LLC;
High Elevation Restoration Tree Survival Monitoring Update**

Evaluation of Success of Tree Planting:
An Interim Report
for property managed by Granite Reliable Power

Millsfield, New Hampshire

Submitted by:
Kevin S. Evans
Professional Forester
N.H. License # 81
November 2016

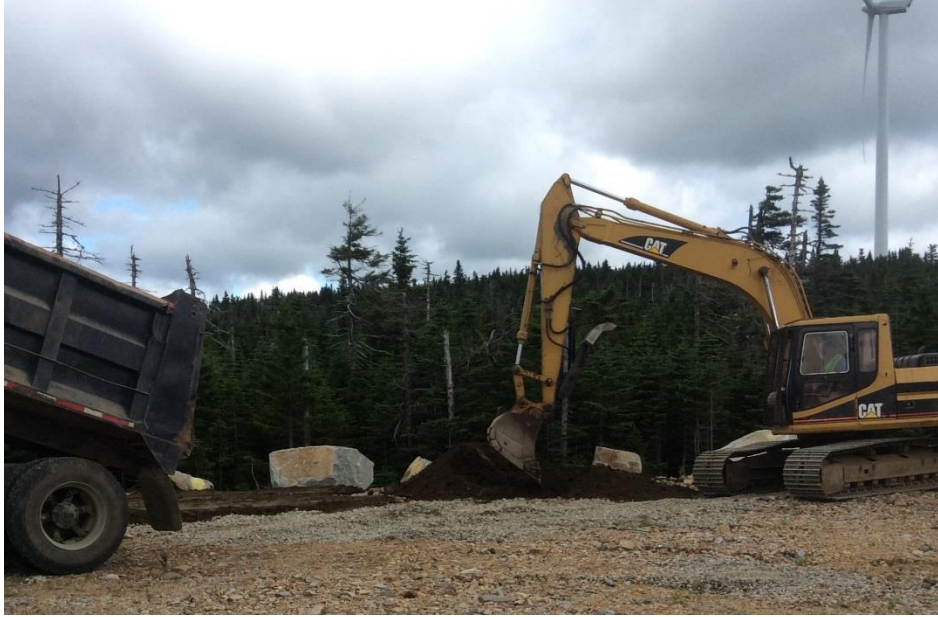
Figure 1: Pad 10: soil spread with excavator (to decrease soil compaction), Dump truck placing soil on pad area delineated with paint. Excavator operator is spreading to specified soil depth for specific pad depths. Machine was then used to tread site once for soil stabilization.

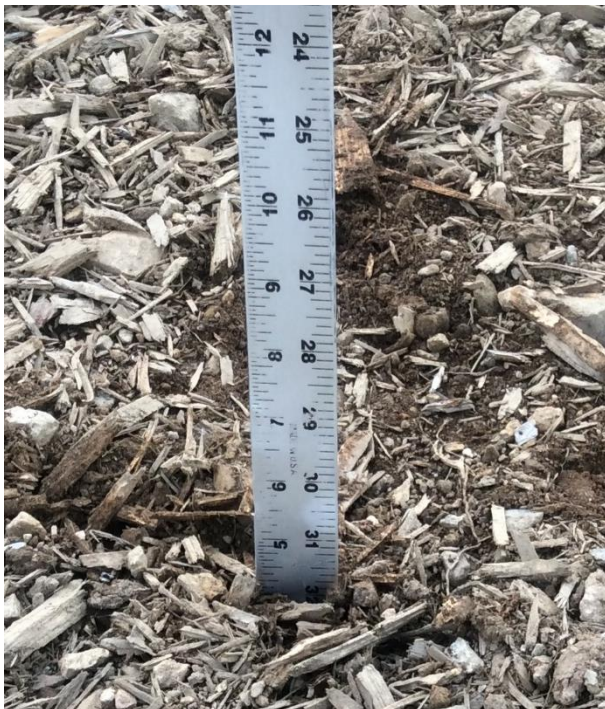
Figure 2: Soil depths were checked at random points on all Pads. They were also coordinated with having wood chips or Jute Mat. This is a 4-inch soil depth with wood chips.

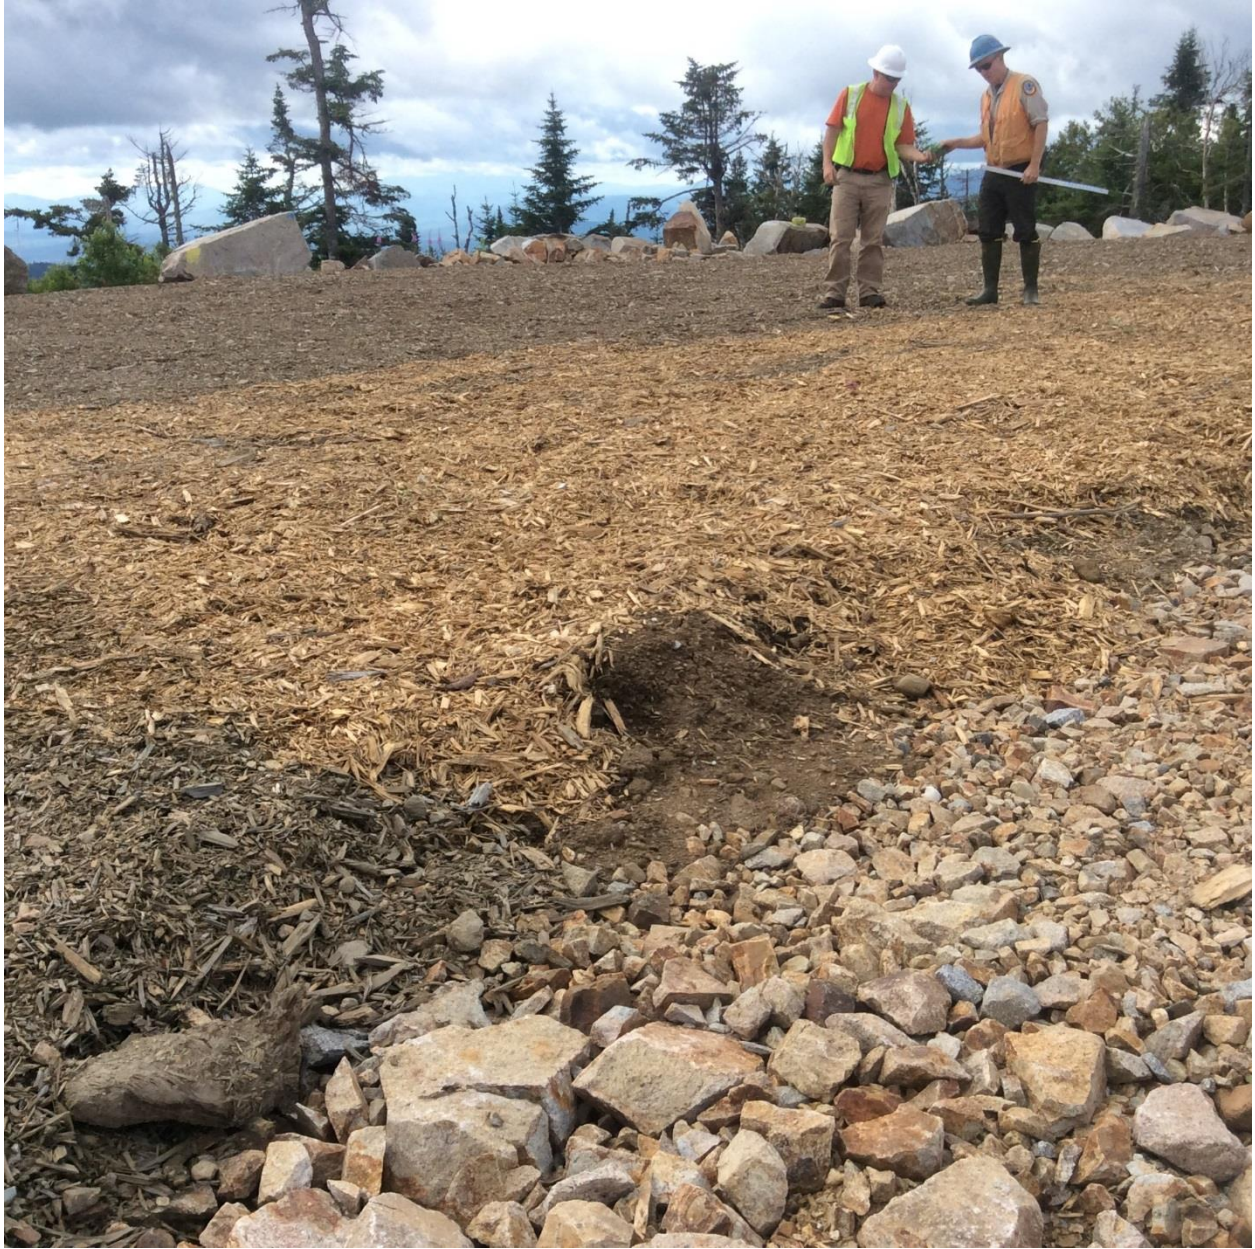
Figure 5: Pad area ready for planting, with correct soil depth and woodchips

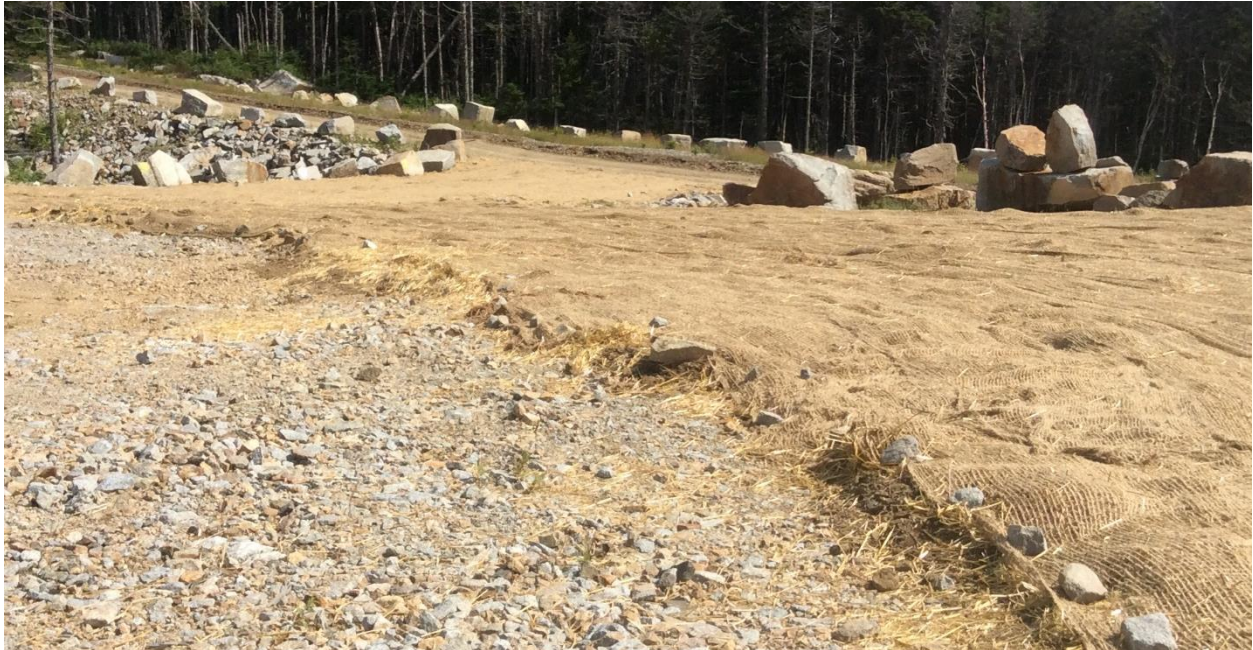
Figure 6: Pad 13- Ready for planting with 4 inches of soil, straw and Jute erosion cloth

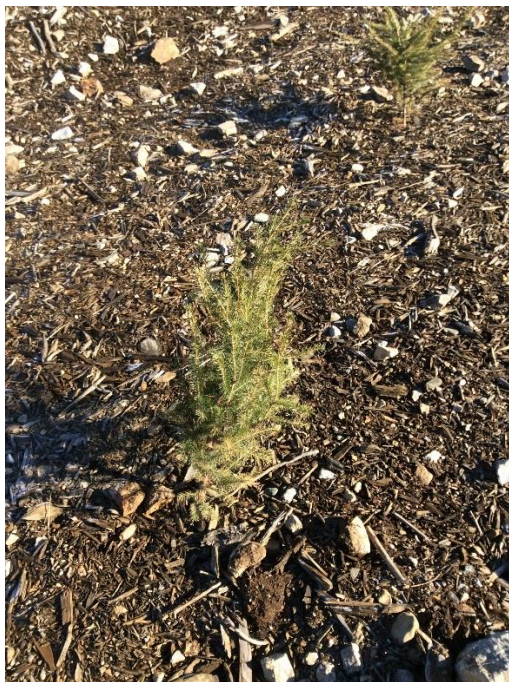
Figure 7: Newly planted seedlings on Pad October 27, 2015

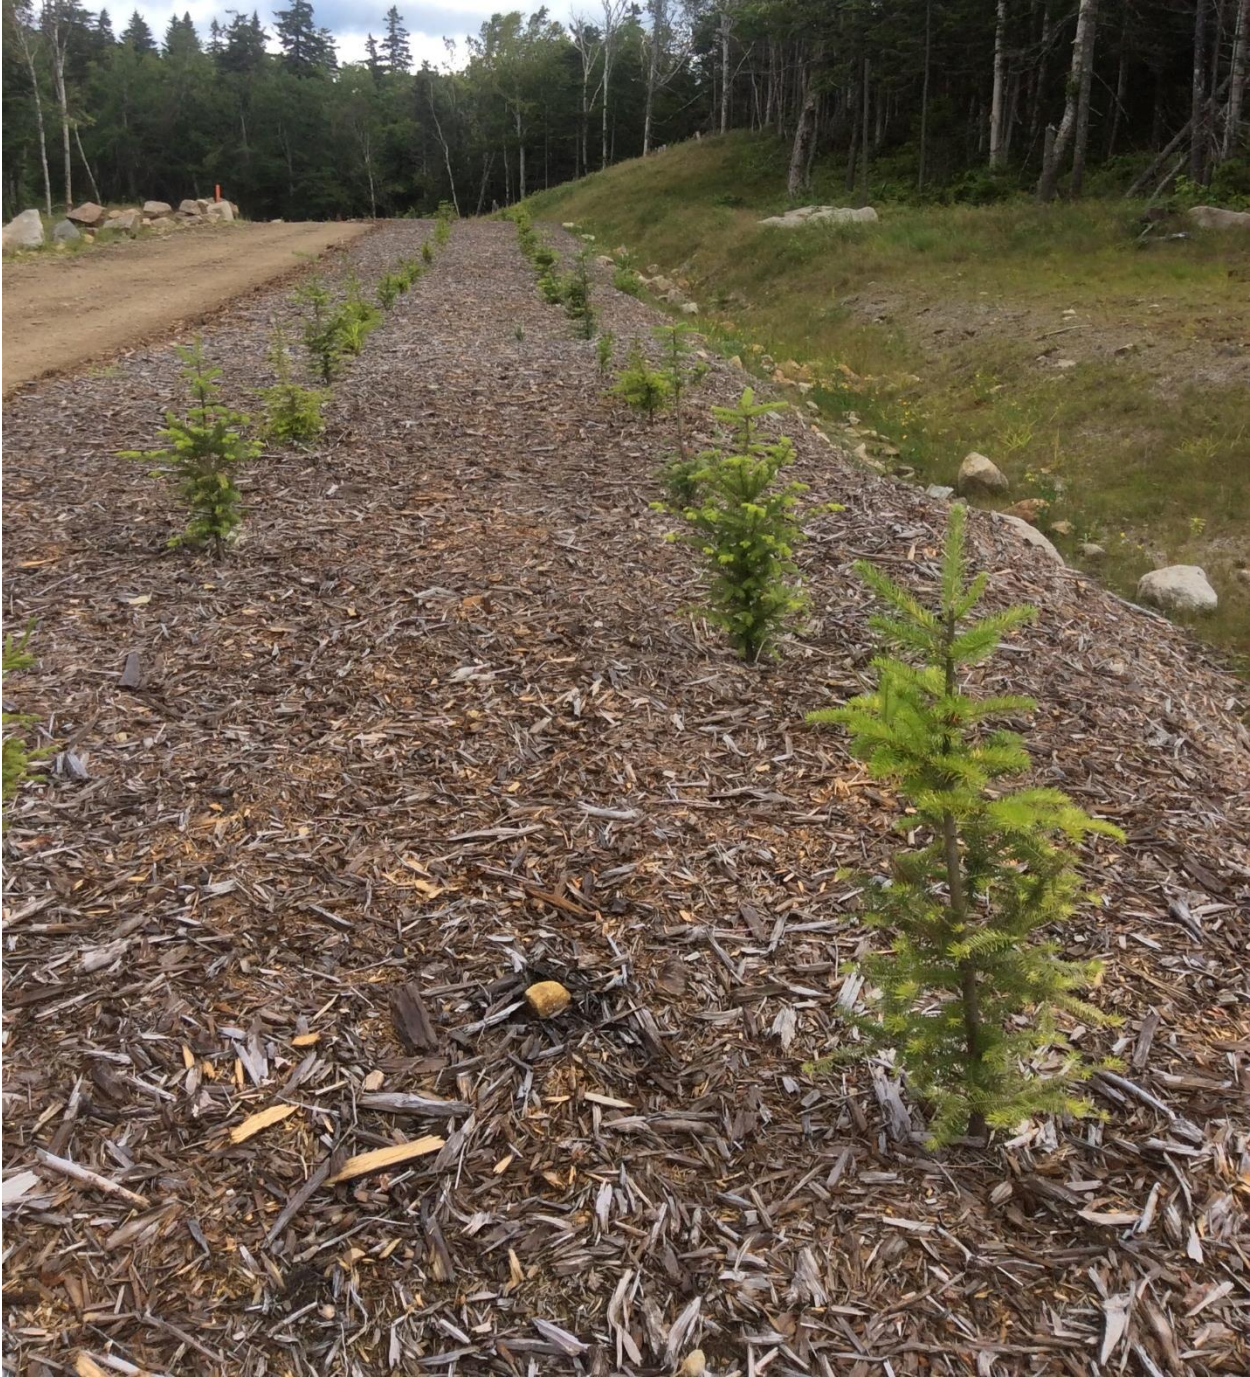
Figure 8: Trees planted on roadway showing 7 foot by 7-foot spacing

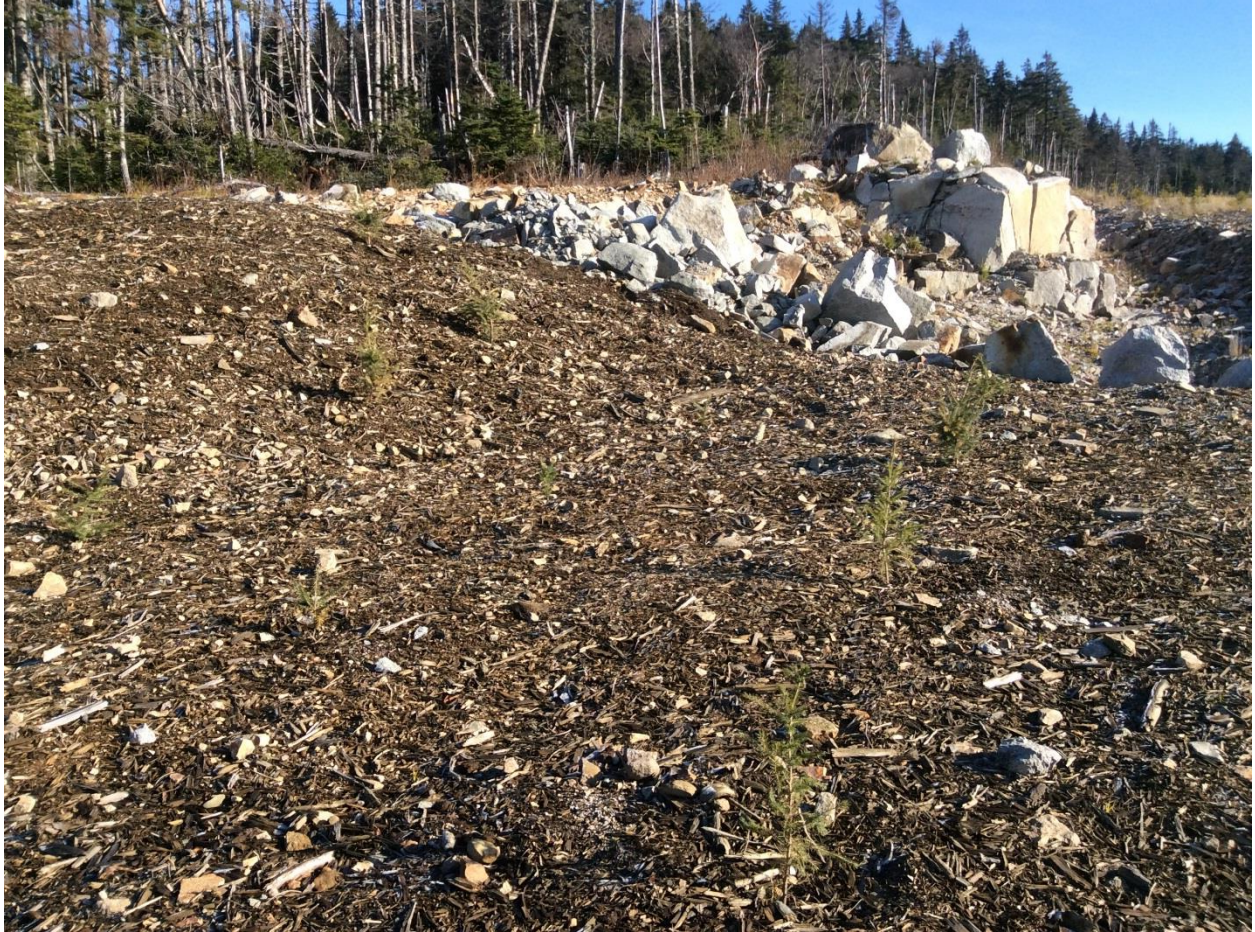
Figure 9: Newly planted seedlings on Pad 15.

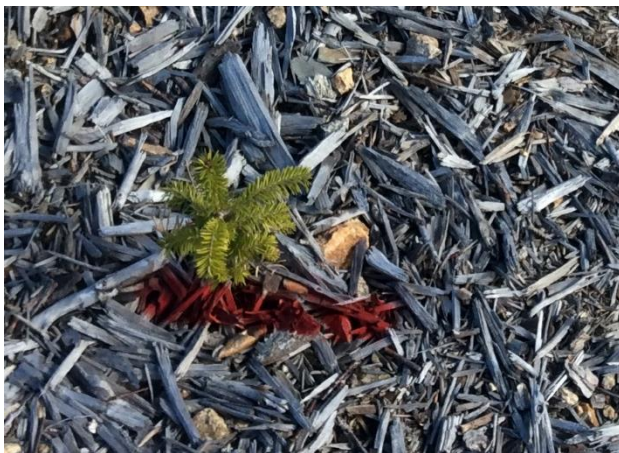
Figure 11: Live tree

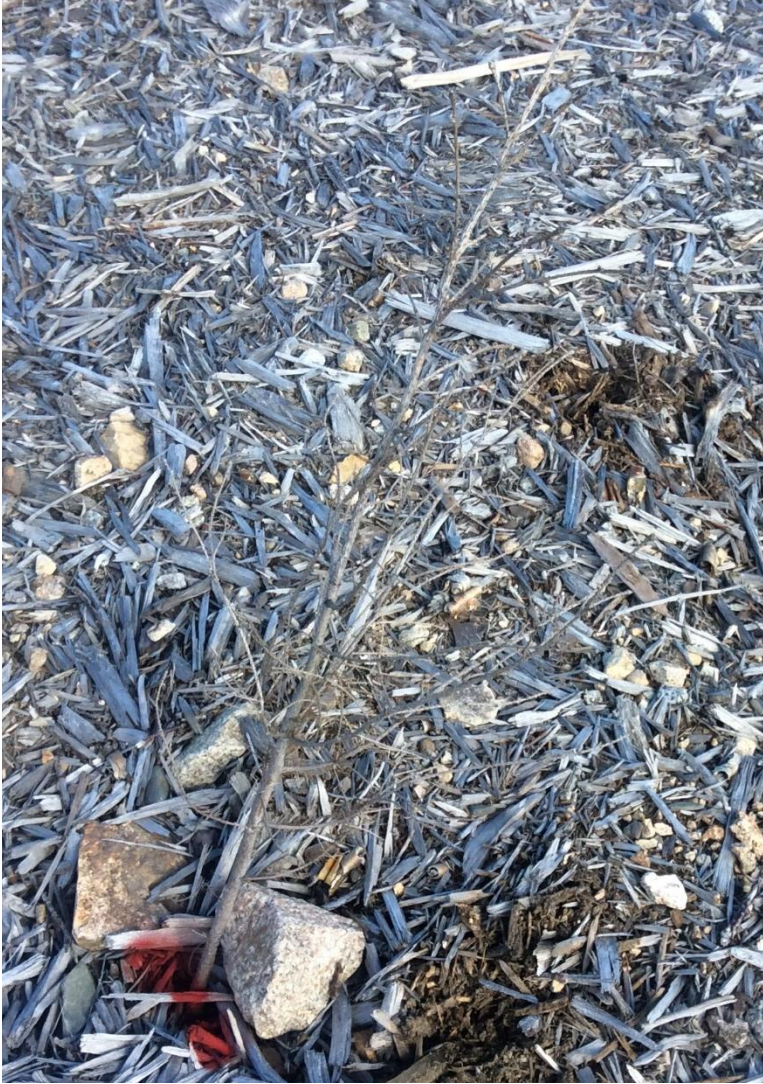
Figure 12: Dead tree. All dead trees, if in question were tested using the Scratch test to make sure they were dead.

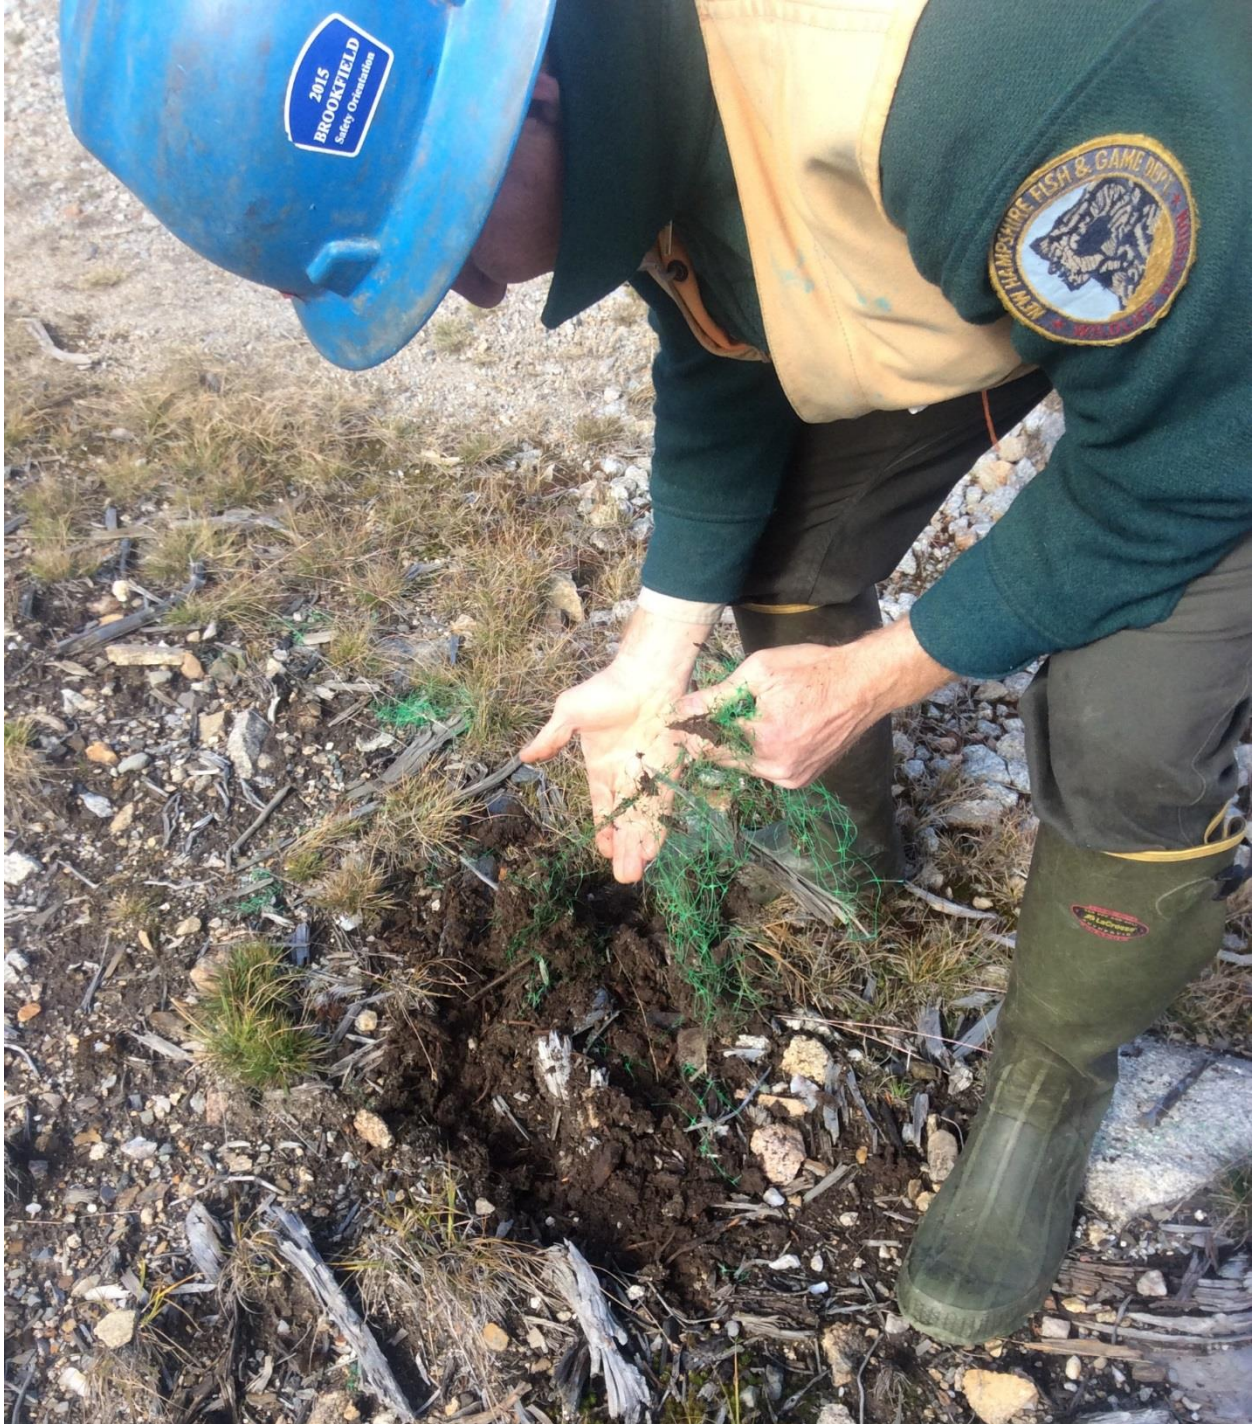
Green mesh - After 5+ years and the moving of soil around, green erosion mesh can still be found. It doesn't breakdown readily and is a potential hazard to wildlife; for future planting projects another product should be considered.

Figure 13: Green erosion mesh. This was picked up from soil removed from roadside, and was then still in the soil on pads after re soiling the pads.

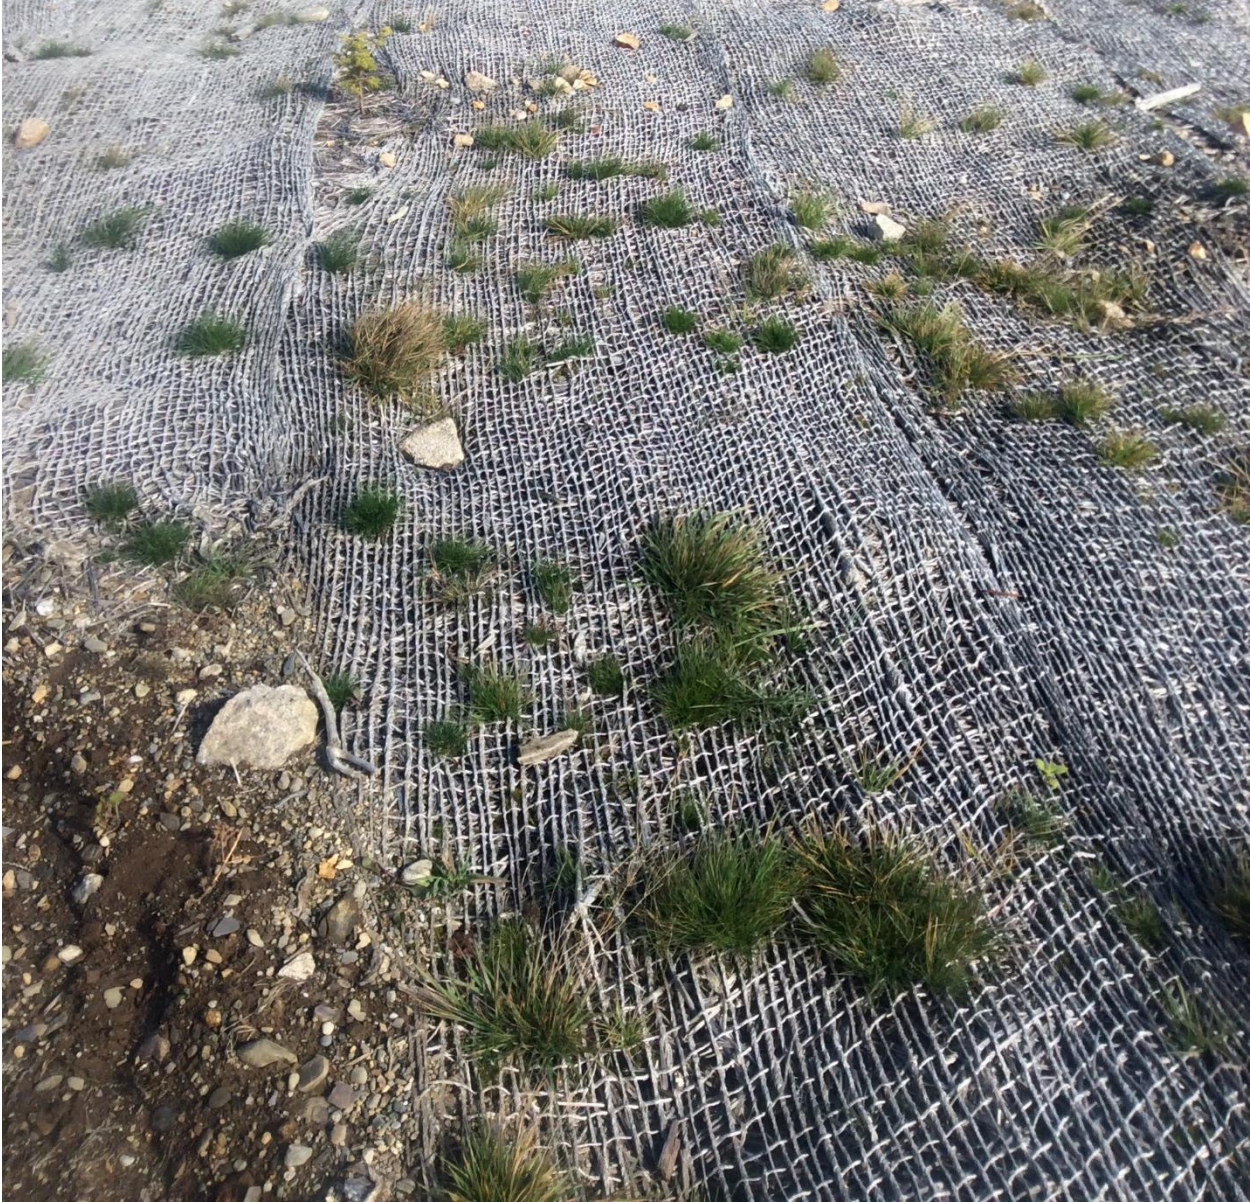
Figure 14: Jute Erosion mesh. After one growing season grass is already establishing itself

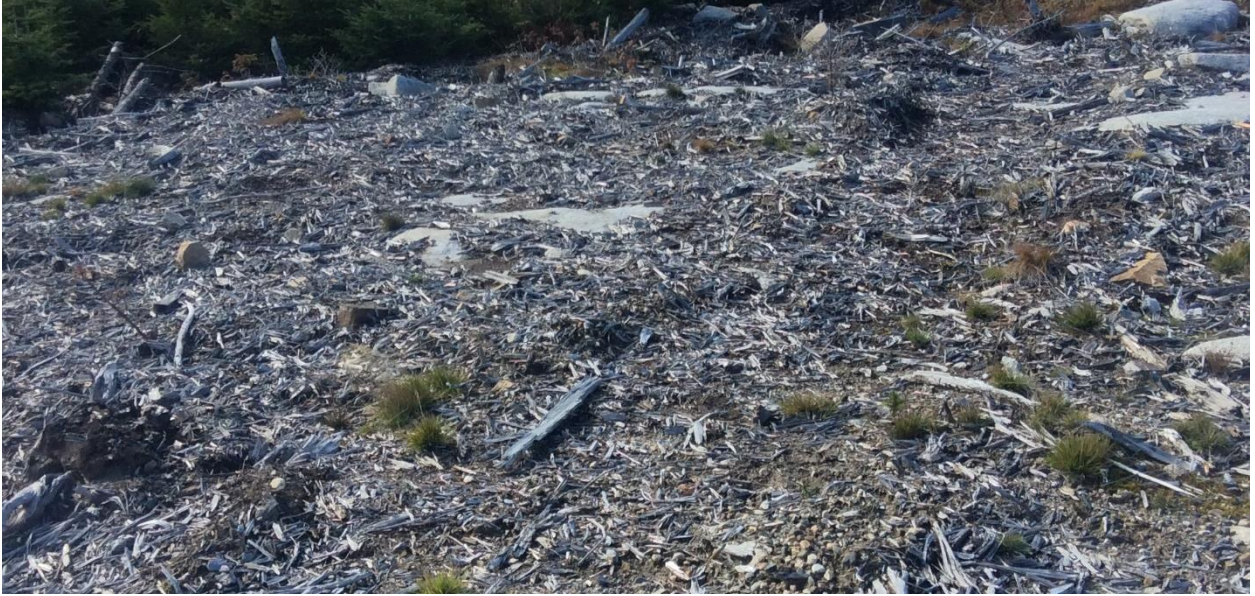
Figure 15: Woodchips 5 years after. Grass having trouble getting established, no natural seedlings.

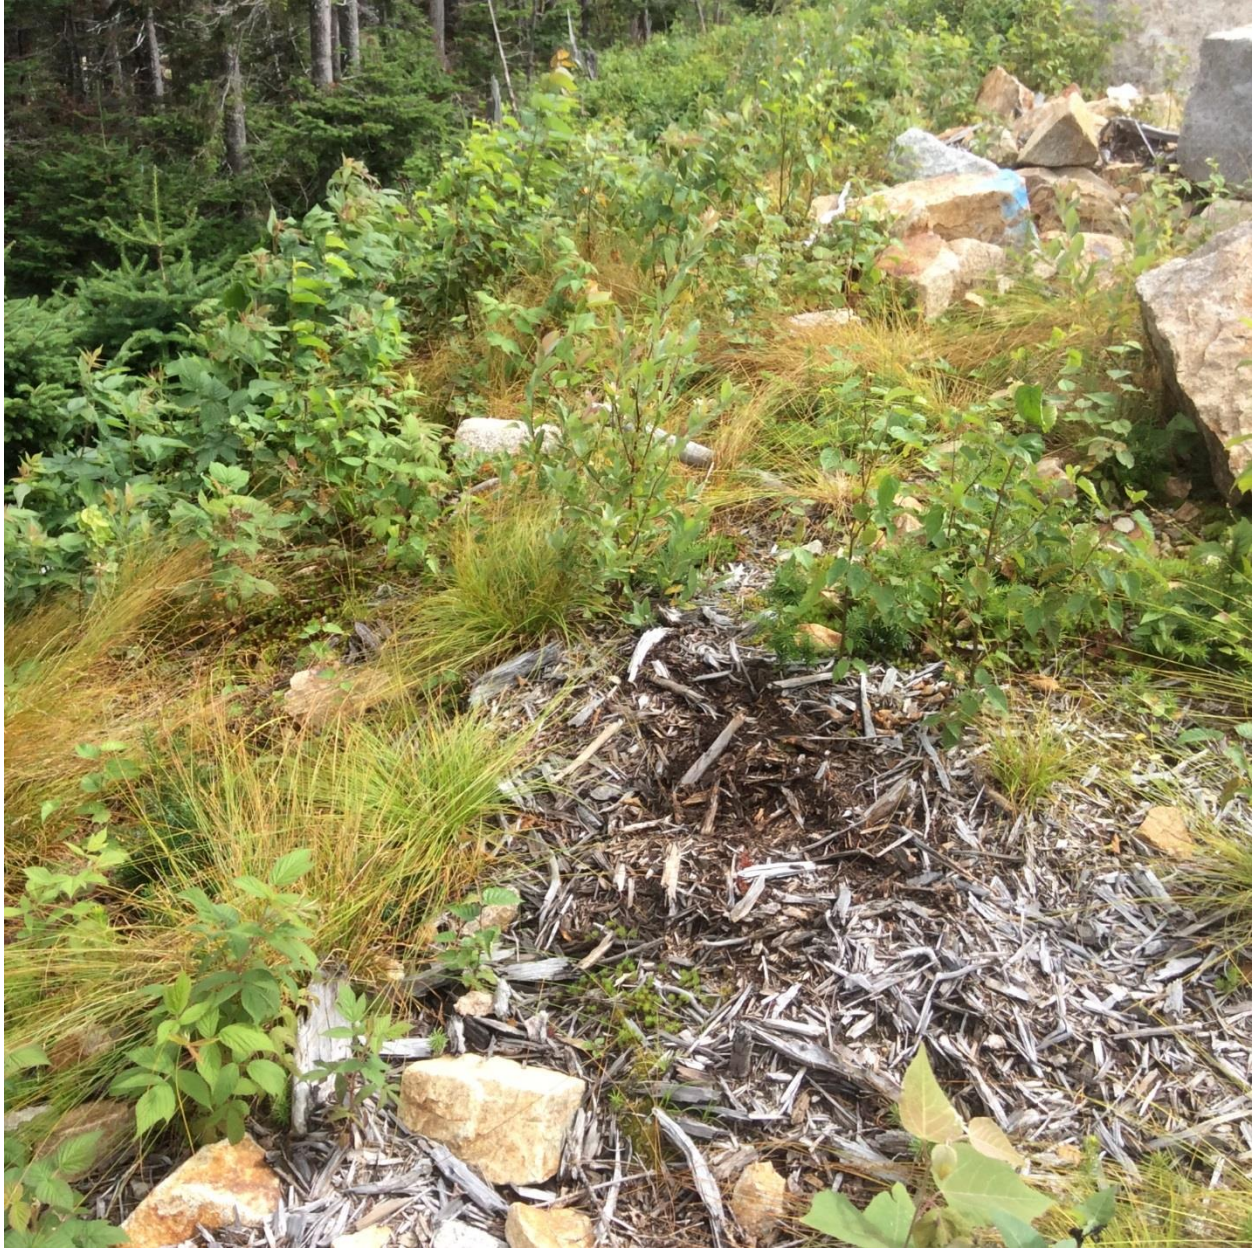
Figure 16: Dirty rock showing signs of recovery where area with woodchips still devoid of any vegetation

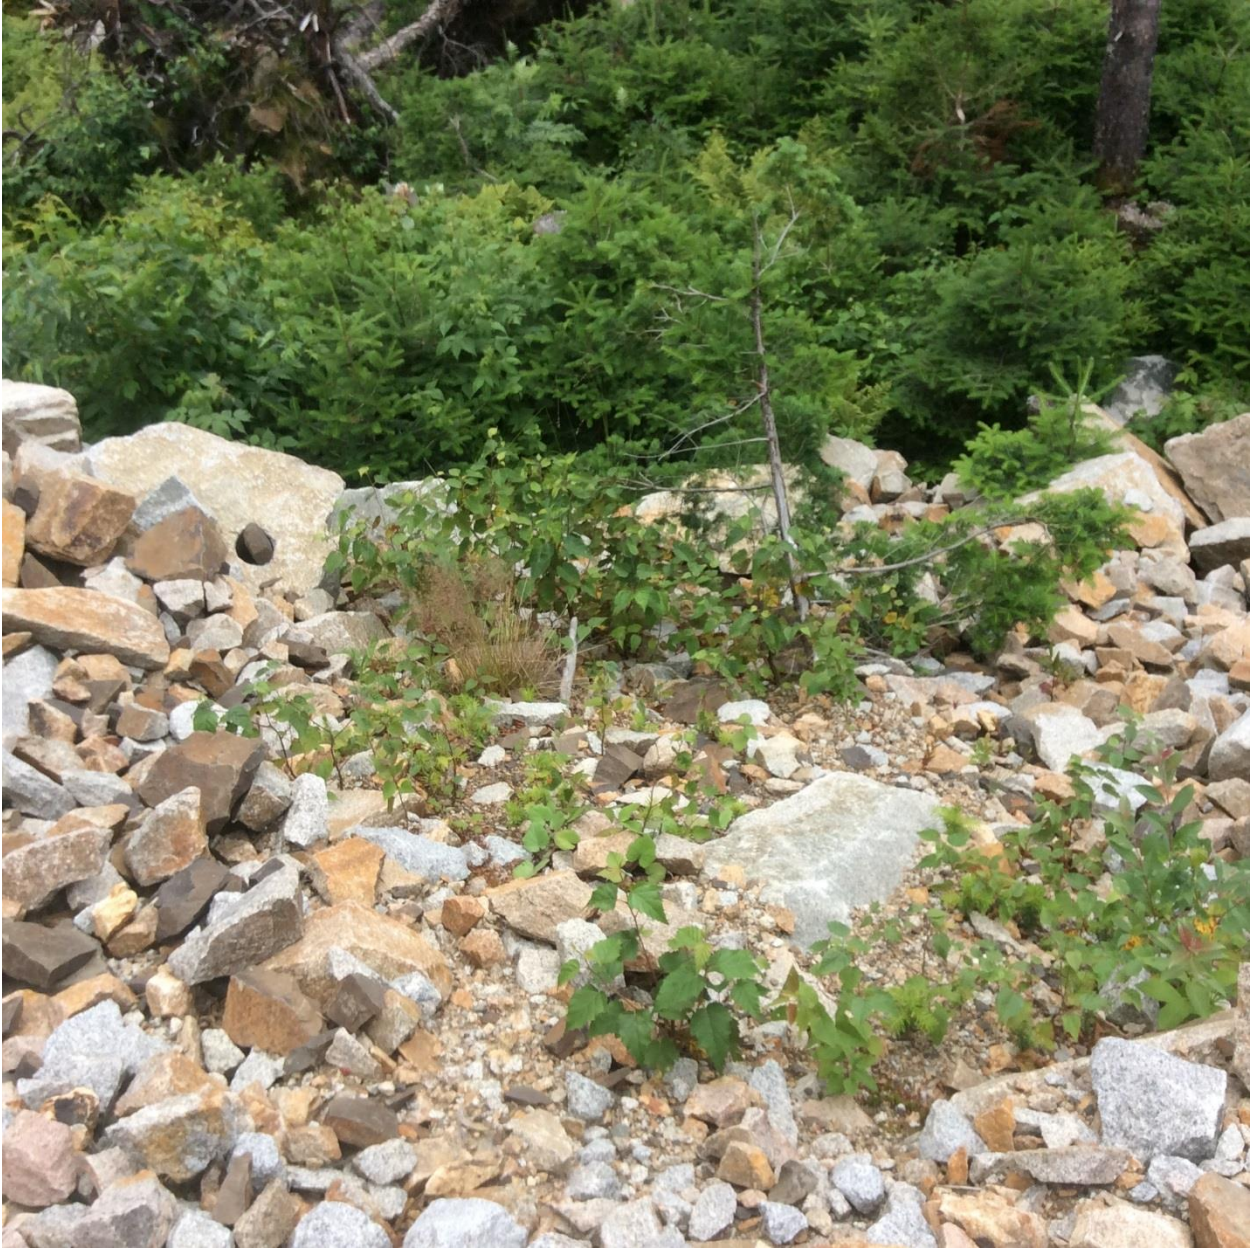
Figure 17: Dirty rock starting to grow vegetation

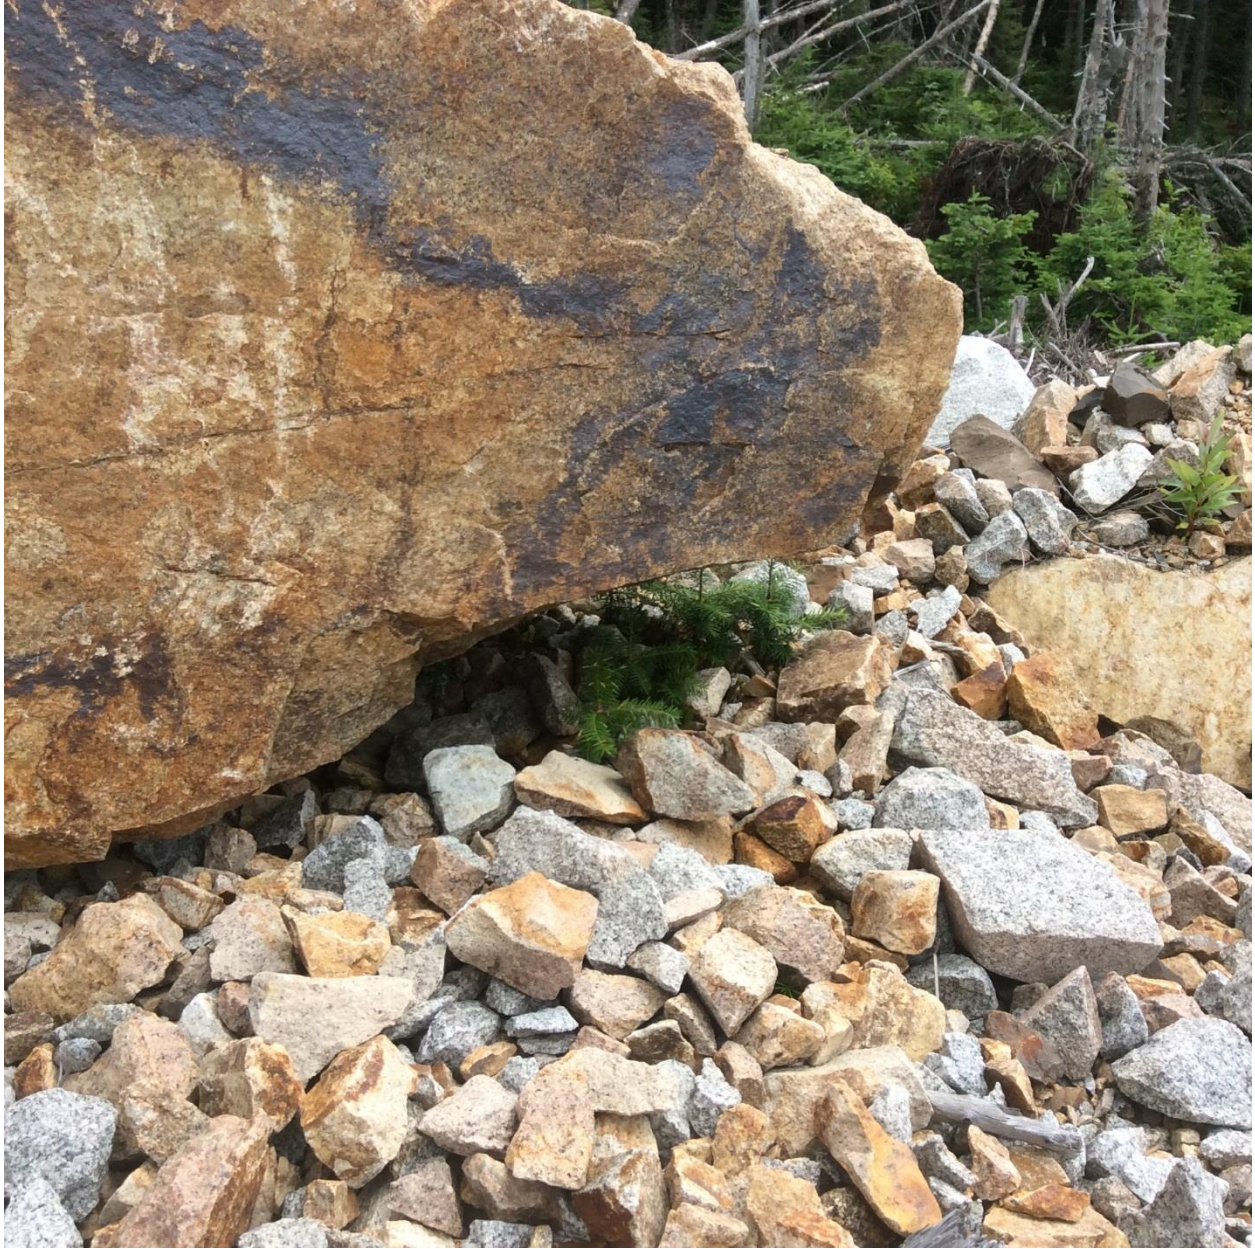
Effects of wind and snow - It was observed that some trees were listing toward the east from high winds. The pads show more signs of wind damage than the roadways and plantings alongside of road, which are more sheltered. Also the winter of 2015-16 was a low snow year; usually smaller trees would have been protected from deeper snow.

Figure 18: Protection from wind and dryness are critical in tree seedling mortality.
