Memorandum

Subject: Antrim Wind Energy Wood Turtle survey and exclusion

Date: September 11, 2018

Project No.: 307985

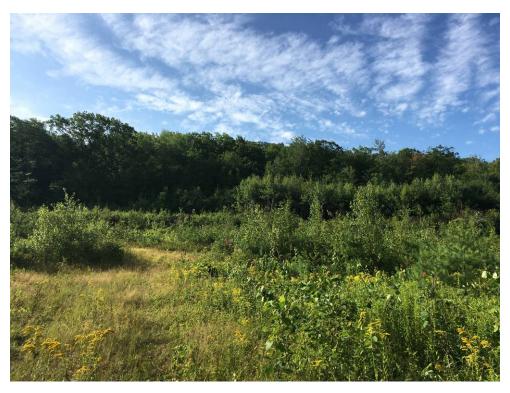
Photo from laydown yard entrance, to the south.

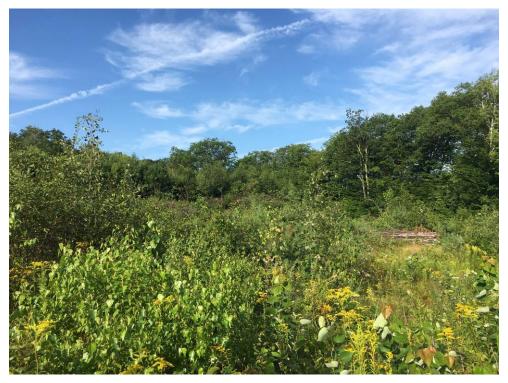
Photo from east side of laydown yard, to the west.

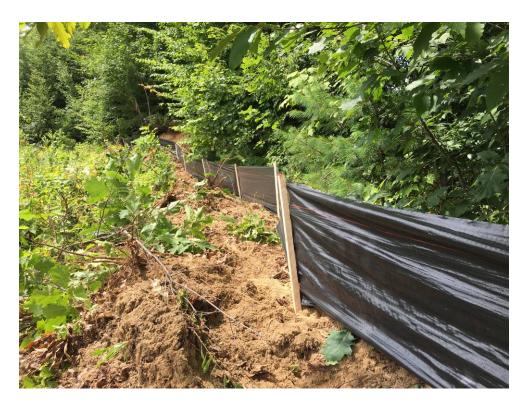
Outer silt fence installed.

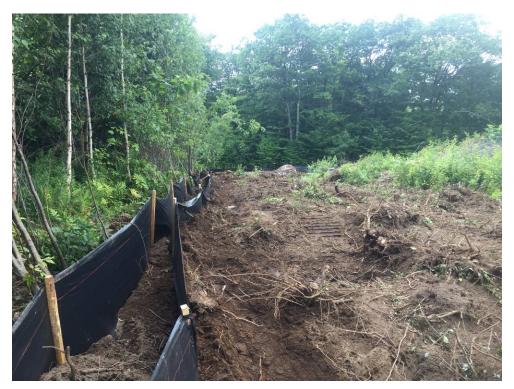
Double silt fence installed.
