**Post-Construction Monitoring  
Report Year 1, Antrim Wind  
Project, 2020**

Antrim, New Hampshire

January 26, 2020

Stantec Consulting Services Inc.  
30 Park Drive  
Topsham, ME 04086

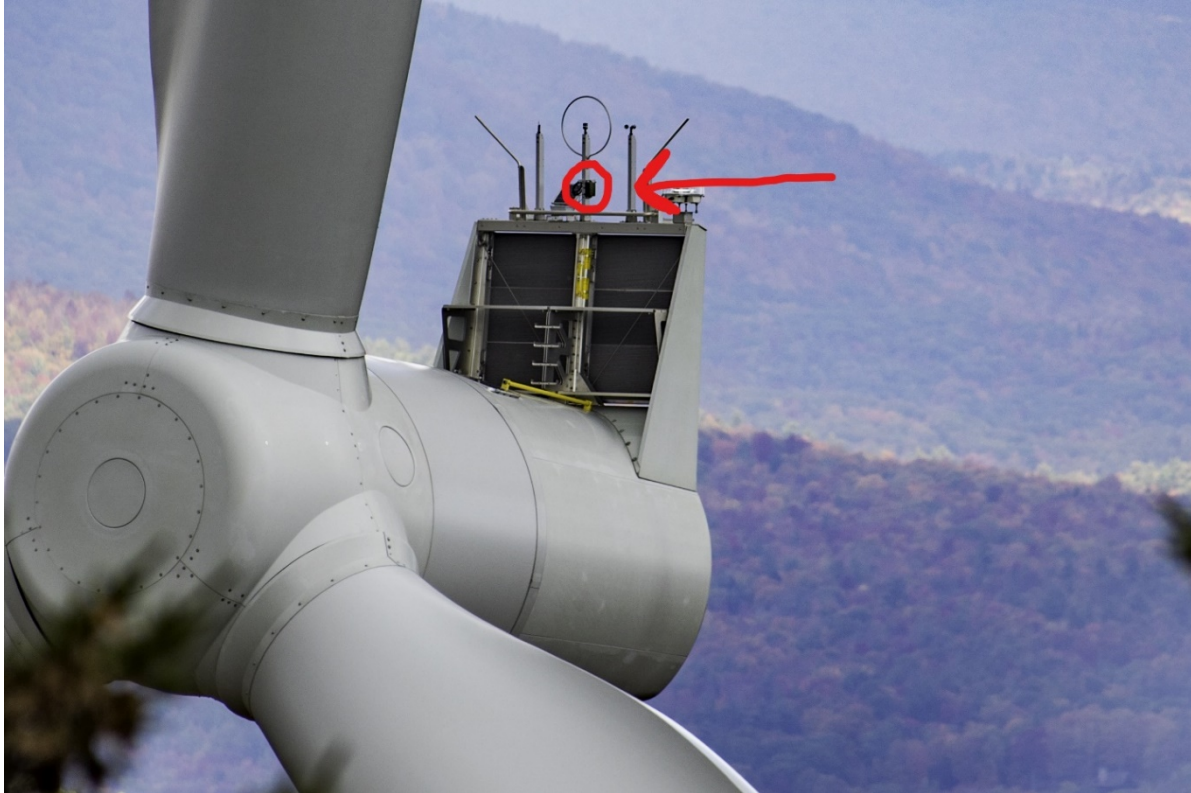
**Figure 2-1. Close-Up of a Wind Turbine with an Acoustic Bat Monitor Mounted at the Back End of the Nacelle**

Stantec coordinated with AWE to install Wildlife Acoustics SM4 full-spectrum acoustic detectors on four Siemens SWT-3.2-113 turbines. While the BBCS required use of two acoustic detectors, a total of four acoustic detectors were utilized to provide capacity for additional data collection and redundancy in case of equipment failure. Acoustic monitors were placed on two turbines within the experimental curtailment treatment (5.0 m/s) group (T01 and T08) and two turbines within the control curtailment treatment (3.0 m/s) group (T03 and T06). The acoustic monitors were mounted at the back end of the nacelle (Figure 2-1) near the wind vanes and anemometers. The detector installation method did not require connection to turbine power or communications infrastructure (detectors used an external 12-volt solar panel to operate) and were attached without permanent modification to the turbine itself. Stantec programmed the detectors to record nightly bat activity from 30 minutes before sunset to 30 minutes after sunrise. Remote data transfer was unavailable so Stantec coordinated with AWE to change memory cards and batteries in the detectors at least twice during the survey period.

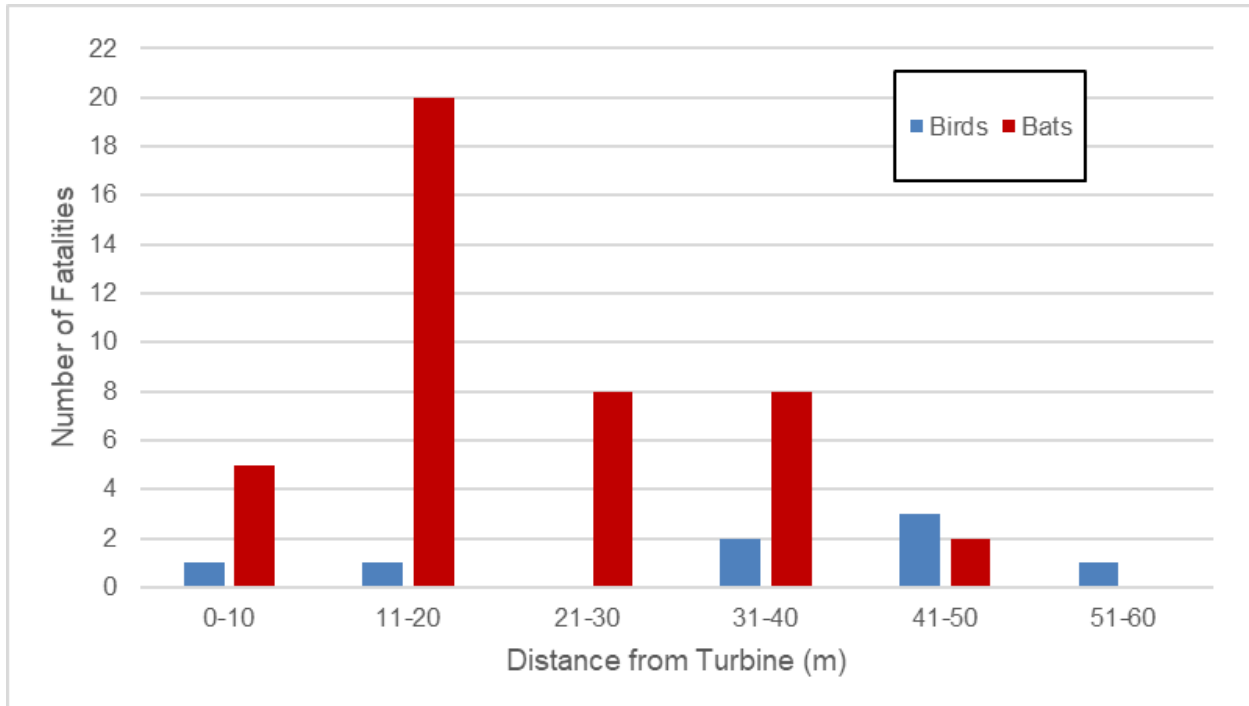
**Figure 3-2. Distribution of Bird and Bat Fatalities Found in 10-m Distance Increments from Turbines, Antrim Wind Project, 2020.**

The distance birds were found from turbine bases ranged from 5 m to 52 m (approximately 16 feet [ft] to 171 ft). The average distance a bird fatality was found from the base of a turbine was 31.7 m (104 ft). The distance bats were found from the turbine bases ranged from 6 m to 48 m (approximately 20 ft to 157 ft). The average distance a bat fatality was found from the base of a turbine was 22.7 m (74 ft). Figure 3-2 shows the distribution of bird and bat fatalities found within 10-m distance increments from the base of turbines. Over half (n=27; 53%) of bird and bat fatalities were found between 0 m and 20 m (0 ft to 66 ft). A large number of bat fatalities (n=20) and a bird fatality (n=1) make up 41.2% of that 53.0% and were found in the 11 m to 20 m (36 ft to 66 ft) range (Figure 3-2).

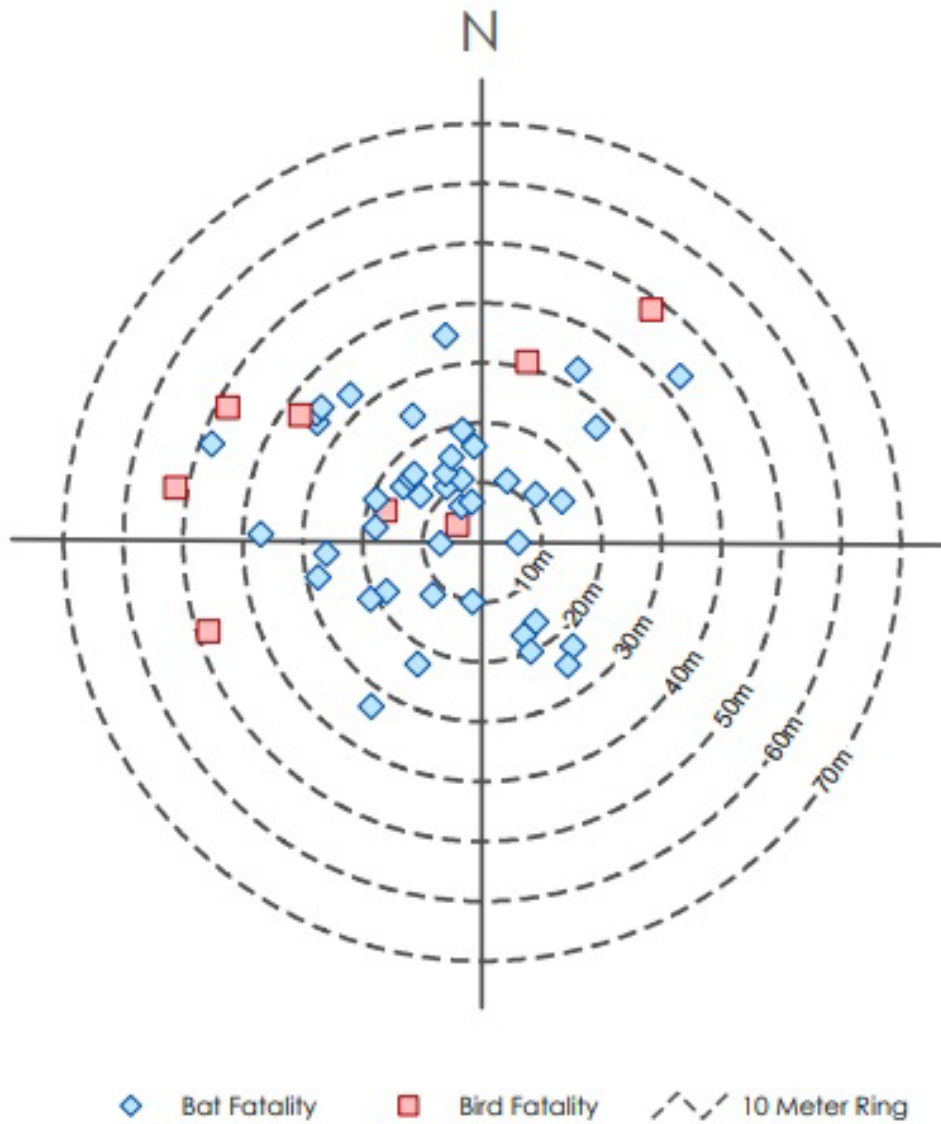
Figure 3-3. Distribution of Bird and Bat Carcasses Found at Antrim Wind Project, 2020.

The range of distances that birds and bats were found from the turbines, the average distances birds and bats were found from the turbines, and the distribution of fatalities at the turbines were summarized. Distances and azimuths of carcasses from turbines were plotted on a scatterplot diagram (Figure 3-3) with 10-m concentric distance increments.

Figure 3-3 shows the locations of bird and bat fatalities found within search plots at 10 m distance increments from turbine bases. Bird fatalities were found in the northwest, northeast, and southwest quadrants of the search plots. Bat fatalities were found in all quadrants of the search plots. All fatalities were found less than 60 m from turbine bases (Figure 3-3).

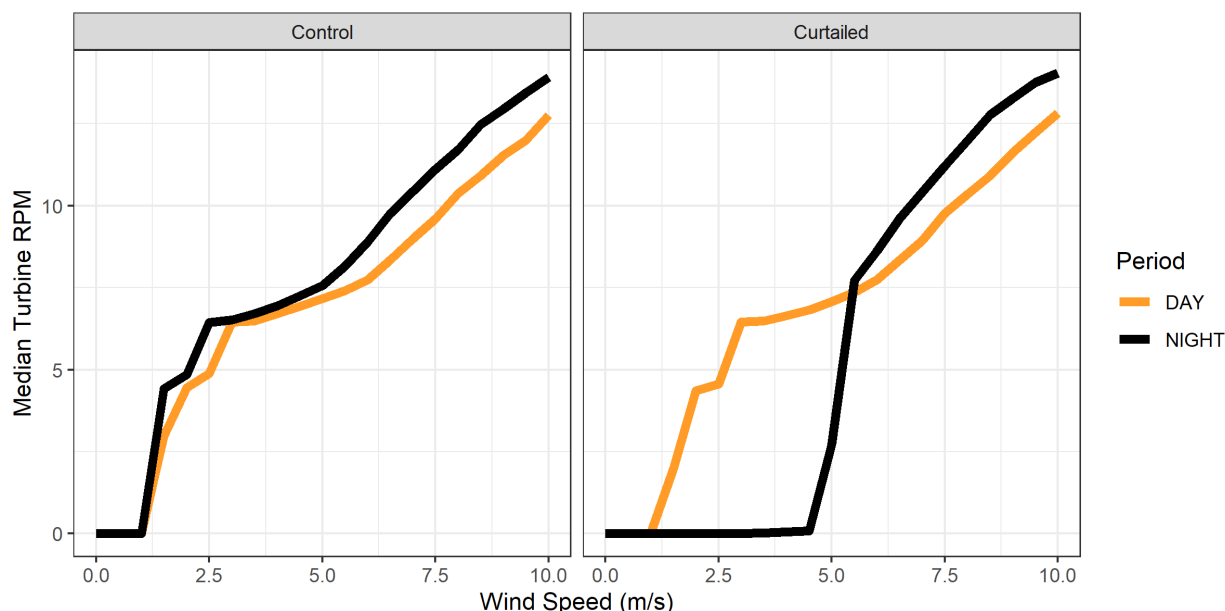
**Figure 3-5. Median Turbine RPM During the Day and Night as a Function of Wind Speed for Treatment Turbines During the Curtailment Period.**

The curtailment period took place during the peak period of bat collision risk. A majority of the bat carcasses were found during the curtailment period; however, bat carcasses were also found before and after the curtailment period. Two bat carcasses were found at the curtailed turbines during the curtailment period and were documented as being fresh with the estimated time of death believed to be the prior night. The previous night’s curtailment activity is summarized in Table 3-16 for the turbine where the two fresh bat carcasses were found.

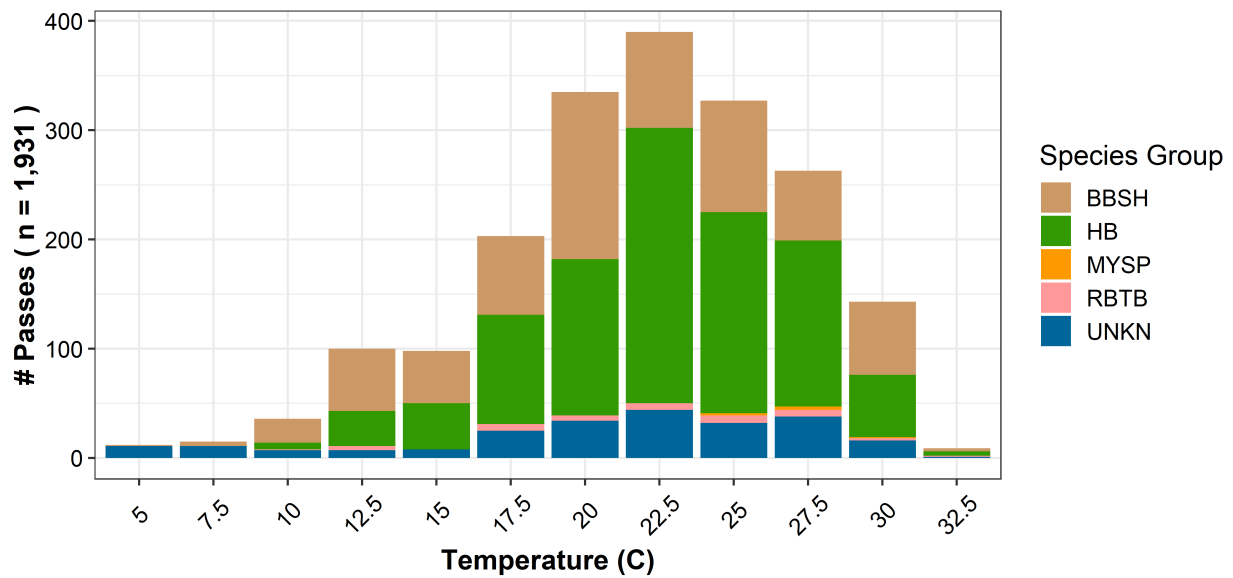
**Figure 3-8. Bat Activity by Temperature Bin (2.5 Degrees C) Recorded at Turbines 1, 3, 6, and 8 Combined, Antrim Wind Project, 2020.**

Bat activity showed clear relationships with temperature and wind speed measured at corresponding turbine nacelles, with 92% of passes for which weather data were available (n = 1,931) occurring when temperature was greater than 15°C and 85% of passes occurring at wind speeds less than 5 m/s (Figure 3-8, Figure 3-9). Considering temperature and wind speed together, bat activity occurred disproportionately during calm, warm conditions, and few bat passes were recorded during times with higher wind speeds or cooler temperatures (Figure 3-10).

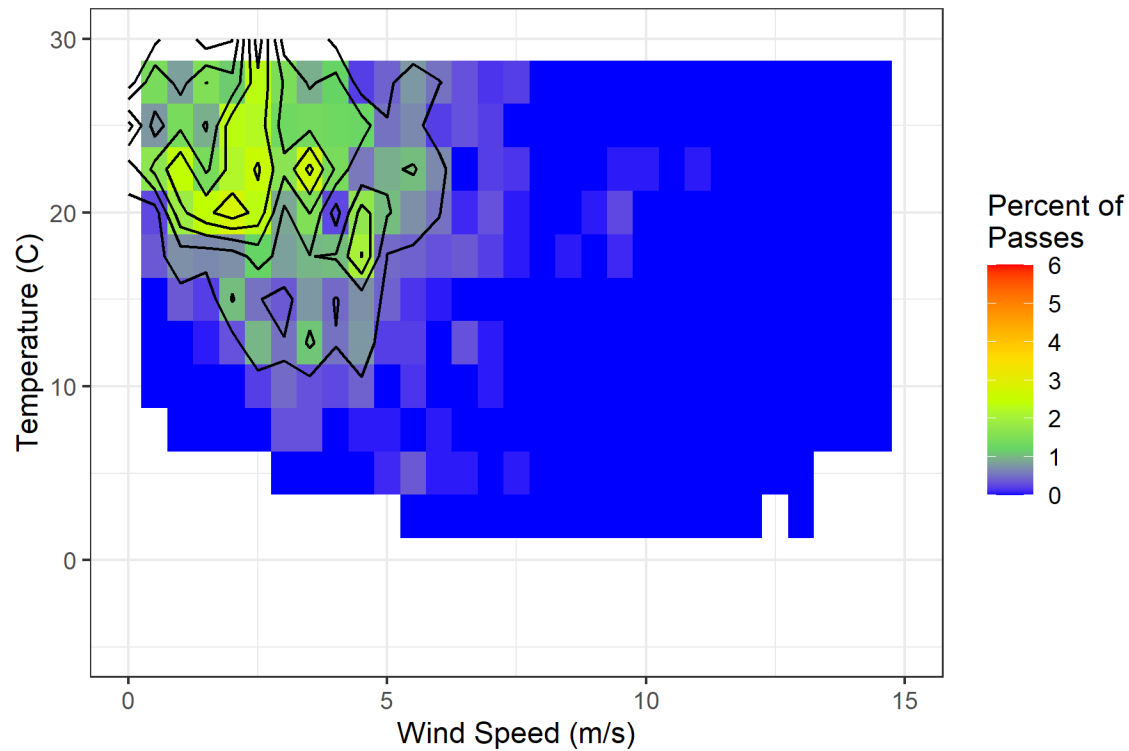
Figure 3-10. Percent of Bat Passes as a Function of Wind Speed and Temperature Based on Nacelle-Mounted Acoustic Detectors, Antrim Wind Project, 2020.

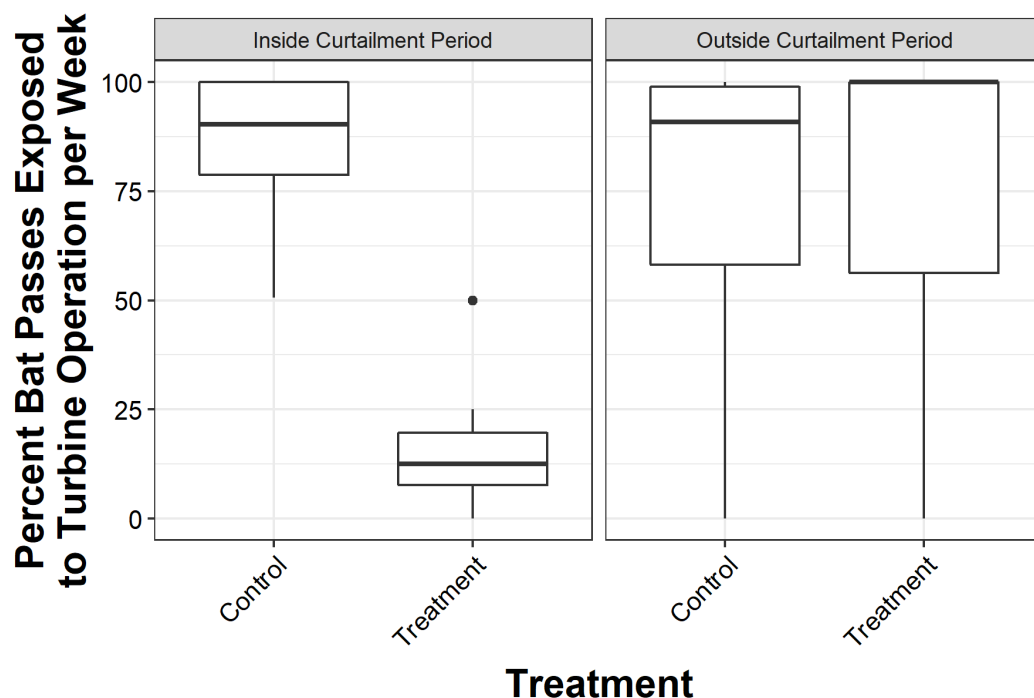
**Figure 3-11. Percent of Bat Passes Exposed to Turbine Operation on a Weekly Basis at Control Versus Treatment Turbines Inside and Outside the Curtailment Period, Antrim Wind Project, 2020.**

Curtailment Period	Treatment	NPasses	Exposed	Percent
Outside	Control	509	388	76.2
	Experimental	567	443	78.1
Inside	Control	489	395	80.8
	Experimental	366	55	15.0
