Re: Groton Wind Project – Bridge Replacement

Request for Project Review by the New Hampshire Division of Historical Resources

Project Title **Groton Wind Farm - Upper Bridge Replacement**

Groton Wind Farm Upper Bridge Replacement
May 2015

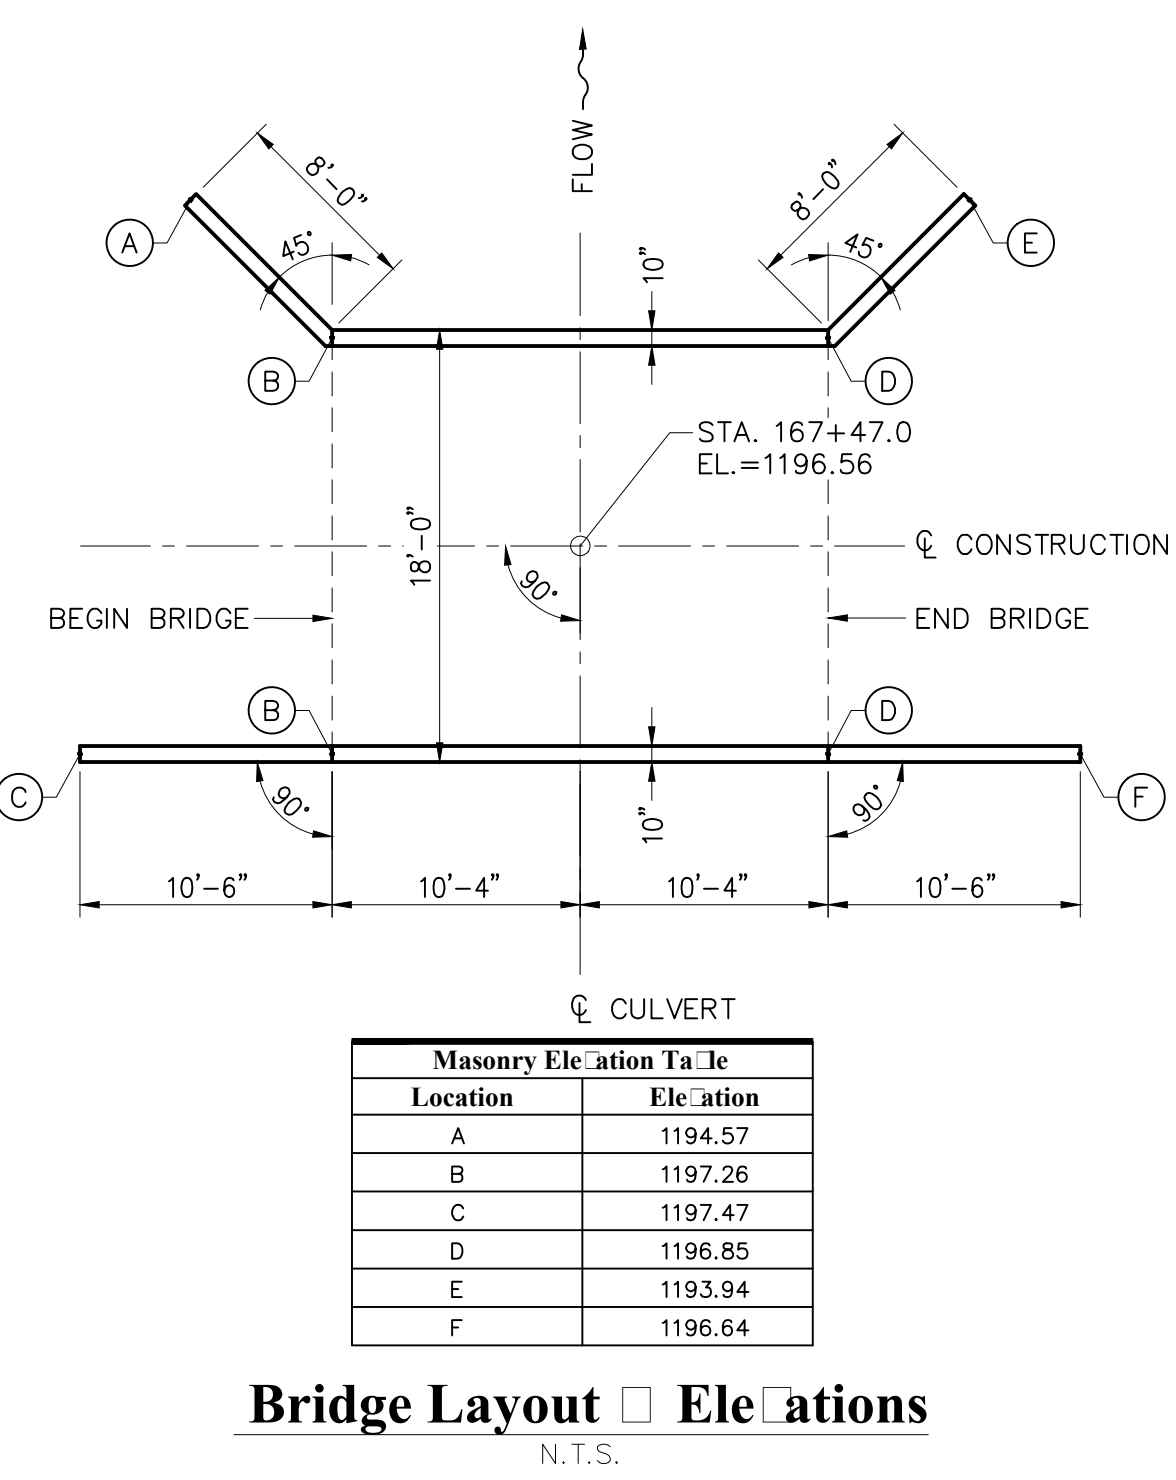
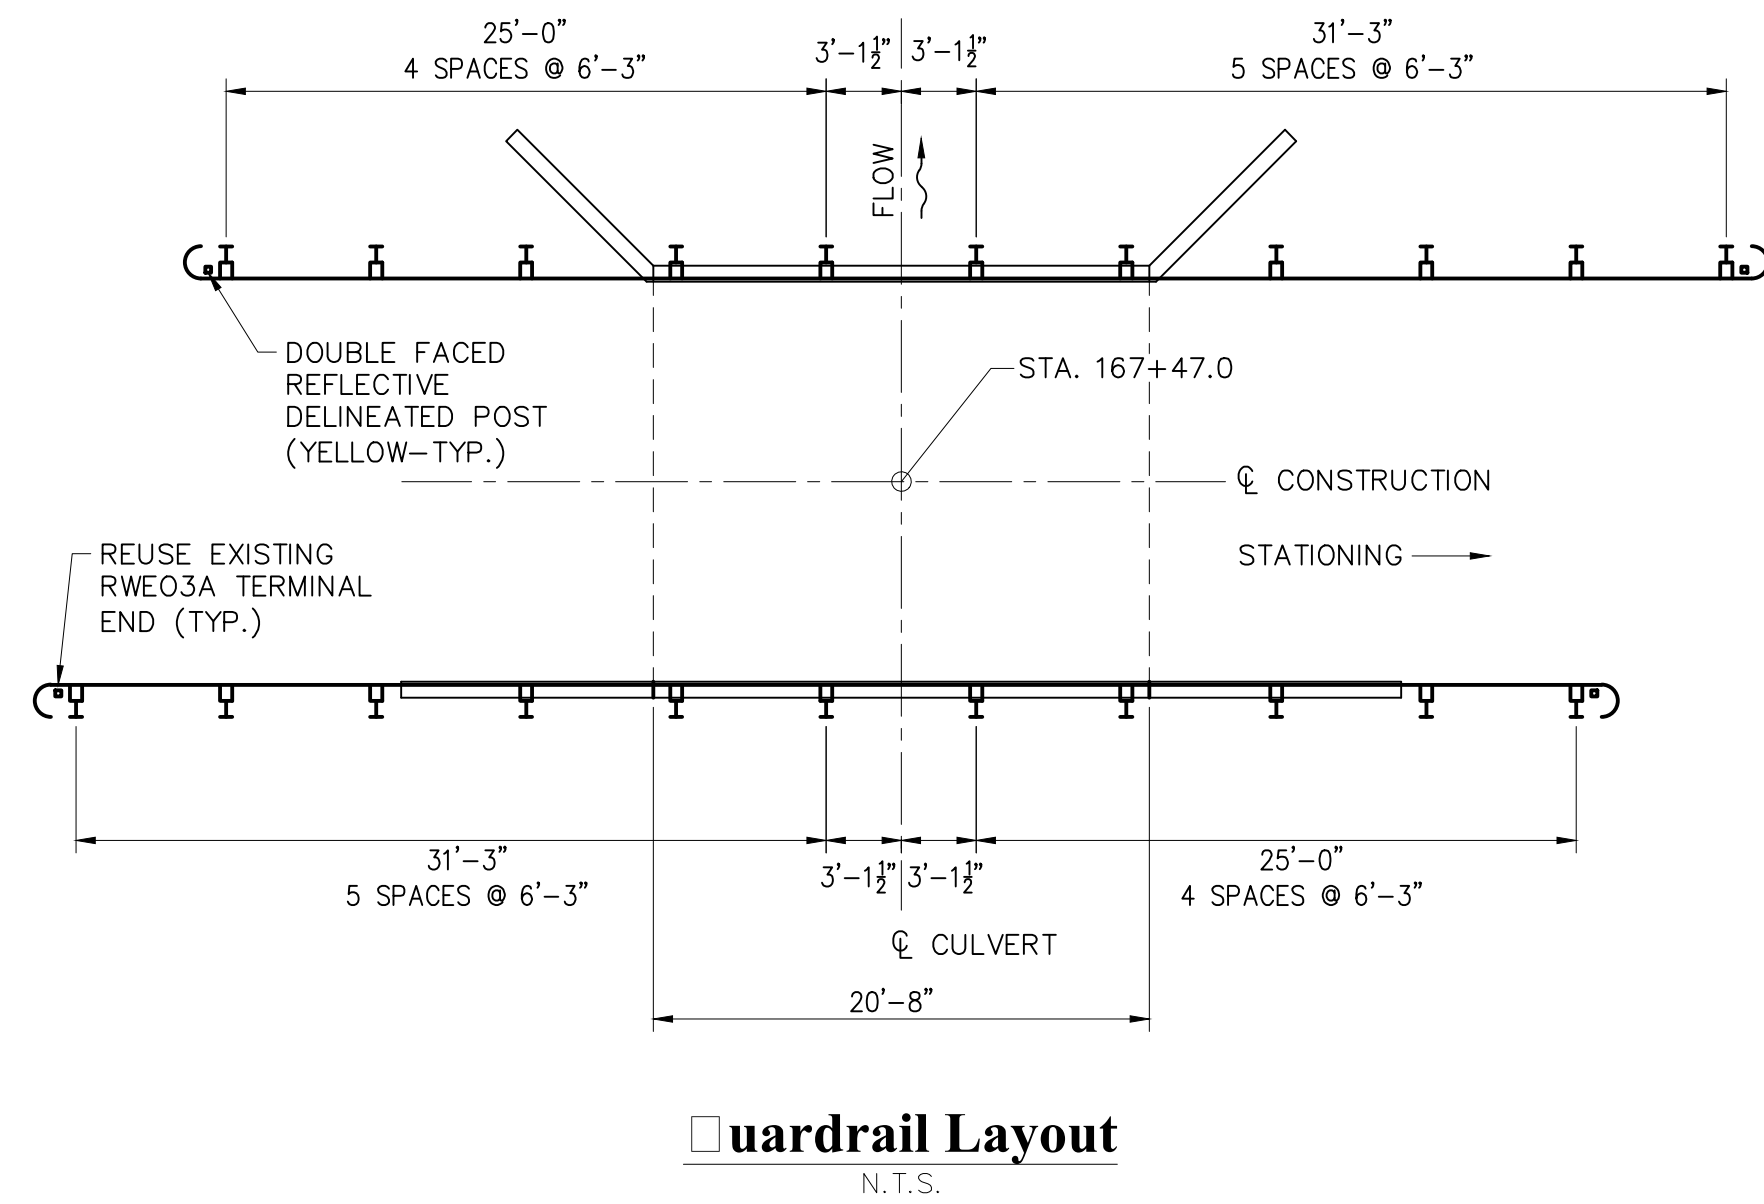
Drawing Title: **Upper Bridge Reconstruction**

- Design and Material Notes**
- FUNCTIONAL CLASSIFICATION: VERY LOW VOLUME, LIMITED ACCESS ROAD, PRIVATE.
 - LIVE LOAD = HL-93, MODIFIED WITH 25% INCREASE IN TRUCK OR TANDEM PORTION OF LOADING.

- HYDRAULIC DATA:
 - A. DRAINAGE AREA = 0.83 SQUARE MILES
 - B. Q2 = 69 CFS; Q10 = 172 CFS; Q25 = 239 CFS; Q100 = 362 CFS
 - C. MINIMUM CLEAR SPAN = 19 FEET (BANKFULL WIDTH X 1.2 PLUS 2 FEET)

- D. DESIGN VELOCITY = 6 FPS
 - E. DESIGN FLOOD = 25 YEAR; CHECK FLOOD (SCOUR) = 100 YEAR
 - F. DESIGN SCOUR = 2 FEET
 - G. DESIGN FREEBOARD (Q25) = 2 FEET MINIMUM

- H. Q25 ELEVATION = 1192.2; Q100 ELEVATION = 1193.1
 - FROST DEPTH = 5.5 FEET
 - A GEOTECHNICAL REPORT WAS PREPARED FOR THIS PROJECT BY S.W.COLE ENGINEERING, INC. DATED MARCH 6, 2015.

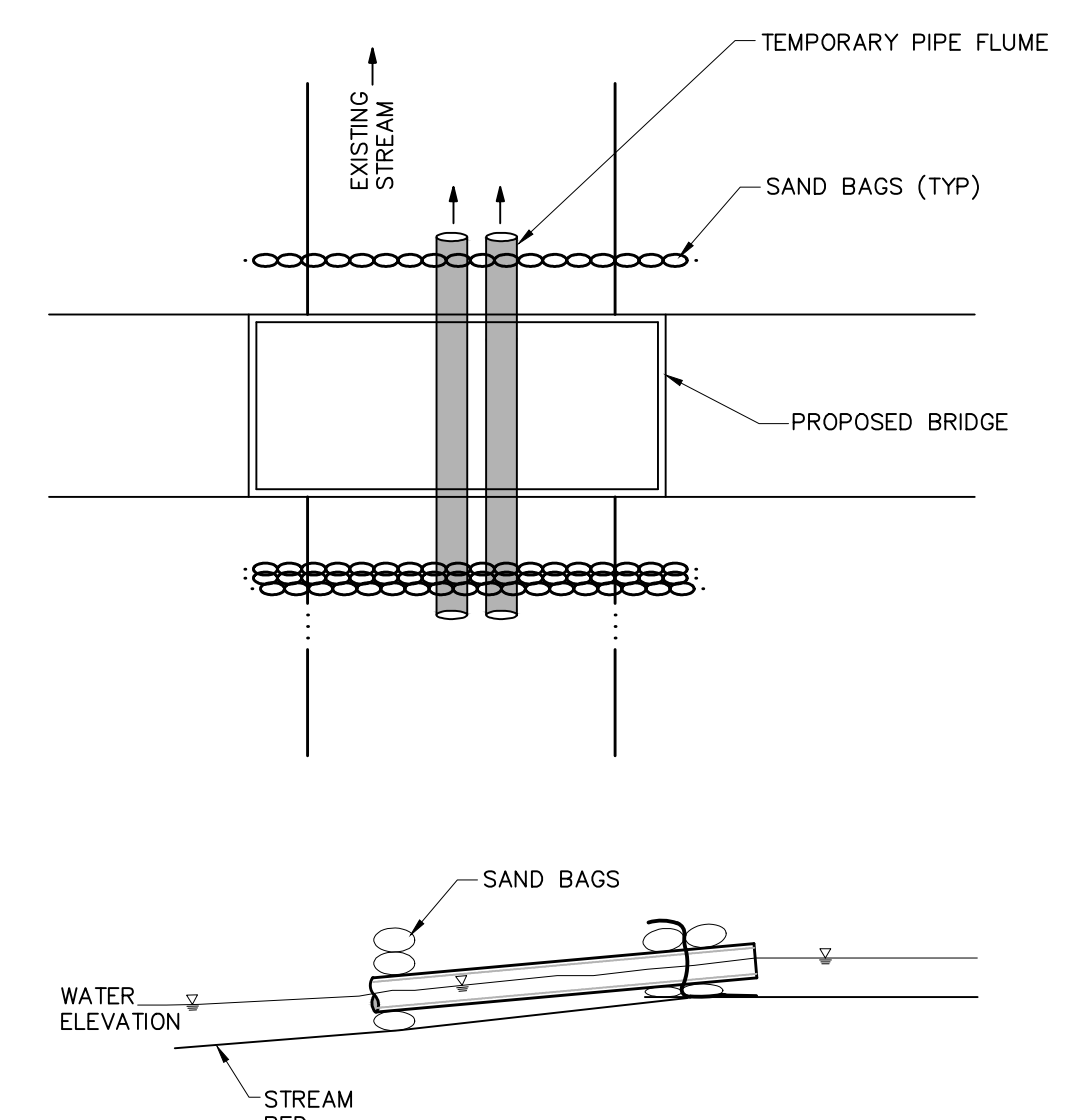
Dam and Flume For Bridge Construction

- CONSTRUCTION ACTIVITIES IN STREAMS WILL BE SCHEDULED FOR PERIODS WHEN FLOWS ARE ANTICIPATED TO BE AT A MINIMUM. IF THERE IS FLOWING WATER DURING CONSTRUCTION THE FLOW SHALL BE DIVERTED AROUND THE WORK SITE IN A STABLE MANNER USING METHODS APPROVED BY THE ENGINEER.
- ONCE SANDBAGS ARE IN PLACE, A TEMPORARY FLUME WILL BE PLACED TO CONVEY ANY FLOW AROUND THE WORK SITE, AS NEEDED.
- COFFERDAMS AND FLUME WILL BE REMOVED AFTER BRIDGE IS INSTALLED. COMPLETE REMOVAL IMMEDIATELY AFTER BRIDGE INSTALLATION, WITHIN ONE DAY WHENEVER POSSIBLE.
- TREES SHALL BE SELECTIVELY TRIMMED ALONG BANKS (IF APPLICABLE) OR CLEARED TO ALLOW EQUIPMENT TO OPERATE. GRUBBING OF ROOTS SHALL BE KEPT TO A MINIMUM.
- DETAIL PROVIDED FOR GENERAL INFORMATION ONLY. THE CONTRACTOR SHALL MODIFY AS NECESSARY TO ACHIEVE REQUIRED DEWATERING OF WORK AREA.

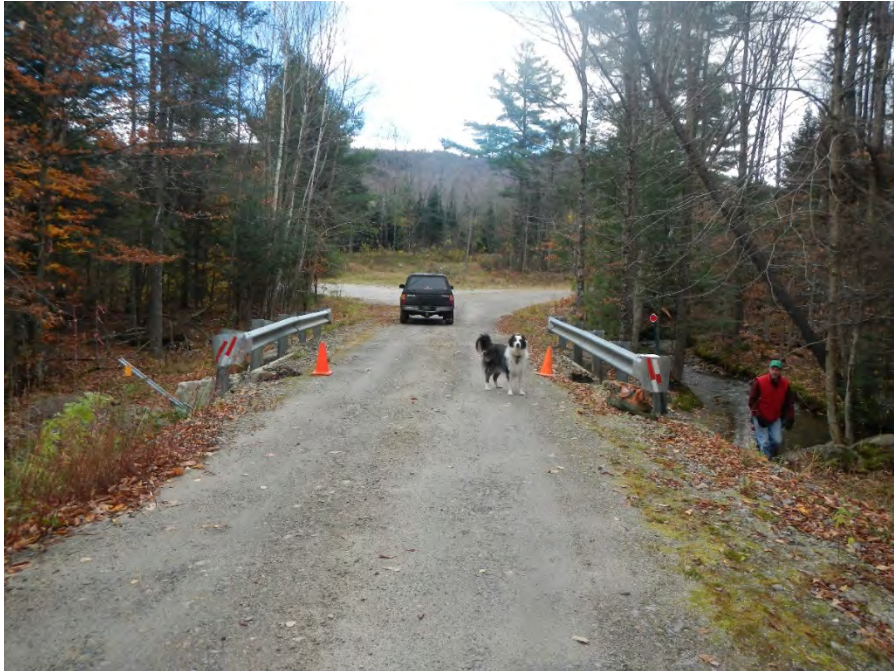
Photo 1: Pre-Emergency Authorization- Looking southeast along Groton Hollow Road, Upper Bridge Crossing of Clark Brook.

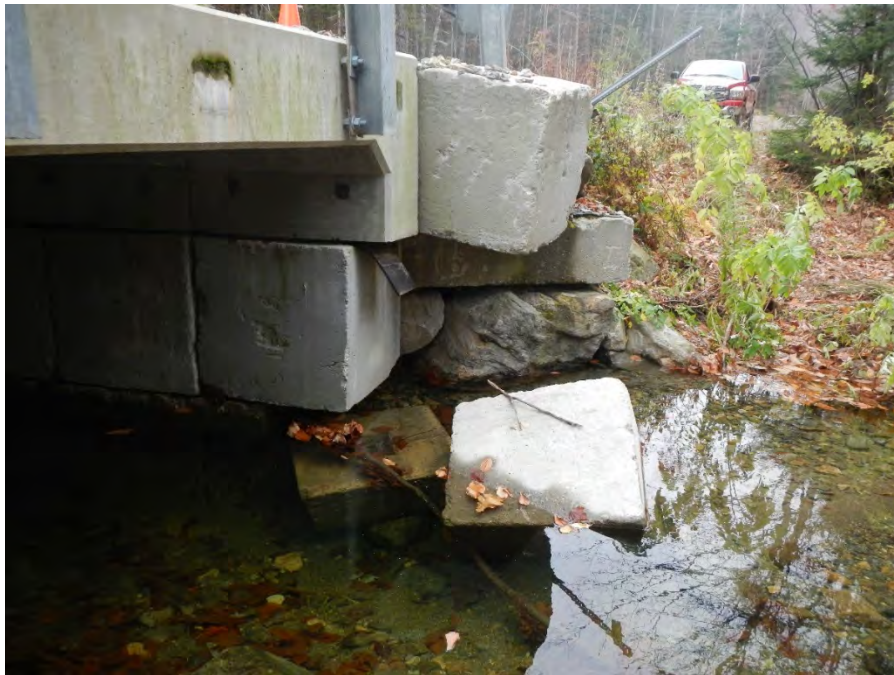
Photo 2: Pre-Emergency Authorization - Looking west at Northwest corner of abutment #1 (downstream side)

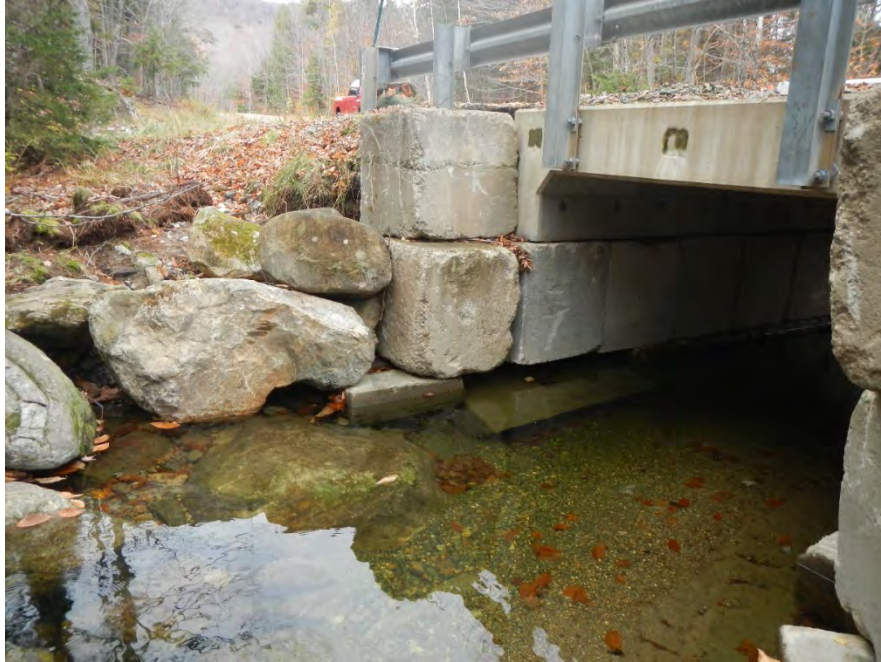
Photo 3. Pre- Emergency Authorization - Looking north at the southwest corner of abutment #1 (upstream side)

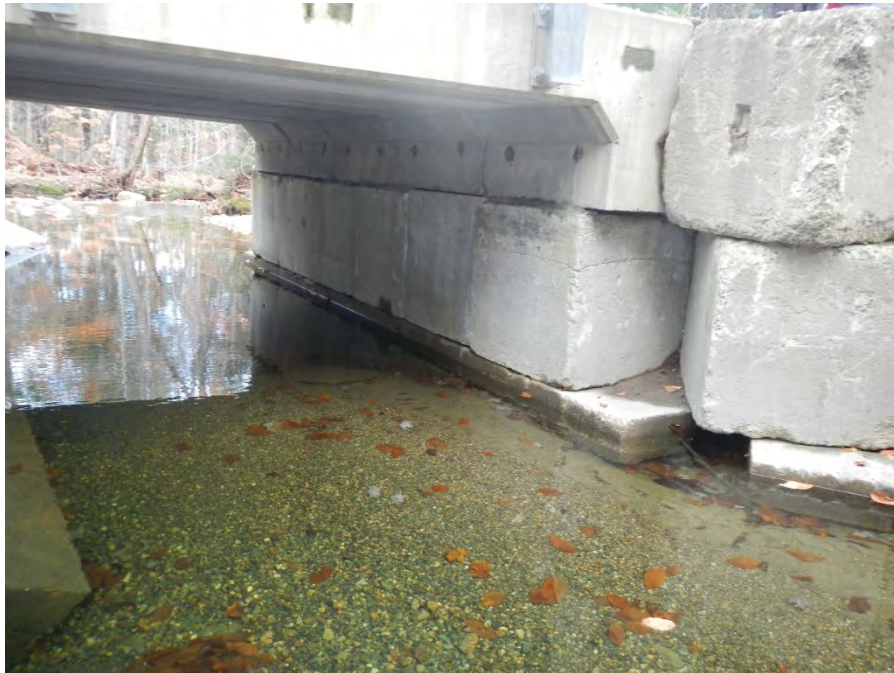
Photo 4. Pre- Emergency Authorization - Looking downstream along abutment #2

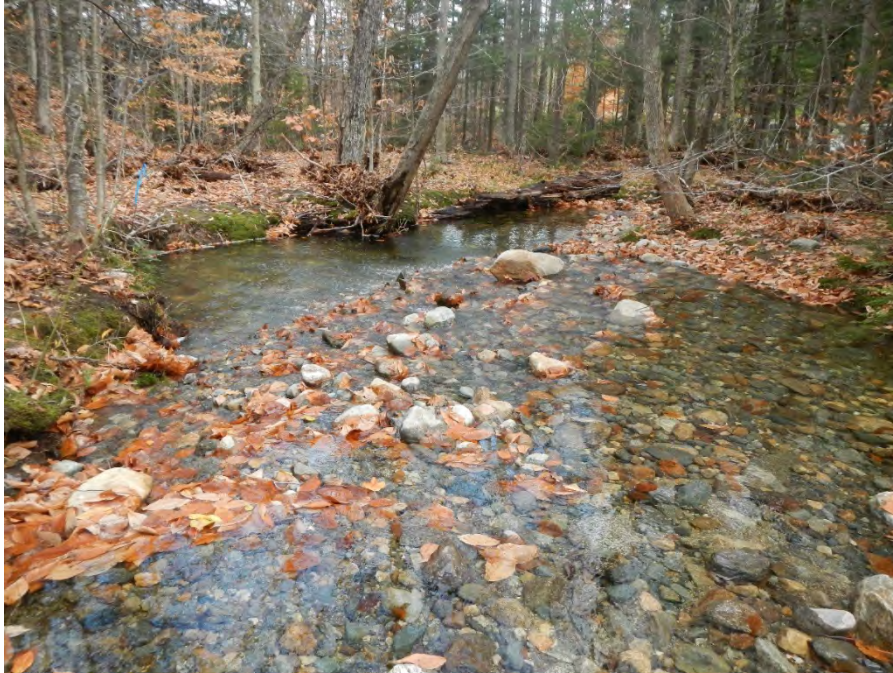
Photo 5. Pre- Emergency Authorization - Looking downstream from bridge.

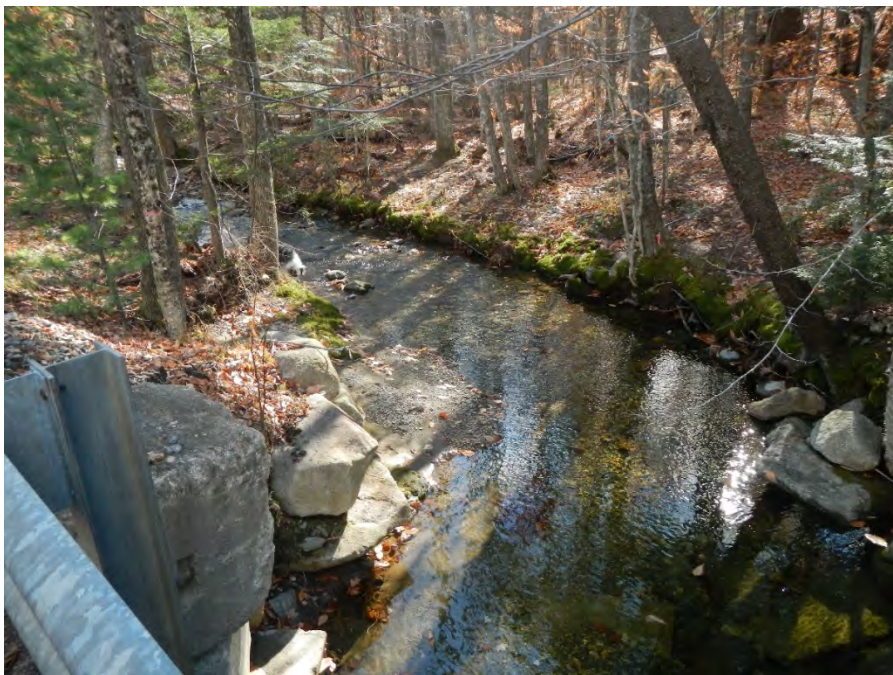
Photo 6. Pre- Emergency Authorization - Looking upstream from bridge.

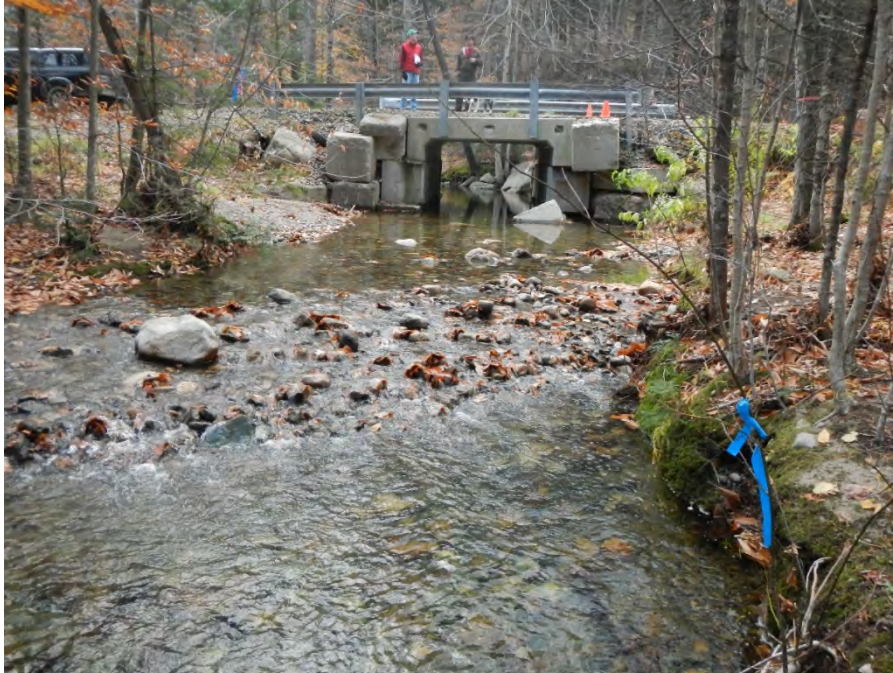
Photo 7. Pre- Emergency Authorization - Looking upstream toward bridge.

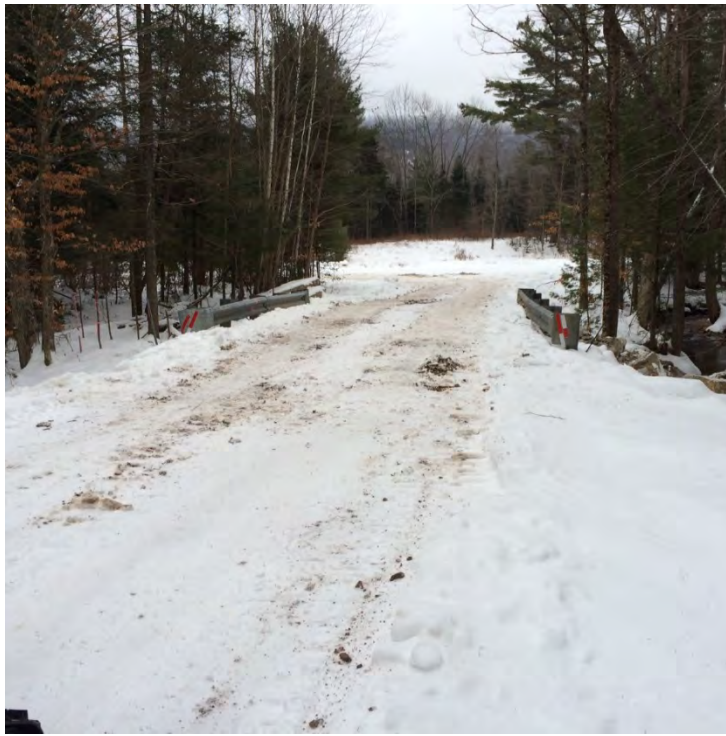
Photo 8. Post- Emergency Authorization - Looking southeast along Groton Hollow Road, Upper Bridge Crossing of Clark Brook

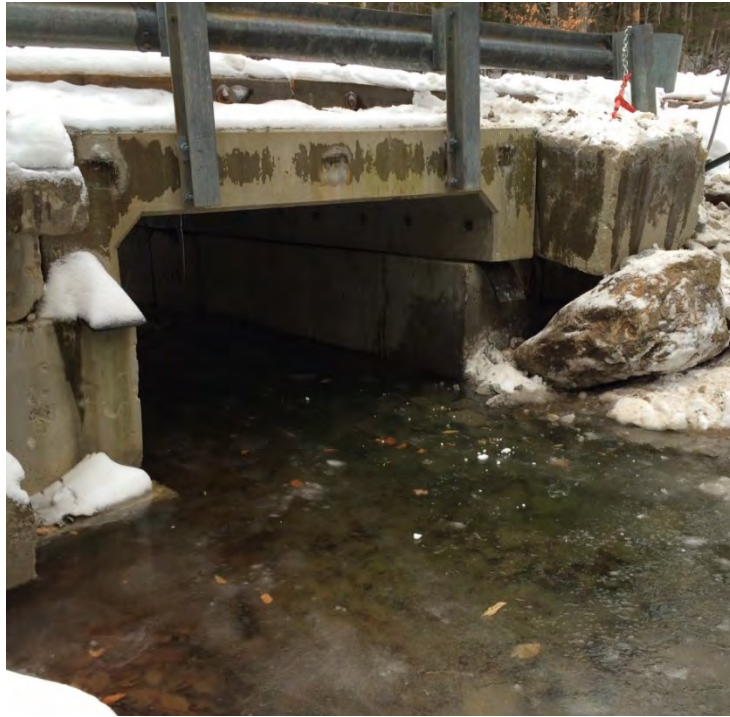
Photo 9. Post- Emergency Authorization - Looking west at Northwest corner of abutment #1 (downstream side).

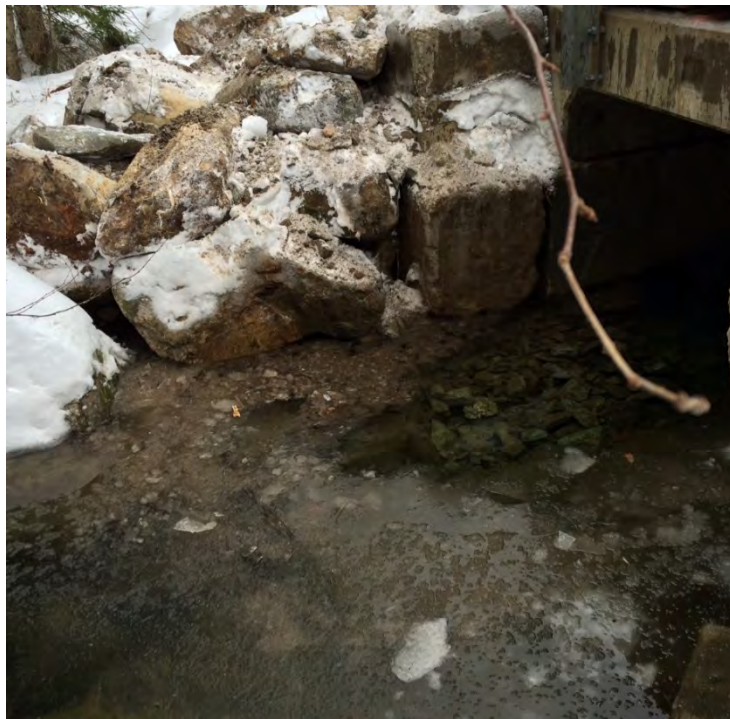
Photo 10. Post- Emergency Authorization - Looking north at the southwest corner of abutment #1 (upstream side)

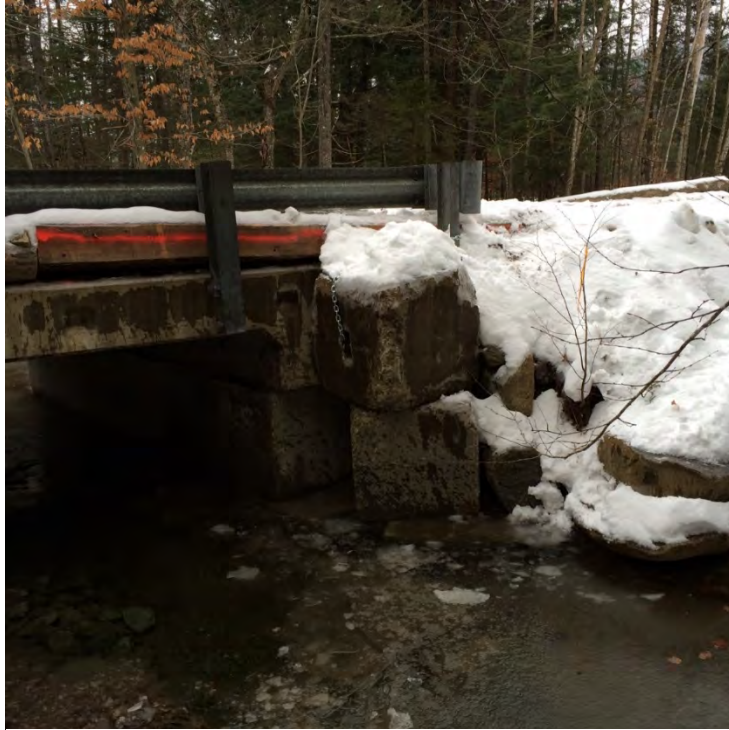
Photo 11. Post- Emergency Authorization - Looking downstream along abutment #2

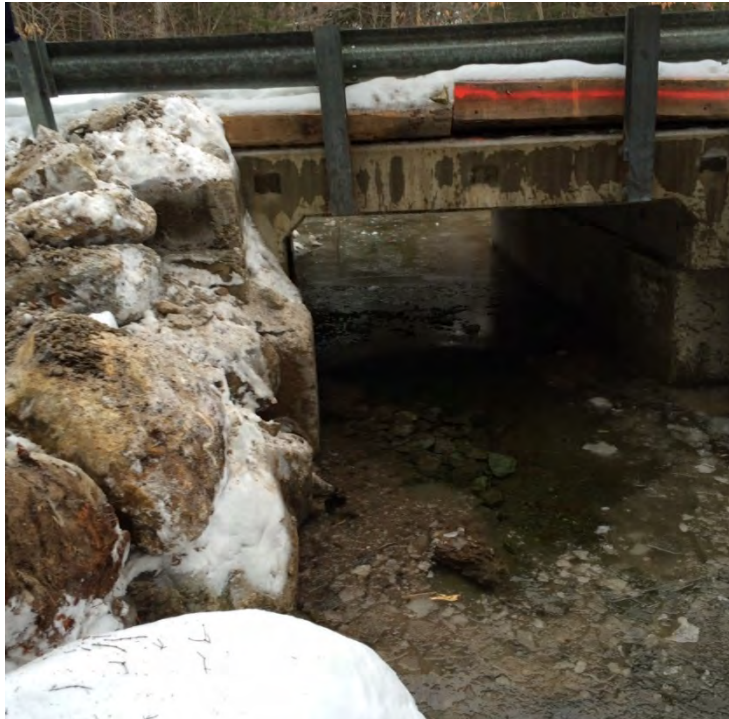
Photo 12. Post- Emergency Authorization – Looking downstream along abutment #1

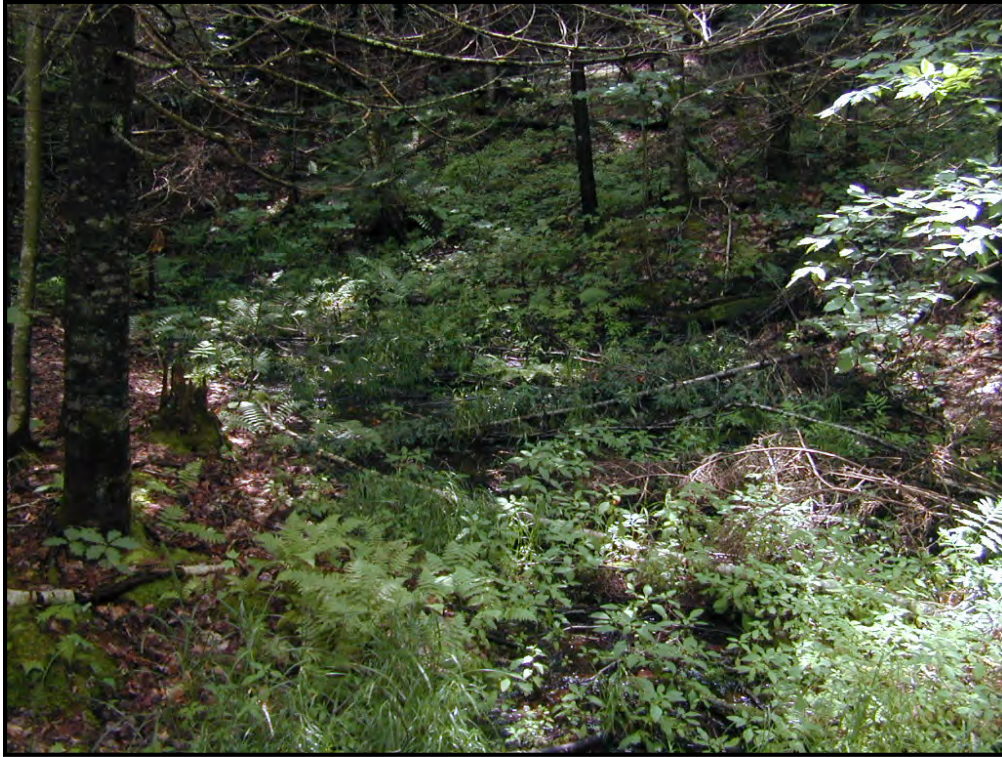
Photo 13: Wetland GH-8 (PFO1E), located within the project area to the southwest of the existing bridge. 140 square feet of permanent impact area proposed in this area.
