SEACOAST RELIABILITY PROJECT VISUAL ASSESSMENT

EXHIBIT 5A: EXISTING CONDITIONS AT LITTLE BAY, DURHAM (SHEET 2 OF 3) SEACOAST RELIABILITY PROJECT VISUAL ASSESSMENT

EXHIBIT 5A: VISUAL SIMULATION OF PROPOSED CONDITIONS AT LITTLE BAY, DURHAM (SHEET 3 OF 3) SEACOAST RELIABILITY PROJECT VISUAL ASSESSMENT

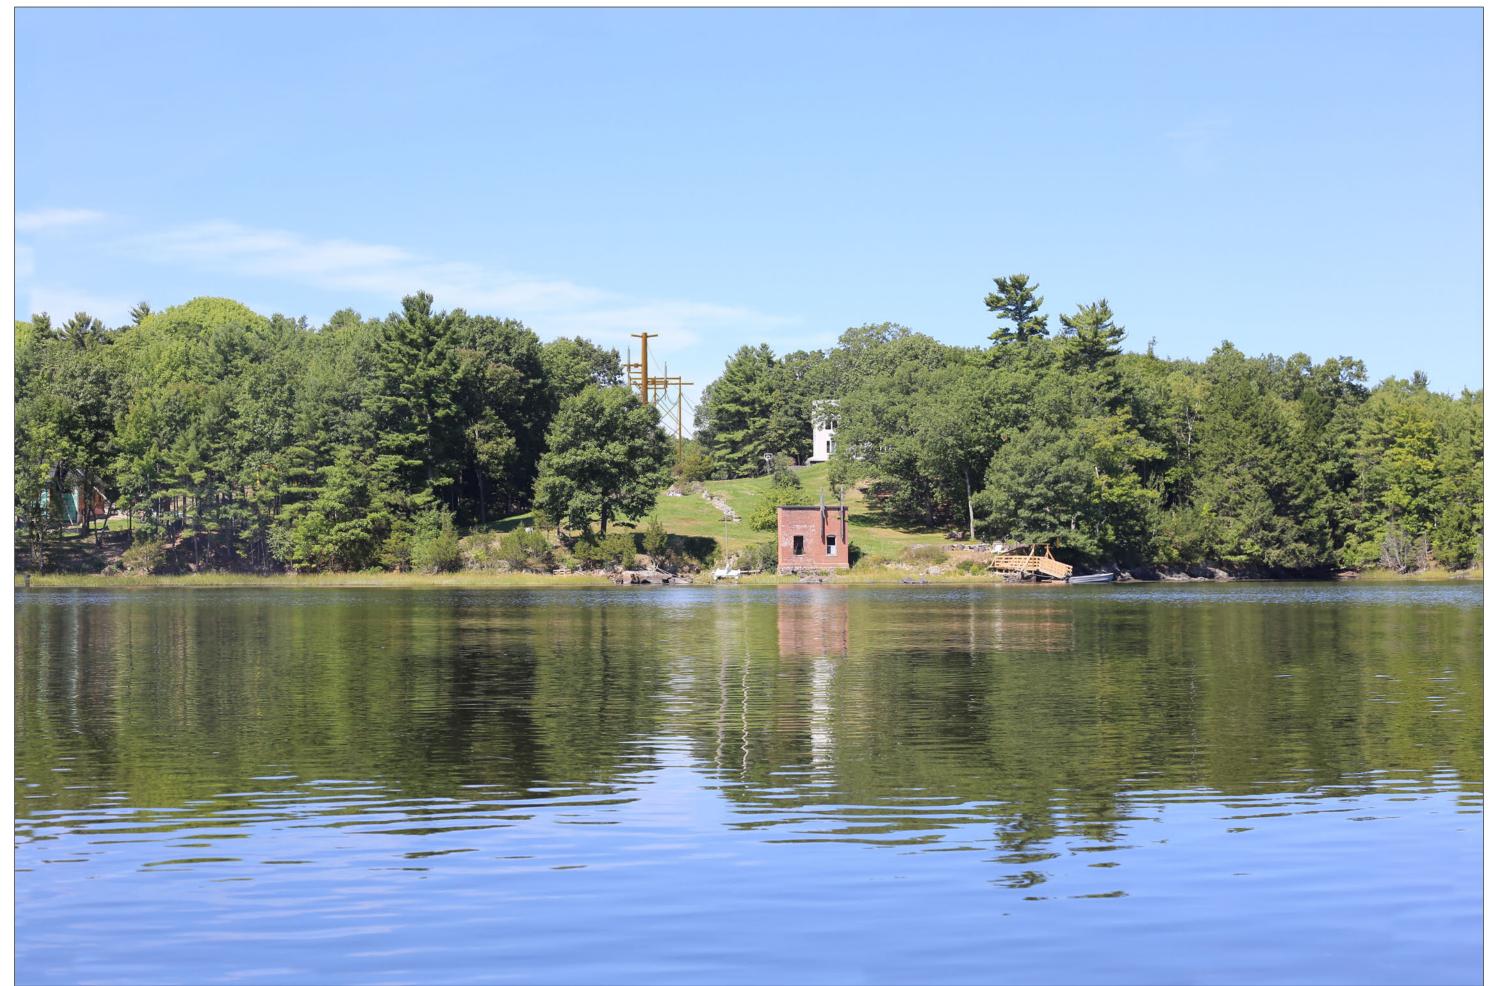
Visible structure type: Weathering steel monopole, 3-pole Visible structure numbers: F107-100, F107-101 Height range of proposed transmission structures (vis ble): 70' (21.3 m) Height range of existing transmission structures (visible): N/A Right of way width: 100'

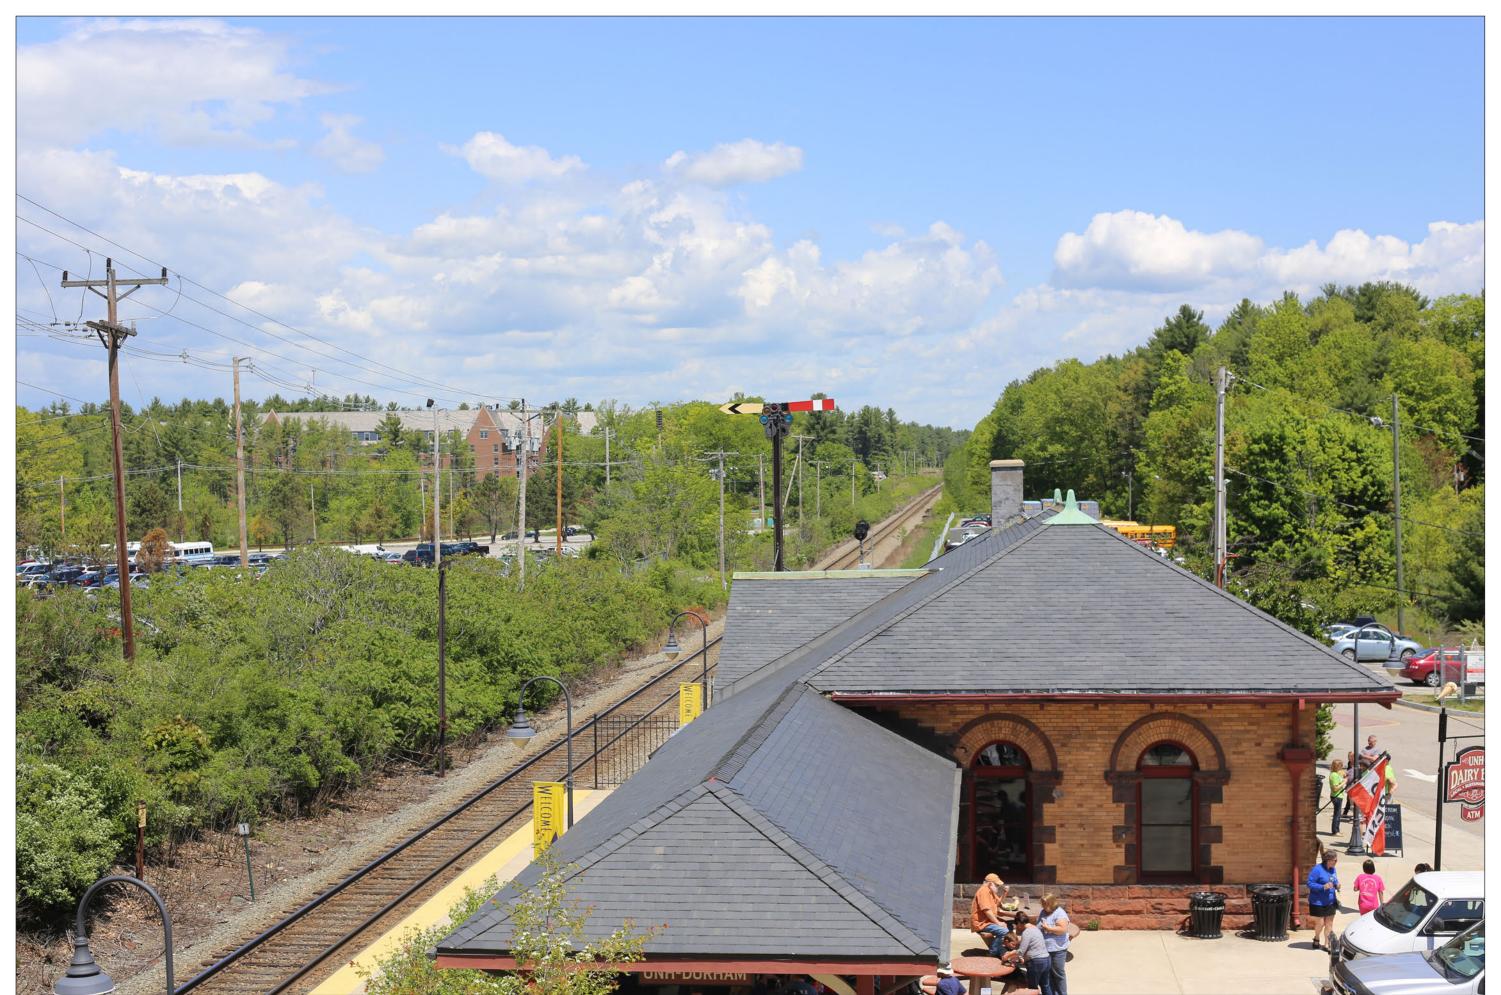
EXHIBIT 8A: EXISTING CONDITIONS FROM DURHAM MAIN STREET/UNH DAIRY BAR, DURHAM, NH (SHEET 2 OF 3) SEACOAST RELIABILITY PROJECT VISUAL ASSESSMENT

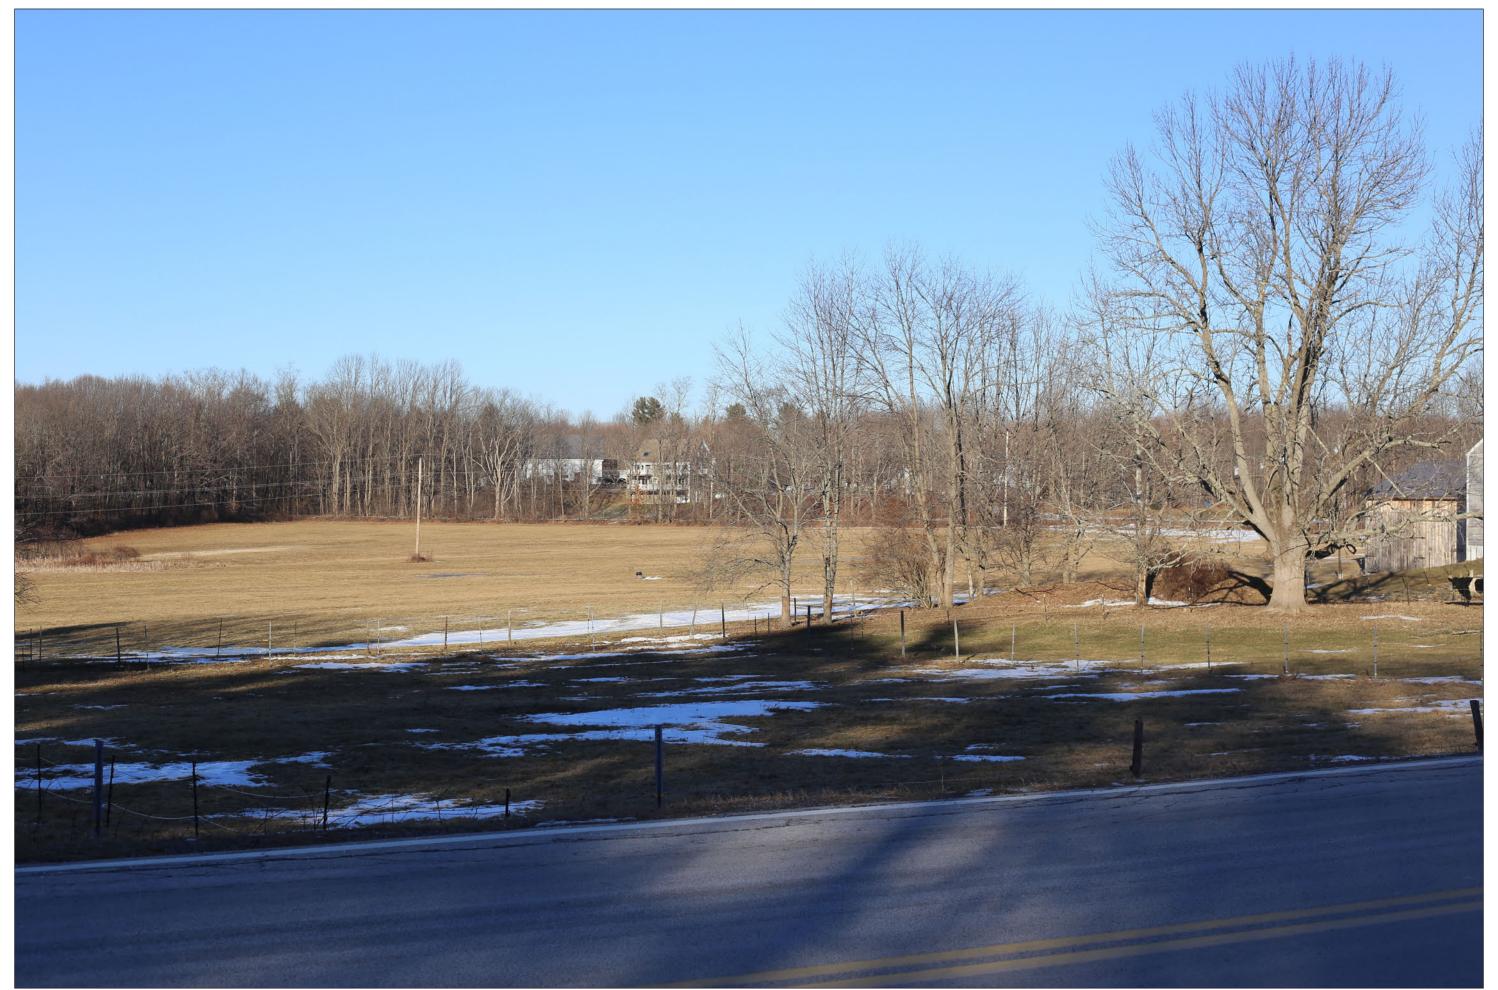
EXHIBIT 12A: EXISTING CONDITIONS AT LITTLE BAY ROAD (FRINK FARM), NEWINGTON (SHEET 2 OF 3) SEACOAST RELIABILITY PROJECT VISUAL ASSESSMENT

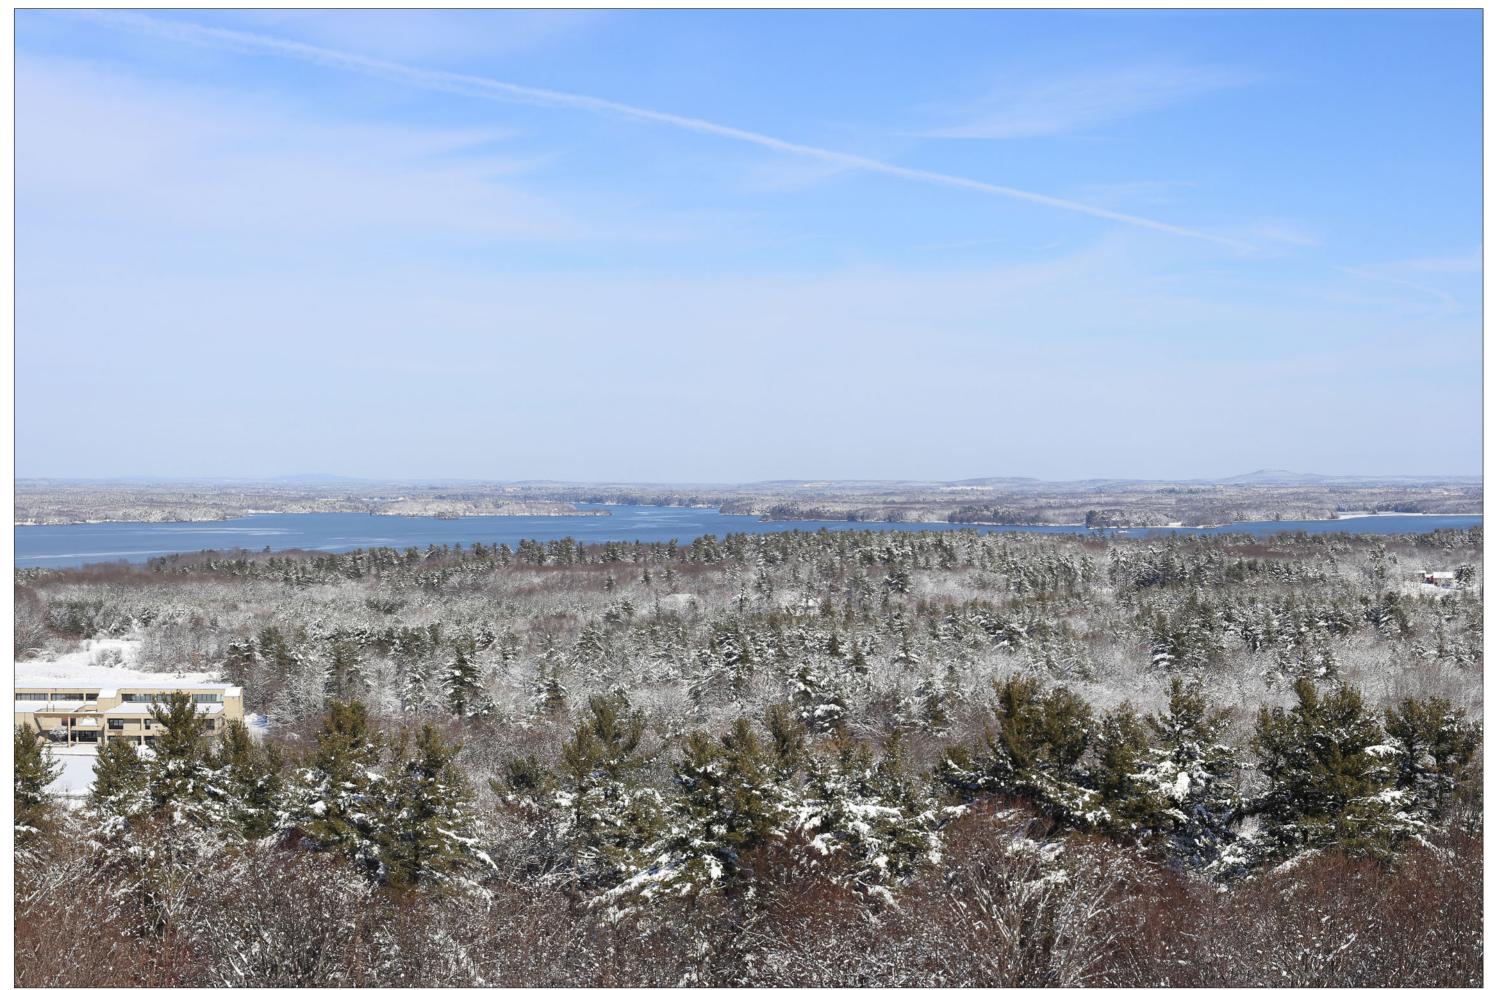
EXHIBIT 13A: EXISTING CONDITIONS AT STRATHAM HILL PARK, STRATHAM (SHEET 2 OF 3) SEACOAST RELIABILITY PROJECT VISUAL ASSESSMENT

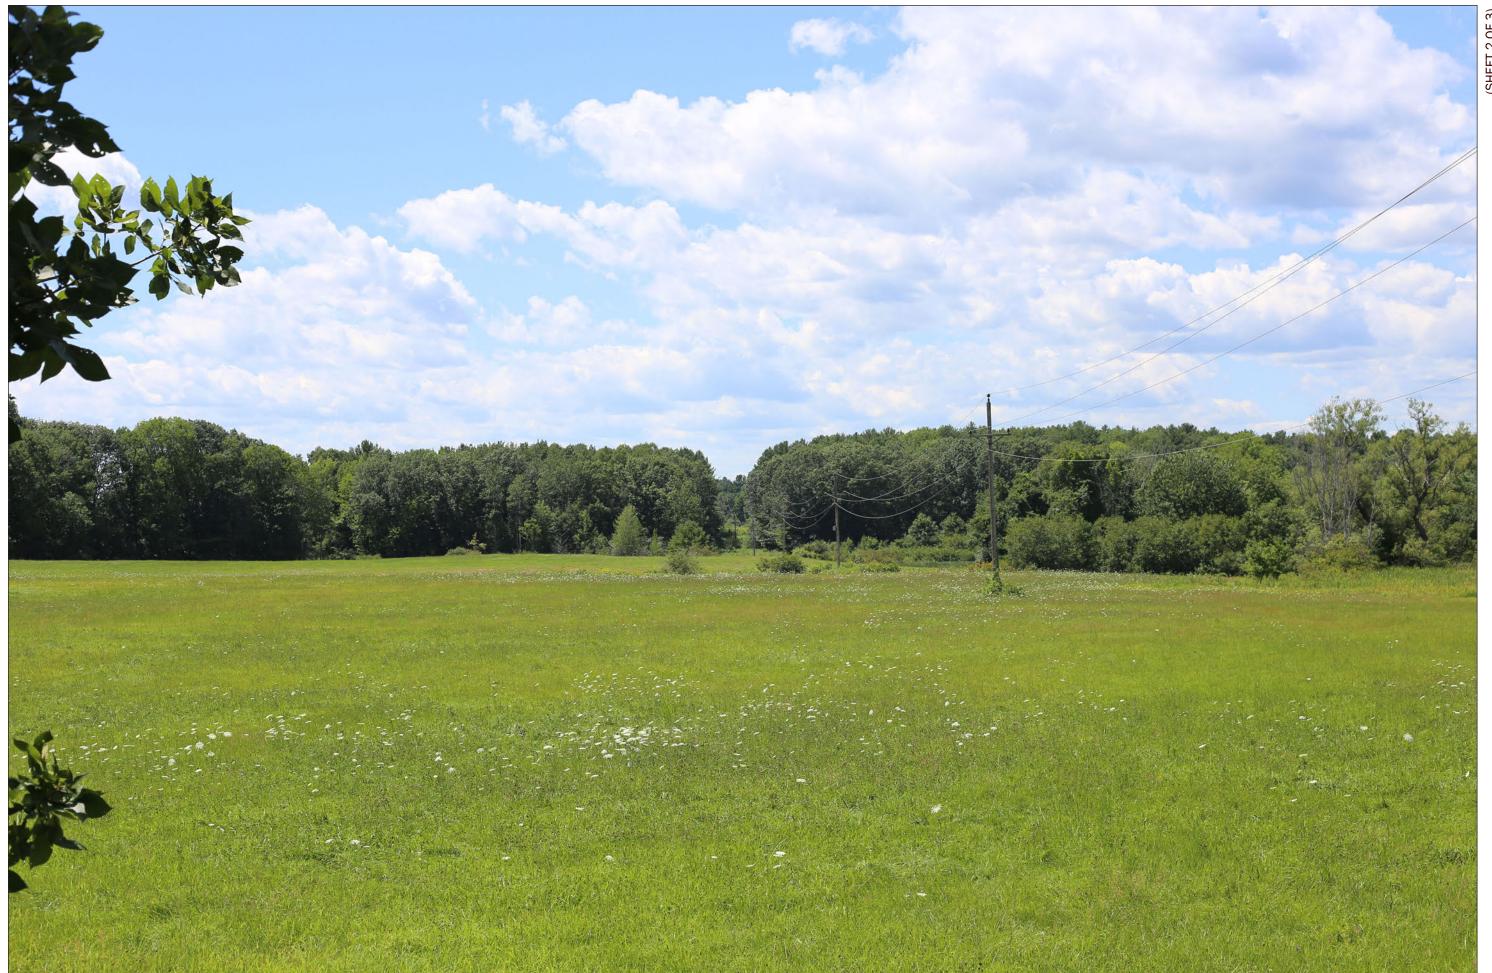
EXHIBIT 20A: EXISTING CONDITIONS AT FRINK FARM AT NIMBLE HILL ROAD & HANNAH LANE, NEWINGTON, NH
SEACOAST RELIABILITY PROJECT VISUAL ASSESSMENT
