SEACOAST RELIABILITY PROJECT VISUAL ASSESSMENT

EXHIBIT 5A: EXISTING CONDITIONS AT LITTLE BAY, DURHAM (SHEET 2 OF 3) SEACOAST RELIABILITY PROJECT VISUAL ASSESSMENT

EXHIBIT 5A: VISUAL SIMULATION OF PROPOSED CONDITIONS AT LITTLE BAY, DURHAM (SHEET 3 OF 3) SEACOAST RELIABILITY PROJECT VISUAL ASSESSMENT

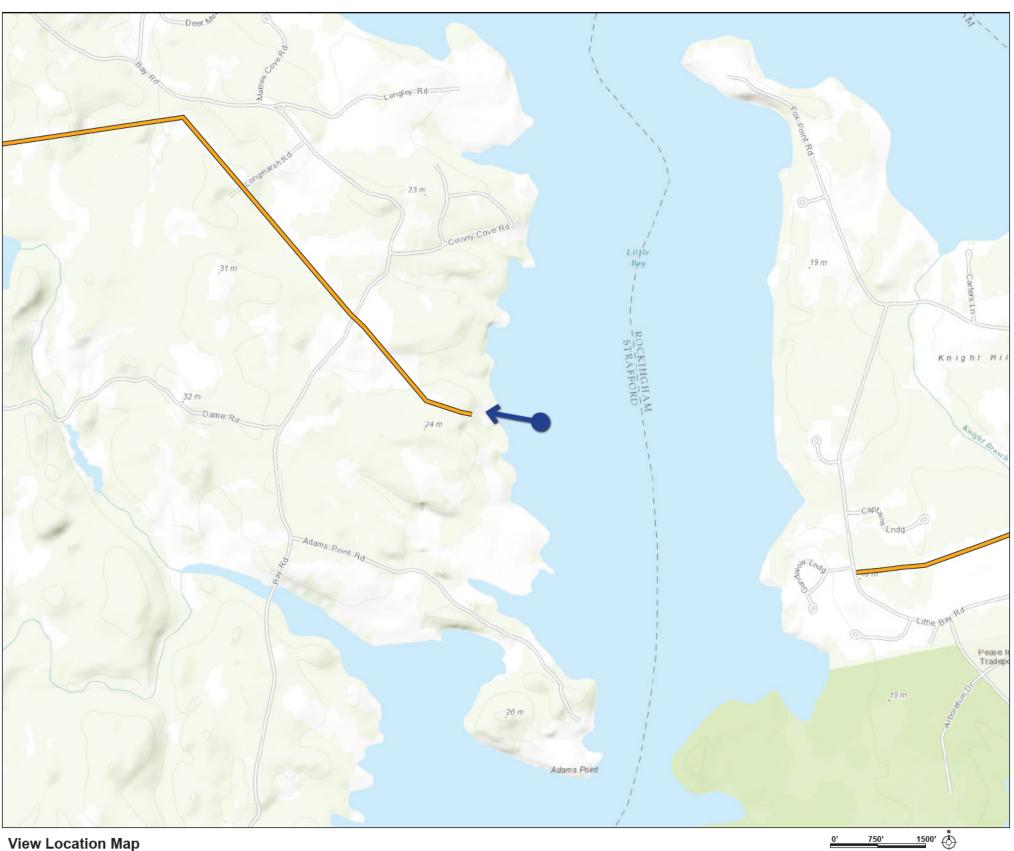
View Location Name: Exhibit 5A
Location: Little Bay, Durham, NH
Classification: Resource
Orientation: West/Northwest
Latitude/Longitude: 43.105286°, -70.868028°
Camera elevation above sea level: 3.00′ (0.91 m)
Simulation viewing distance: 21.3 in (54.102 cm)
Distance to nearest visible structure: 0.17 miles (0.27 km)
Distance to furthest visible structure: 0.22 miles (0.35 km)

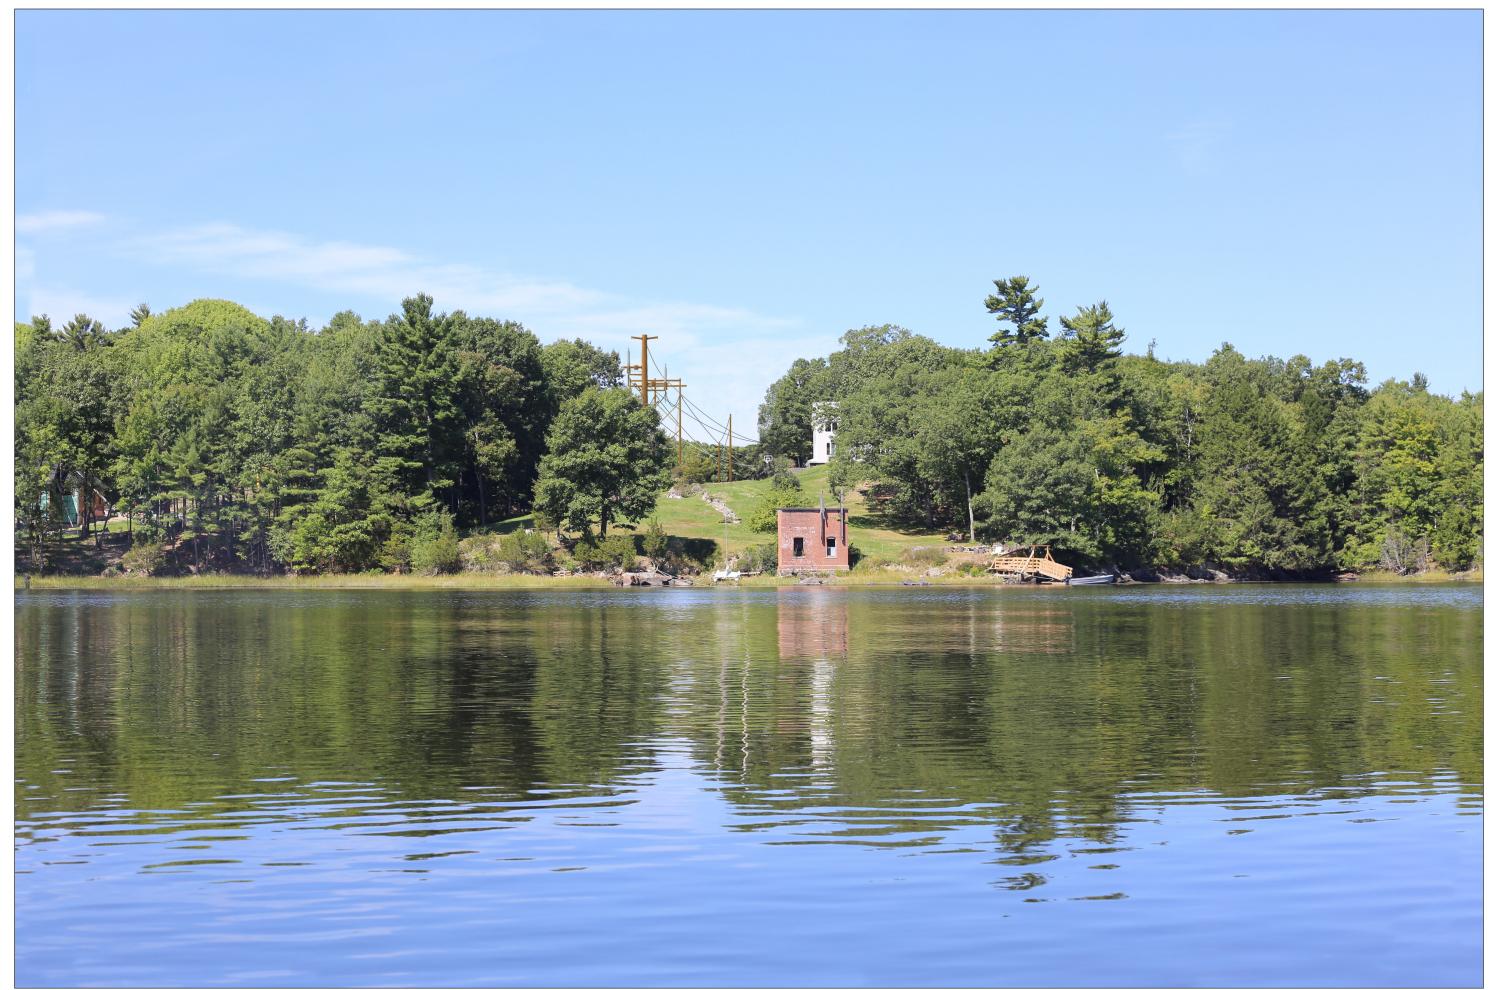
Visible structure type: Weathering steel monopole, 3-pole Visible structure numbers: F107-100, F107-101 Height range of proposed transmission structures (visible): 70' (21.3 m) Height range of existing transmission structures (visible): N/A Right of way width: 100'

2. This simulation depicts structures, conduc-

tors, and technical equipment as well as

visibility of any associated clearing.
