CONSTRUCTION MONITORING REPORT

Eversource Transmission Lines:
F107

**Madbury, Durham,
Newington, Portsmouth,
NH**

NAI Project No:
23840.39

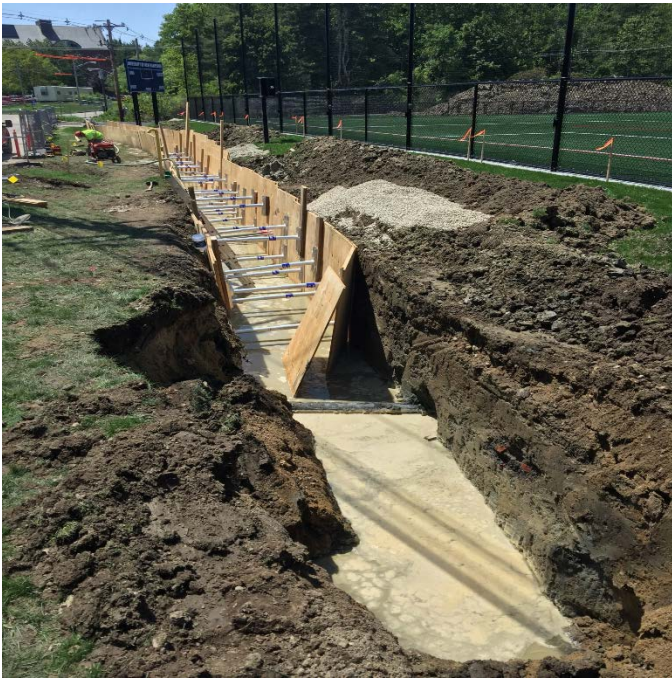
- While excavating along the cable trench alignment on June 3, 2019, McCourt struck and broke an unmarked waterline next to Colovos Rd at UNH. The scene was properly secured and the correct personnel were notified. To access the pipe for repair, the crew pumped the water from the trench to a rain garden just south of their trench.
- The straw waddle along trenching activities in A lot overtopped again in the storm event on Jun 5th, 2019.

Fig 1: The trench that was flooded due to the water line break. Viewing south. (Approx. 1330 on Jun 3, 2019).

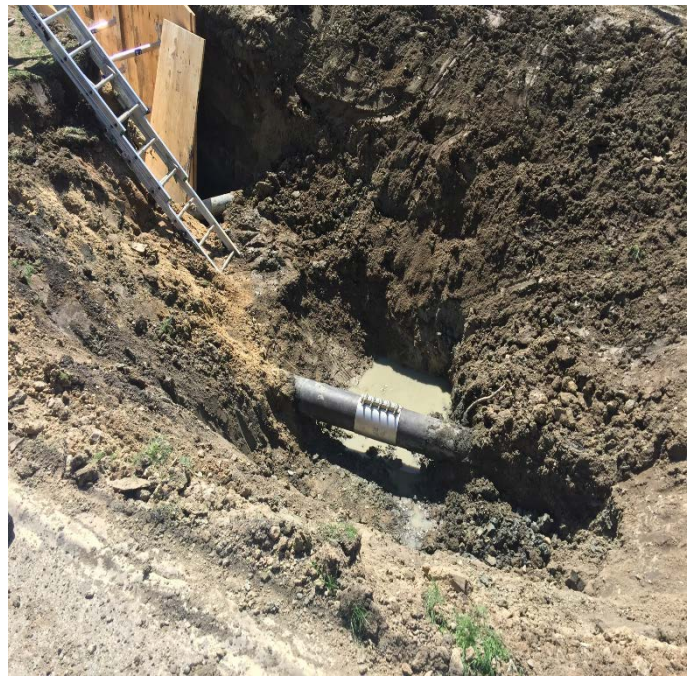
Fig 2: The water line repair patch. Viewing west. (Approx. 1330 on Jun 3, 2019).

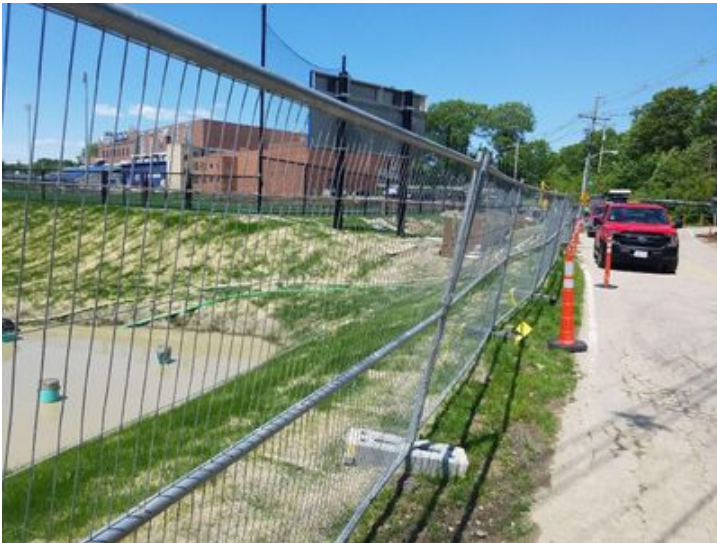
- The water from the broken main that was pumped out of the trench and into the rain garden was turbid due to the high silt and clay content in the soil.

Fig 3: McCourt pumped the water out of the trench and discharged into the Rain garden along Colovos Rd. Viewing north. (Approx. 1330 on Jun 3, 2019).

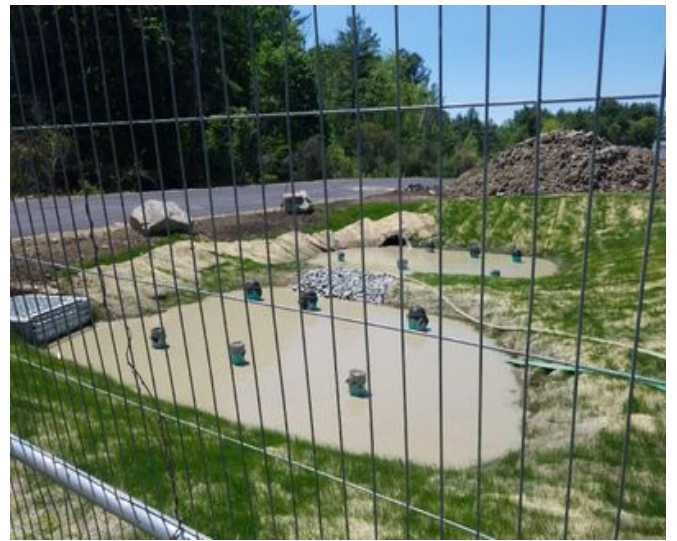
Fig 4: Rain garden along Colovos Rd. The rain garden is full of water. Viewing west. (Approx. 1330 on Jun 3, 2019).

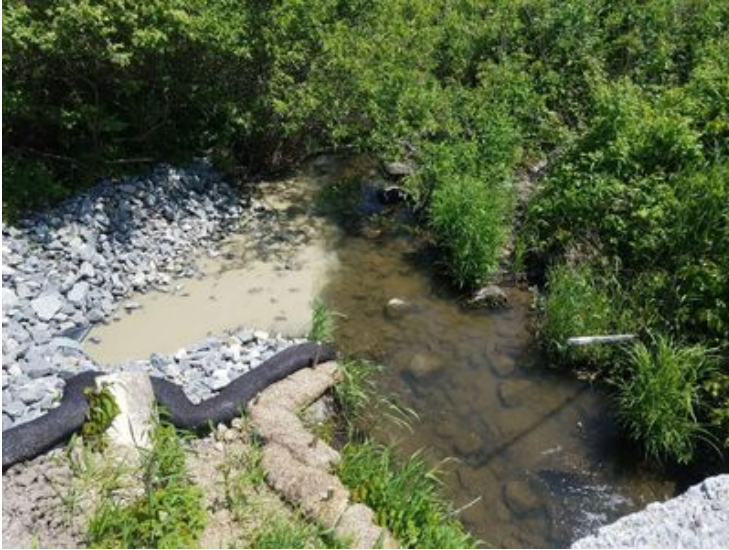
- Once capacity was reached in the rain garden, turbid water began to discharge into College brook from the rain garden's outlet structure.
- When I arrived on site I evaluated the incident and notified McCourt to stop dewatering activities.

- The turbid discharge was comprised of fine particles that do not easily settle out of suspension.
- On the following morning on June 4, 2019. No turbid discharge was observed at the rain garden outlet structure.

Fig 5: Discharge from the rain garden into College brook. Viewing east. (Approx. 1330 on Jun 3, 2019).

- Moving forward, the plan for dewatering the trench is as follows:
 - Water will be pumped across Colovos Road and discharged into the upland grassy area north of College Brook

- The discharge end of that hose will be connected to a filter bag surrounded by straw bales that are double staked and/or silt fencing.
 - Additional BMPs will be employed as needed.

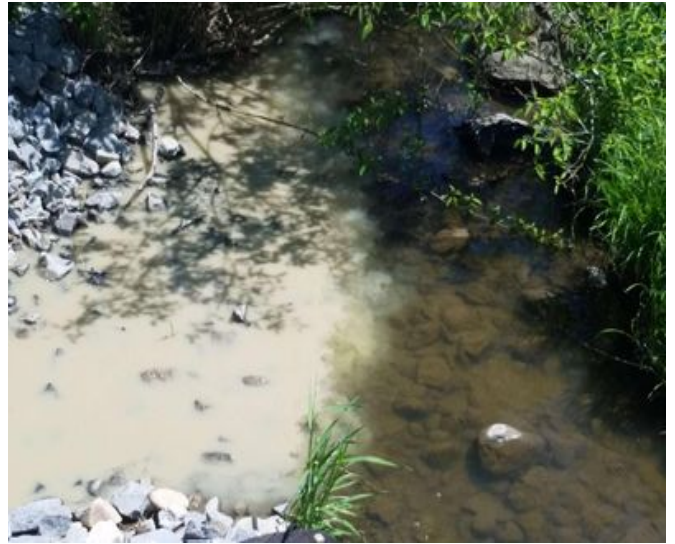
Fig 6: Discharge from the rain garden into College Brook. Viewing east. (Approx. 1330 on Jun 3, 2019).

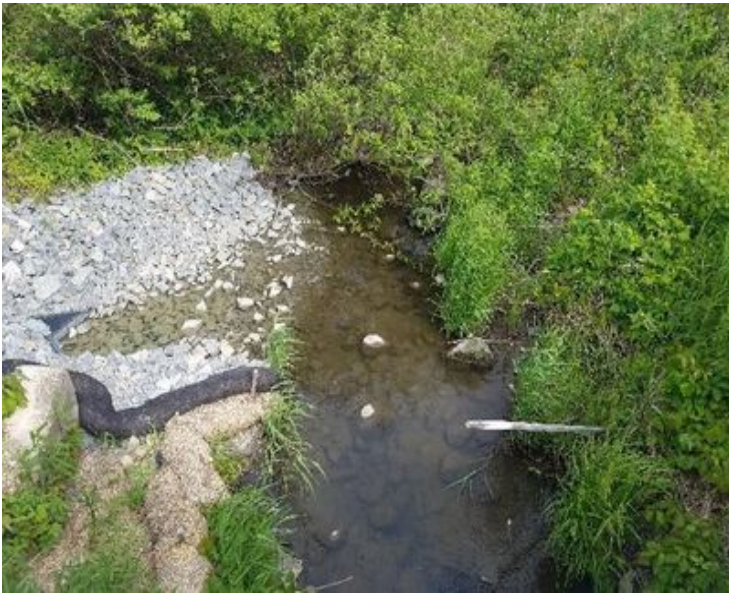
Fig 7: College Brook. There is no more sediment discharging into the Brook. Viewing east. (Approx. 0630 on Jun 4, 2019).

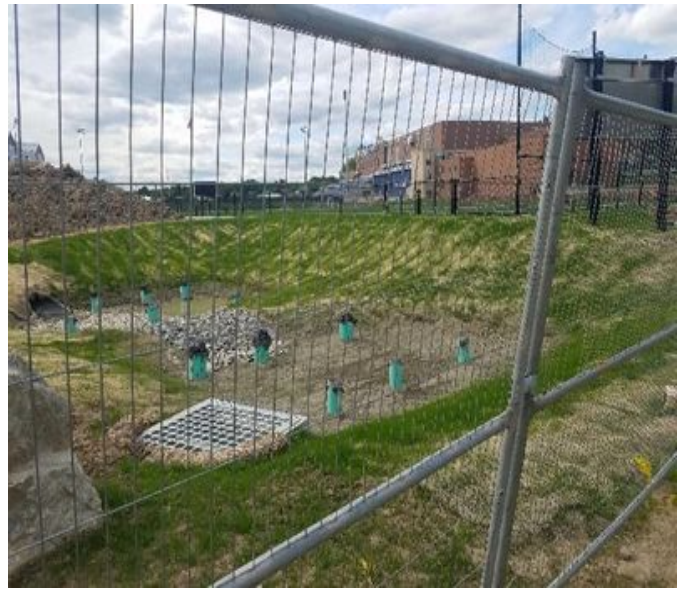
Fig 8: Rain garden. The water has drained and subsided. Viewing west. (Approx. 0630 on Jun 4, 2019).

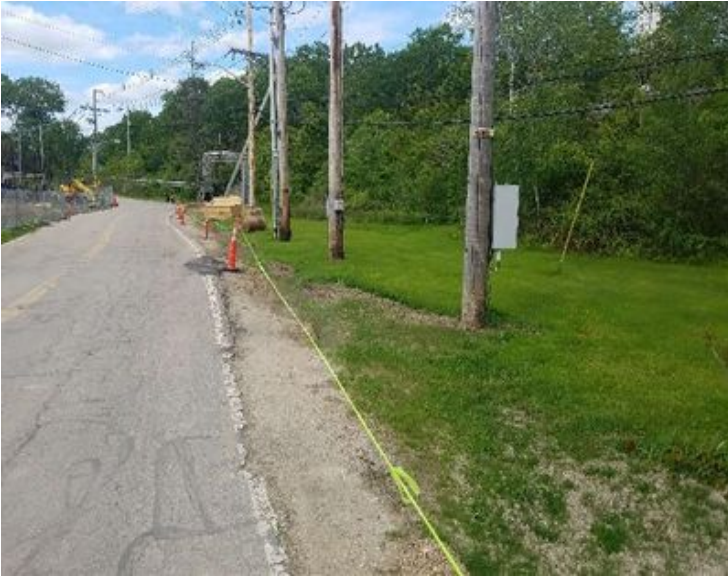
Fig 9: Proposed area east of Colovos Rd to discharge the trench water, with filter bag & BMPs installed. Viewing north. (Jun 5, 2019).

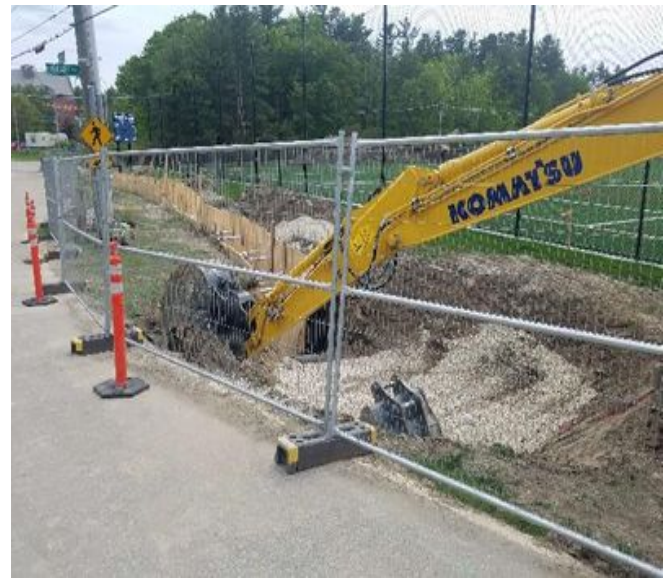
Fig 10: Repairs made and excavation filled with stone. Viewing south. (Jun 5, 2019).

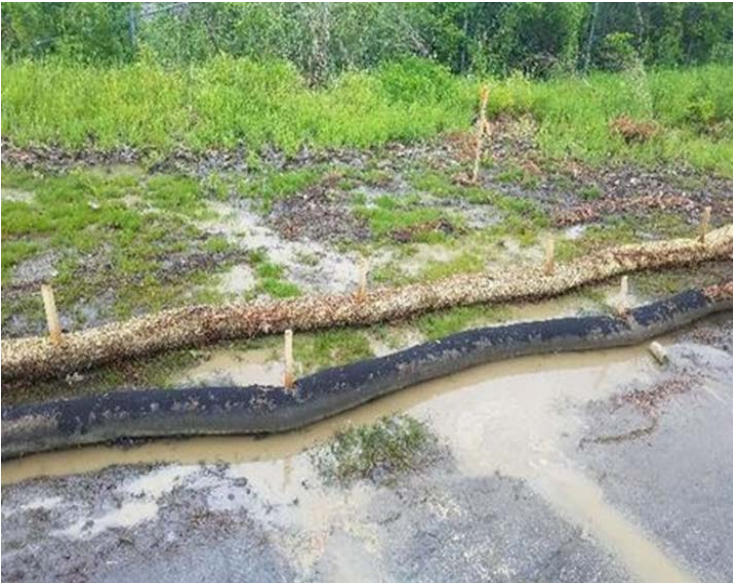
Fig 11: Low area in A lot where McCourt will install additional BMPs. Viewing east. (Jun 6, 2019).

- McCourt will not pump water until they fully install the above items, they are waiting for material.
- **BMPs**
 - Once McCourt receives the materials they will install the action item above as well as additional BMPs in the low area in A lot adjacent to their trenching activities (see photograph below)

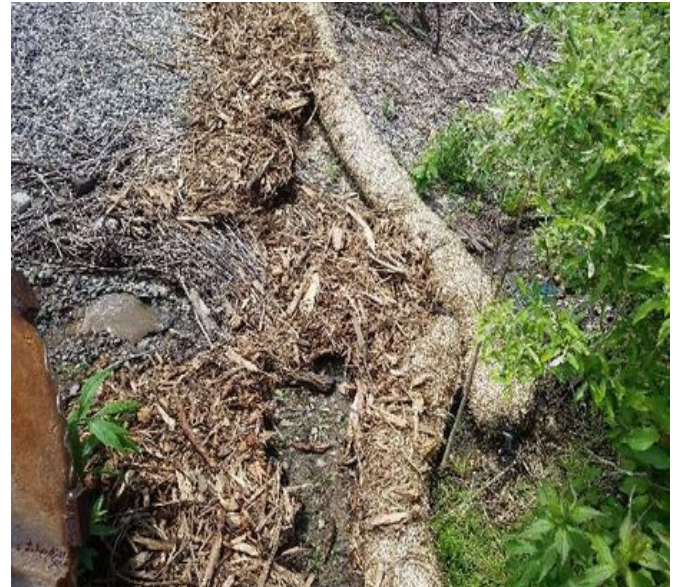
Fig 12: Straw wattle surrounding lay down yard off of Gosling Road needs to be staked in. Viewing west. (Jun 6, 2019).

- Straw waddles installed around lay down area off of Gosling Road need to be staked in, additional waddle/berm may need to be installed, (see photograph below).

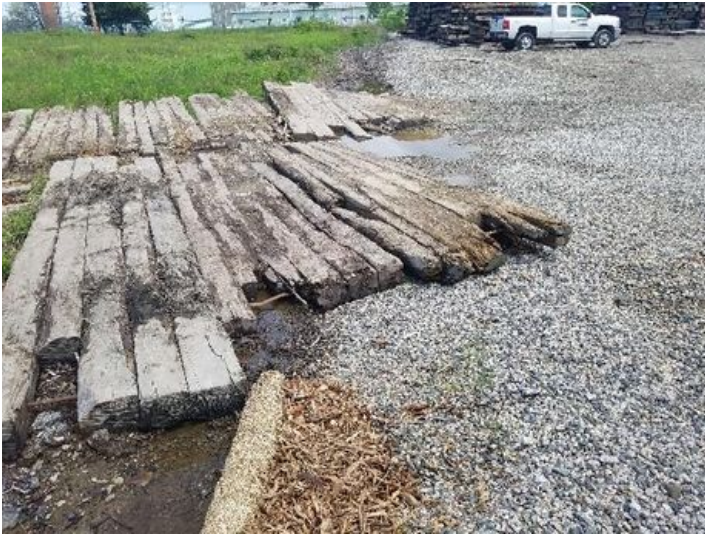
Fig 13: Area in lay down yard off of Gosling Road where additional BMPs may be required. Viewing north. (Jun 6, 2019).

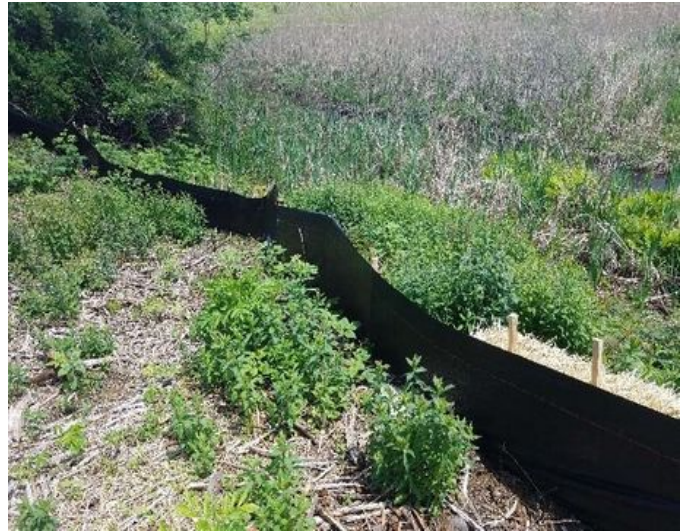
Fig 14: Silt fence near Str. F107-137 installed correctly. Viewing north. (Jun 6, 2019).
