CONSTR	UCTION MONITORI	NG REPORT	
TYPE OF INSPECTION: <u>x</u> we	eekly <u>X</u> Storm Event _	_Incident Corrective Action	Eversource Transmission Lin <u>F107</u>
Date: 06/20/19 Time: 12:00pm W If yes, how did you determine whether a 0.25" Storm event information is from Pease Air For +Storm event information (approx.): NOTE: *SWPPP for storm event on 6-13-19 was subr	storm event has occurred? ce Base. Start date: 06/13/19 Start date: 06/16/19 Start date:		Madbury, Durham, Newgington, Portsmouth, NH Alteration of Terrain Permit: SEC Docket No. 2015-004 Environmental Permit: SEC Docket No. 2015-004 USEPA NOI Tracking No: NHR1000QN NHR1000QT NHR1000QO NHR1000S6
Inspector name(s), title(s) and qualification		nandeau Environmental	NAI Project No: <u>23840.39</u>
Inspector and Marc Jacobs, CPESC, Nothers present/qualifications(s): Sam Weather conditions (since last inspection	Eames Eversource cons	·

Eversource Seacoast Reliability Project

Construction Monitoring Report #8

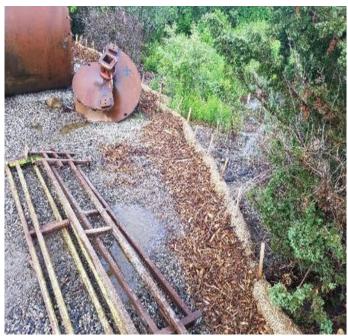
Fig 1: Combined berm installed around laydown area off of Gosling Rd. Viewing south. (6-14-19).

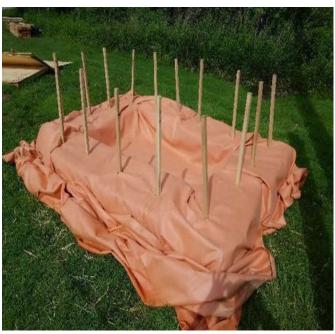
Fig 2: Dewatering apparatus installed along Colovos Rd, north of College Brook, UNH. Viewing northeast. (6-14-19).

• McCourt and I discussed leaving the dewatering apparatus as is for now until additional straw bales arrive on site. The trench dewatering plan is to slowly discharge water from the trench along Colovos Rd into the folded up filter bag that will be placed inside the already constructed dewatering apparatus. I will be on site during the initial start of dewatering the trench to inspect the dewatering activities. If the filter bag or the dewatering apparatus isn't properly filtering out the water from the trench then McCourt will stop pumping water and expand the dewatering apparatus to an approximate size of 14'X14' to encase the 12'X12' filter bag that they are using. This will give the filter bag more room to expand within the apparatus and more efficiently filter the discharged water, see fig 2 below.

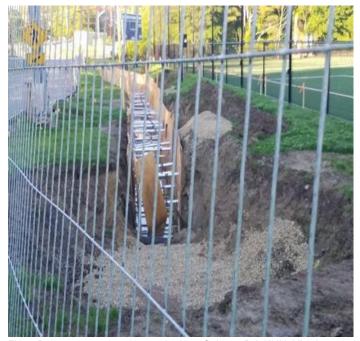
Fig 3: Rain water present in trench along Colovos Rd, UNH. Viewing south. (6-17-19).

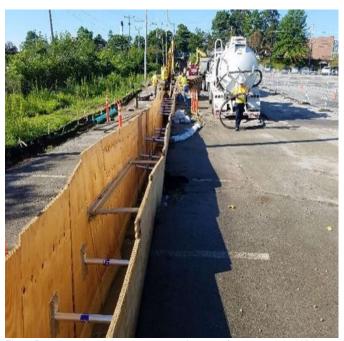
Fig 4: Pump truck used to pump out rain water from trench in "A" lot. Viewing south. (6-17-19).

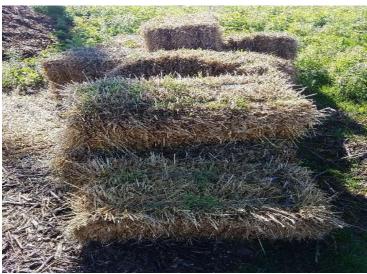
Fig 5: Straw bales stored in lay down area off of Gosling Rd in open area need
To be covered. Viewing east. (6-18-19).

- o McCourt will install a silt fence on the north side of the Waterworks Rd laydown yard, between the soil stockpile and wetland DW65. This will protect the wetland from any soil runoff from the laydown area. McCourt was instructed to key the silt fence into the ground, leaving no space between the fence and the ground surface. This corrective maintenance will be done by the end of the day (6-20-19) in preparation for Thursday's rain event.
- Again the contractors have been reminded that they need to have spare BMP supplies on hand in case of emergencies. These spare supplies should be kept dry at all times; this is a requirement of the BMPs, Eversource and DES.

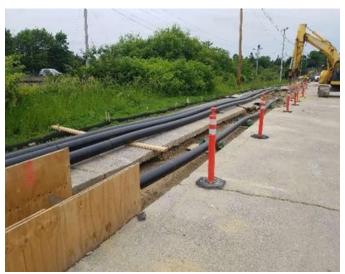
Fig 6: McCourt installing pipe and duck bank in "A" lot. Viewing south. (6-17-19).

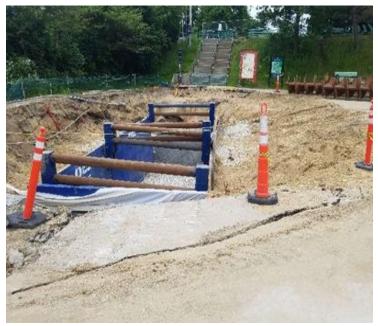
Fig 7: McCourt finalized the jacking pit in "A" lot. Viewing south. (6-18-19)

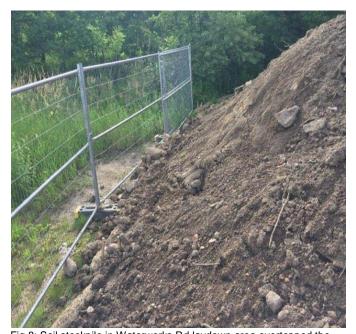
The soil that is stockpiled in the Waterworks Rd laydown area overtopped the straw waddles that they had in place. McCourt was instructed to install silt fence around any soil stockpiles.

Fig 8: Soil stockpile in Waterworks Rd laydown area overtopped the Straw waddle. Viewing east. (6-17-19).

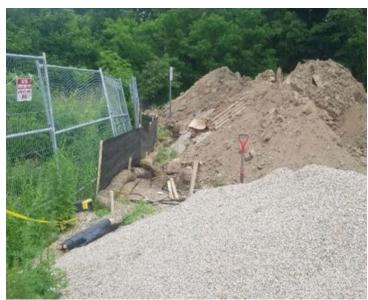
Fig 9: McCourt installed silt fencing and straw waddle between the soil stockpile In Waterworks Rd and wetland DW65. Maintenance needed, see above. Viewing east. (6-17-19).

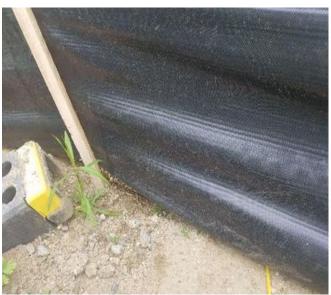
Fig 10: Silt fence installed in the Waterworks Rd laydown area needs to be keyed into the ground, see above. Viewing east. (6-18-19).
