Subject **Daily Monitoring Report**

Project Independent Environmental Monitoring, Little Bay Submarine Cable Installation, Seacoast Reliability Project

Project No. E2X85301 **File** Daily Monitoring Report_SRP Little Bay IEM_Cable Removal 10-19-19

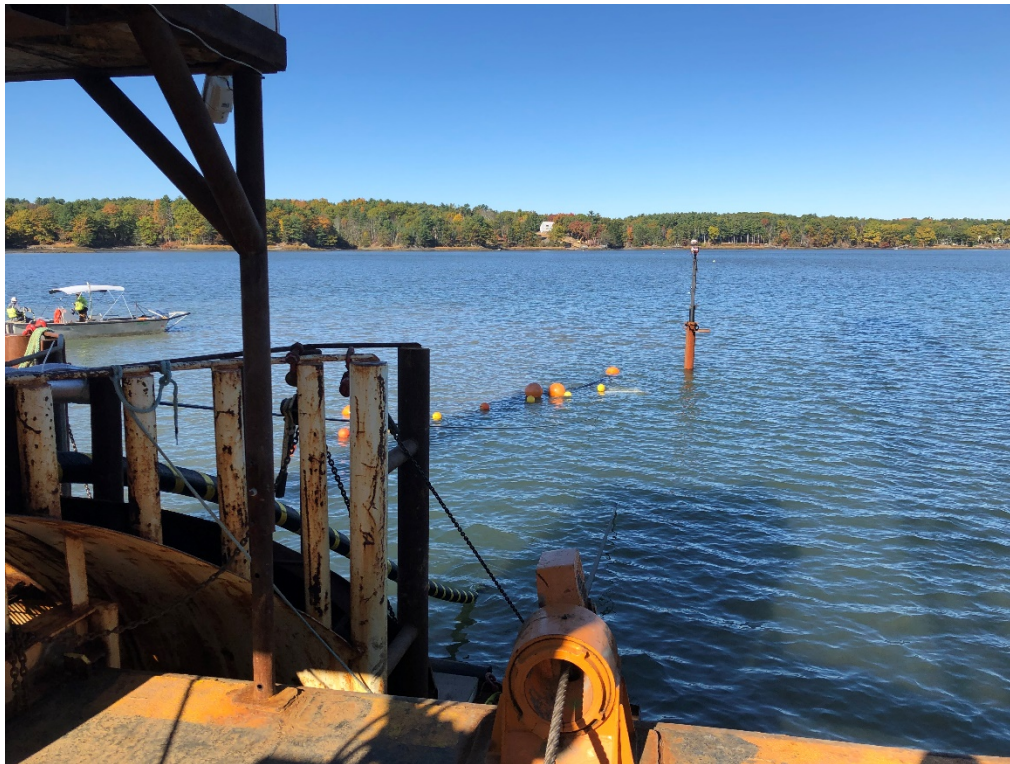
Jet sled approximately 50' of setback from cable chute and barge. Plow is located on the western side of the channel in 3 – 5 feet of water. Slightly visible, localized plume near jet plow.

Item	Observations and Notes
1	Jet plow operations – Resume Cable #1 installation where plowing left off on 10-18-19 on the western edge of the channel. Jet plow was winched to approximately 50' setback from barge with pump barge, dive barge and other work boats fastened to main barge. Anchor barge in center of channel, spuded down. Four-point anchor spread in use. One full anchor move and one-half anchor move completed using tug and work boats – no use of anchor barge. IEM tracking progress of plow with station numbers and Google Earth based survey markers.
2	Water quality monitoring – NH DES, IEM, Eversource and Normandeau conferred on Friday to discuss Saturday (10-18-19) planned operations. Parties agreed that water quality monitoring would continue as long as Normandeau boats could operate. With jet plow within viewing distance of barge, a localized plume was observed at the edge of

Item	Observations and Notes
	the channel but became less visible with depth as plow progressed across the channel. No turbidity exceedances reported from water quality monitoring team.

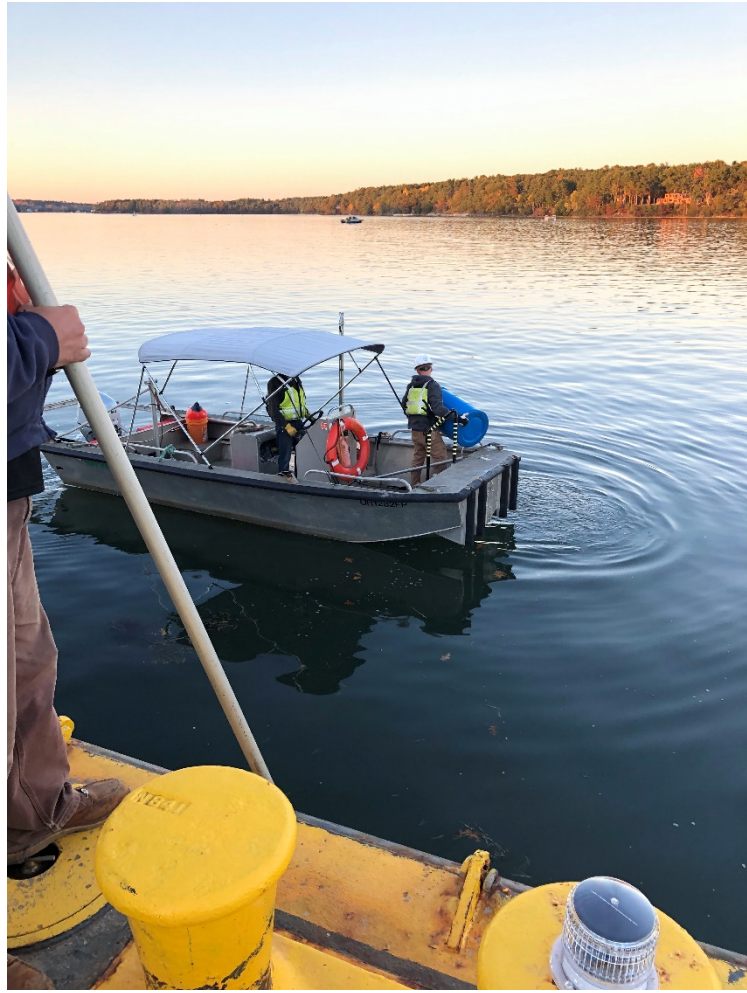
<p>IEM reports large (approx. 35-40 gallon plastic drum) in Little Bay directly in the path of the barge and jet plow. Durocher Marine deployed workers to recover the drum. It was brought onboard and reused/disposed off.</p>
