Subject **Daily Monitoring Report**

Project Independent Environmental Monitoring, Little Bay Submarine Cable Installation, Seacoast Reliability Project

Project No. E2X85301 **File** Daily Monitoring Report_SRP Little Bay IEM_Cable 3 Install Day 1_11-7-19

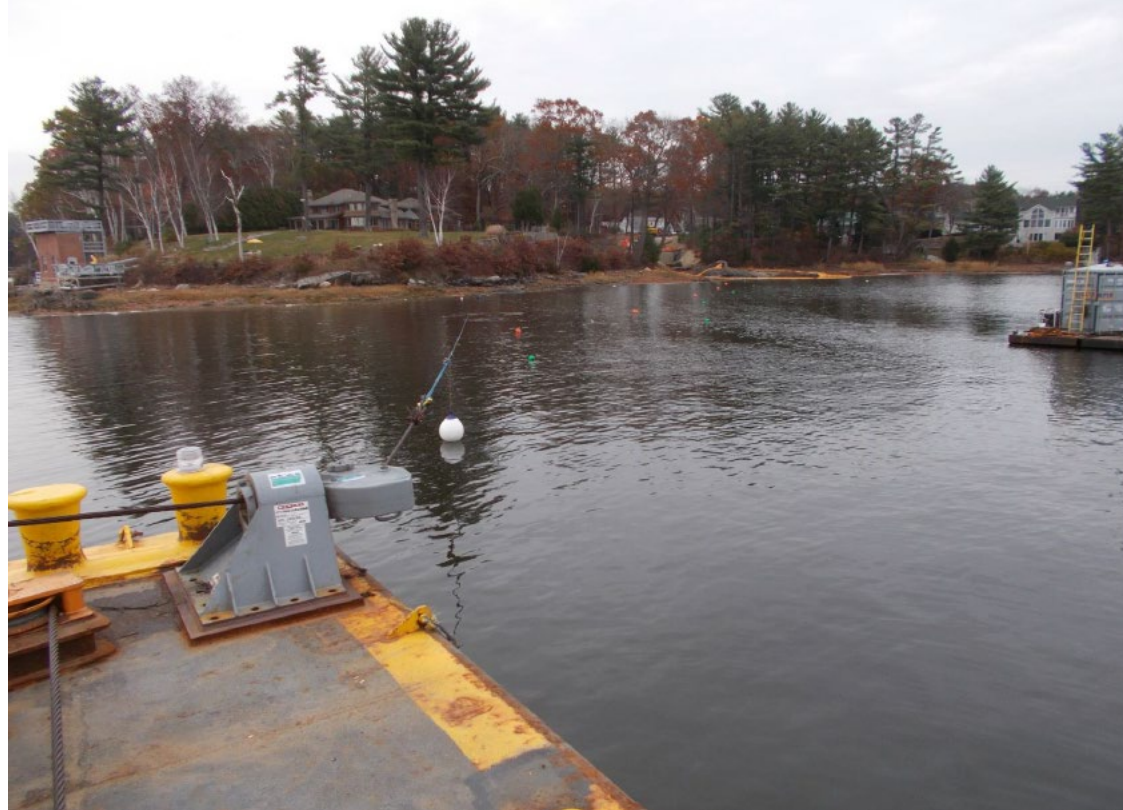
Cable 3 installation approaching the eastern landfall (Gundalow Landing). Port bow anchor wire in view and diver barge on the right side of the frame. Photo courtesy of Durocher Marine.
