Subject **Weekly Monitoring Report – Diver Burial Activities**

Client Eversource Energy **Date** November 16, 2019

Project Independent Environmental Monitoring, Little Bay Submarine Cable Installation, Seacoast Reliability Project

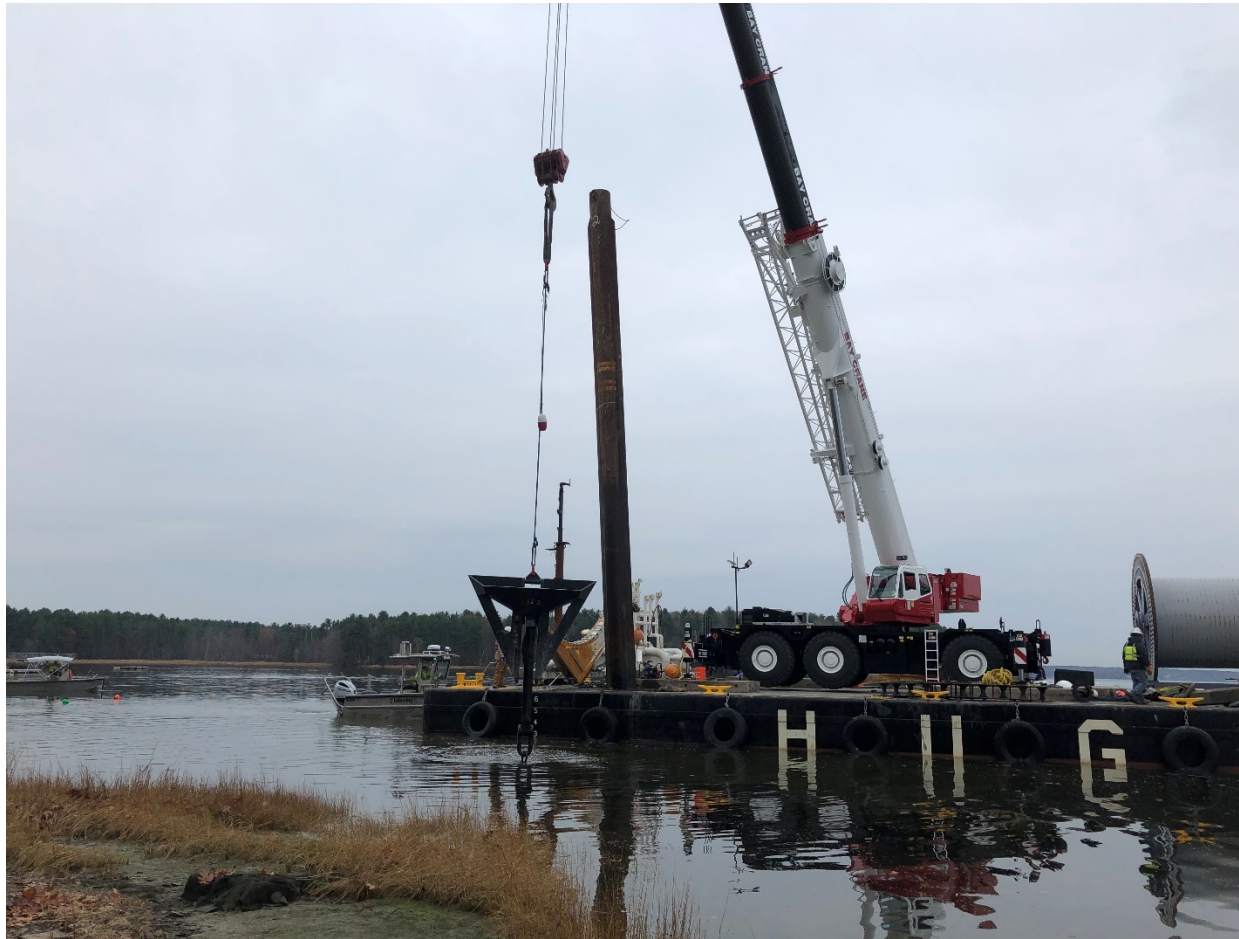
Anchor removal on eastern tidal flat (11-11-19).

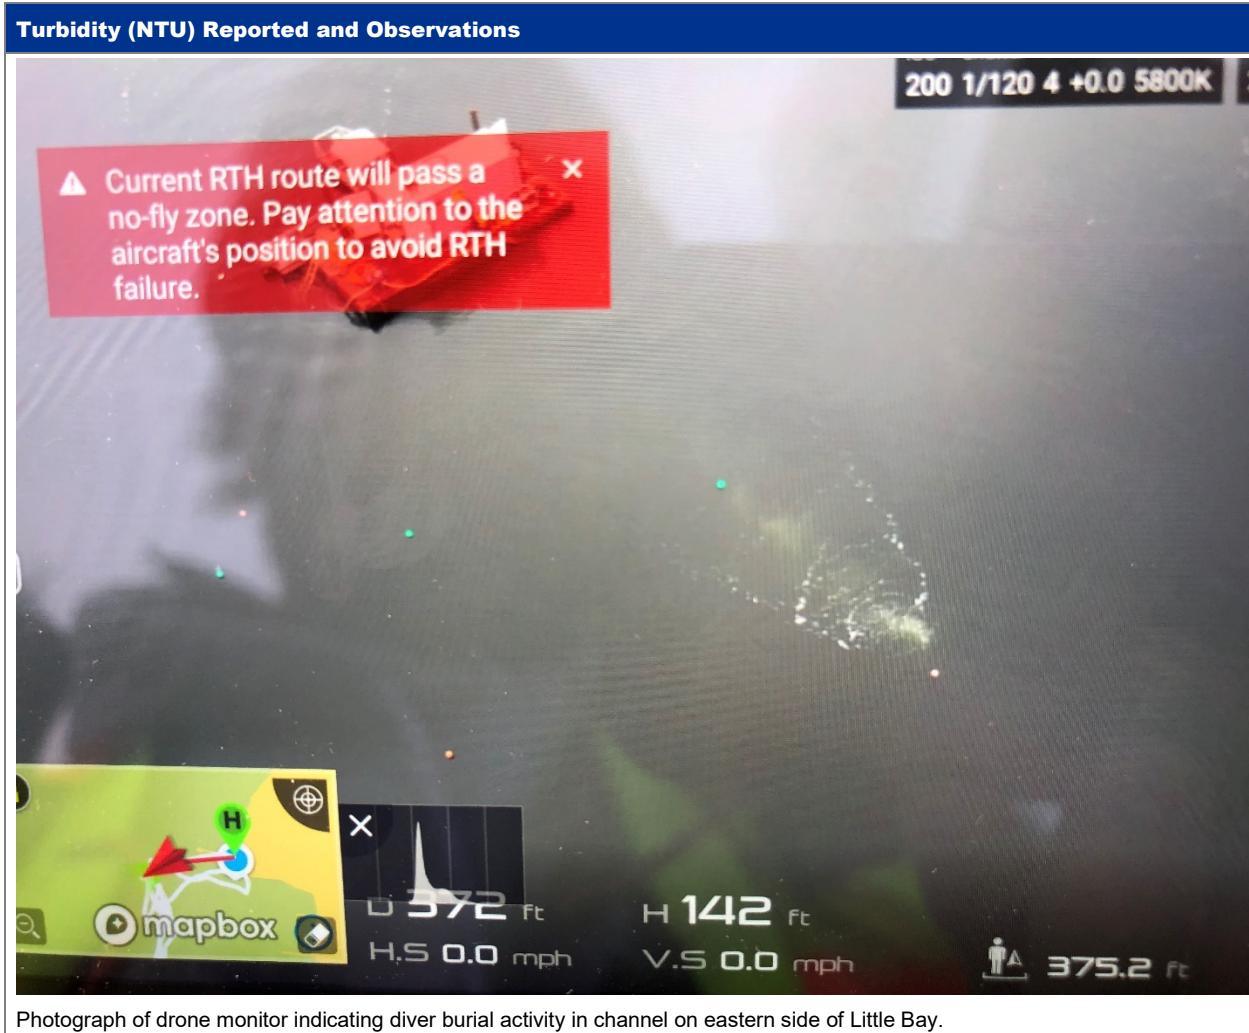
Turbidity Monitoring Spreadsheet for SRP 2019 NEARFIELD STATION 19A HAND JETTING							Turbidity Monitoring Spreadsheet for SRP 2019 NEARFIELD STATION 19 REFERENCE				
Date	Turbidity (NTU)	Time	Depth (S, M, B)	JET PLOW AVERAGE	REFERENCE AVERAGE						
11/11/2019	3.8	10:45	S	8.45	8.50						
	4.3		B								
11/12/2019	3.6	12:10	S								
	3.8		B								
11/12/2019	3.6	13:11	S	Max	Max Time	Depth					
	4.5		B	19.5	10:38	S					
11/12/2019	4.4	14:45	S								
	4		B								
11/12/2019	2.6	10:45	S	Reference Max	Reference Max Time	Reference Depth					
	2.7		B	9.0	0:00	B					
11/12/2019	2.9	12:15	S								
	2.6		B								
11/12/2019	2.5	13:40	S								
	2.9		B								
11/14/2019	6.3	10:05	S								
	7.7		B								
11/14/2019	19.5	10:38	S								
	6.8		B								
11/14/2019	5	11:45	S								
	5.4		B

Preliminary data results from Water Quality Team on 11-14-19. Note one reading of 19.5 NTU at 10:38 from surface measurement at Station 19A approximately 500' from activity. Additional readings from this or other stations did not result in exceedances at day.

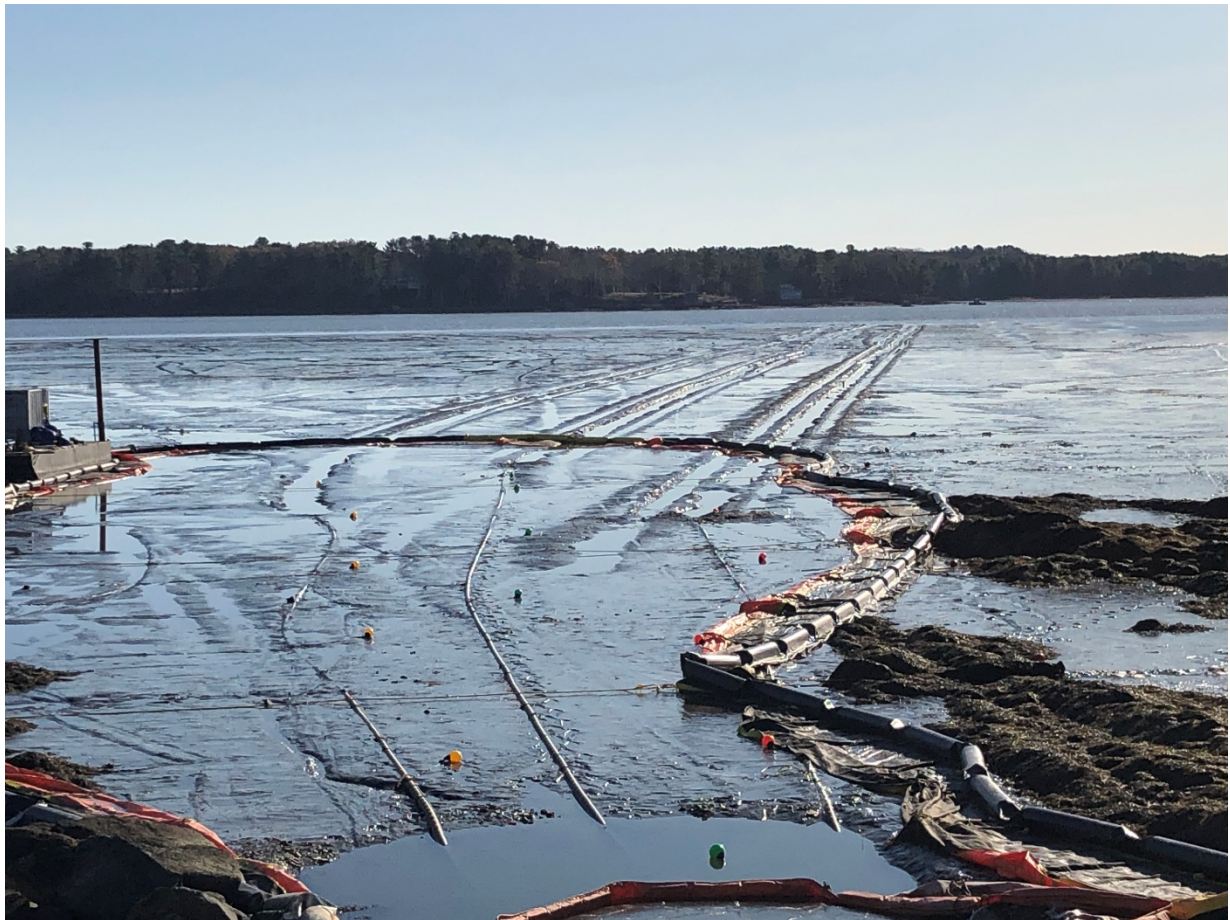
Photograph taking from Durham landfall location looking toward Newington landing along SRP submarine cable alignment during low tide (0845) the morning of 11-16-19 indicating bottom disturbance from jet plow installation of the three cables. Evidence of diver burial (hand-jetting) results on the northern cable inside of the turbidity barrier (left side of the photo closest to small spud barge).

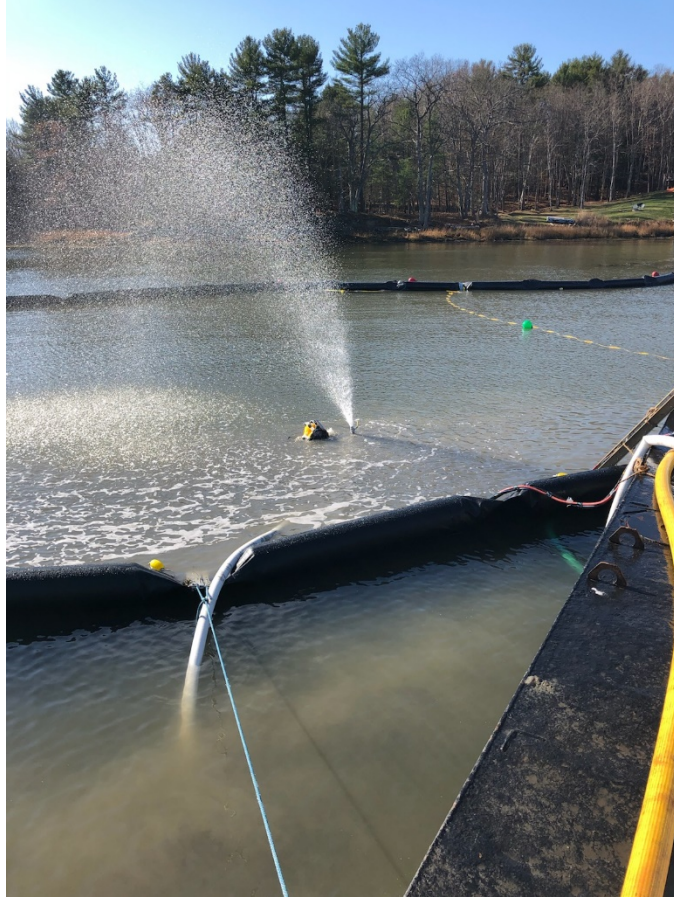
Diver burial in less than three feet of water within the turbidity barrier. Hand jet tool is “T” shaped with pressurized water out of both ends of the tool such that water shoots directly skyway (i.e., spouts) when held in certain positions at low water. Photograph taken by Durocher Marine from the diver barge located immediately adjacent to the turbidity curtain (11-15-19).
