**Subject**                      **Weekly Monitoring Report – SRP Submarine Cable Diver Burial Activities**

**Project**                      Independent Environmental Monitoring, Little Bay Submarine Cable Installation, Seacoast Reliability Project

Weekly Monitoring Report – SRP Submarine  
 Cable Diver Burial Activities  
 November 17 - 23, 2019

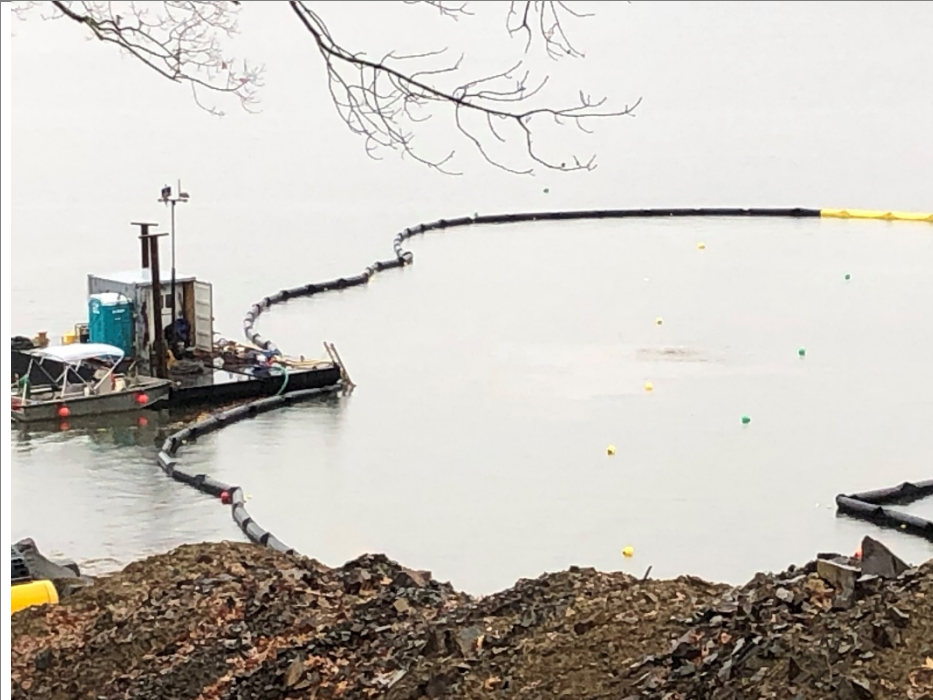
View from Getchell Property, Durham, NH showing diver barge (left), bottom-founded turbidity barrier, northern cable (yellow buoys) and center cable (green buoys). Surface indication (bubbles) of diver working on northern cable.

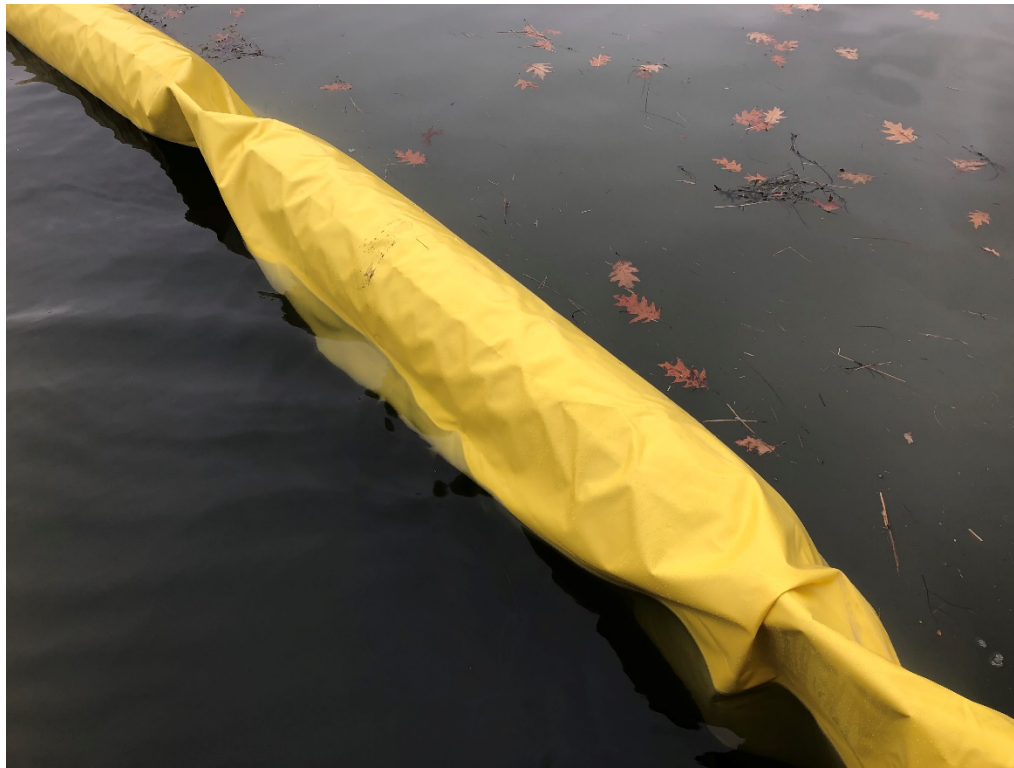
Offshore apex (yellow segment) of turbidity barrier deployed on western diver burial work location. Inside the barrier is evident by leaves and turbidity water (at surface).

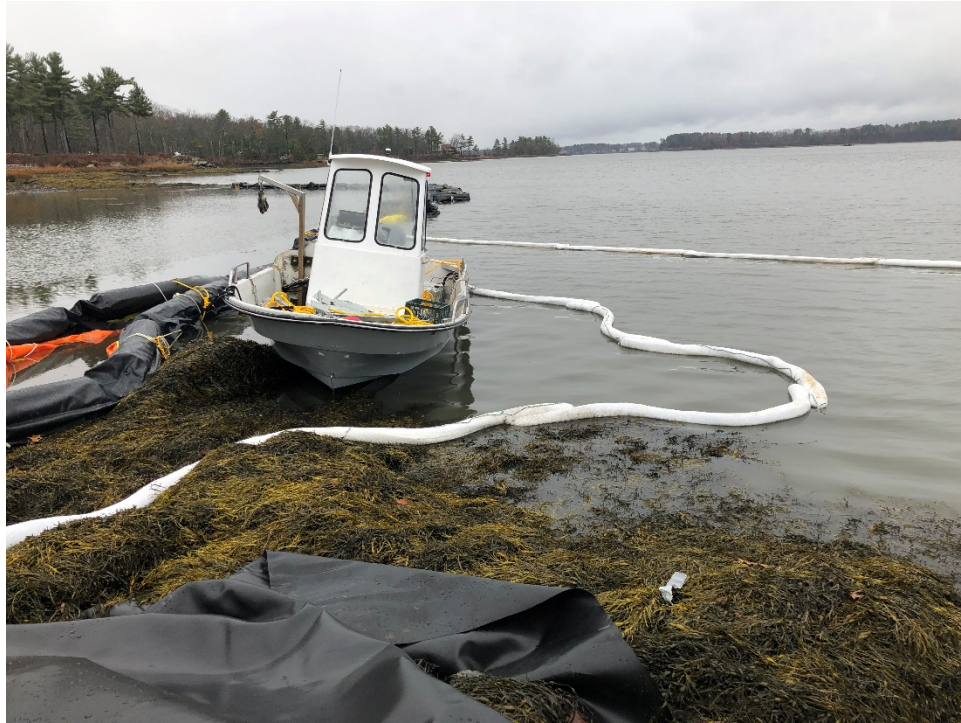
Mackworth Env vessel upright and on rocks at Durham landing. Absorbent booms deployed by Durocher. Turbidity barrier meant for the eastern diver burial operation is in the photograph to the left. (Vessel capsized when Mackworth was attempted to stage the barrier offshore prior to towing to the eastern shore.)

Item	Observations and Notes
	Minimal diver burial on the western side was completed on Saturday, 11/23/19 due to problems with the barrier. Eversource, Mackworth and other contractors working on a solution to the turbidity barrier because there is potential for cable damage due to dragging anchors.
4	<p><b>Capsized Mackworth Env Vessel</b> – IEM was alerted that the Mackworth Env vessel capsized at 0815 on November 20, 2019 just off the Durham shore while preparing to pull the 2<sup>nd</sup> turbidity barrier from the western shore to the eastern shore for installation prior to east side tidal flat diver burial. The one operator was quickly able to get out of the water and up to his truck. No one injured. Gas tank recovered from vessel. Vessel flipped upright. Small sheen from boat evident near shore to the south and outside of turbidity barrier. Durocher quickly deployed absorbent booms from dive barge and other work barge.</p> <p>IEM on site by 0845. Spoke with DES' Chris Nash by phone. No ongoing release. No major sheen or smell associated with capsized boat. Eversource reported that environmental services was arriving to address the spill and clean up. Mackworth lifted the boat out of the water onto a barge for transport to Great Bay Marine.</p>

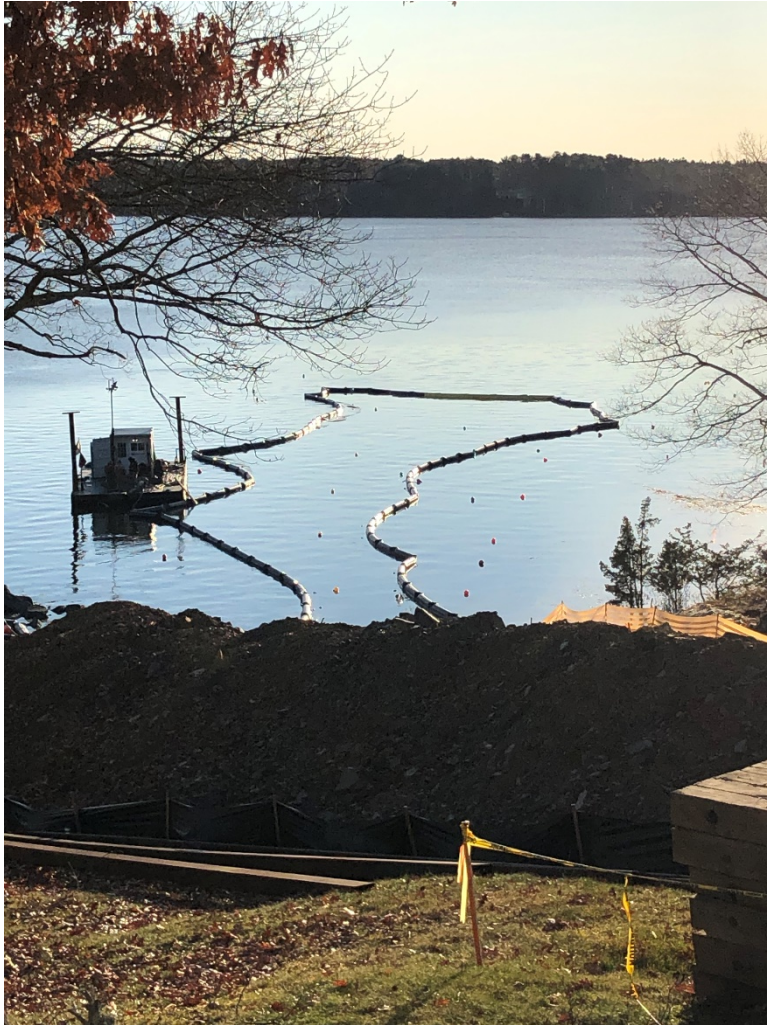
Photograph taken from Getchell Property, Durham, NH the morning of Saturday, November 23, 2019 indicating the southward (to picture left) shift of the bottom-founded turbidity barrier on the western side of Little Bay. High winds the night before likely resulted in the movement of the barrier's anchors, which snagged on the southern cable. Shifted position of the cable limited the diver burial on western side.

3	<p><b>Turbidity Barrier</b> – The turbidity barrier on the western tidal flat appeared to be structurally sound and placed appropriately to contain the diver burial activities until Friday evening, November 22<sup>nd</sup>. Possible movement of turbidity barrier was reported by IEM to Normandeau and Eversource at Friday afternoon site walk at Durham landing.</p> <p>Normandeau conducted turbidity measurements (in situ) inside and outside of the turbidity curtain. Preliminary results reported to IEM indicate barrier is working. Visual observations from shore and drone indicate some transport of very fine, very light-colored sediments at the surface <i>through</i> the curtain on the western shore.</p> <p>On Saturday, November 23<sup>rd</sup>, it was evident that the turbidity barrier on the western side had shifted in the previous 12-16 hours due to tide and wind. (Friday night was very windy; gusting up to 30 kts.)</p>
