Summary of Work Activities

Weekly Monitoring Report – SRP Submarine
 Cable Diver Burial Activities
 December 8 - 14, 2019

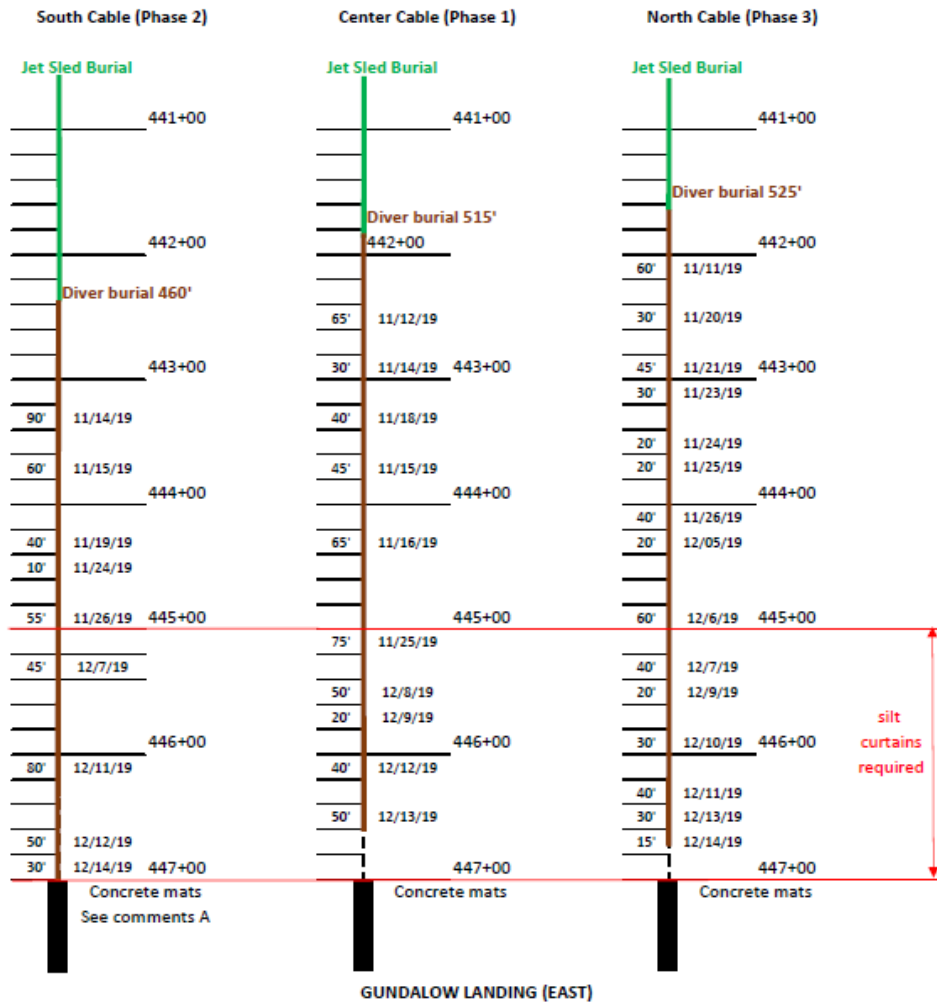
East Side Burial Graph (through December 14, 2019, Durocher Marine)

East Diver Burial Daily Tracking Graph REV01_12-14-19

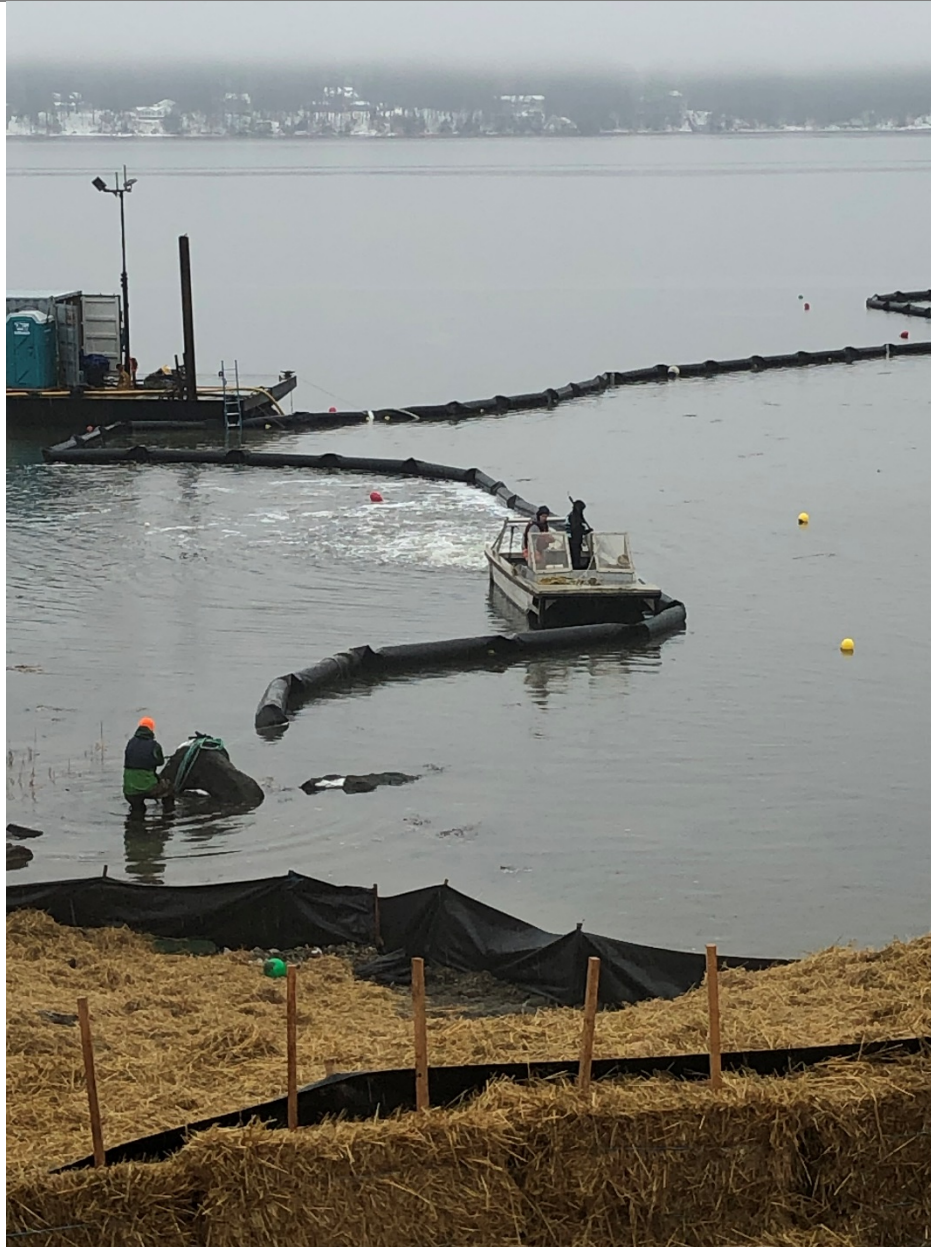
View from Getchell Property, Durham, NH showing Mackwork Env staff adjusting northern end of the turbidity barrier on the west side of Little Bay because it moved, or was moved, offshore resulting in a gap at the shoreline (12-9-19).

3	<p>Turbidity Barrier/Western Tidal Flat – The turbidity barrier on the western tidal flat shifted north with the tide on December 8, 2019 and impinged under the diver barge causing it to sink under water surface. Nearfield (500') water quality monitoring stations reported elevated turbidity but not an exceedance. On December 9, 2019, the western side turbidity barrier required repositioning. The northern end had shifted, or was moved, offshore resulting in a gap nearshore. Mackwork Env installed a section of Type I Silt Curtain across the gap. West side diver burial was completed on December 10, 2019 at 1003. Dive team from west side relocated to east side to assist with diver burial on eastern tidal flat.</p> <p>On December 11, 2019, Mackworth began first reefing of the western barrier by pulling the bottom of the barrier up by 4 – 12 inches from the bay floor. IEM and DES agreed to no "waiting period" between reefing and when removal of the barrier could take place. Mackworth performed second reefing of the western barrier over a one-hour period and then released the anchors on the northern leg to remove this section to make room for the Durocher Marine concrete mattress installation process. Entire turbidity barrier was removed from western tidal flat on December 12, 2019.</p>

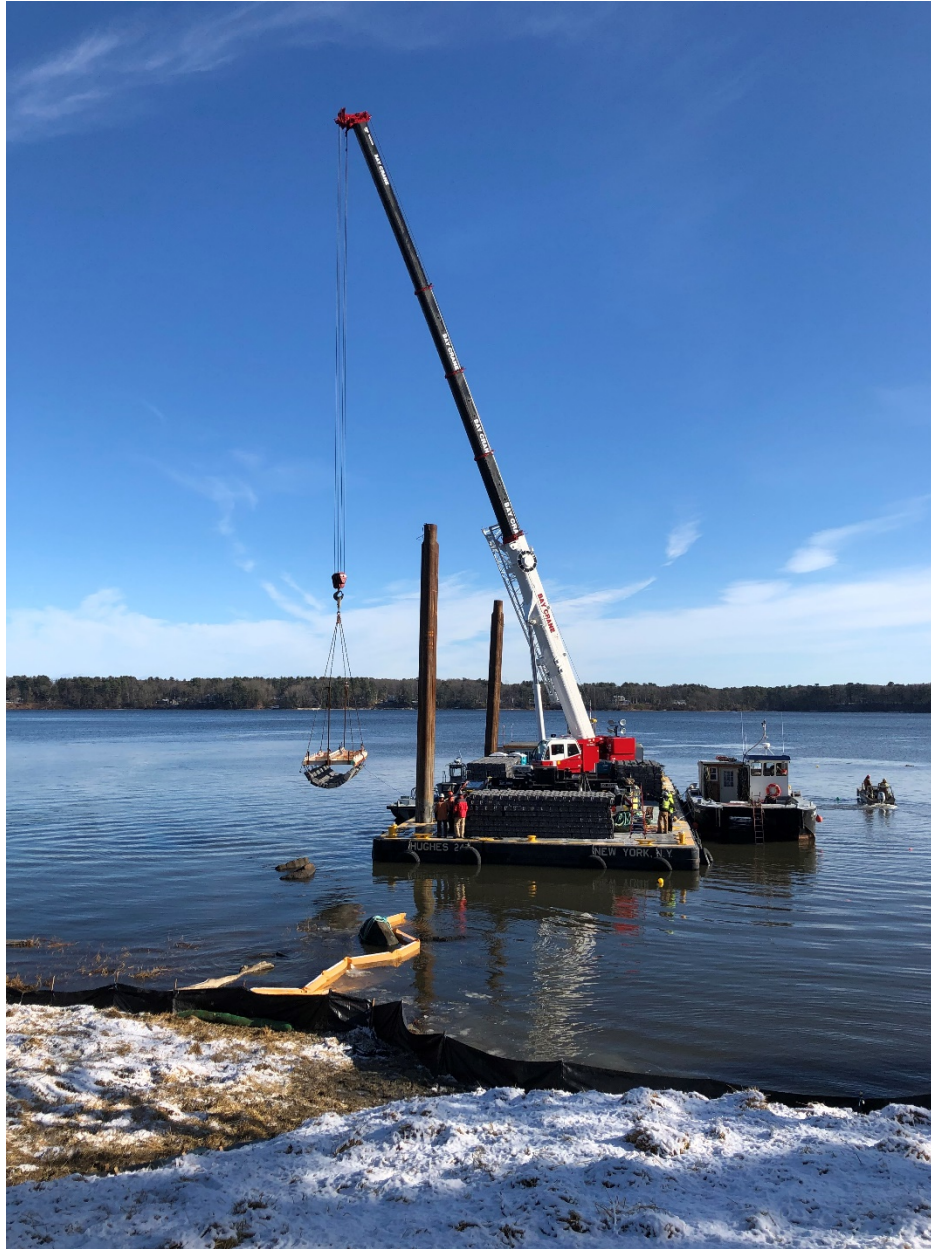
View from Getchell Property (Durham, NH) at the start of concrete mattress installation on the western tidal flat (12-11-19).

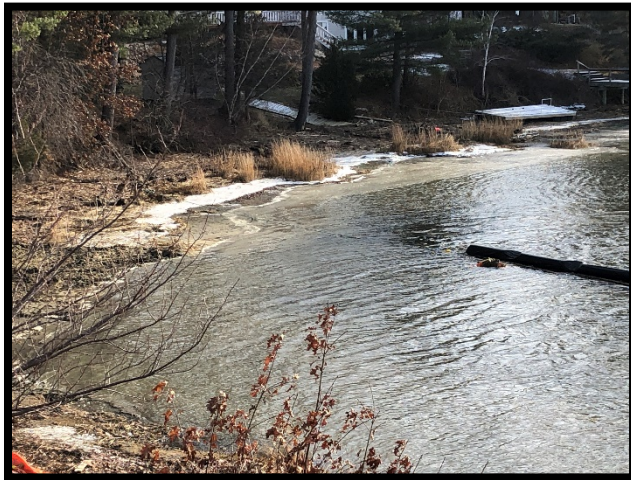
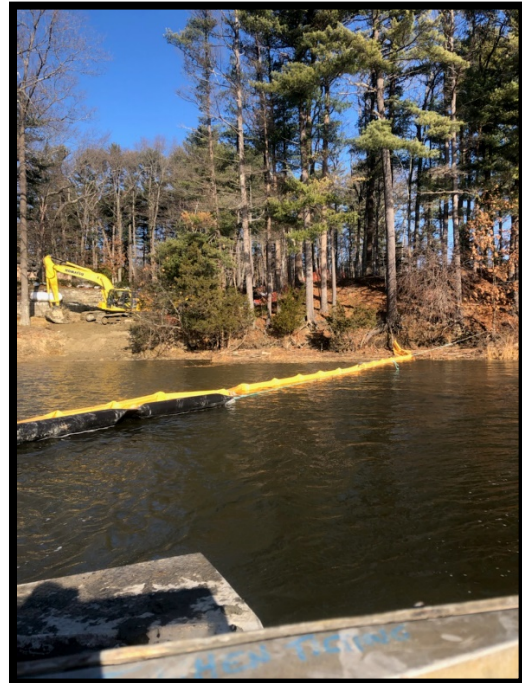
Turbidity barrier on eastern tidal flat had been relocated to allow for shoreline backfilling and stabilization within the cable trench. IEM requested that the gap at the shoreline be repaired. Mackworth Env was unable to pull the barrier ashore and use Type I silt curtain to fill the gap.

Item	
1	Install silt contain system to replace failed turbidity barrier. Continue diver burial on eastern tidal flat with two dive teams.
