Subject	Weekly Monitoring Report – SRP Submarine Cable Diver Burial Activities			
Client	Eversource Energy	Date	December 20, 2019	
Project	Independent Environmental Monitor Reliability Project	ing, Little Bay Subm	arine Cable Installation, Seacoast	
Project No.	E2X85301	File	Daily Monitoring Report_SRP Little Bay IEM_Diver Burial 12-15 to 12-18	
Prepared by	Jeffrey Nield	Phone No.	617-963-3109	
Copies to	Gregg Comstock, NH DES David Price, NH DES Chris Nash, NH DES Kurt Nelson, Eversource Energy Pamela Munroe, NH SEC

Weekly Monitoring Report – SRP Submarine Cable Diver Burial Activities December 15 - 18, 2019

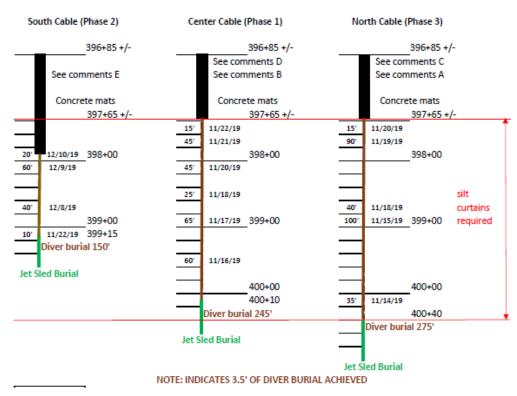
West Side Burial Graph (through December 18, 2019, Durocher Marine)

West Diver Burial Daily Tracking Graph 12-18-19

DURHAM (WEST)

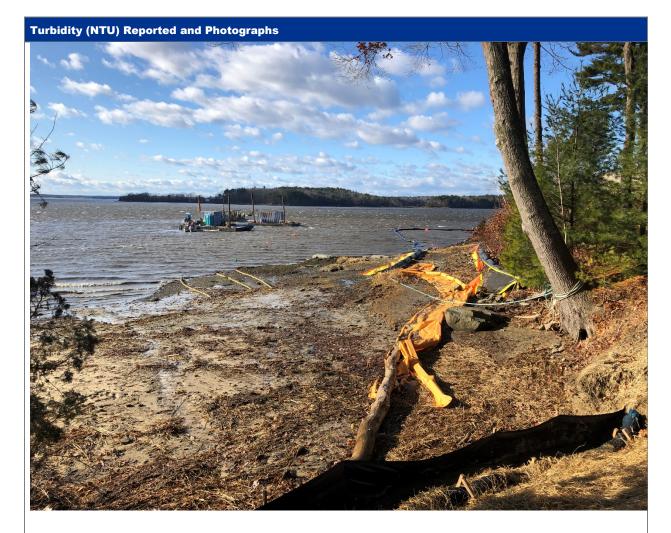
View from Gundalow Landing site, looking at Adams Point, with two dive barges spudded in place. Mackworth Env turbidity barrier failed by breaking free of its southern anchors and drifting to the north.

3	Turbidity Barrier/Eastern Tidal Flat – At 1505 on December 14, 2019, the turbidity barrier on the eastern tidal flat completely failed when it broke free of its southern anchors and drifted over the cable to the point of the Beswick Property where is gathered around the rocks and Beswick dock. Eversource and its contractors requested of the IEM if work could proceed without a turbidity barrier. The IEM issued an email directing Eversource and its contractors to install a serviceable and safe turbidity curtain to contain the diver burial work area as soon as possible prior to resuming diver burial on the eastern tidal flat. Mackworth Env installed a replacement system using Type I silt curtain and segments of their turbidity barrier on December 15 – 16, 2019.

ltem	
1	IEM submitted an email to NH DES (on 12-14-19) providing input regarding the complete failure of the turbidity barrier on the eastern tidal flat and Eversource's request to continue work without it. Since permit conditions require that a silt curtain be in place during diver burial, Eversource and its contractors will install a silt containment system on the eastern tidal flat on 12/15 or 12/16.
2	No water quality exceedances of the BSAL were reported. Normandeau monitoring hourly because of failed turbidity barrier.
3	IEM made daily requests to Eversource and its contractors to monitor the state of the silt curtain and make any repairs or adjustments if gaps or shifts appeared.

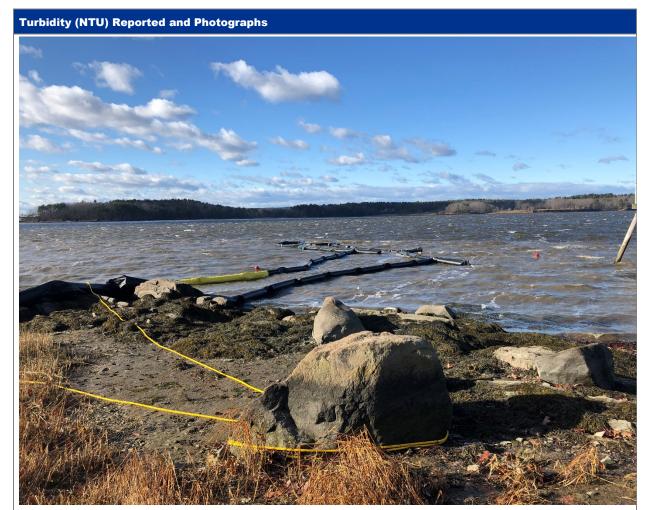
Mackworth Env barrier after breaking free. The barrier was drifting toward the Beswick dock to the right. Mackworth secured the barrier in place out of the way of the diver barges.

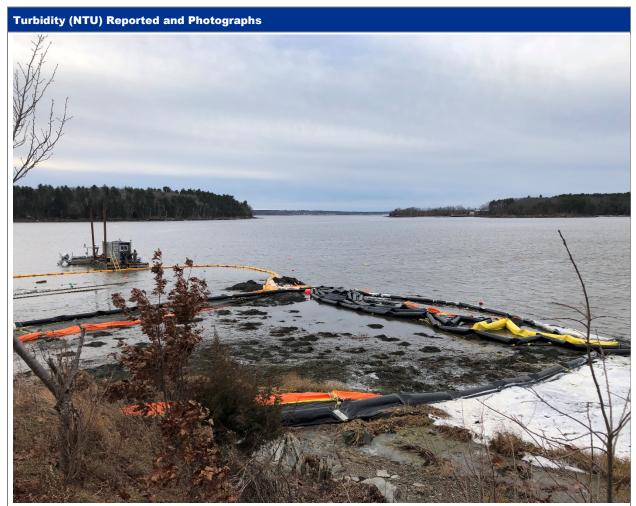
Replacement silt curtain using segments of the turbidity barrier and Type 1 silt curtain. Remainder of the northern segment of the turbidity barrier was secured to the north of the work area.

Day/Date	Work Description
	Mackworth turbidity barrier on east side failed on Saturday, December 14, 2019. From Sunday, December 15 to Monday, December 16, 2019 Mackworth installed a hybrid silt curtain consisting of 500 feet (+/-) of Type I silt curtain and the remainder the bottom-founded turbidity barrier.
Tuesday, December 17, 2019	East side diver burial – three dive teams working from 0730 to 1655. Water quality monitoring using one vessel sampling every hour because of the high background turbidity and failed turbidity barrier. Drone not flying due to snow. Mackworth maintaining a replacement silt curtain system.
Wednesday, December 18, 2019	East side diver burial – three dive teams working from 0730 to 1425. Water quality monitoring using one vessel sampling every hour because of the high background turbidity and failed turbidity barrier. Drone flying. Mackworth maintaining a replacement silt curtain system.
