Re: Seacoast Reliability Project - SEC Docket 2015-04 Notification of Minor Construction-Related Changes Submarine cable and Eastern Shore Landing

Newington Cable Landing and Slope Restoration

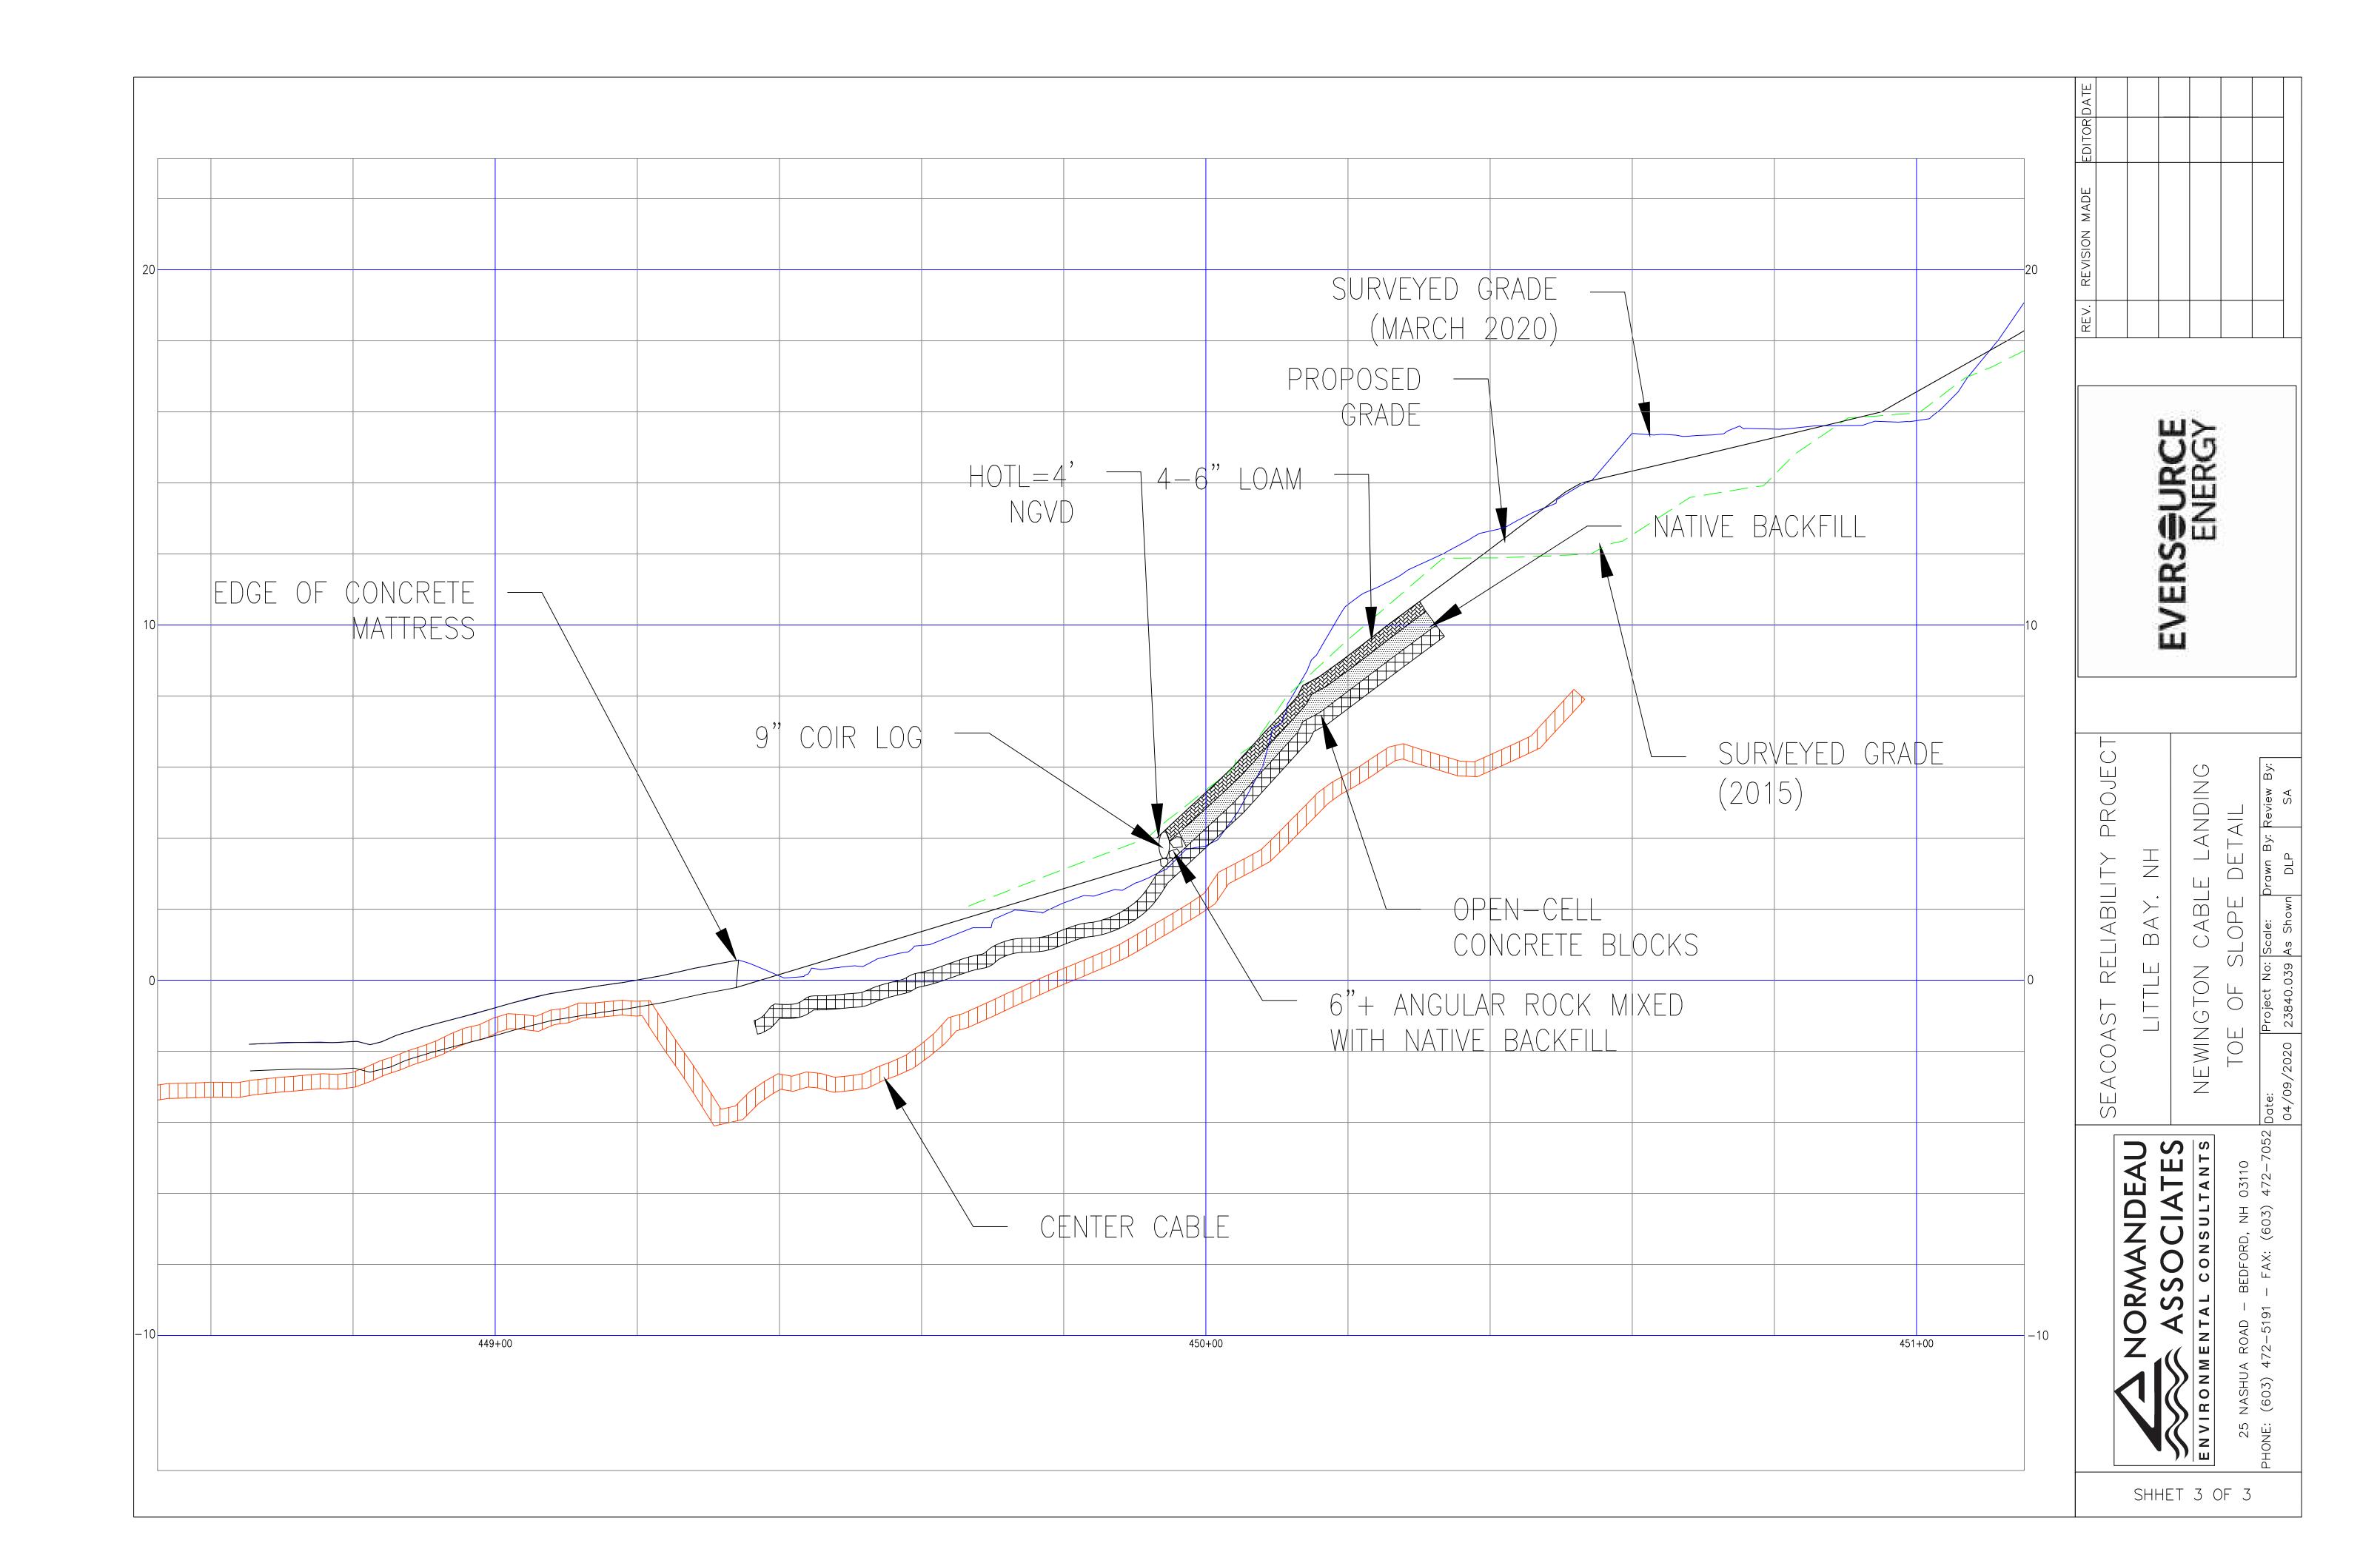
Plan Sheet 3 - Toe of Slope Detail

The toe of slope in the intertidal zone will be stabilized with a combination of rock and soil, similar to the shoreline restoration on the west side of the cable crossing. A 9" coir log will be installed at the intersection with the tidal flats to both stabilize the new toe and tie the work into the adjacent steep slopes as shown on Sheet 3, the Toe of Slope Detail Plan.

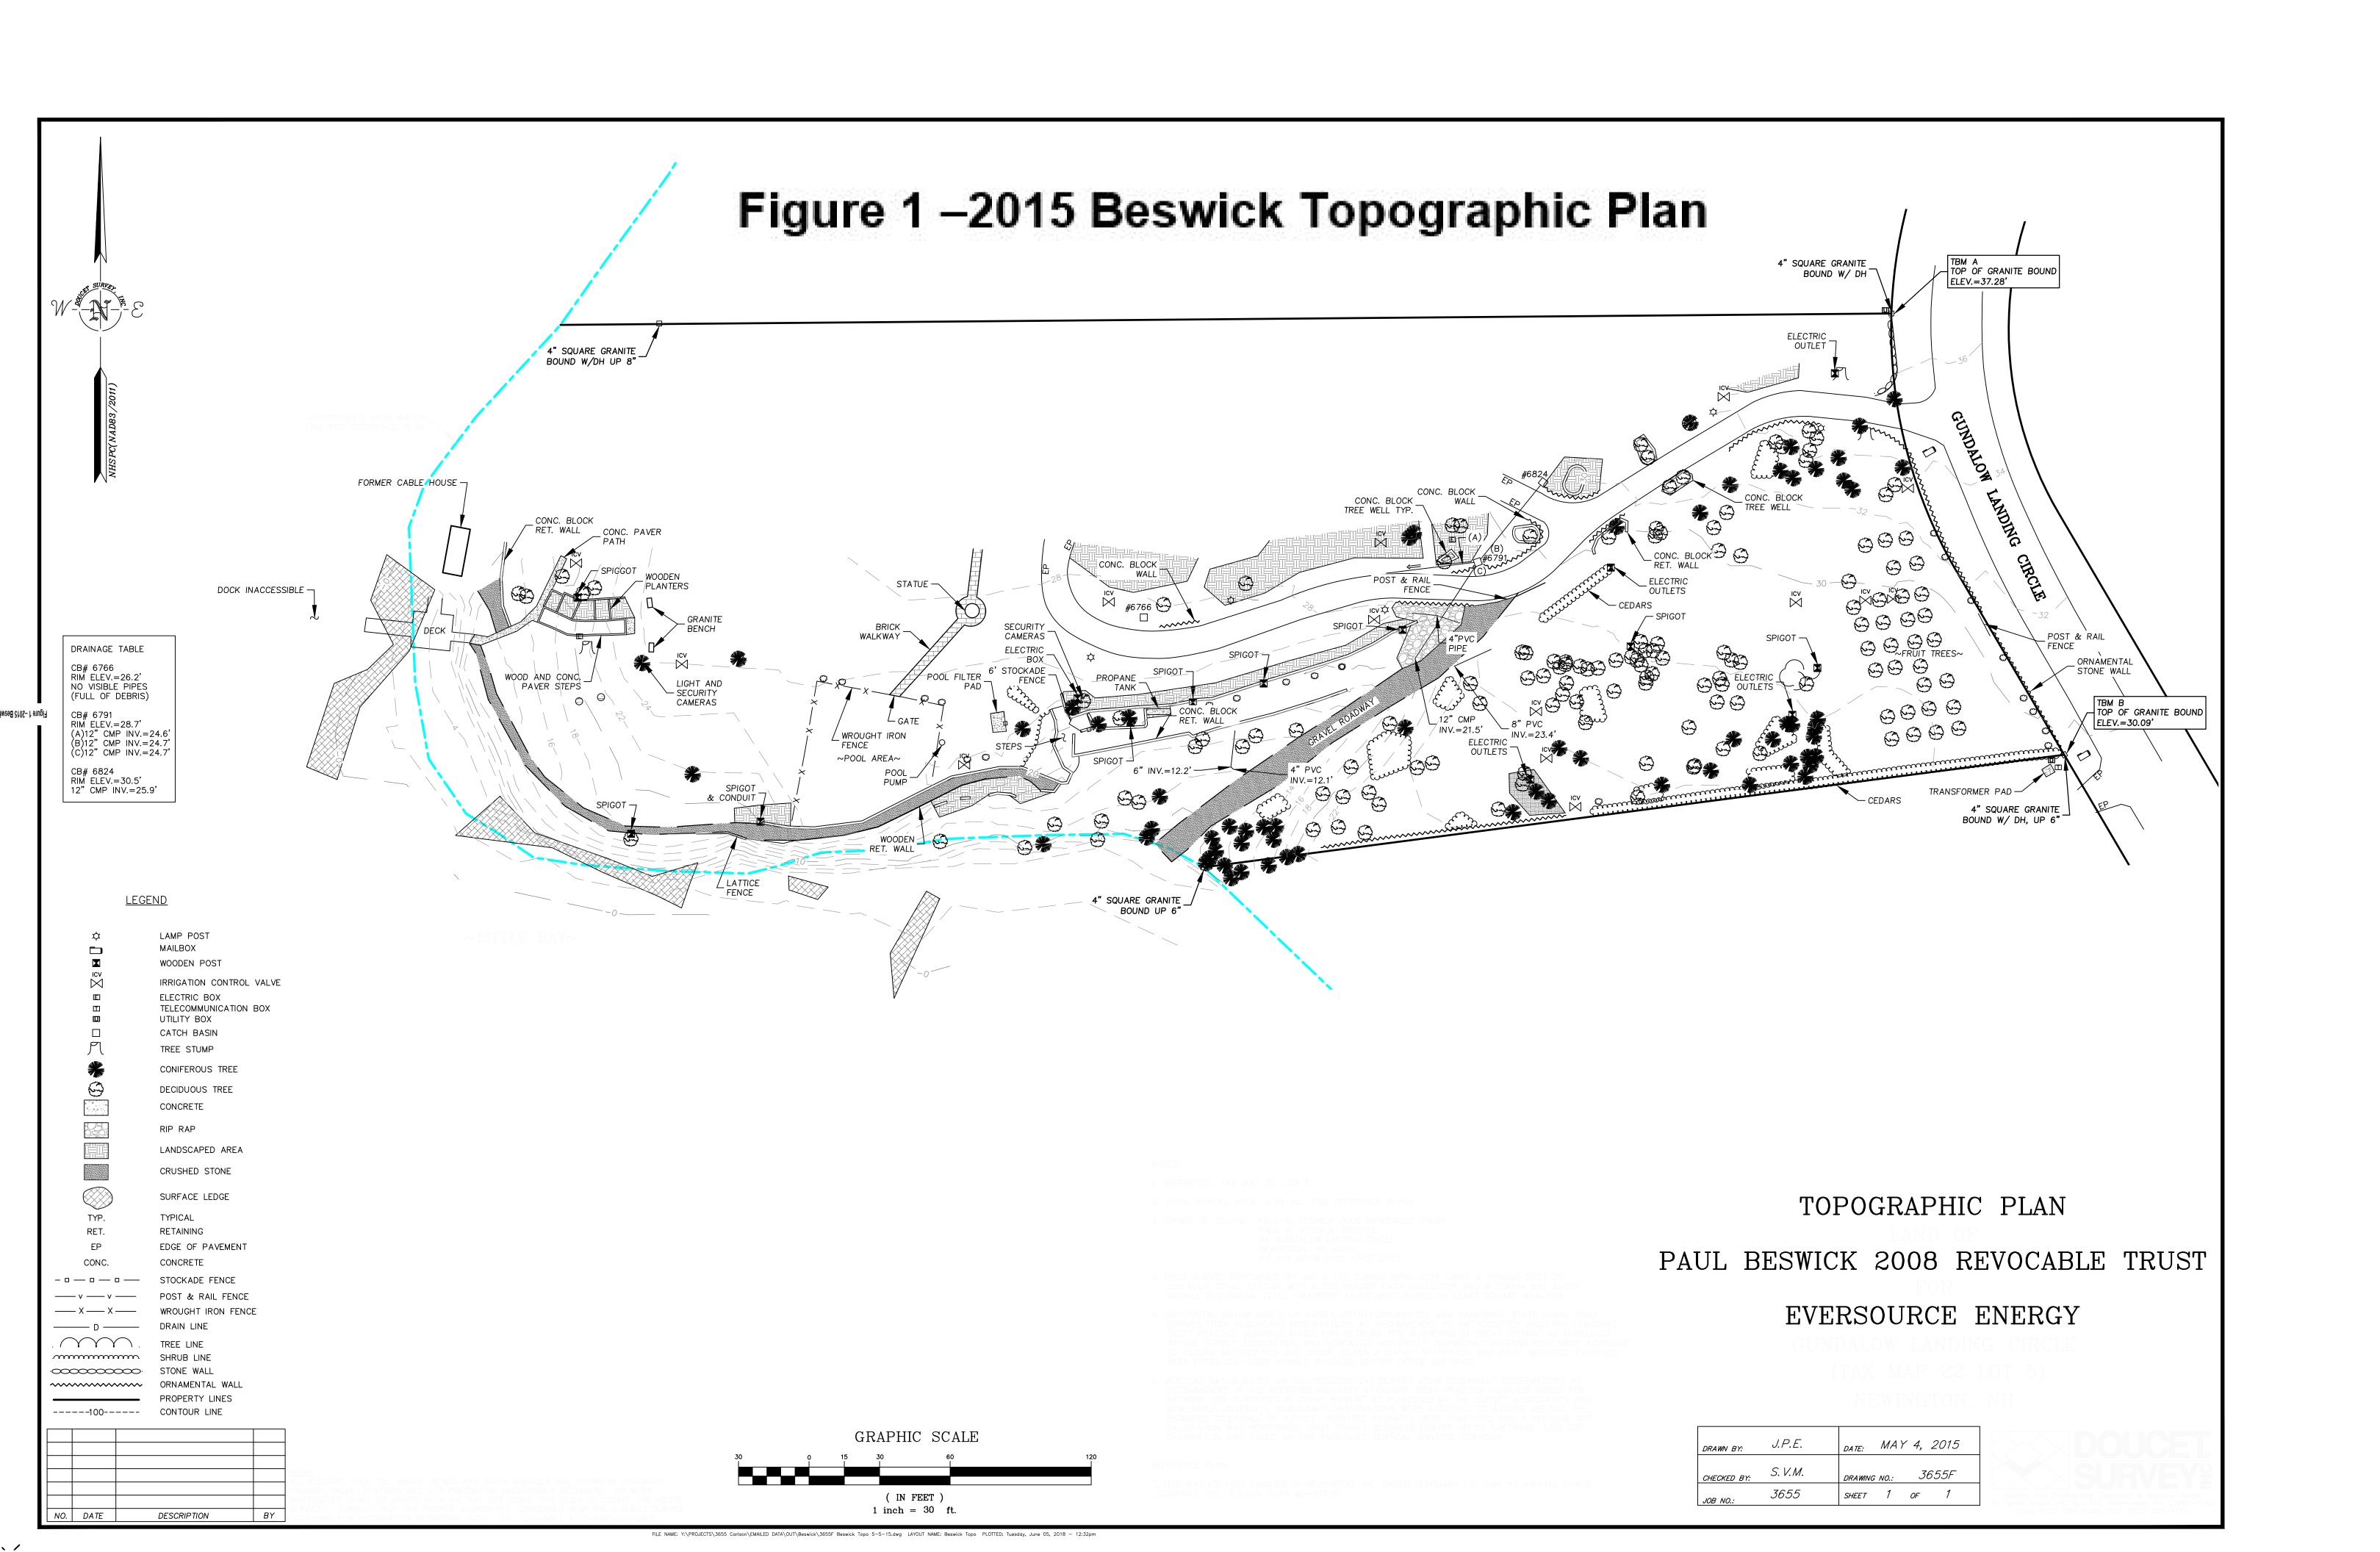
Figure 1 -2015 Beswick Topographic Plan

The underlying landowner has requested to review the revised final design and grading and has asked that a gravel path be restored from her driveway to as close to the shore as possible to allow cartop boat and kayak launching. The original gravel path was shown in a 2015 preexisting conditions plan (Figure 1) and preconstruction photographs provided as Attachment-2. The grades shown on Figure 1 represent the original grades; they are being used to help determine the final grades at the site.

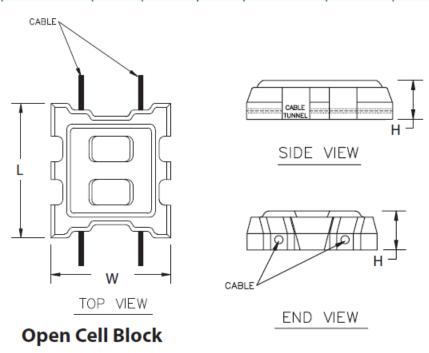
ARMORFLEX BLOCK & UNIT SPECIFICATIONS

Each Armorflex block (refer to the Armorflex Specifications in Attachment-1) is 13" x 11.6" in area. The blocks are laced together with manufacturer-supplied cable to form a continuous surface. To provide sufficient protection, the blocks will extend approximately 2' beyond the edges of the outside cables. To install the additional protection, Eversource's contractors will employ similar trenching methods as were permitted for use in the nearshore area to install the submarine cables. A small excavator and loader will work sequentially from construction matting in the dry during low tide cycles. The contractors will side cast the sediments and subsequently lay the concrete blocks by hand at depths that allow for a target depth of 12" of sediment backfill over the blocks. Disturbed areas will be backfilled at the end of each low-tide work cycle and turbidity curtains will be installed surrounding the work area.

ArmorFlex Unit Specification								
Concrete Block Class	Open/Closed Cell	Nom. Dimensions (in.)			Gross Area/	Min. Block Weight		Open
		L	W	Н	(sq. ft.)	lbs	lbs/sq. ft.	Area %
30S	Open	13	11.6	4.75	0.98	33	35	20

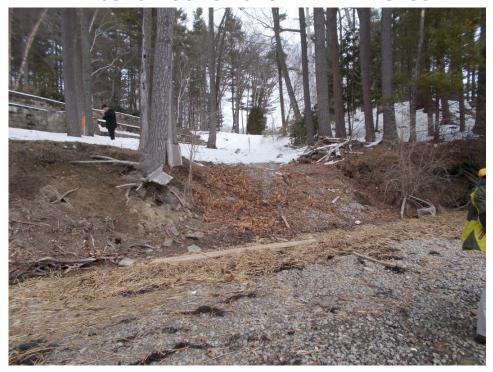
Photograph 1: Pre-construction photo of Gundalow Landing looking northeast on 03/21/17

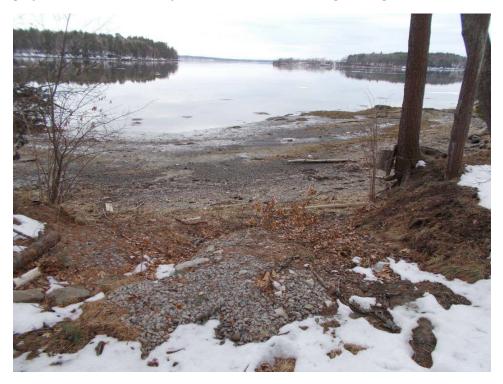
Photograph 2: Pre-construction photo of Gundalow Landing looking southwest on 03/21/17

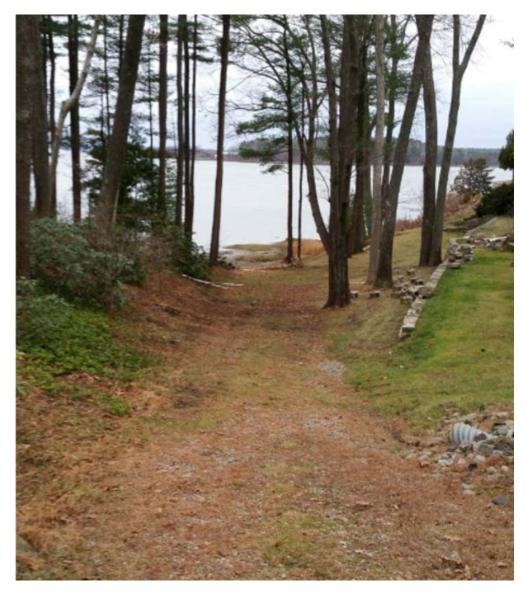
Photograph 3: Preconstruction view of upper slope and gravel access looking southwest
