**SRP Underground Cable
Flowable Thermal Fill (FTB) Areas of Concern
Summary of Assessment and Corrective Actions
June 5, 2020**

This document summarizes Eversource’s assessment and corrective actions for two locations identified along the project route where the SRP underground duct bank and/or flowable thermal back fill (FTB) appear to have altered preconstruction drainage patterns and where leaching of compounds associated with the cement portion of the flowable fill is occurring.

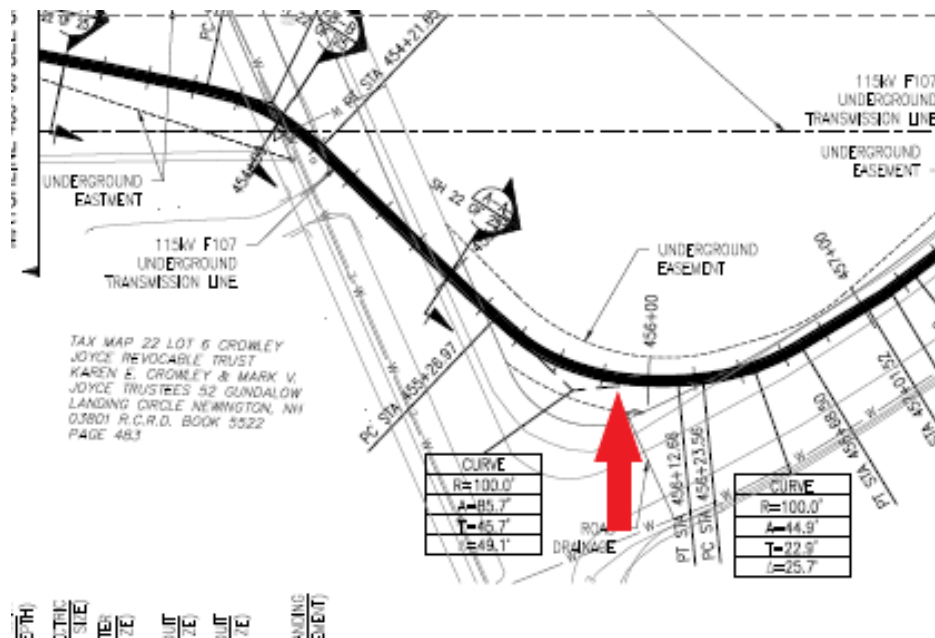
Figure 1: Plan view of underground cable – Veitas property

Following construction of the underground cable duct bank on the 29 Gundalow Landing property in the Fall of 2019, seepage and whitish material began accumulating in the vicinity of a drainage culvert that ultimately leads to Little Bay. The concrete cable duct bank is located between approximately 3 to 4 feet below grade at this location. Shovel test holes in the area indicate that the FTB (aggregate mixed with cement) is present above the duct bank to approximately 1 foot below grade.

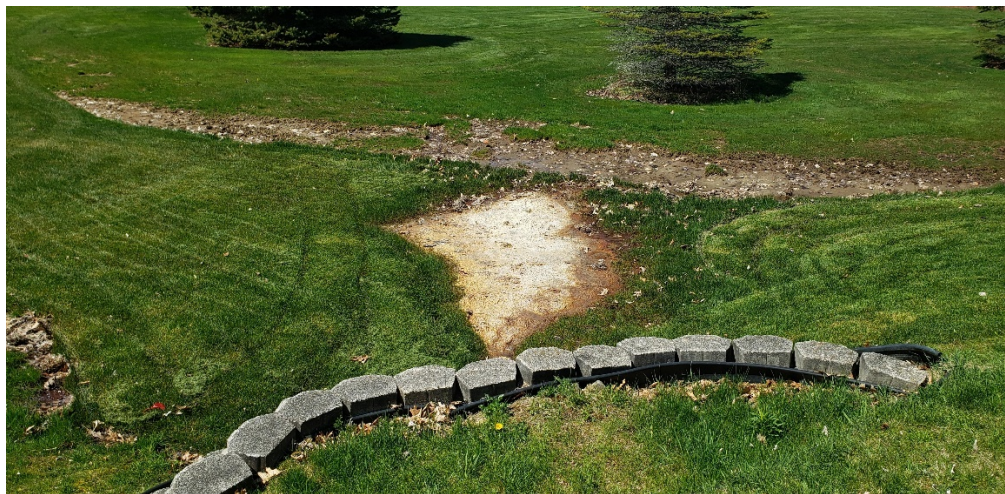
On May 6, 2020 Eversource and GZA investigated the white precipitate that had accumulated on the sod in this area to confirm that it was associated with the flowable fill above the duct bank. The area where precipitate accumulated was approximately 20 feet long by as much as 10 feet wide.

Photograph 1: Precipitate observed on ground surface at 29 Gundalow Landing property on May 5, 2020

Based on the elevated pH observed in the first seepage sample and the chemical analysis conducted, it is evident that the white precipitate is primarily calcium carbonate (CaCO₃) or lime. These lab results and pH observations confirm that the white precipitate material is directly attributable to the FTB leaching into shallow/runoff groundwater.

The sod impacted with the white precipitate was removed on May 6, 2020 and black filter fabric was placed on the bare soils in this area to assess whether the precipitate was continuing to accumulate in this area.

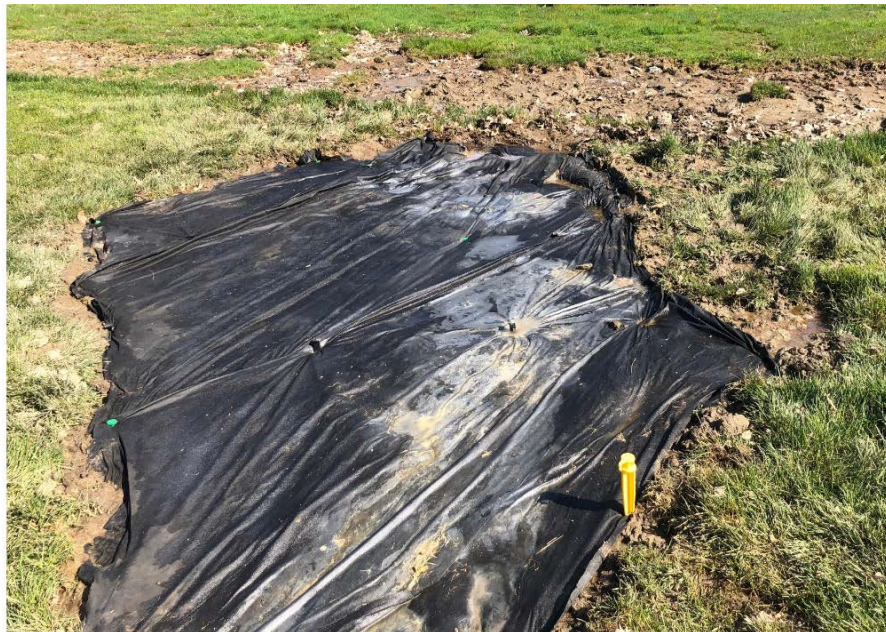
Eversource and GZA conducted visual observations of the area and observed that some minor amounts of white precipitate have collected on the filter fabric following removal of the impacted sod.

Photograph 2: Precipitate accumulating on filter fabric May 20, 2020

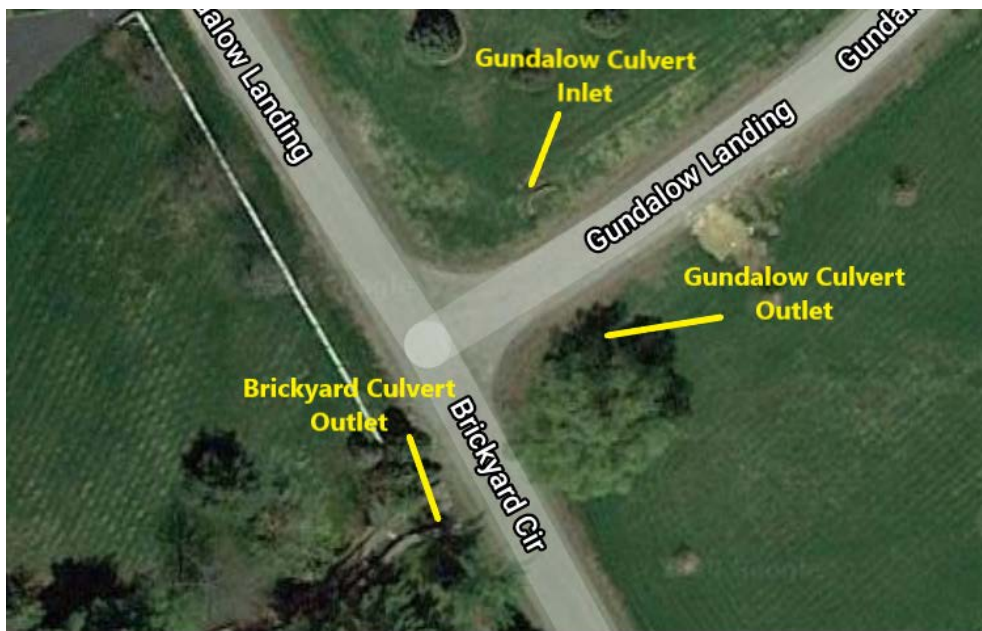
Based on the high pH observed in the seepage water, Eversource and GZA field monitored the seepage pH using a properly calibrated pH meter at the Gundalow Landing culvert inlet at the 29 Gundalow Landing property, the Gundalow Landing culvert outlet which is approximately 50' from the area of concern and the Brickyard Circle culvert outlet which is approximately 100' from the area of concern at the locations shown in the figure below. Monitoring was conducted on May 18, 19, 20, and 30, 2020.

Figure 2: pH monitoring locations Gundalow Landing and Brickyard Circle

The pH data show that the pH levels decrease with increasing distance from the 29 Gundalow Landing property and that the pH levels at the two downstream monitoring locations are decreasing over time. Elevated pH levels are consistently observed at the Gundalow Landing culvert inlet.

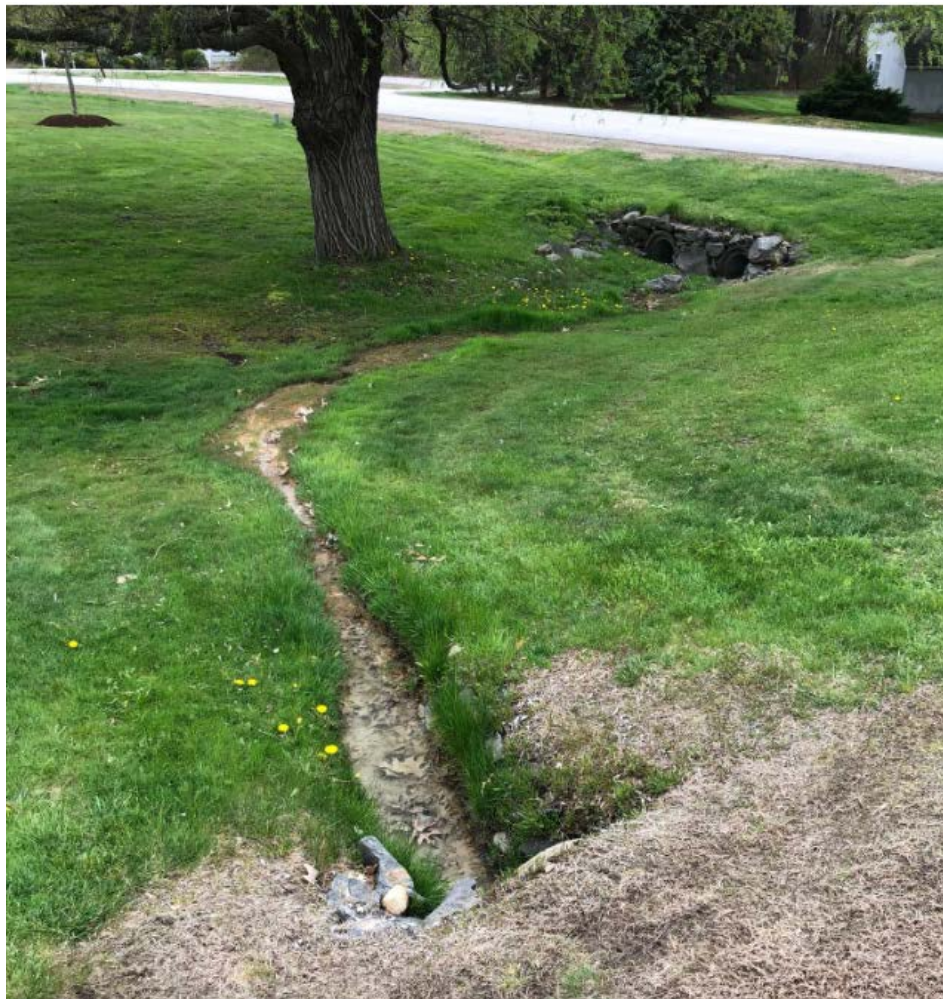
The drainage course in the area monitored consists of a narrow drainage channel at the Gundalow culvert outlet. The drainage course at the Brickyard Circle culvert outlet is a grassed area bound by field stone walls. (See photographs 3 and 4 below). The downstream sample locations have been at pockets of standing water. There was no continuous flow observed during the monitoring events. While the drainage course ultimately interfaces with Little Bay approximately 400' from the Brickyard Circle culvert outlet, Eversource has not identified any releases of water with elevated pH to Little Bay.

Photograph 3: Drainage Course at Gundalow Landing Culvert Outlet (View facing southwest)

On June 2, 2020, the drainage course and grades at the Gundalow Landing culvert outlet were improved to prevent the current condition of damming of water downstream of the culvert.

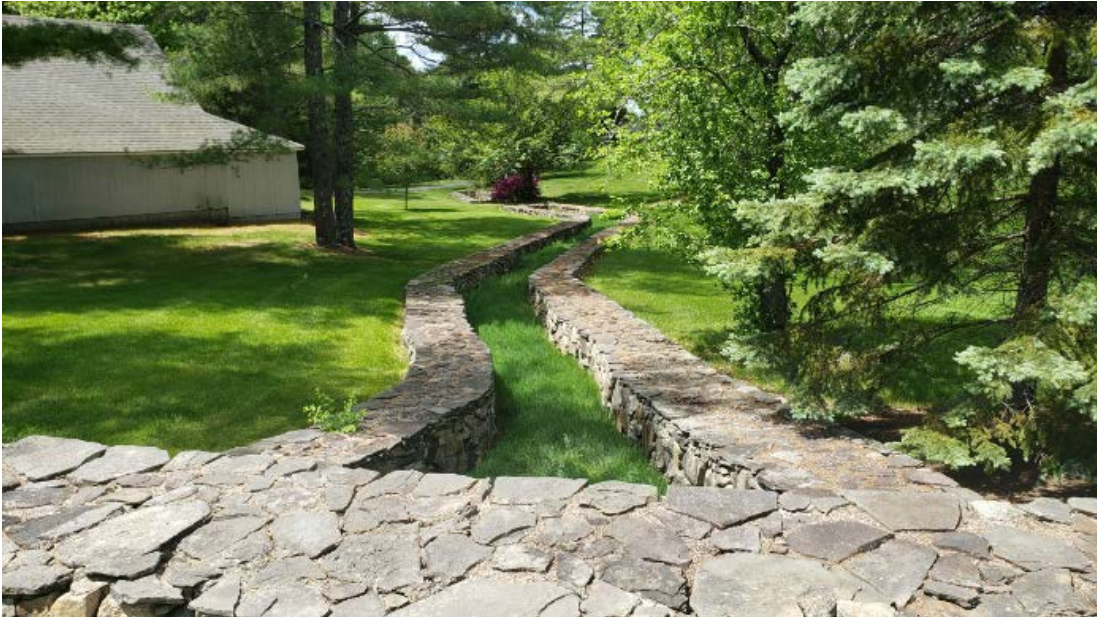
Photograph 4: Drainage course south of Brickyard Circle (facing south)

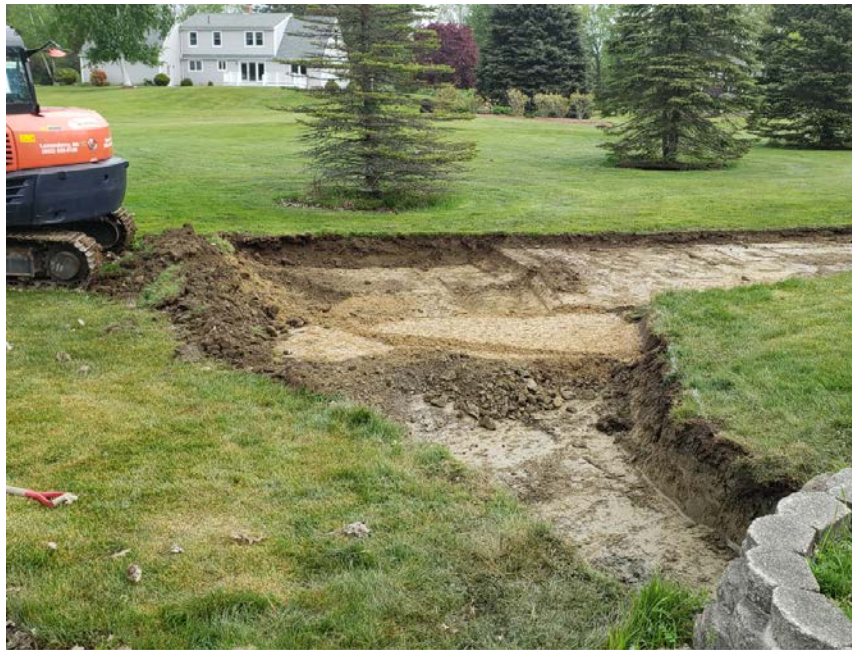
Photograph 5: Excavation of 29 Gundalow Landing Seepage Area in progress

As discussed, the duct bank and flowable fill appear to have altered the normal subsurface shallow groundwater flow patterns, causing water to seep to the ground surface. To mitigate this condition, on May 26, 2020 Eversource excavated approximately 1.5 feet of flowable fill above the duct bank along with the tight silt and clay soils in the seepage area, in an area that measured approximately 24 feet long by 20 feet wide at its widest point. Prior to the excavation, surface seepage in the culvert was recovered and due to the elevated observed pH, will be properly disposed of at a water treatment facility. A perforated subdrain wrapped in filter fabric that outlets to the culvert was installed in the center of the excavation.

Filter fabric and stone were installed near the culvert inlet. The rest of the excavation was backfilled with approximately 18 inches of permeable sand and gravel.

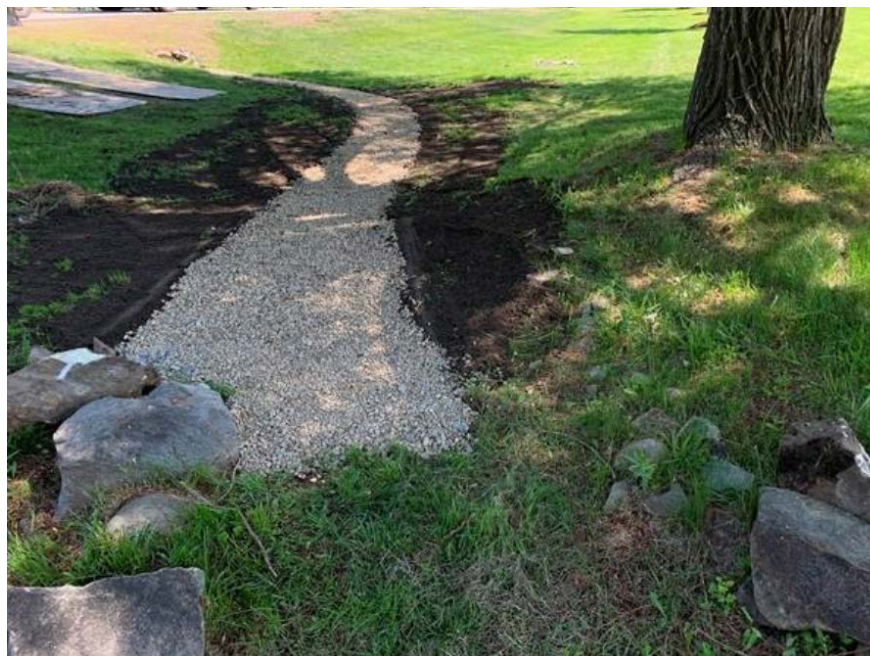
Photograph 6: Drainage course improvement at Gundalow Landing Culvert Outlet (View facing northeast)

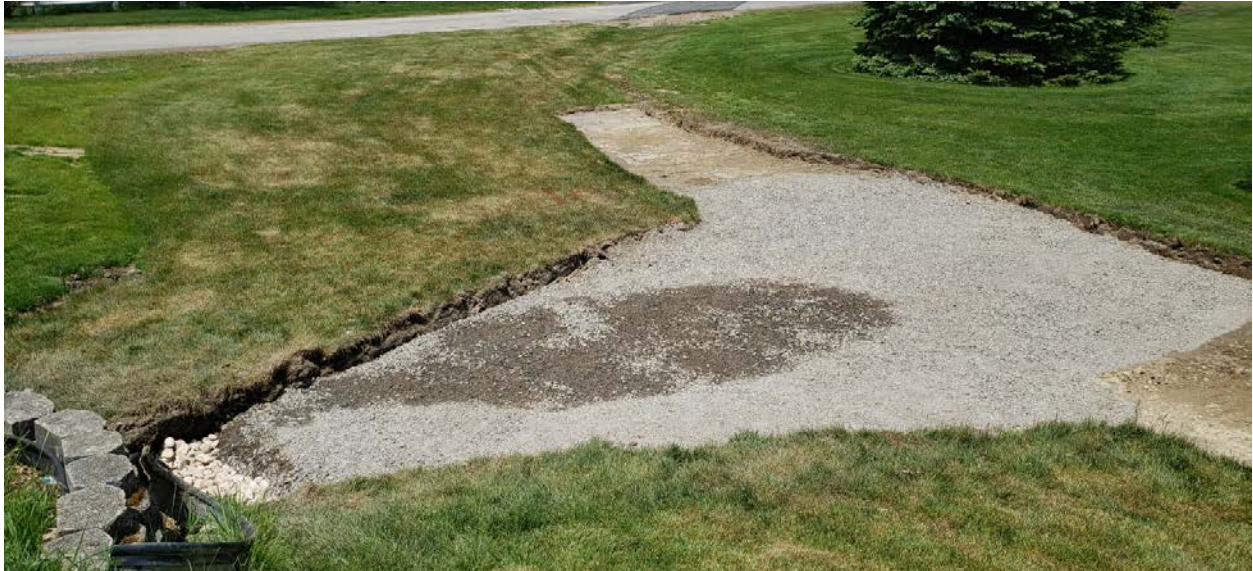
During and following the excavation on the 29 Gundalow Landing property it was observed that seepage is preferentially flowing in the flowable fill layer. Minor seepage was observed during the excavation on May 26, 2020. In the days following, seepage has been observed at the surface of the sand and gravel layer, however, little or no flow has been observed discharging to the culvert.

Photograph 7: View of Gundalow Landing seepage area following excavation and backfill with sand and gravel

pH of the seepage in this area and the downstream drainage course will be monitored closely in accordance with The FTB Monitoring Plan prepared by GZA and submitted to the Department concurrently with this Report. If elevated pH readings persist additional assessment/corrective actions will be implemented.

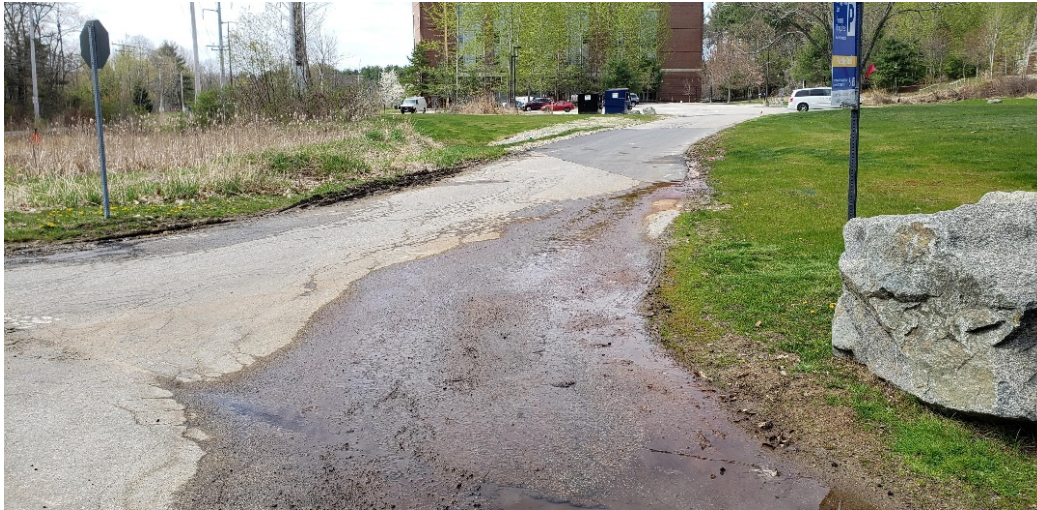
On May 6, 2020 Eversource and GZA investigated the seepage. Water was observed emanating from the edge of the Greggs Hall access road. The water seeped along the pavement towards Waterworks Road. Iron staining was observed in the seepage course along the Greggs Hall access road and Waterworks Road.

It was assessed that the groundwater that normally flows eastward was being impeded by the duct bank and/or flowable fill and breaking out at the ground surface.

Photograph 8: Seepage observed on the Greggs Hall access road and Waterworks Road May 6, 2020

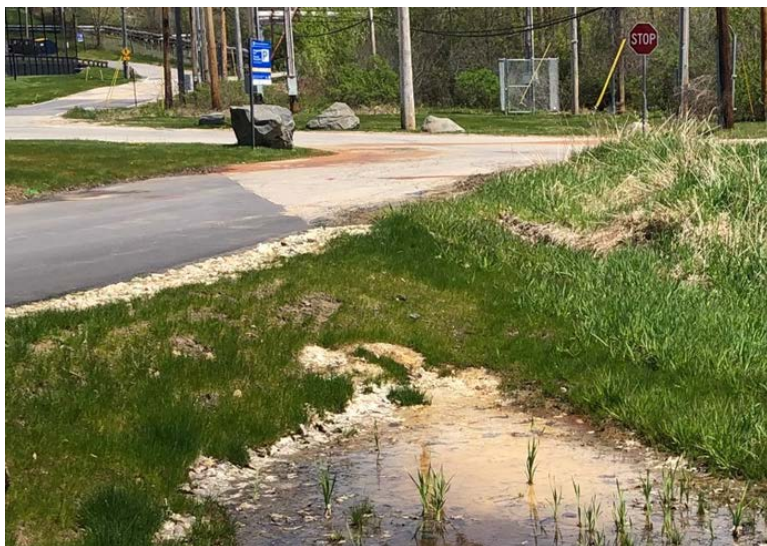
In addition, white precipitate, similar to what was observed at the Gundalow Landing property was observed along the grassed slope on the south side of the Greggs Hall access Road and within standing water of a wetland complex. Based on the analysis conducted at Gundalow Landing, this material is also assumed to be primarily calcium carbonate (CaCO_3).

Photograph 9: Precipitate observed south of the Greggs Hall access road

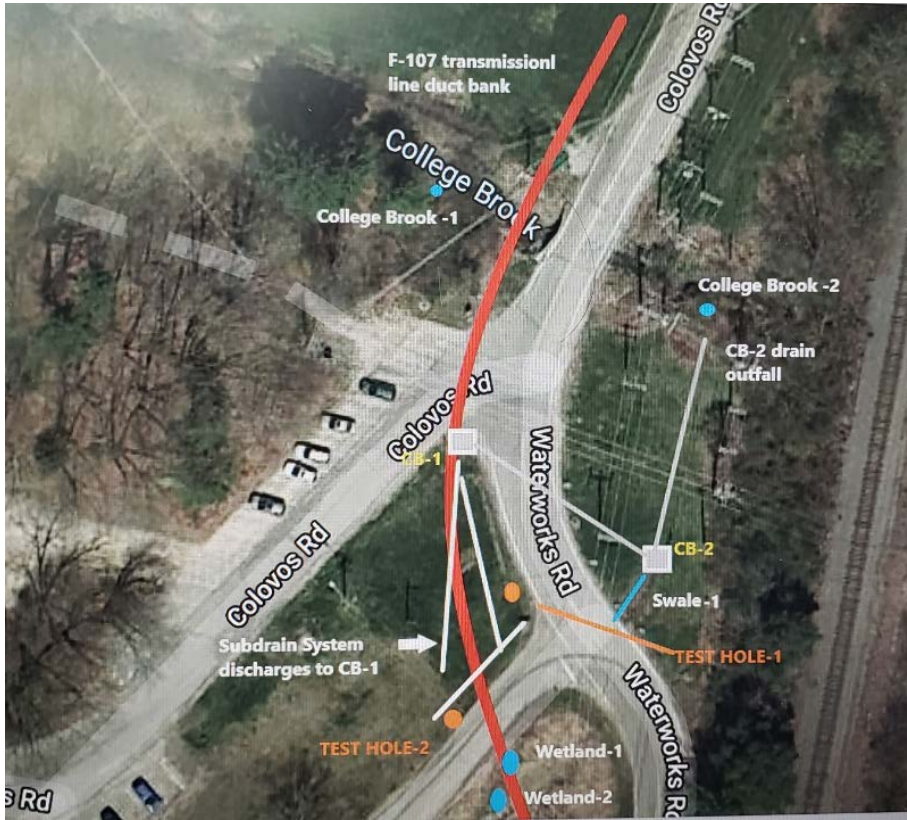
On May 15, 2020, to assess potential water quality issues, GZA monitored pH at several locations. Site details and sample/monitoring locations are shown in Figure 6 below. pH was field monitored at the Swale-1 location, where iron precipitate was observed, in standing water at the Wetland-1/Wetland-2 locations, at the College Brook-1/College Brook-2 locations and at the CB-2 drain outfall location. The data are provided in Table 2 below.

Figure 4: UNH Area of Concern Assessment Plan

As shown on Figure 6, the subdrain and stone trench system was designed in cooperation with UNH to capture shallow groundwater in the area of concern. The subdrain system, which consists of 6 inches of perforated pipe within a gravel trench, between the depths of approximately 2 feet to 3 feet below grade, discharges to catch basin CB-1. Catch basin CB-1 is piped to the downstream catch basin CB-2 which also receives stormwater flows from Swale-1. CB-2 discharges to College Brook in the vicinity of the College Brook-2 sample location.

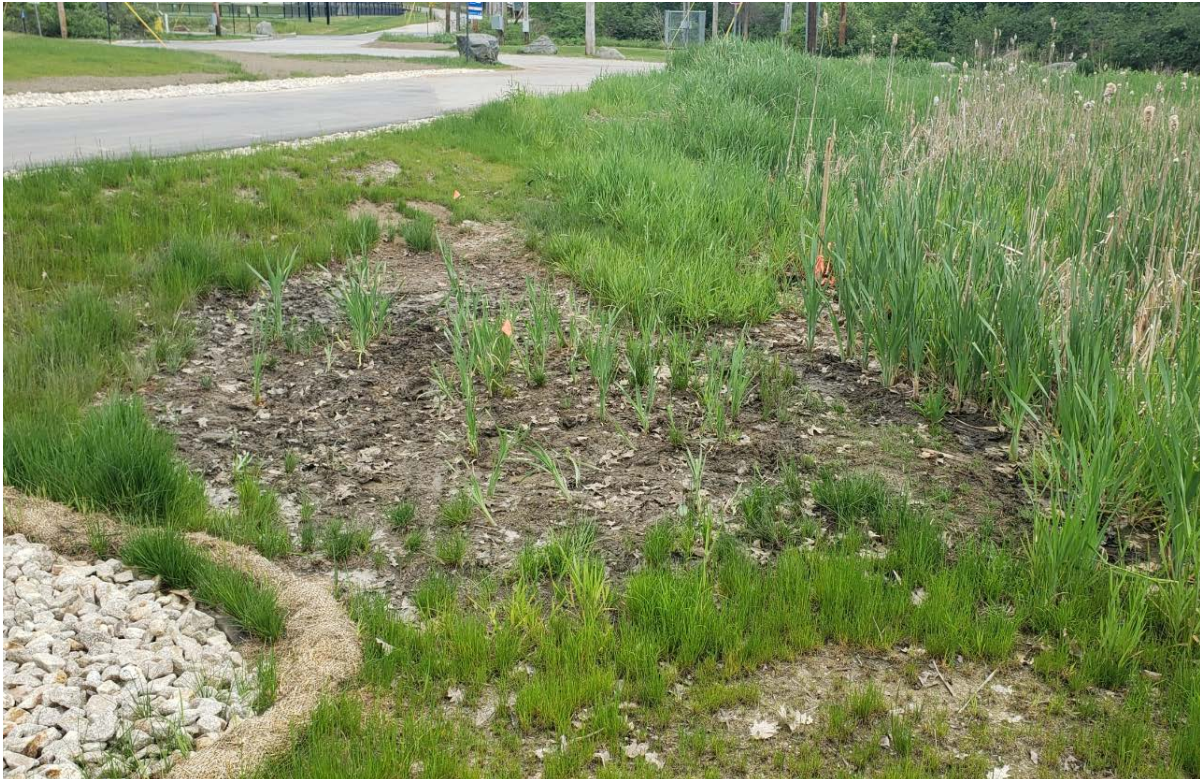
Photograph 10: UNH cattail swamp following precipitate removal 5/29/2020

Between May 26 and May 29, 2020, there was no standing water in the area of the cattail swamp where precipitate had been observed. It is possible that the subdrain system is responsible, to some degree, of diverting the post construction condition of shallow seepage that was responsible for the observed precipitate at this location.

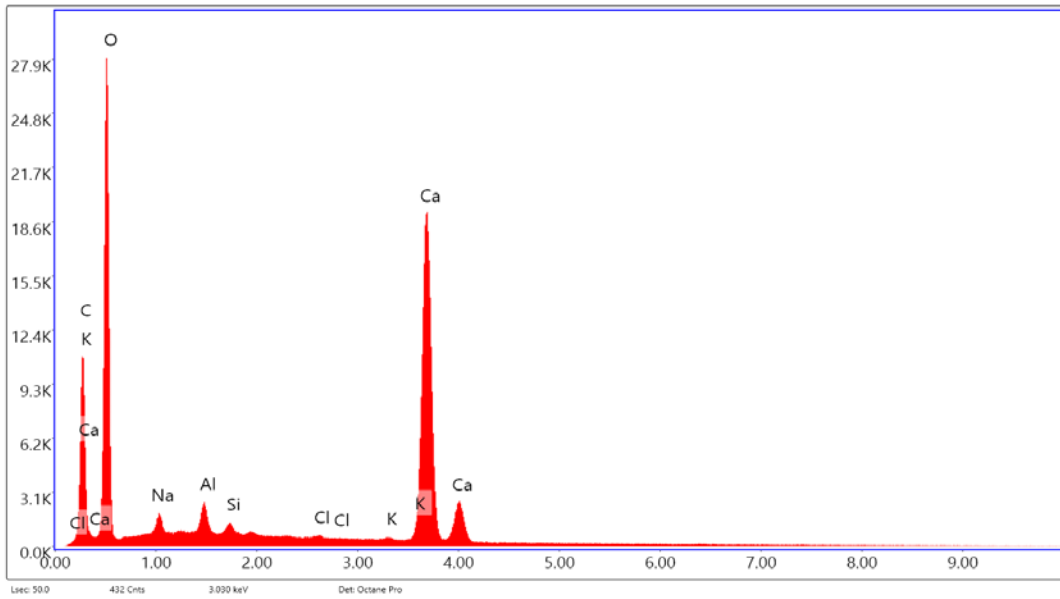
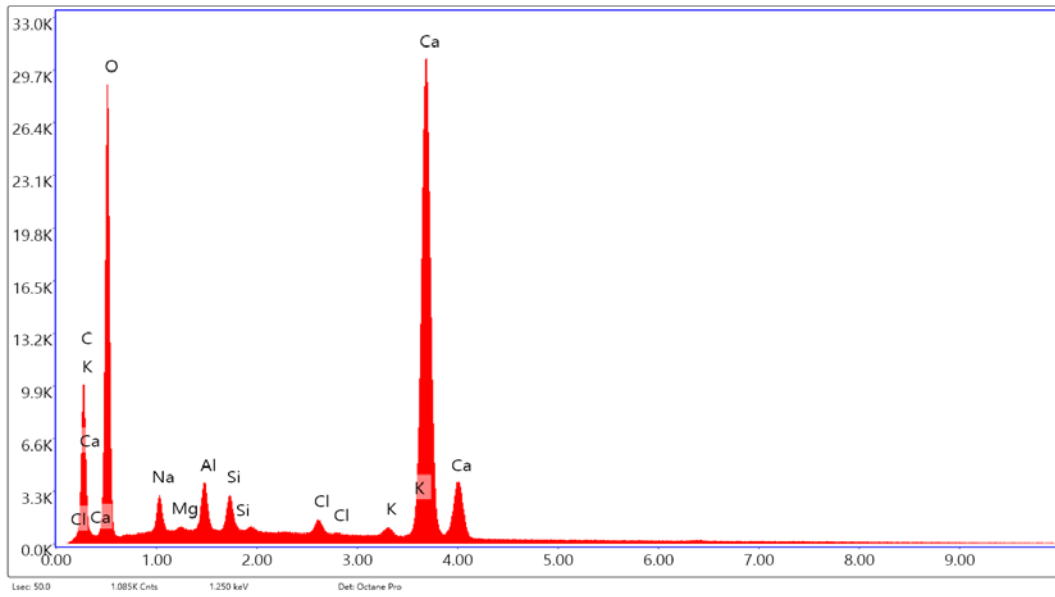
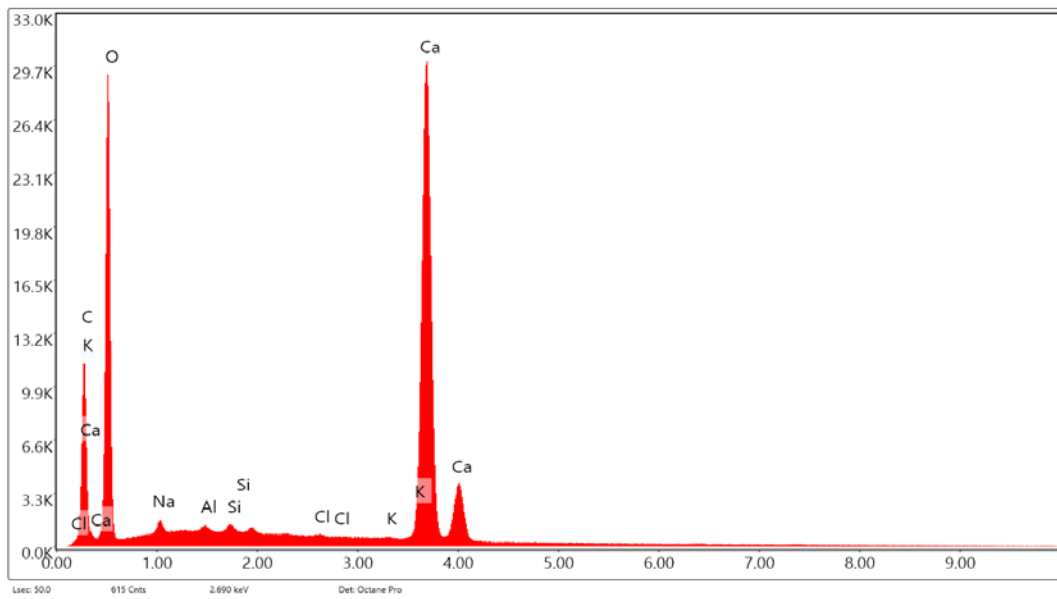
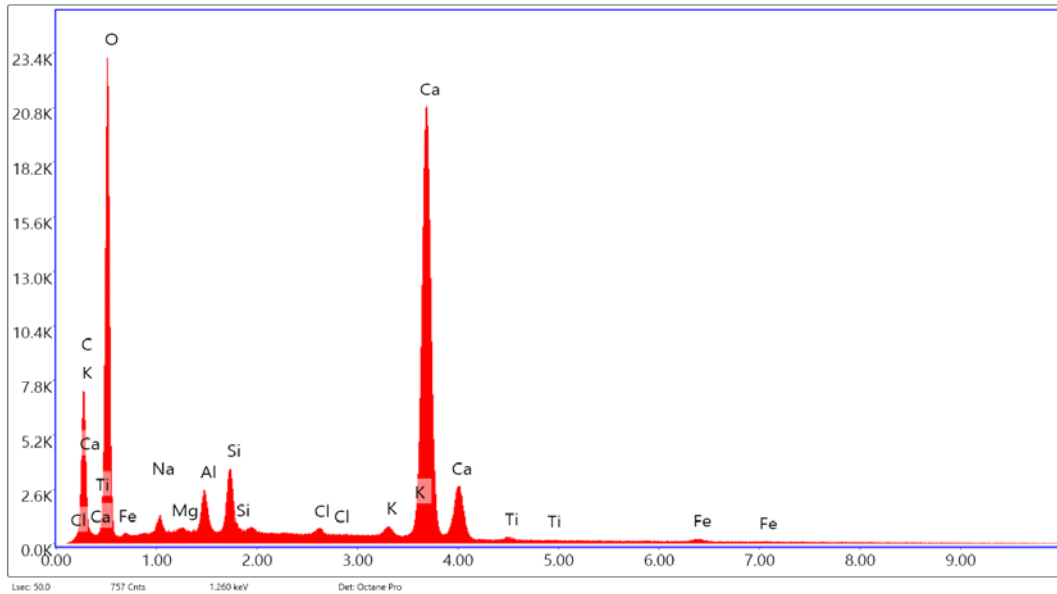
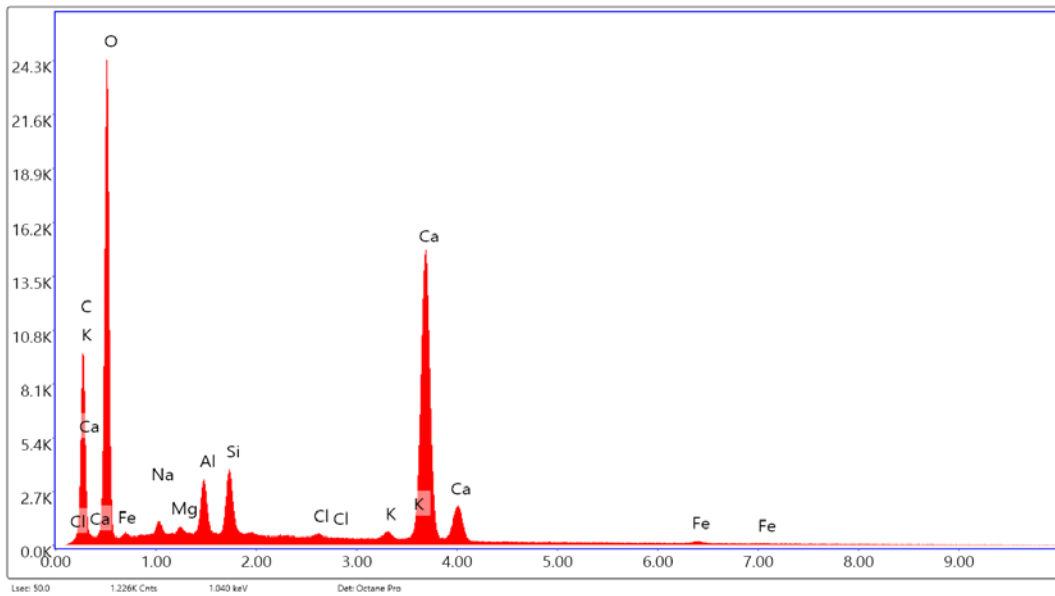
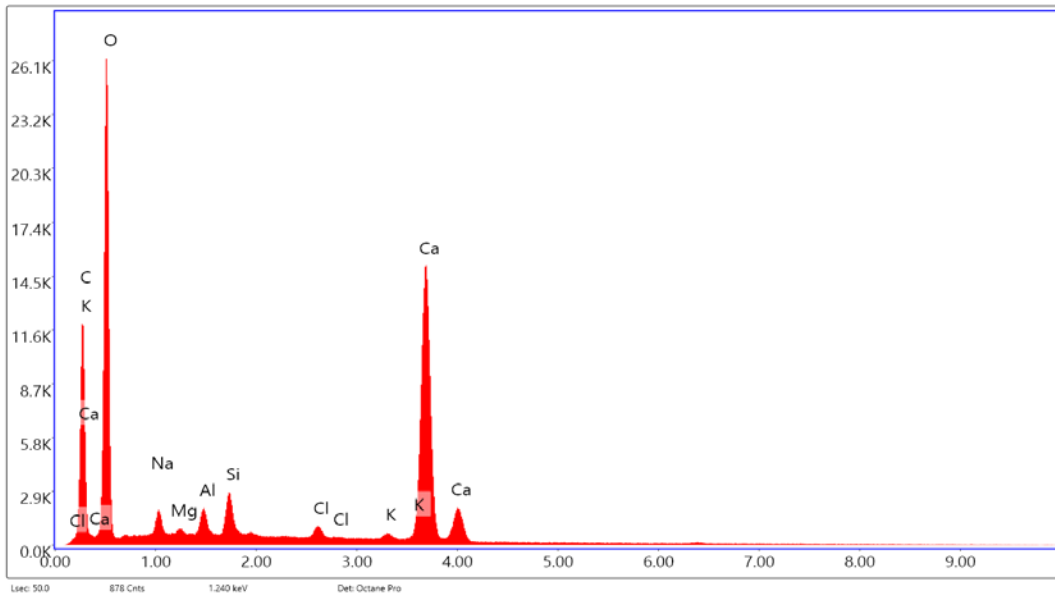
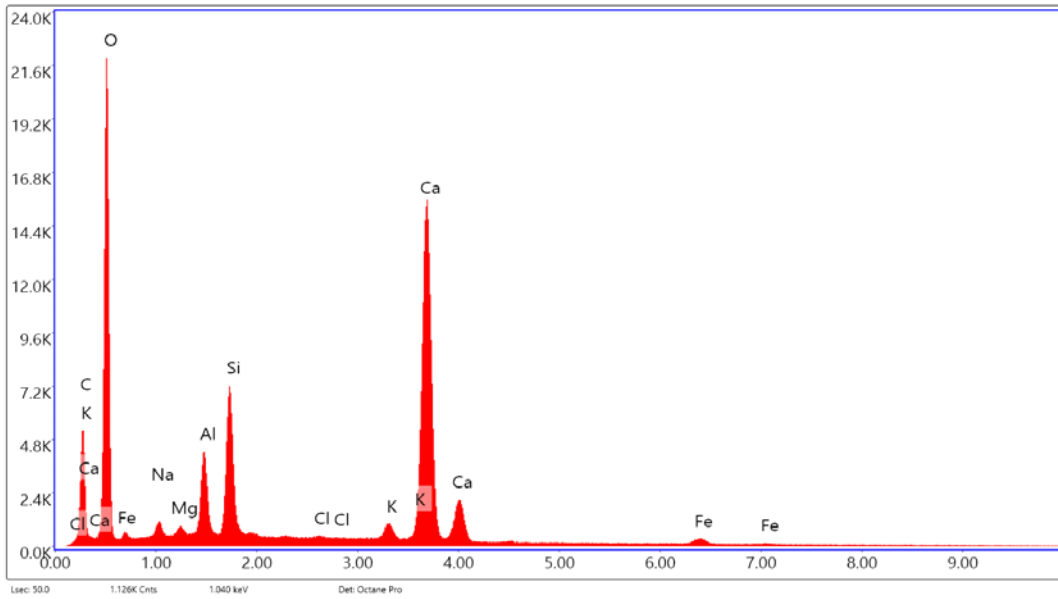
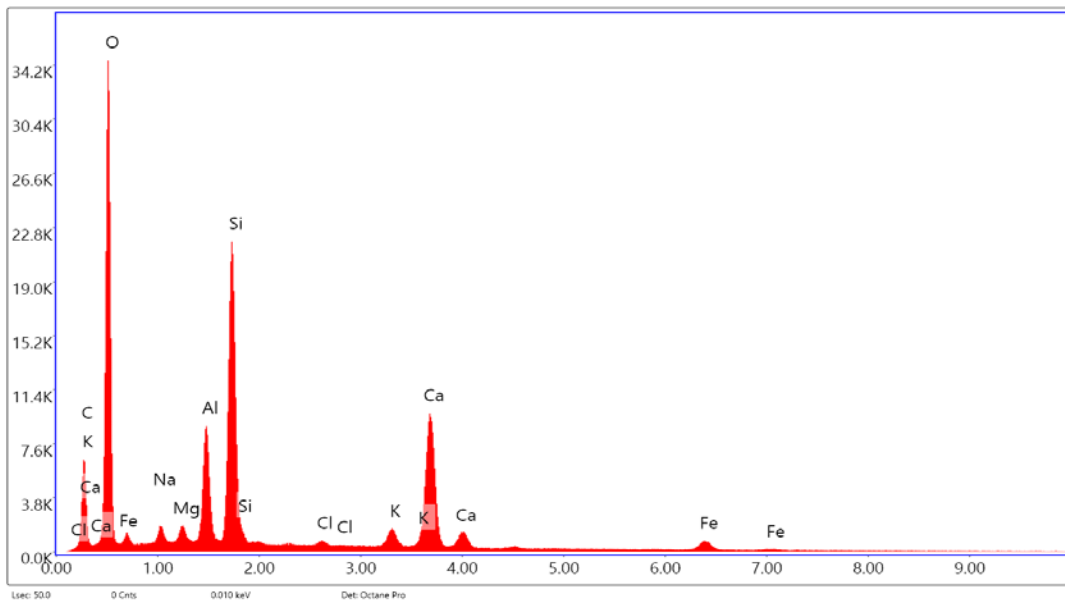
Figure 1: EDS spectrum generated by unknown material
