RE: Post construction review of stone walls – Seacoast Reliability Project (#6528)
(Durham Historic Association’s Historic Resources Status Update of November 1, 2020)

HISTORIC RESOURCES – STATUS UPDATE NOV 1, 2020 – DURHAM HISTORIC ASSOCIATION

Damage to Protected Stone Walls Caused by the SRP

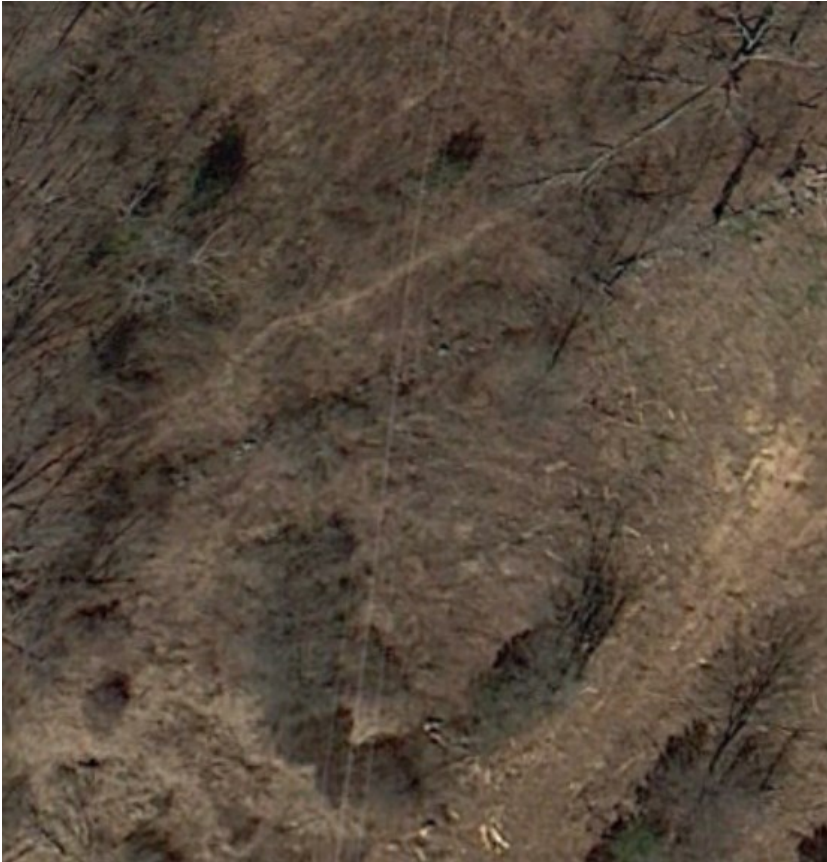
2013 WP-7 and WP-8

These stone walls bordered the driveway to the John Emerson Thompson Farm. The walls are archaeologically sensitive, as detailed by the Eversource archaeologist. There was no vehicular access over these stone walls before the SRP. The 2013 image shows prior access was the road in the lower right. The image also shows the footpath between WP-7 and WP-8.

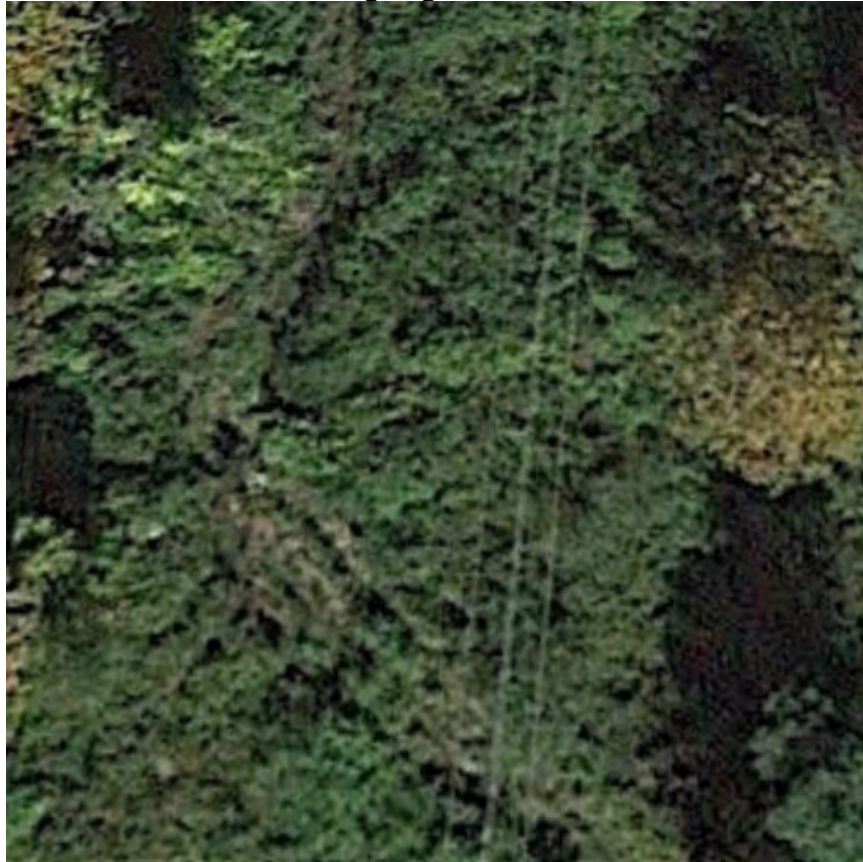
2017 Track of the Drilling Rig

The 2017 image shows the track of the drilling rig. The same track over WP-7 and WP-8 was later used for pylon installation. Eversource Exhibit Appendix 33 indicates WP-7 measured 1.5 feet tall and WP-8 measured 2 feet tall.

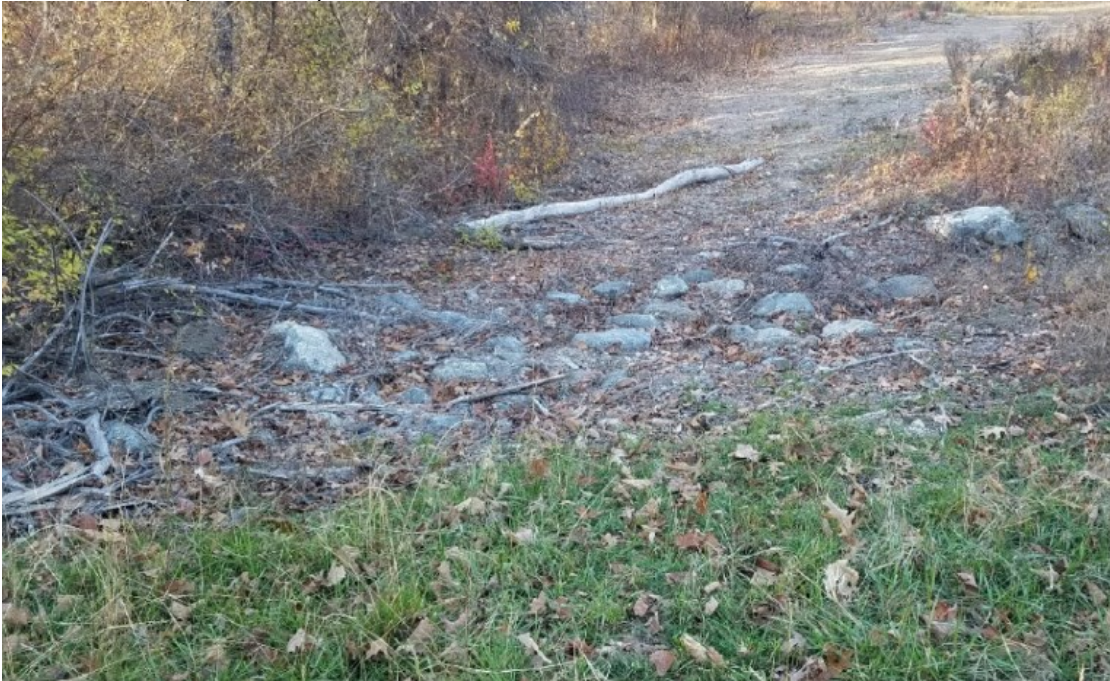
WP-7 (east wall) and WP-8 (west wall)

2020 WP-7 (east wall) crushed, was 1.5 feet tall

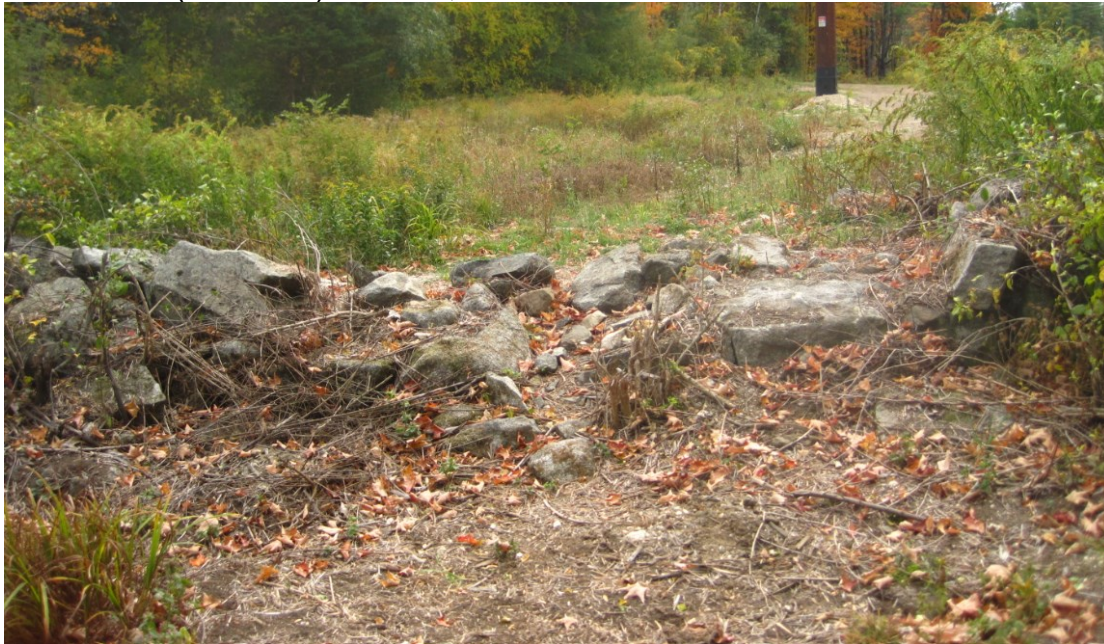
2020 WP-8 (west wall) crushed, was 2 feet tall

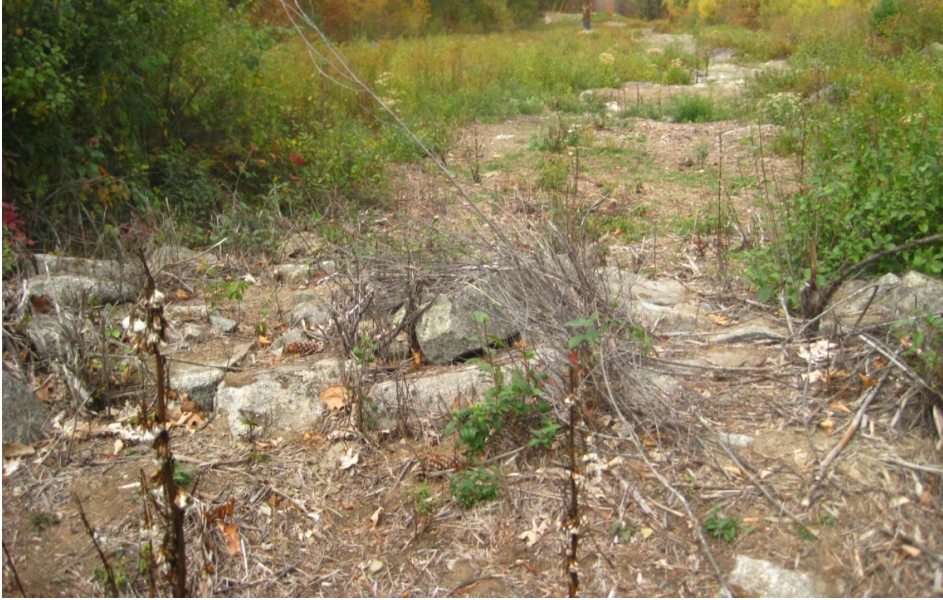
This stone wall is a property boundary in the field system used for centuries before the railroad embankment was widened in 1910. This stone wall is in an archaeologically sensitive area as it was part of the Cornet Winthrop Smith farm. Appendix 33 indicates this wall measured 2 feet tall by 4 feet wide.

2020 stone wall crushed by heavy equipment

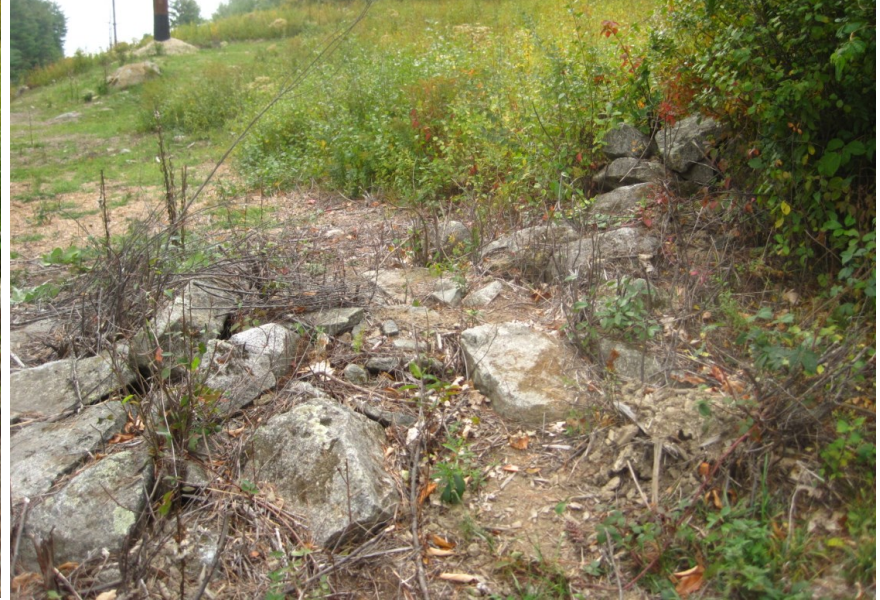
2020 wall crushed

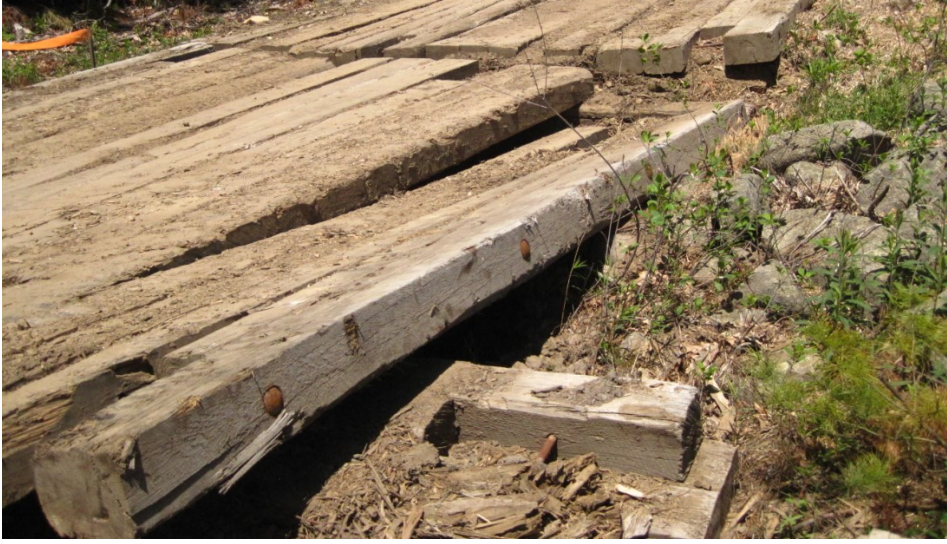
This stone wall is in the Historic District and once outlined a field on a local farm. Appendix 33 indicates this wall measured 1.5 feet tall.

2020 timber mat support failure over the stone wall

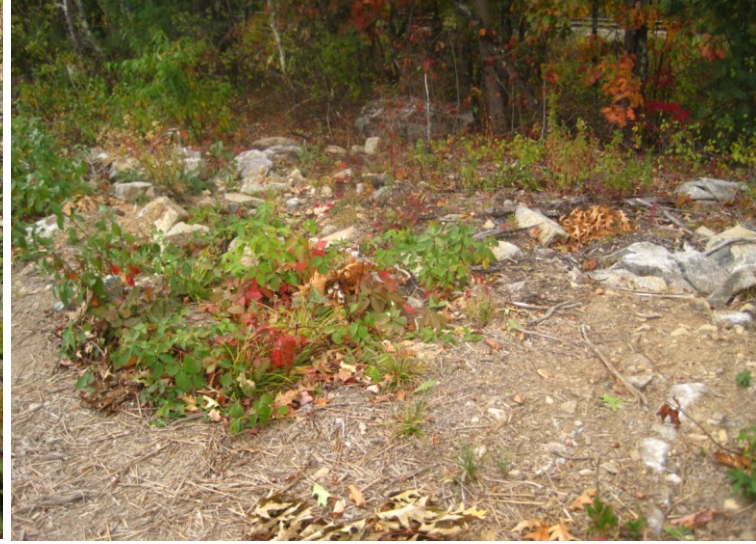
2020 field stones from a stone wall are nearby

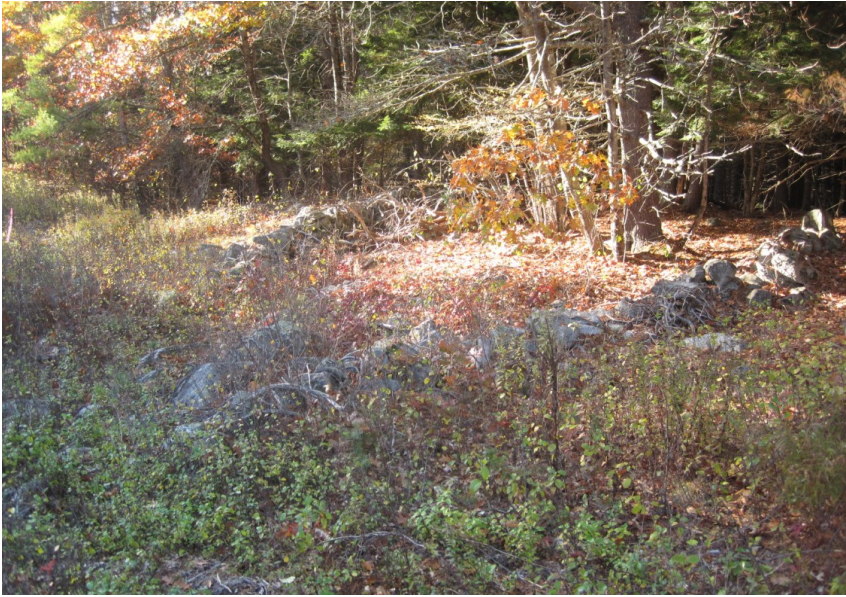
This pair of stone walls, WP-15 and WP-15A, form a cattle drive or drift way in the Historic District. WP-15 is the west wall and WP-15A is the east wall. These walls were protected with timber mats. WP-15A was not damaged, however WP-15 was crushed.

2016 cattle drift way WP-15 and WP-15A

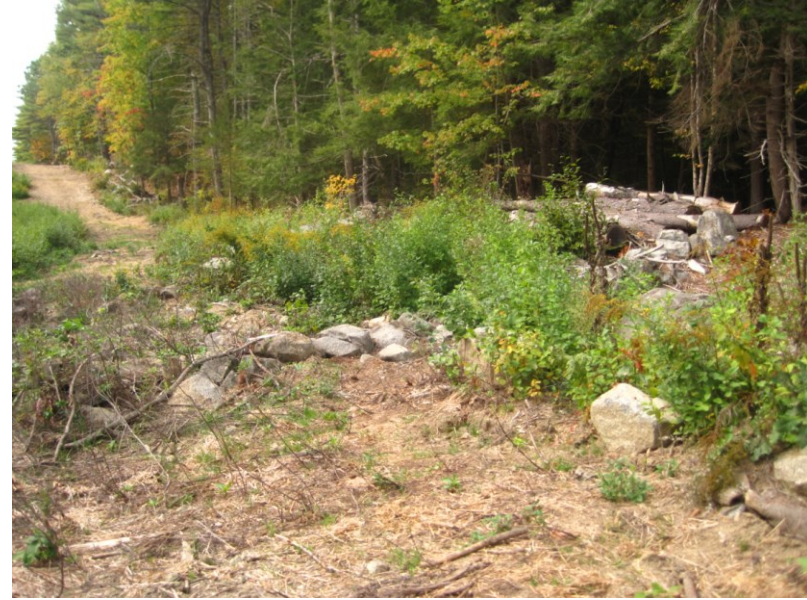
2020 WP-15 (left) WP-15A (right)

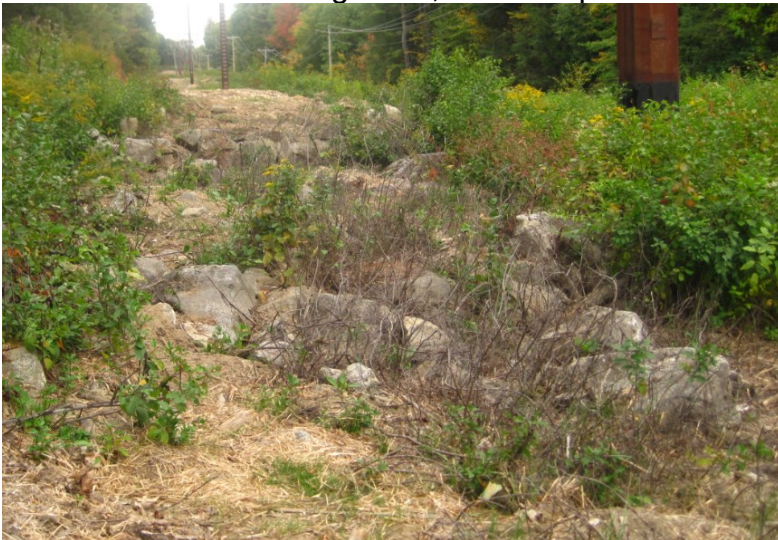
2020 WP-15 in the foreground, wall collapsed

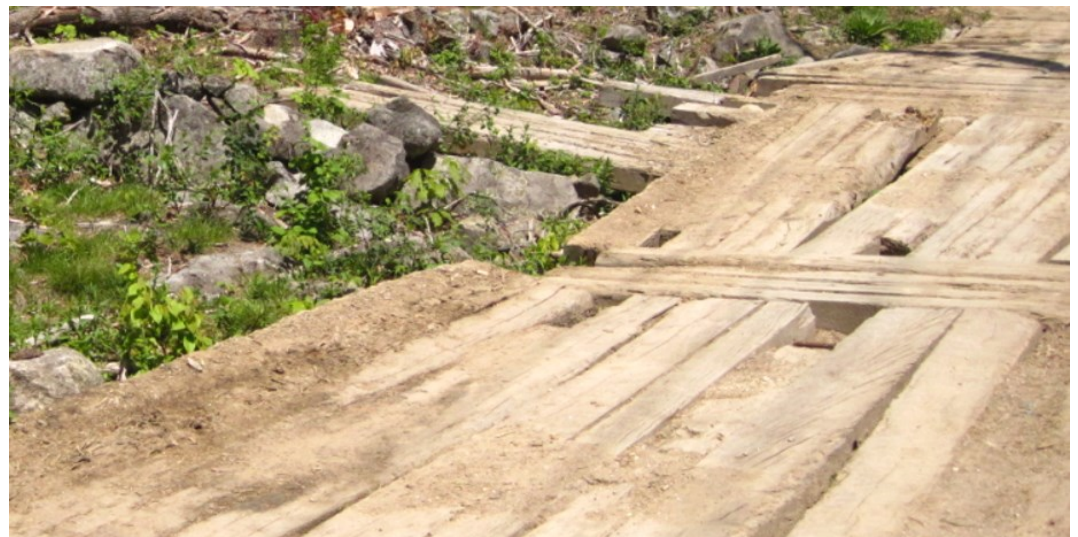
2020 support of timber mat was inadequate above WP-15

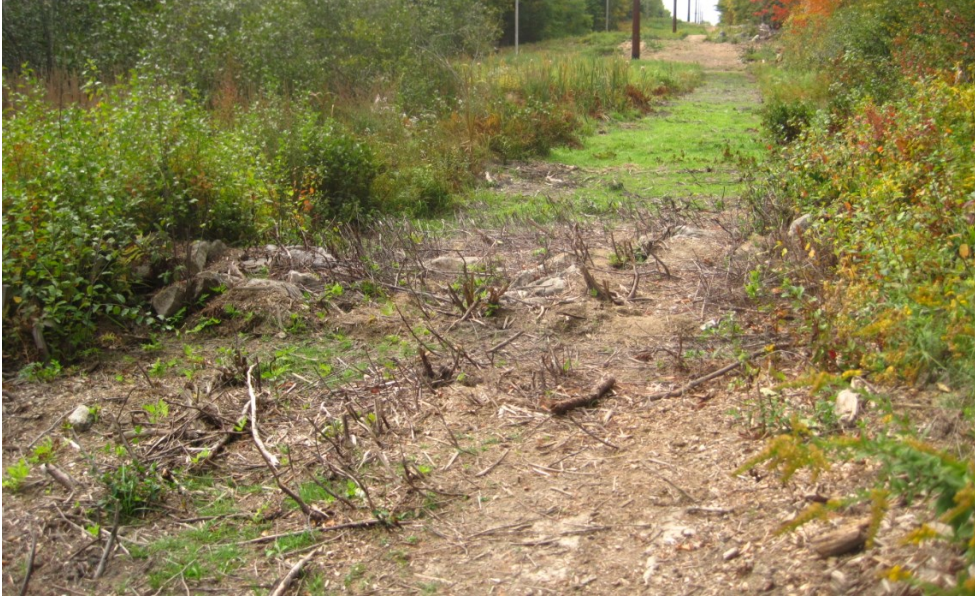
This stone wall marked an ancient land boundary and is situated in the Historic District. Appendix 33 indicates this wall measured 2 feet high and 4 feet wide.

2020 stone wall crushed into the ground

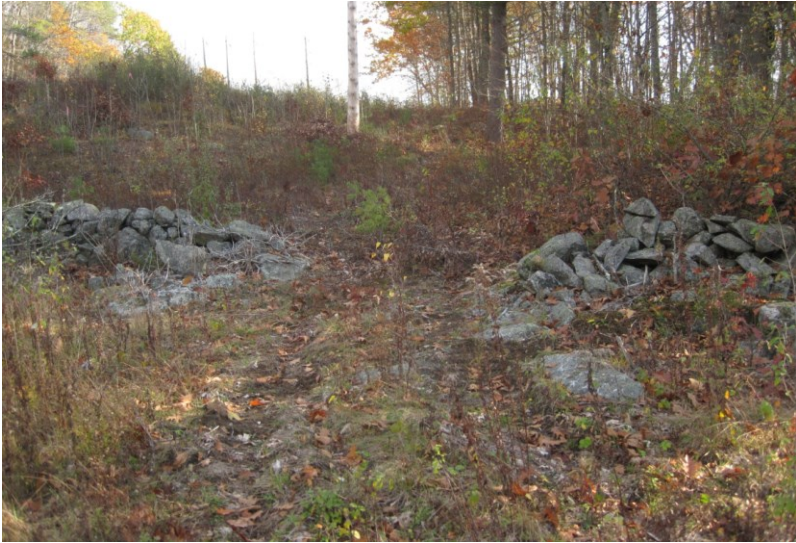
2016 WP-18

This stone wall once surrounded an arable field in the Historic District. Public Service of NH had breached the stone wall in the past. Eversource agreed to use the existing breach for access. After the SRP, the stone wall is degraded.

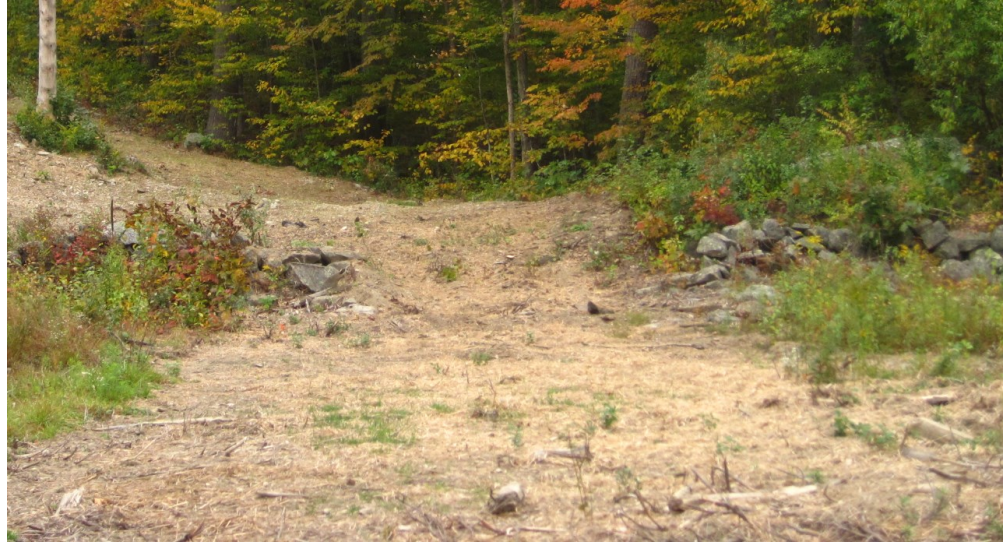
2020 breach is wider, wall damaged, stones missing

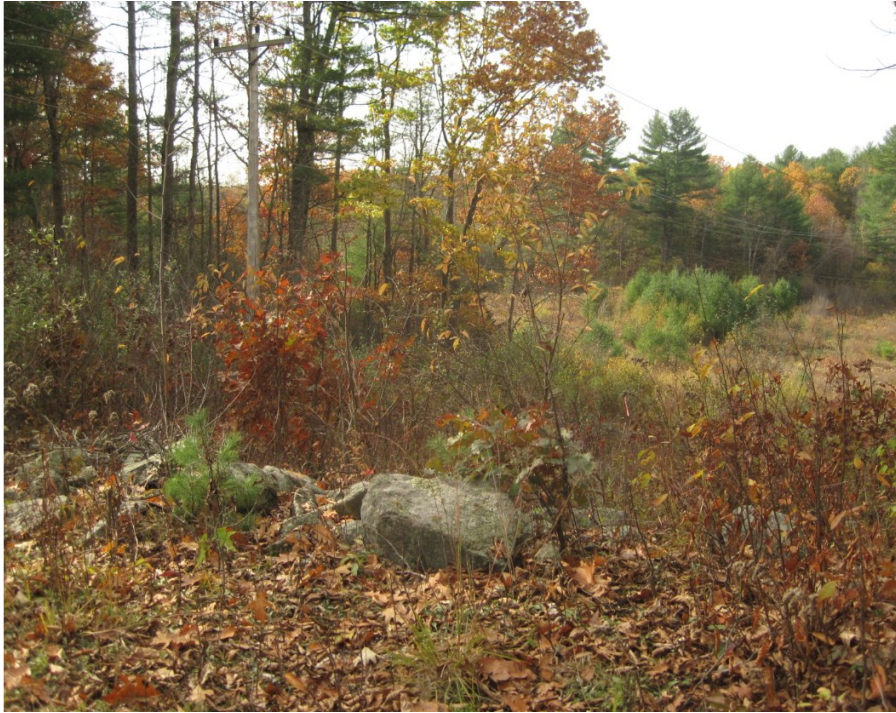
2016 view west

Stone wall WP-19 crosses the hill behind the Moriarty farmhouse. The house was built before 1760 and both resources are located in the Historic District. Appendix 33 indicates the stone wall measured 1.5 feet high and 4 feet wide.

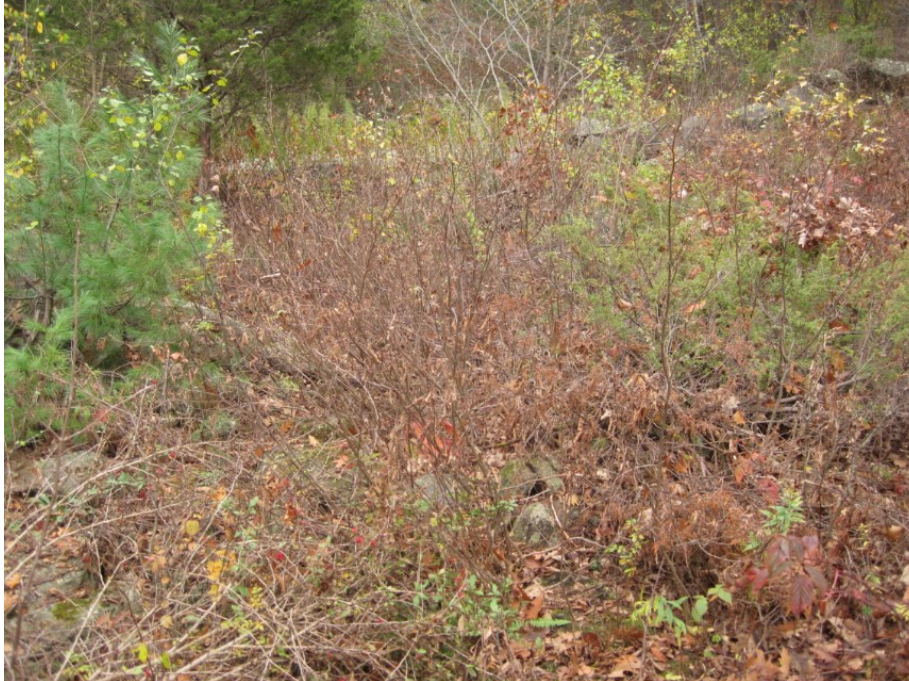
2016 stone wall WP-25 visible at bottom of image, WP-24 above

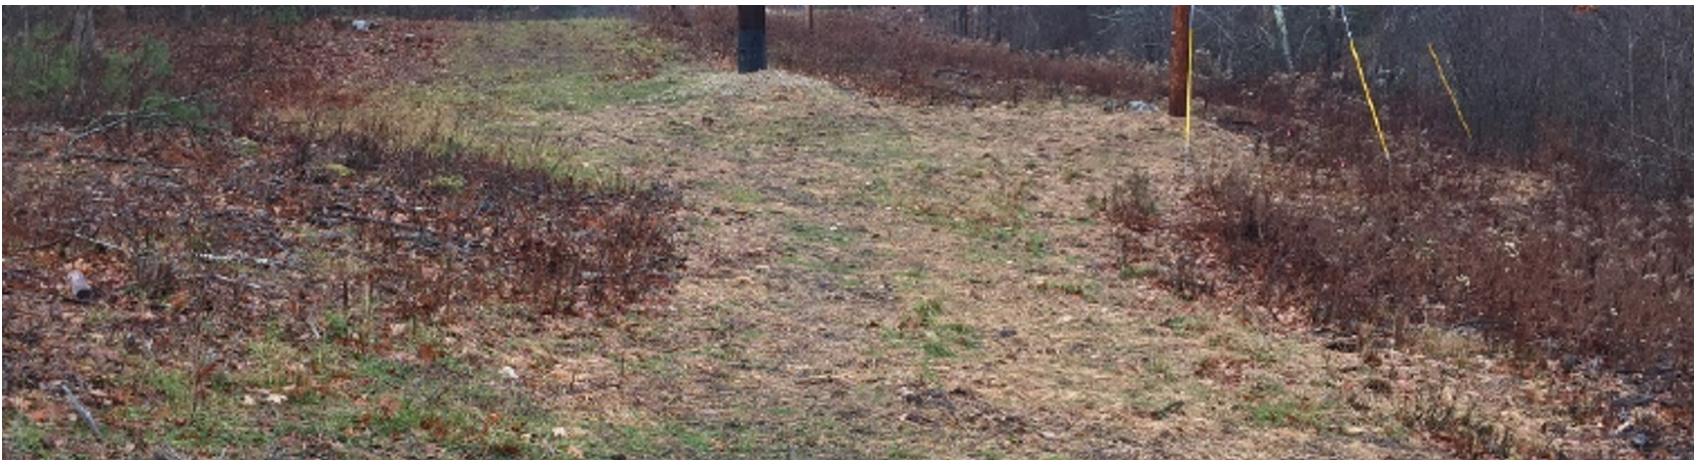
This stone wall is a property boundary. The agreement was to use the existing breach, however the opening was widened and the stone wall driven over or crushed into the ground. Now it is difficult to find the stone wall. Appendix 33 indicates this stone wall measured 1.5 feet high by 3 feet wide.

2020 a few rocks

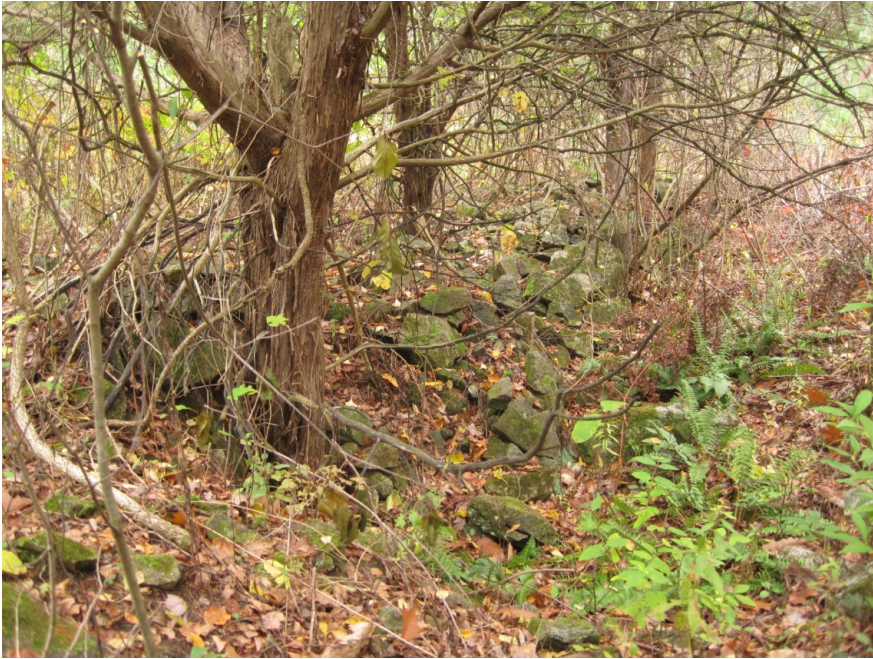
2016 view north

This stone wall is a property boundary. We agree about the images sent by Eversource, there was no new damage to that section of stone wall WP-24; that section was crushed flat by PSNH in the past. The new damage is to the west of the flattened section. It appears the new damage to the wall was caused by gravel fill dumped on the flat area north of the stone wall, and later the left-over fill was smoothed. The gravel fill is pushed up against the north side of the stone wall and over the stone wall in several places. Appendix 33 indicates the wall measured 2 feet high and 3 feet wide.

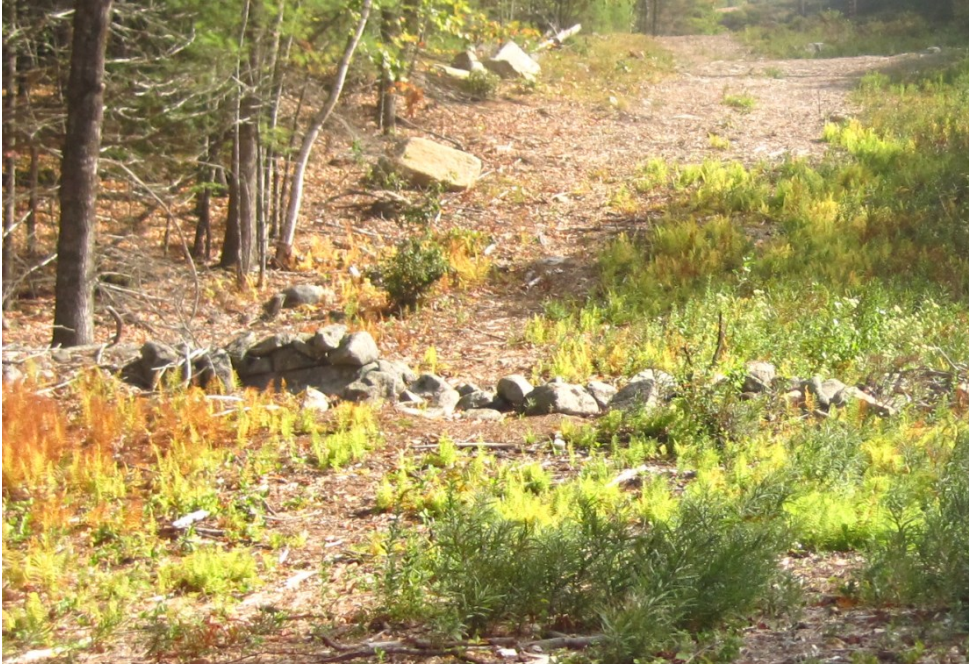
Stone wall WP-30 is the east wall of a large oval enclosure that extends beyond the easement on both sides. It was used to keep the oxen that hauled stone for the adjacent granite quarries during the 18th and 19th centuries. The timber mat failed and the stone wall was crushed. Granite rocks in the crushed area were split by the weight of the equipment crossing the timber mat.

2020 wall crushed

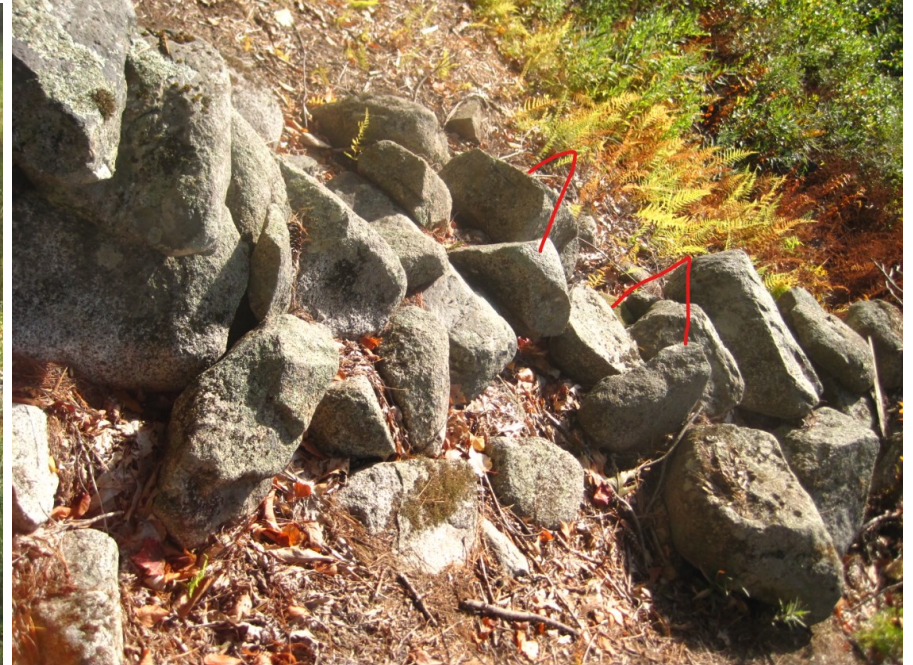
2020 granite split by the weight of equipment, see red lines

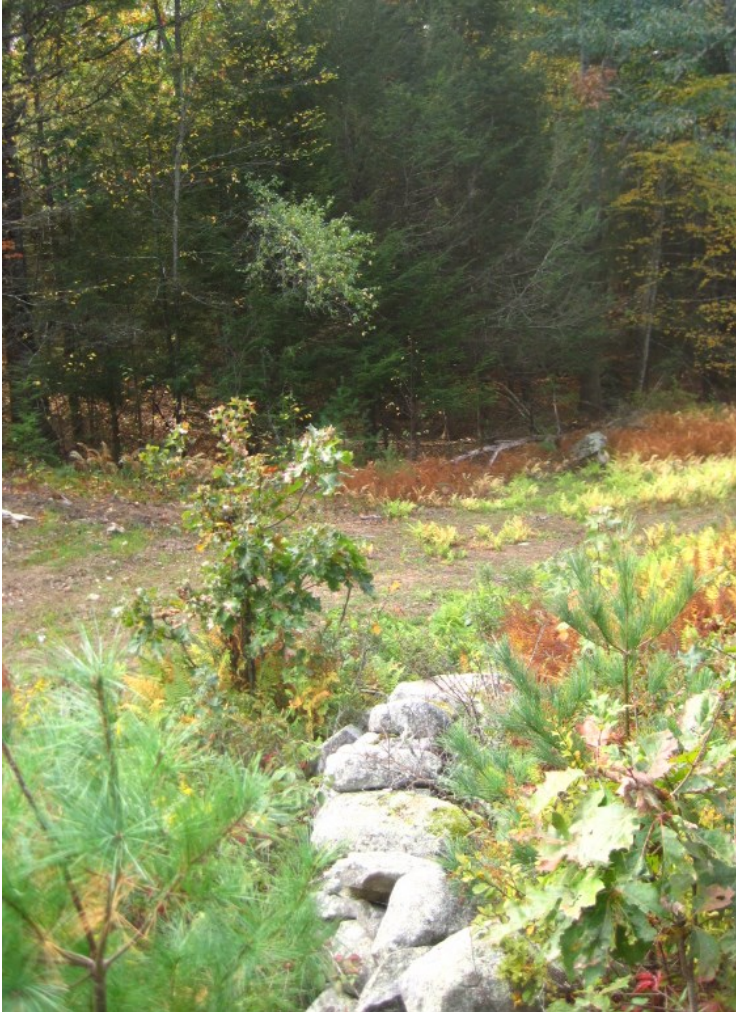
The south breach that was widened is now 57 feet wide. The north breach was closed with a pile of loose stones, with large rocks and quarried split granite from the archaeologically sensitive site bulldozed up against the loose stones. Other stone walls in the easement were rebuilt by qualified professionals, including WP-35, but this stone wall was not.

2020 south breach, was 9 ft, now 57 feet wide

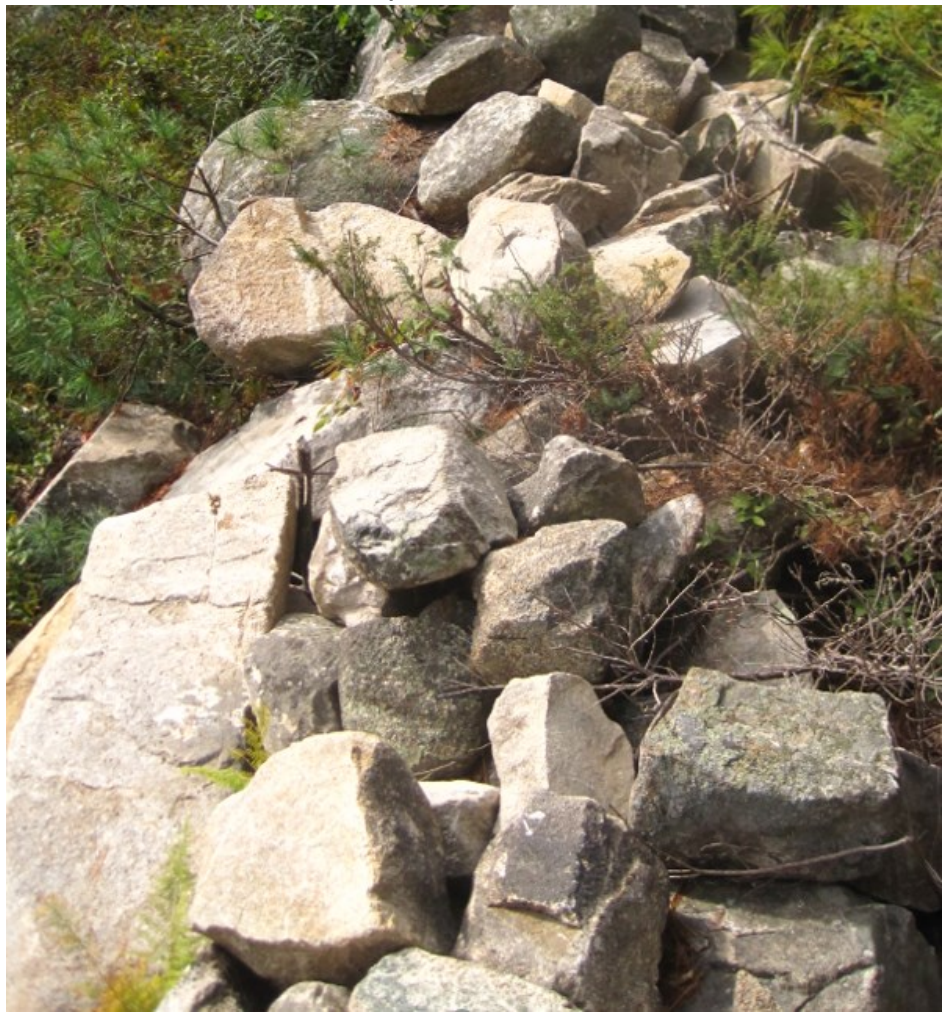
2020 north breach, now a pile of loose stones

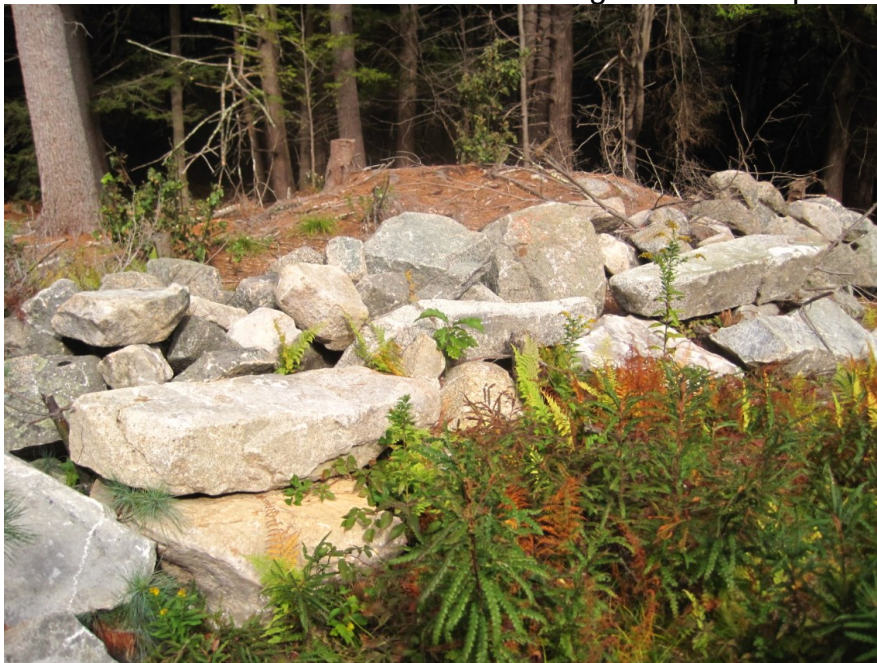
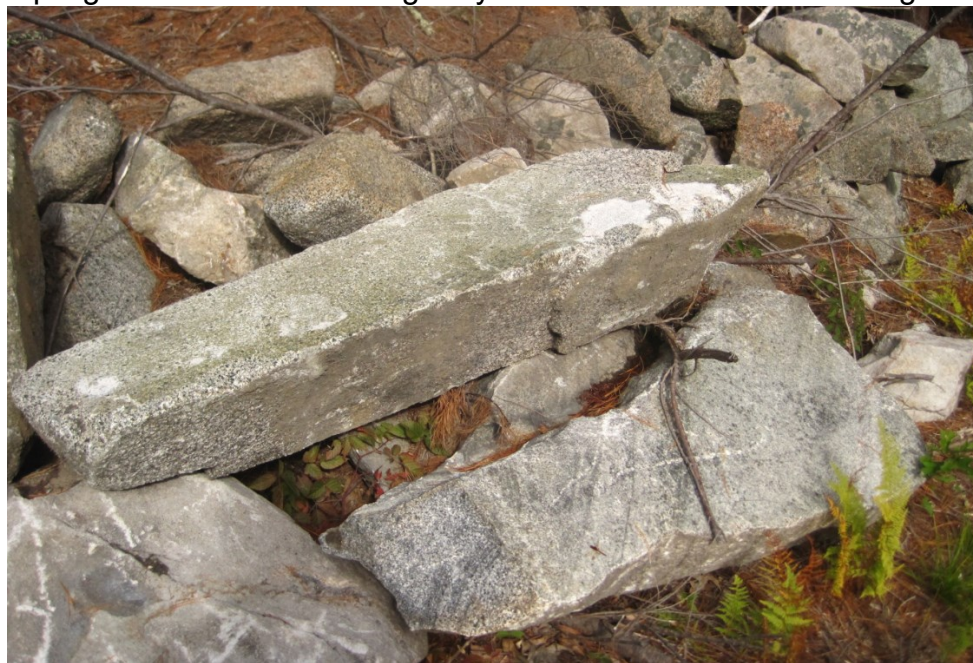
2020 north breach – loose stones with large rocks and quarried split granite from archaeologically sensitive site bulldozed alongside

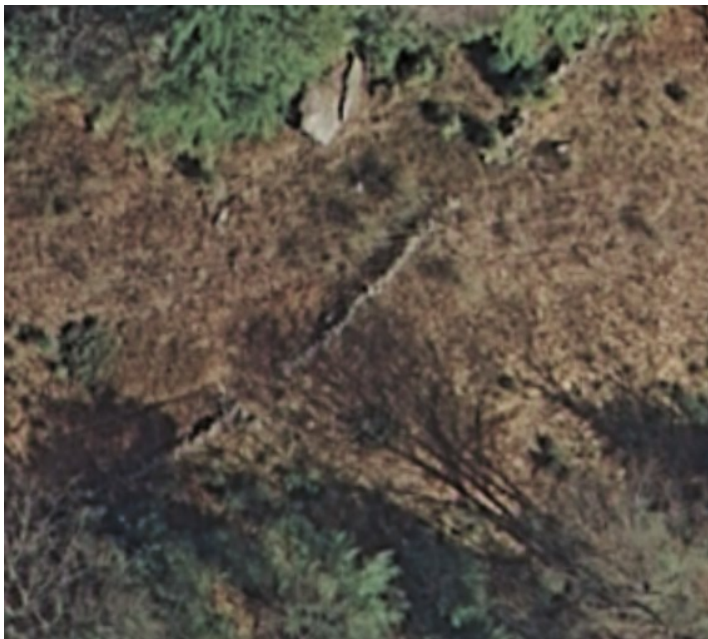
Stone wall WP-33 is a property boundary that runs through the Historic Granite Quarry District. Eversource's archaeologist designated this area a sensitive site for archaeology. In the past, Public Service of NH made two breaches in this stone wall, each measuring 8 to 10 feet wide. It was agreed one breach would be widened and the other repaired.

2010 WP-33 before the SRP

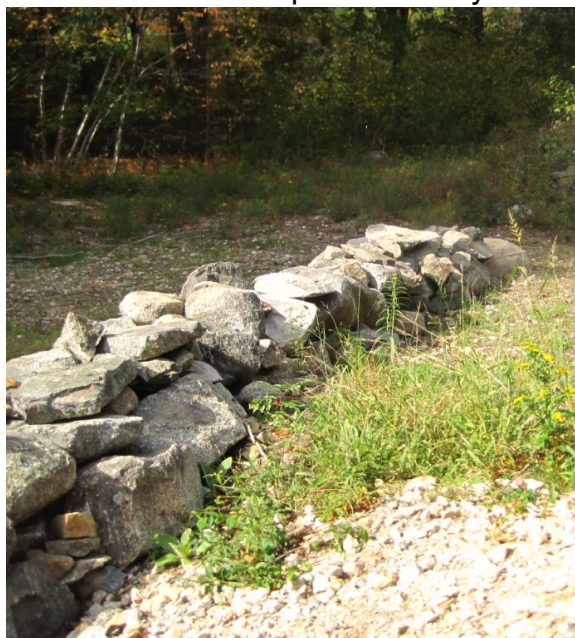
Comparison – WP-35 was professionally rebuilt during the SRP
