DRAINAGE MONITORING REPORT

Eversource Transmission
Line:

F107 - Seacoast Reliability Project

Durham, New Hampshire

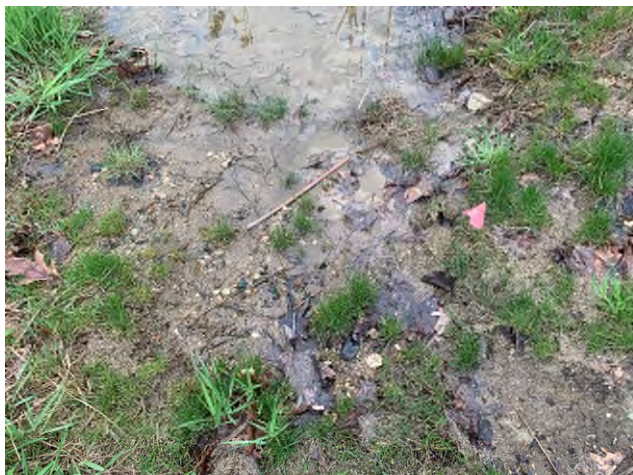
UNH Wetland - 1 (Stormwater Area)

Location: UNH Wetland – 1 (Stormwater Area)

Status of surface water at the time of inspection? Dry Standing Flowing

pH: --

Observations/Notes: Dry

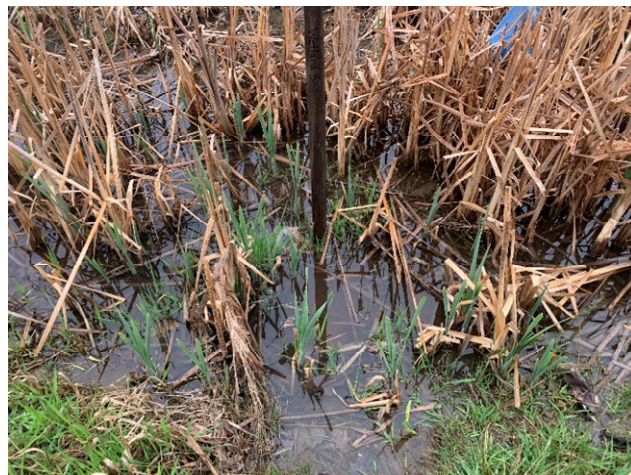
UNH Wetland - 2 (Stormwater Area)

Location: UNH Wetland – 2 (Stormwater Area)

Status of surface water at the time of inspection? Dry Standing Flowing

pH: 7.1

Observations/Notes: Standing water approx. 3" deep.

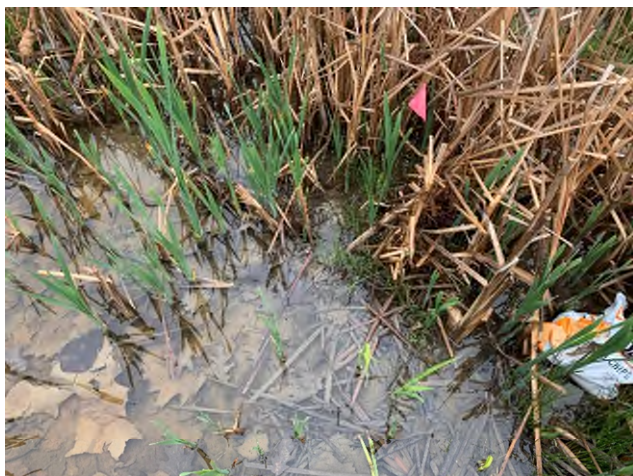
UNH Wetland - 3 (Cattail Wetland)

Location: UNH Wetland – 3 (Cattail Wetland)

Status of surface water at the time of inspection? Dry Standing Flowing

pH: 7.0

Observations/Notes: Standing water approx. 6" deep.

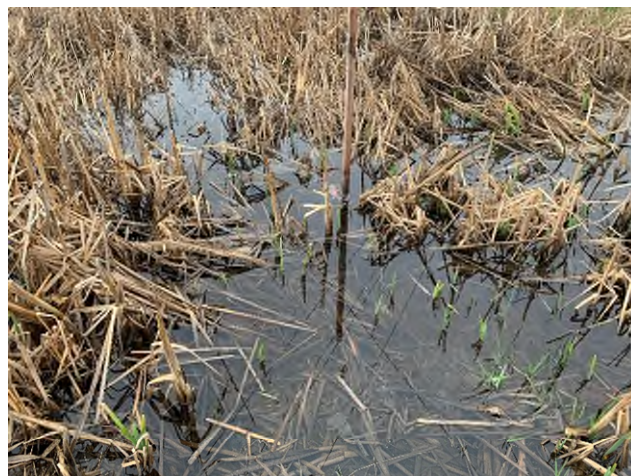
UNH Wetland - 4 (Cattail Wetland)

Location: UNH Wetland – 4 (Cattail Wetland)

Status of surface water at the time of inspection? Dry Standing Flowing

pH: 7.0

Observations/Notes: Standing water approx. 6" deep.

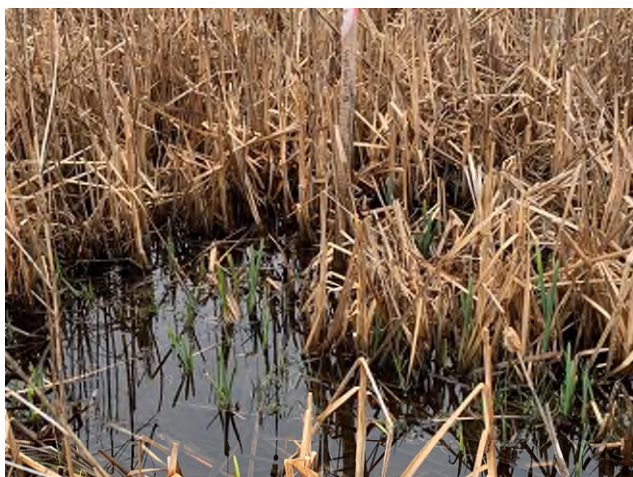
UNH Wetland - 5 (Cattail Wetland)

Location: UNH Wetland – 5 (Cattail Wetland)

Status of surface water at the time of inspection? Dry Standing Flowing

pH: 6.8

Observations/Notes: Standing water approx. 5" deep.

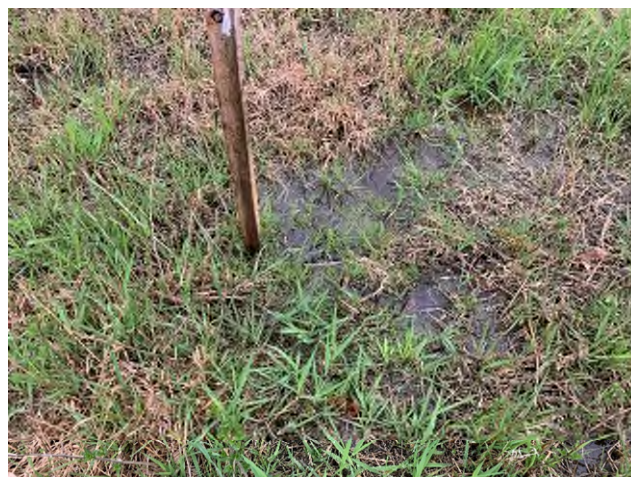
UNH Wetland - 6 (Cattail Wetland)

Location: UNH Wetland – 6 (Cattail Wetland)

Status of surface water at the time of inspection? Dry Standing Flowing

pH: 6.7

Observations/Notes: Small area of standing water approx. 1" deep.
