CONSTRUCTION MONITORING REPORT

Eversource Transmission Lines:
F107

TYPE OF INSPECTION: Weekly Storm Event Incident Corrective Action

Date: **06/21/19** Time: **12:00pm** Was this inspection triggered by a 0.25" storm event? Yes No
If yes, how did you determine whether a 0.25" storm event has occurred? Rain Gauge Weather Station
Storm event information is from Pease Air Force Base.

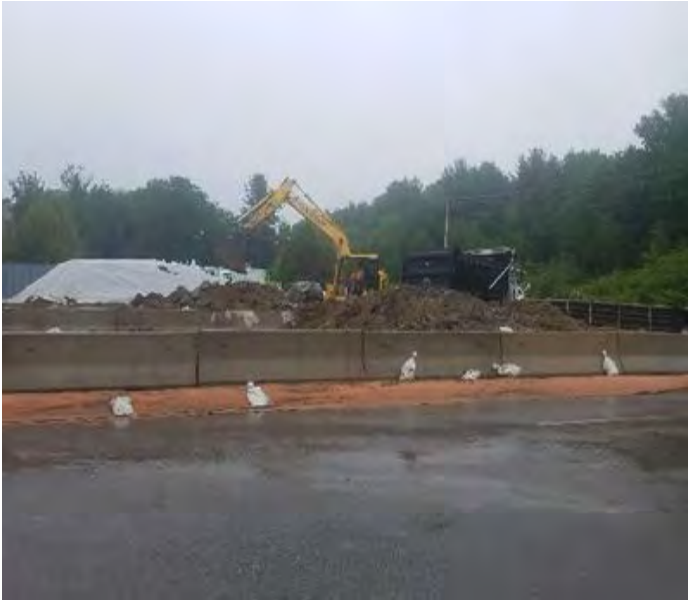
Fig 1: GZA continues to haul out soil from stockpile area in "A" lot. Viewing north. (6-20-19).

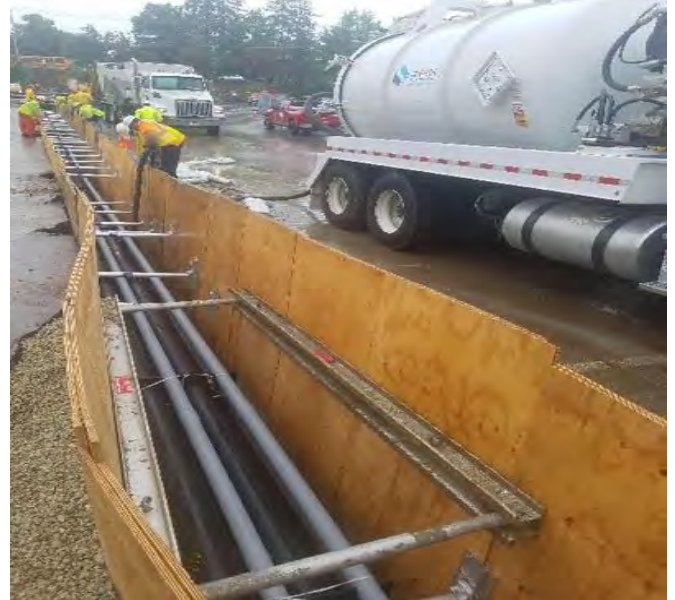
Fig 2: Vac truck is used to pump rain water out of trench in "A" lot. Viewing south. (6-20-19).

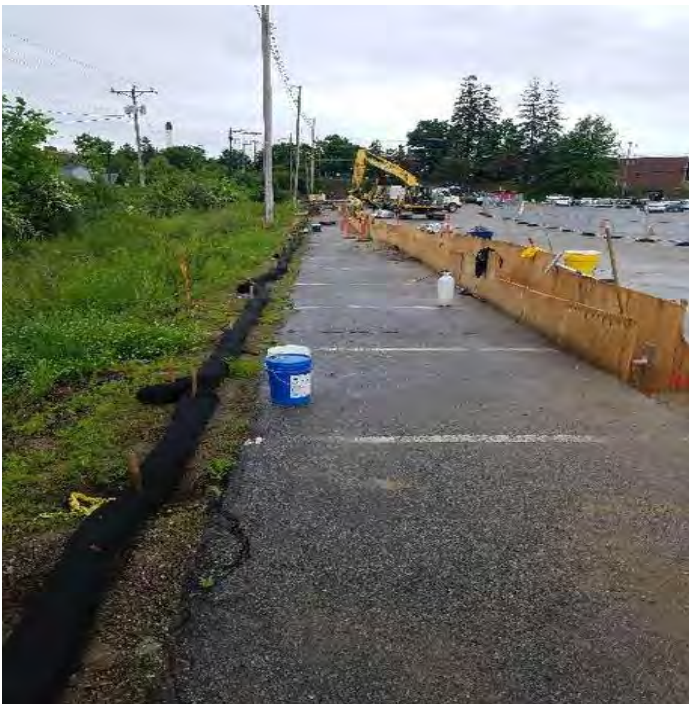
Fig 3: Silt sock installed along trenching activities in "A" lot. Viewing south. (6-21-19).

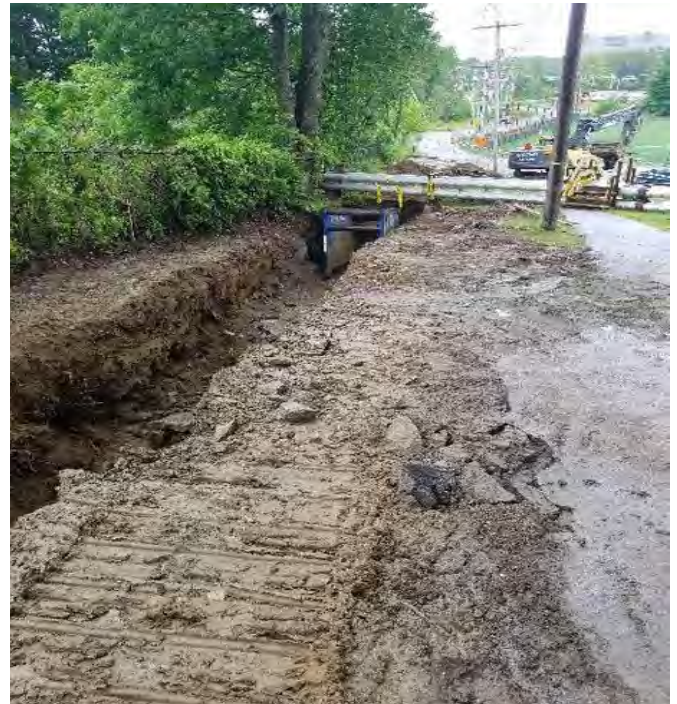
Fig 4: Trenching for duct bank next to field house at UNH. Viewing south. (6-21-19).

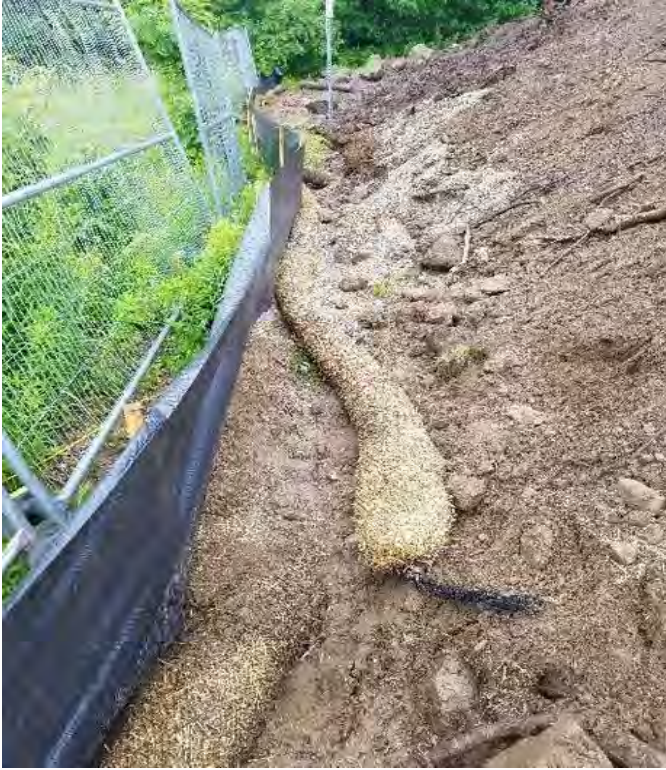
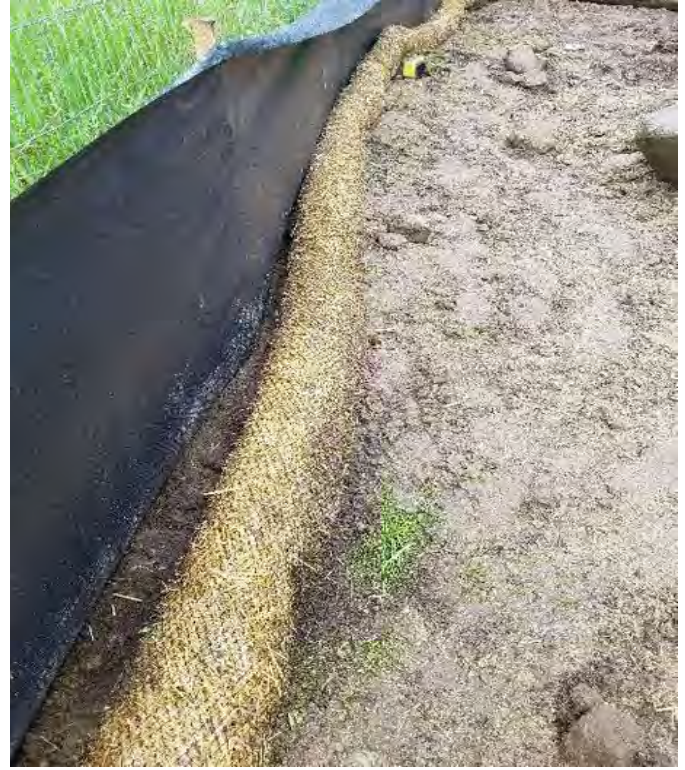
Fig 5: Silt fence and straw wattle installed between soil stockpiled in Waterworks Rd lay down area and wetland DW65. Viewing east. (6-21-19).

Fig 6: Silt fence and straw wattle installed between soil stockpiled in Waterworks Rd lay down area and wetland DW65. Viewing east. (6-21-19).

- The soil in the Waterworks Rd laydown was stockpiled slightly beyond the straw wattles that they had in place. McCourt was instructed to install silt fence around any soil stockpiles.
- **BMPs**
 - McCourt installed a silt fence on the north side of the Waterworks Rd laydown yard, between the soil stockpile and wetland DW65. This protected the wetland from any soil runoff from the laydown area. McCourt was instructed to key the silt fence into the ground, leaving no space between the fence and the ground surface. (This maintenance was completed 6-20-19).
 - The contractors have been reminded that they need to have spare BMP supplies on hand in case of emergencies. These spare supplies should be kept dry at all times; this is a requirement of the BMPs, Eversource and DES.

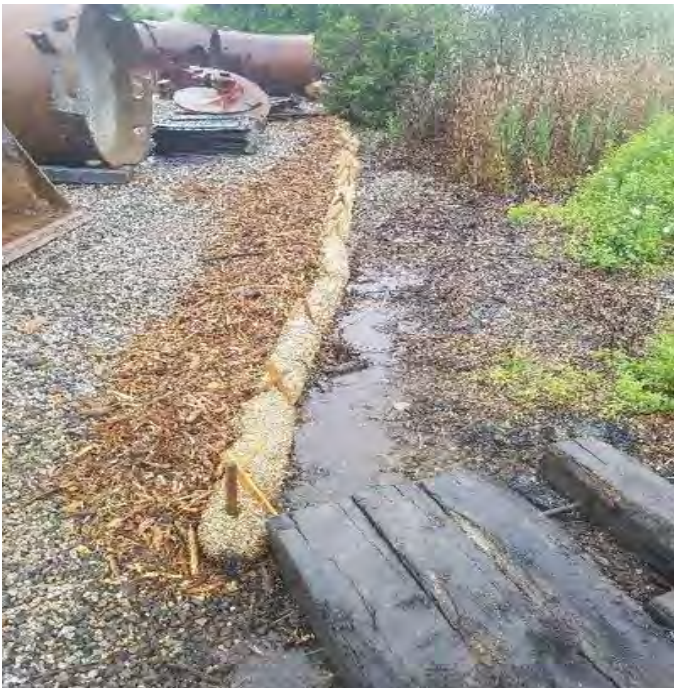
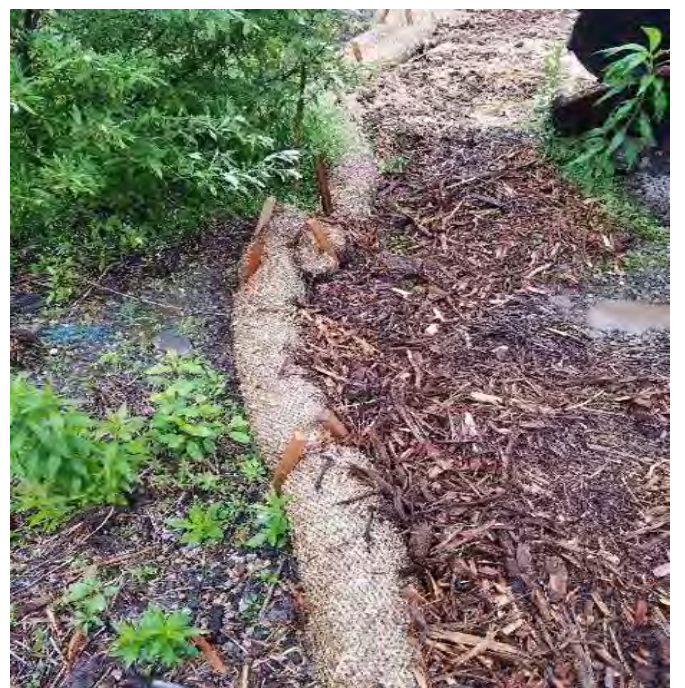
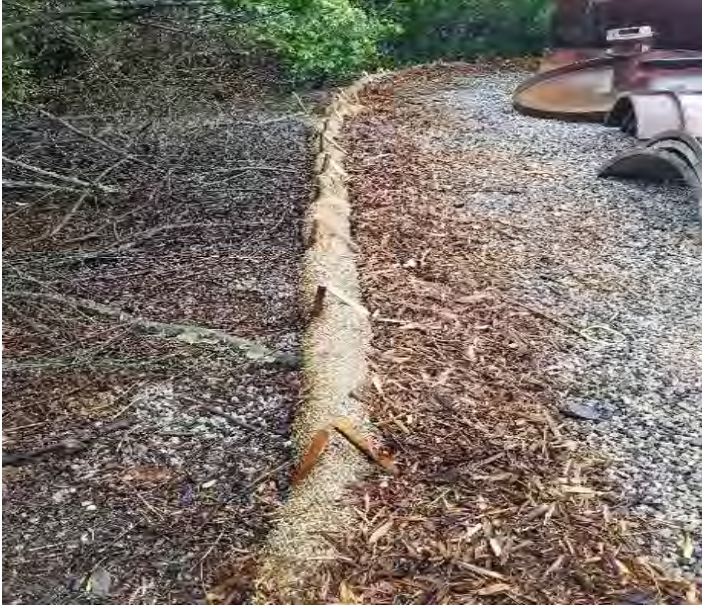
Fig 7: Combined berm installed correctly in lay down area off of Gosling Rd. Viewing south. (6-20-19).

Fig 8: Combined berm installed correctly in lay down area off of Gosling Rd. Viewing north. (6-20-19).

Fig 9: Combined berm installed correctly in lay down area off of Gosling Rd. Viewing east. (6-20-19).

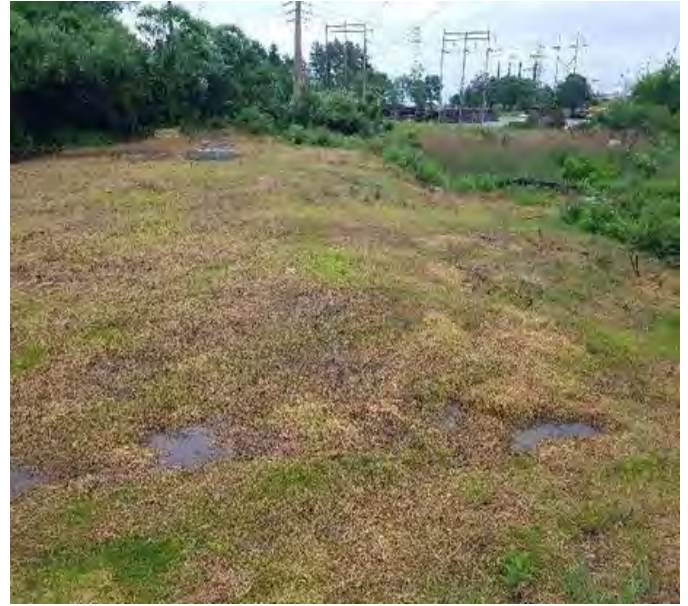
Fig 10: Str. F107-137 foundation and work pad seeded and broadcast with straw, grass beginning to grow. Viewing northeast. (6-20-19).

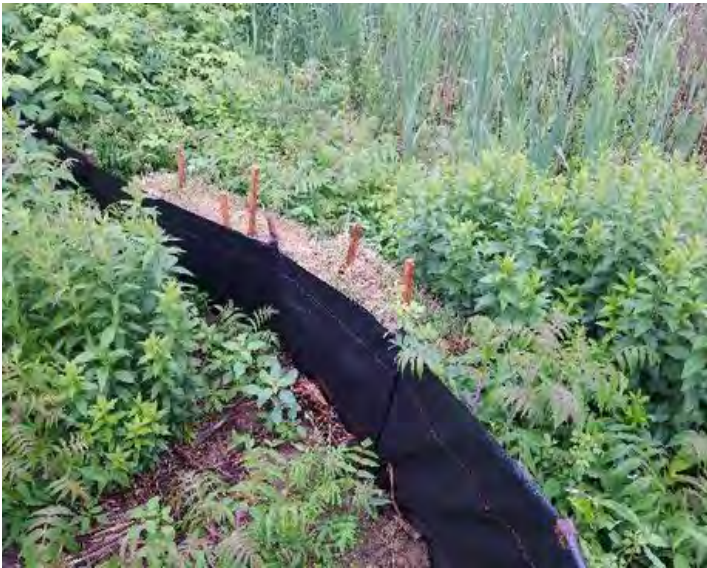
Fig 11: Silt fence and straw bales installed in low lying area between Str. F107-137 and wetland NW37. Viewing northeast. (6-21-19).

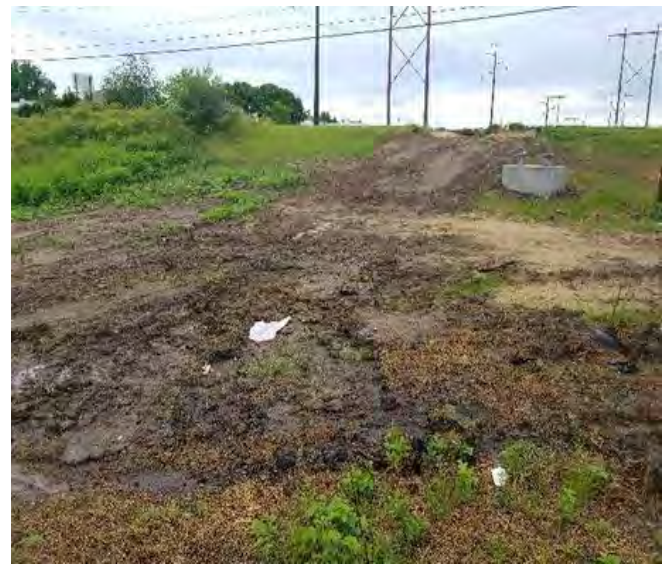
- Exposed soil was observed next to Str. F107-136 due to utility work along Woodbury Ave.

Fig 12: Exposed soil next to Str. F107-136 due to utility work along Woodbury Ave. Viewing southwest. (6-21-19).

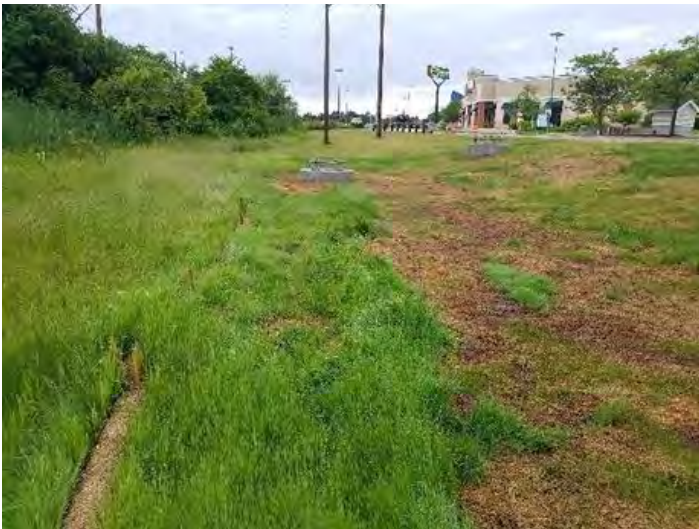
Fig 13: Str. F107-135 foundation and work site. Straw wattle are installed correctly and area has been seeded and broadcast with straw. Viewing southwest. (6-21-19).

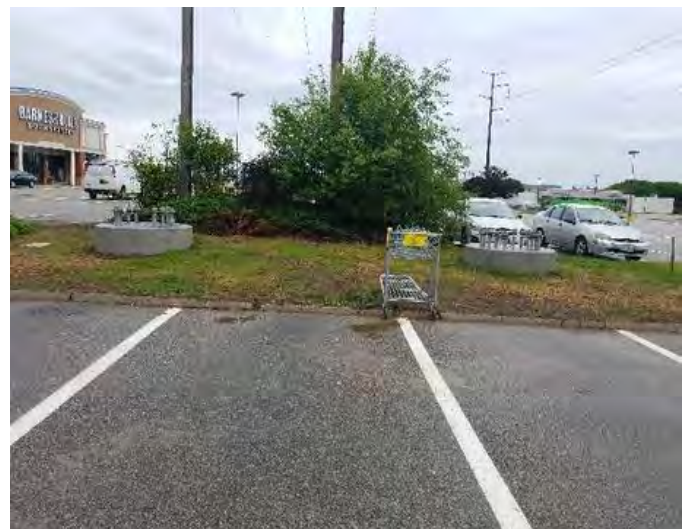
Fig 14: Str. F107-135 foundation in Newington mall parking lot, note germination. Viewing northeast. (6-21-19).
