Re: Northern Pass Wetland Application - Wetland File No. SEC -2-15-02817

On behalf of Northern Pass Transmission LLC, Normandeau Associates Inc. is submitting this request to supplement the application for a Standard Dredge and Fill Permit for the Northern Pass Transmission Line Project from Pittsburg to Londonderry, NH. This request will address the replacement or repair of culverts which do not meet the standards in the NHDES stream rules (Env-Wt 900) on proposed off-ROW access roads. These roads are located on Wagner Forest lands in Coos County, are used primarily for forestry purposes, and were permitted under a forestry Permit by Notification. The proposed change of use to construction access triggers the stream rule requirement, as identified in data request #A-7 in the Department of Environmental Services May 16, 2016 Progress Report to the NH Site Evaluation Committee. The culvert work will improve aquatic habitat connectivity and stormwater flow in streams crossed by logging roads that Northern Pass is planning to use for construction of the Project.

Culvert Locations  
(Northern Area)  
NPT ORAR Culvert Improvements  
Coos County, New Hampshire

Normandeau Associates, I

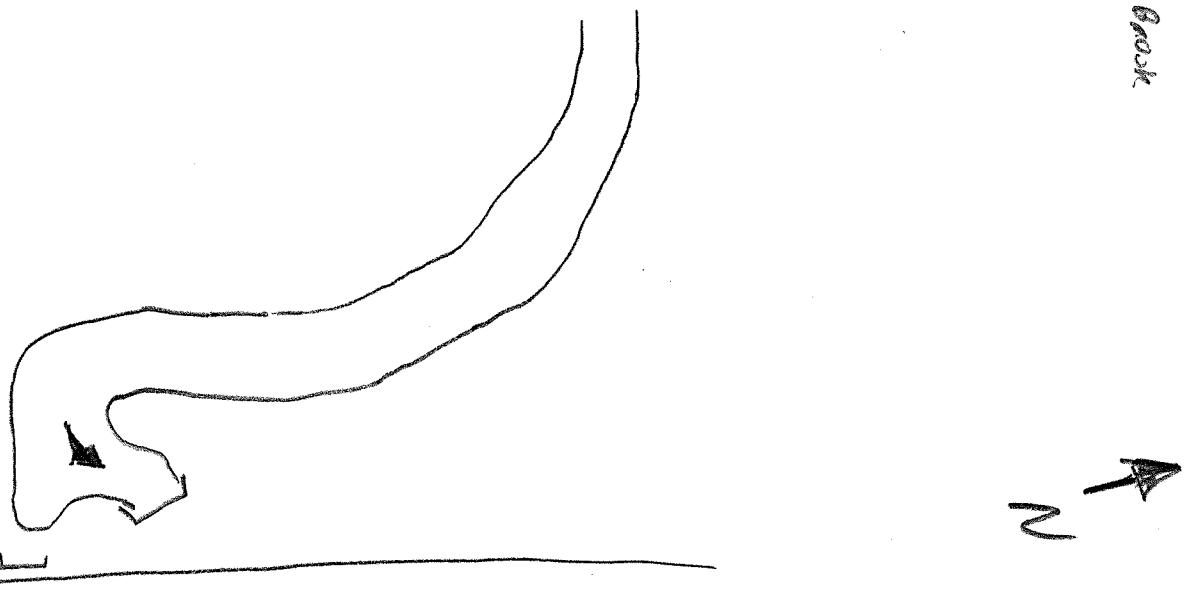
Downstream (lower) of curve hung due  
to lateral scour from Newell Branch

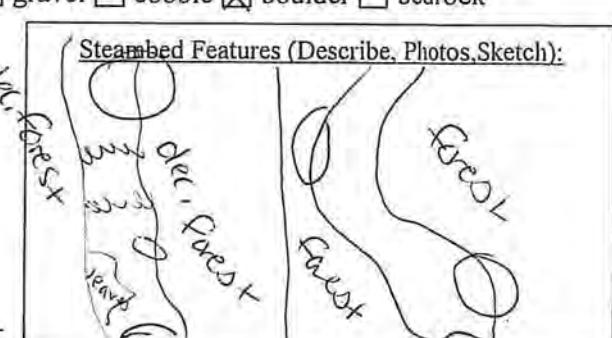
Dominant Channel Material (visual assessment):  sand  silt  gravel  cobble  boulder  bedrockPebble Count:  YES  NO (Tier 3 sites) 95 Photo of Outlet Structure and Downstream ConditionsInlet Data:  GPSDepth of water at inlet: 1" (example):

3" - channel - see commentDistance between top and bottom of culvert/bed material: 24"

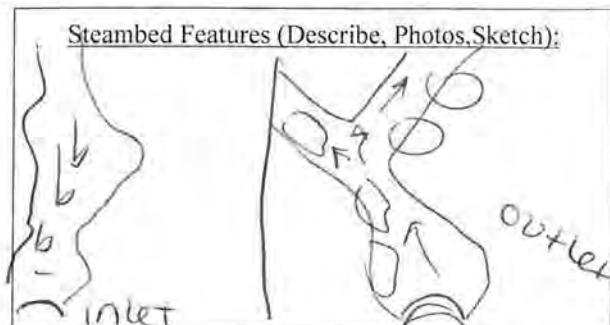
Dominant Channel Material (visual assessment):  sand  silt  gravel  cobble  boulder  bedrockPebble Count:  YES  NO (Tier 3 sites) 20 Photo of Outlet Structure and Downstream ConditionsInlet Data:  GPS5" culvert  
channel

Distance between top and bottom of culvert/bed material: 36"

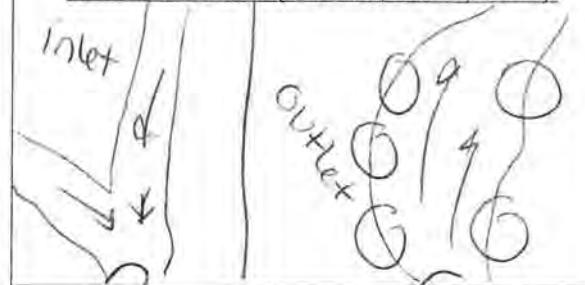
Dominant Channel Material (visual assessment):  sand  silt  gravel  cobble  boulder  bedrockPebble Count:  YES  NO (Tier 3 sites) 10 Photo of Outlet Structure and Downstream Conditions**Inlet Data:**  GPSDepth of water at inlet: 4" (example): Distance between top and bottom of culvert/bed material: 59"**Steambed Features (Describe, Photos, Sketch):**

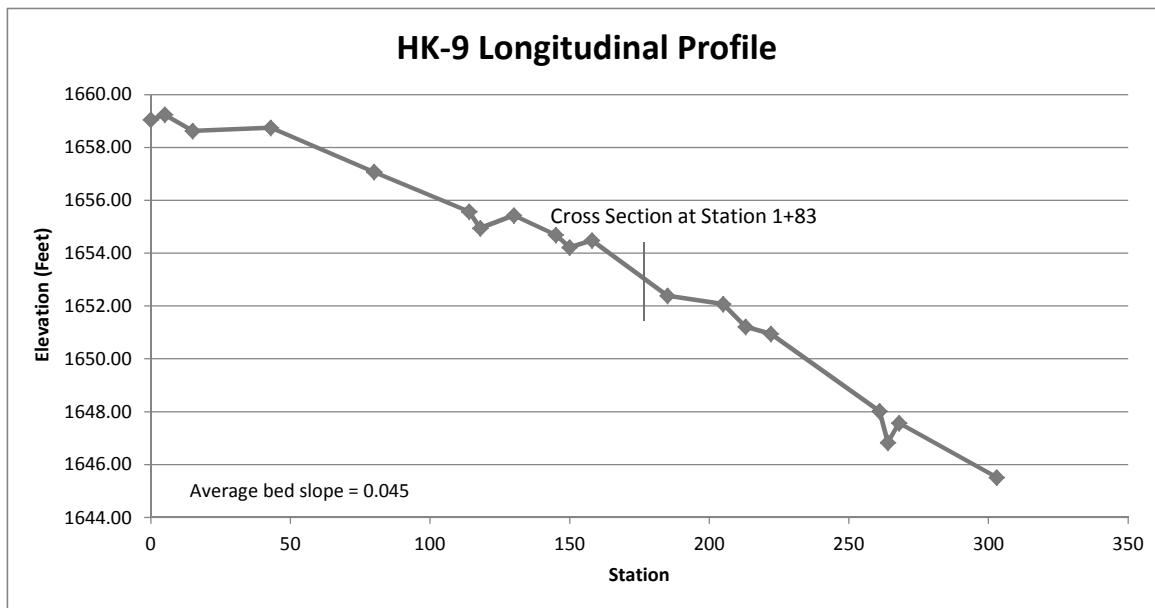
## HK-9 Cross Section

Station	Foresight	Backsight	Elevation	Notes
STA #1		16.18	1661.68	Backsight to Culvert Inlet - Invert
0	2.63		1659.05	riffle
5	2.44		1659.24	Pmax
15	3.05		1658.63	Bpool
43	2.93		1658.75	Bglide
80	4.61		1657.07	Riffle-mid
114	6.11		1655.57	Briffle
118	6.73		1654.95	Pmax
130	6.25		1655.43	Bpool
145	6.99		1654.69	Briffle
150	7.46		1654.22	Pmax
158	7.20		1654.48	Bpool
185	9.29		1652.39	Briffle
205	9.60		1652.08	Bglide
213	10.46		1651.22	Briffle
222	10.73		1650.95	Bglide
261	13.66		1648.02	Briffle
264	14.85		1646.83	Pmax
268	14.11		1647.57	Bpool
303	16.17		1645.51	Briffle
	16.18		1645.50	Culvert Inlet - Invert
	17.20		1644.48	Culvert Outlet - Invert
	9.42		1652.26	Culvert Inlet - Top
	10.25		1651.43	Culvert Outlet - Top
	8.00		1653.68	<b>Benchmark, rt side, downstream (pin on road edge in ground)</b>
	18.33		1643.35	Outlet Invert substrate
	20.39		1641.29	Pmax at outlet

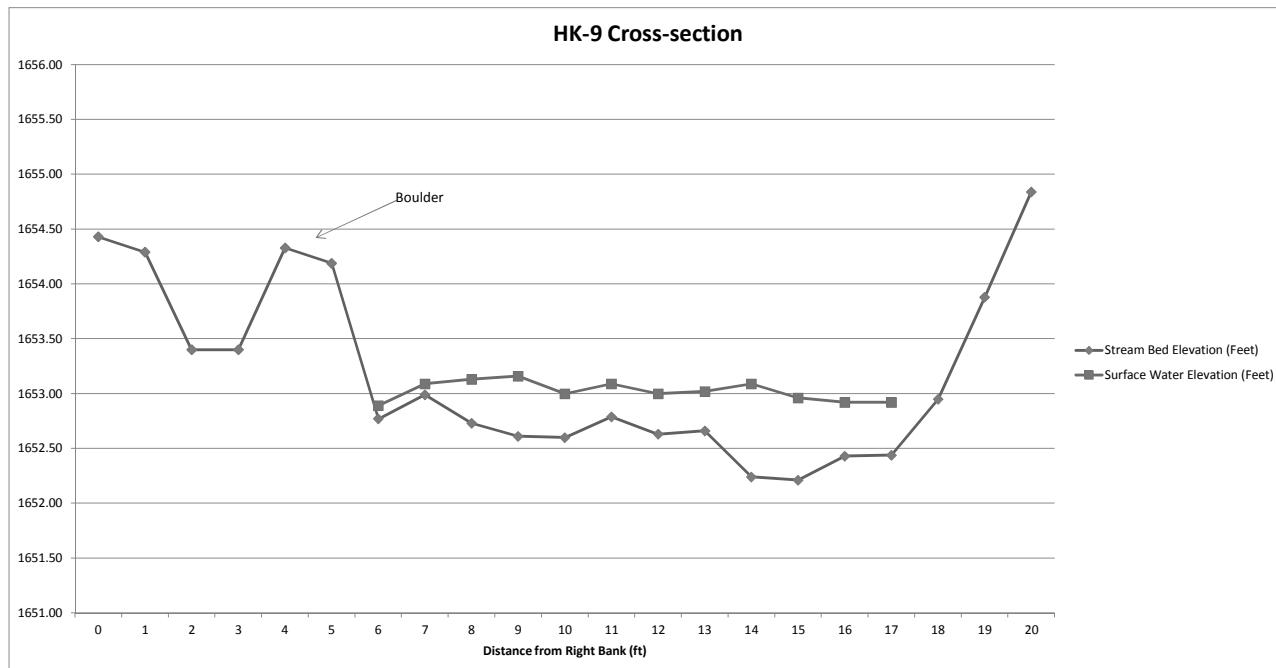
## HK-9 Pebble Counts

Particle Size (ft)	Downstream of Culvert			Upstream of Culvert			Cross-Section		
	Pebble Counts	Class %	Cum % finer	Pebble Counts	Class %	Cum % finer	Pebble Counts	Class %	Cum % finer
Sand (< 0.007')	4	4	4	0	0	0	0	0	0
Gravel (0.007 - 0.21')	13	13	17	5	5	5	20	20	20
Cobble (0.21 - 0.83')	40	41	58	52	52	57	54	54	74
Boulder (0.83 - 13.3')	41	42	100	43	43	100	26	26	100
Bedrock (> 13.3')	0	0	100	0	0	100	0	0	100
Total	98	-	-	100	-	-	100	-	-
D50 (ft.)	0.706	-	-	0.747	-	-	0.554	-	-

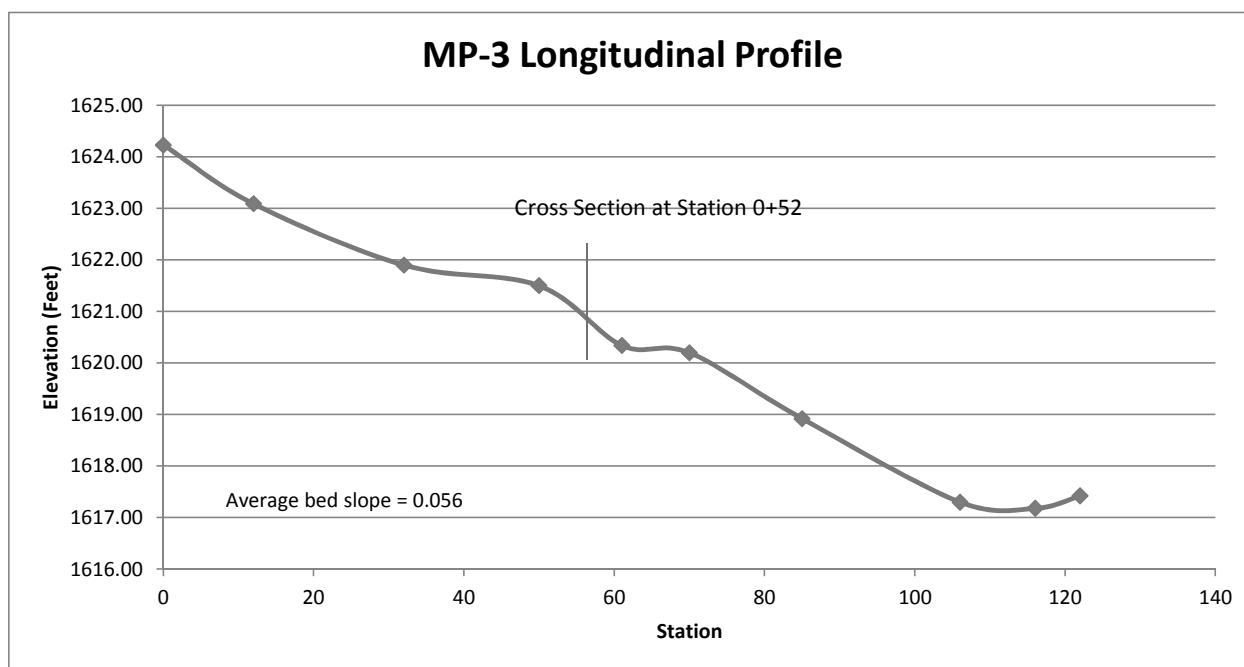
### MP-3 Cross Section

10.04		1620.64	Culvert 2 Outlet - Top
	2.10		1628.58	<b>Benchmark on Yellow Birch</b>

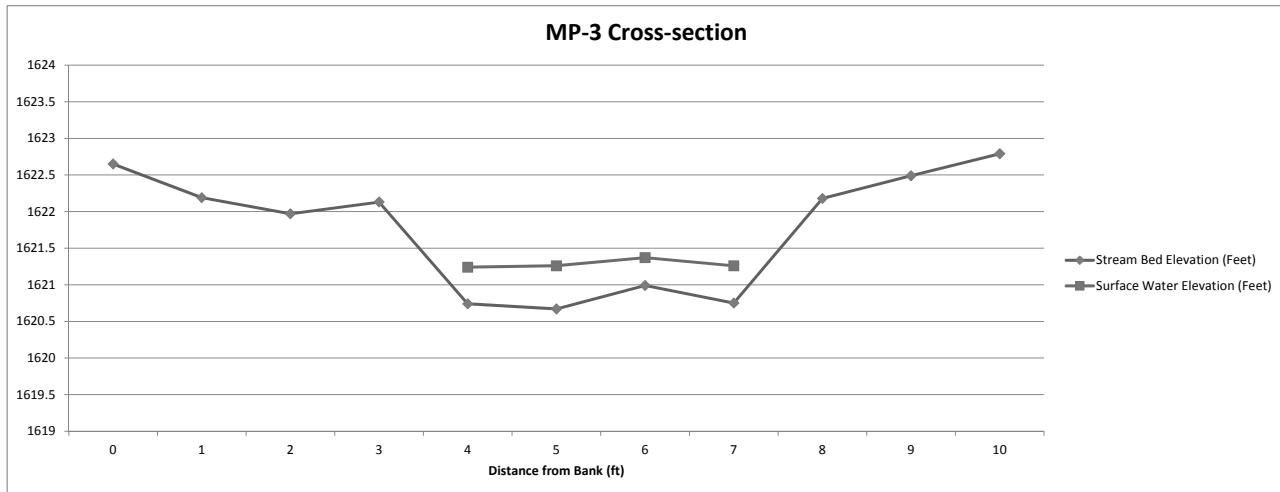
### MP-3 Pebble Counts

Particle Size (ft)	Downstream of Culvert			Upstream of Culvert			Cross-Section		
	Pebble Counts	Class %	Cum % finer	Pebble Counts	Class %	Cum % finer	Pebble Counts	Class %	Cum % finer
Sand (< 0.007')	13	13	13	4	4	4	3	3	3
Gravel (0.007 - 0.21')	20	20	33	26	26	30	7	7	10
Cobble (0.21 - 0.83')	52	52	85	22	22	52	34	34	44
Boulder (0.83 - 13.3')	15	15	100	48	48	100	56	56	100
Bedrock (> 13.3')	0	0	100	0	0	100	0	0	100
Total	100	-	-	100	-	-	100	-	-
D50 (ft.)	0.413	-	-	0.774	-	-	2.166	-	-
